### MINERALS PROGRAM INSPECTION REPORT

<b>MINE NAME:</b> Gray Pit	<b>MINE/PROSPECTING ID#:</b> M-1990-148	<b>MINERAL:</b> Gravel	<b>COUNTY:</b> Kiowa
<b>INSPECTION TYPE:</b> Monitoring	<b>WEATHER:</b> Clear	<b>INSP. DATE:</b> January 30, 2024	<b>INSP. TIME:</b> 13:30
<b>OPERATOR:</b> Kiowa County	<b>OPERATOR REPRESENTATIVE:</b> Rick Spady	<b>TYPE OF OPERATION:</b> 110c - Construction Limited Impact

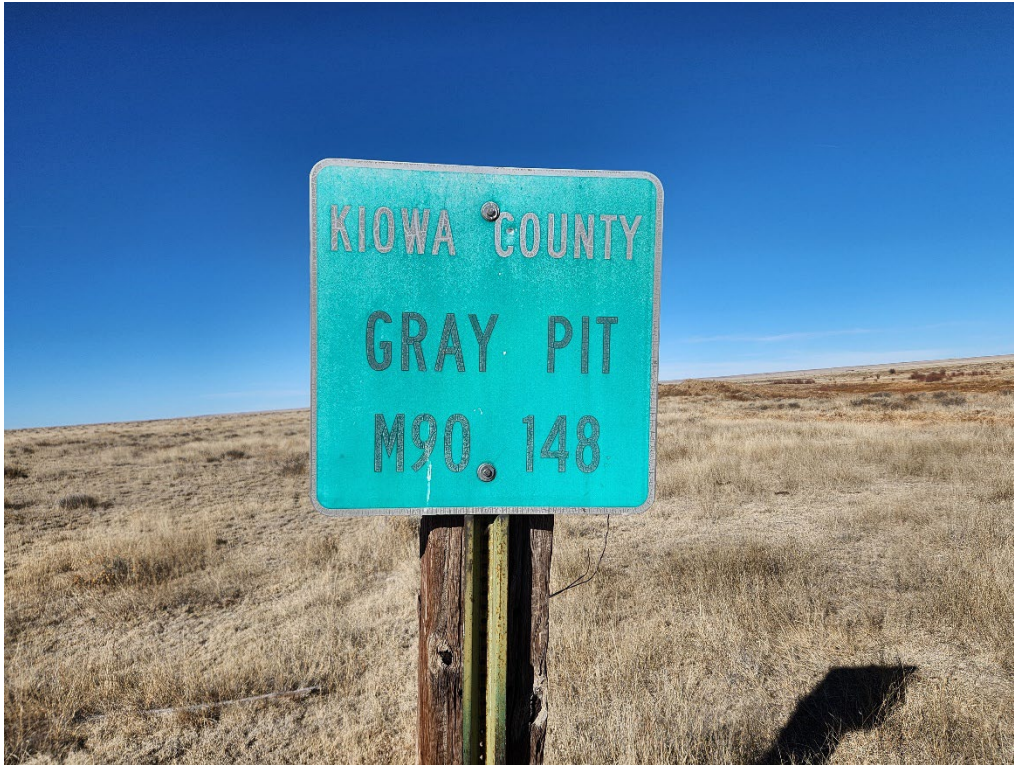
**PROBLEM/POSSIBLE VIOLATION:** Problem: The current mine identification sign posted at the entrance of the mine site is weathered and the permit number is no longer readable. The sign also does not include a statement that the reclamation permit for the operation has been issued by the Colorado Mined Land Reclamation Board (CMLRB). This is a problem for failure to meet all requirements of a mine identification sign per Rule 3.1.12(1).

The mine entrance sign is weathered away and difficult to read. There is also no statement on the mine entrance sign that a reclamation permit for the operation has been issued by the Colorado Mined Land Reclamation Board (CMLRB), therefore the sign does not include all information required by Rule 3.1.12(1). This is cited as a problem in the report (see page 1). The operator will need to submit photo documentation that a proper sign has been posted by the corrective action due date.

**Photo 1.** Mine entrance sign looking east.

**CORRECTIVE ACTIONS:** The operator shall, at the entrance of the mine site post a sign, which shall be clearly visible from the access road, with a minimum size equaling one hundred and eighty-seven (187) square inches, such as eleven (11) inches in height and seventeen (17) inches in width, with appropriate font size, with the following: the name of the operator, the operation name, a statement that a reclamation permit for the operation has been issued by the CMLRB, and the permit number. The operator shall submit photo documentation that a proper sign has been posted by the corrective action due date.

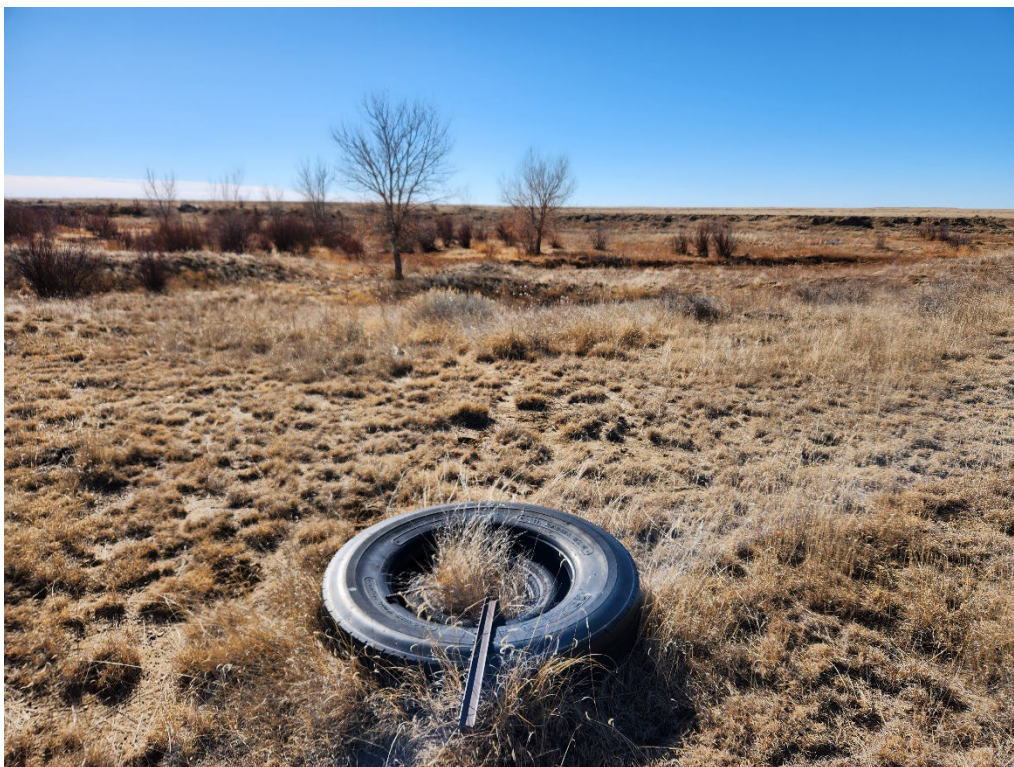
**Photo 2.** Permit boundary marker in the southwest corner looking north.

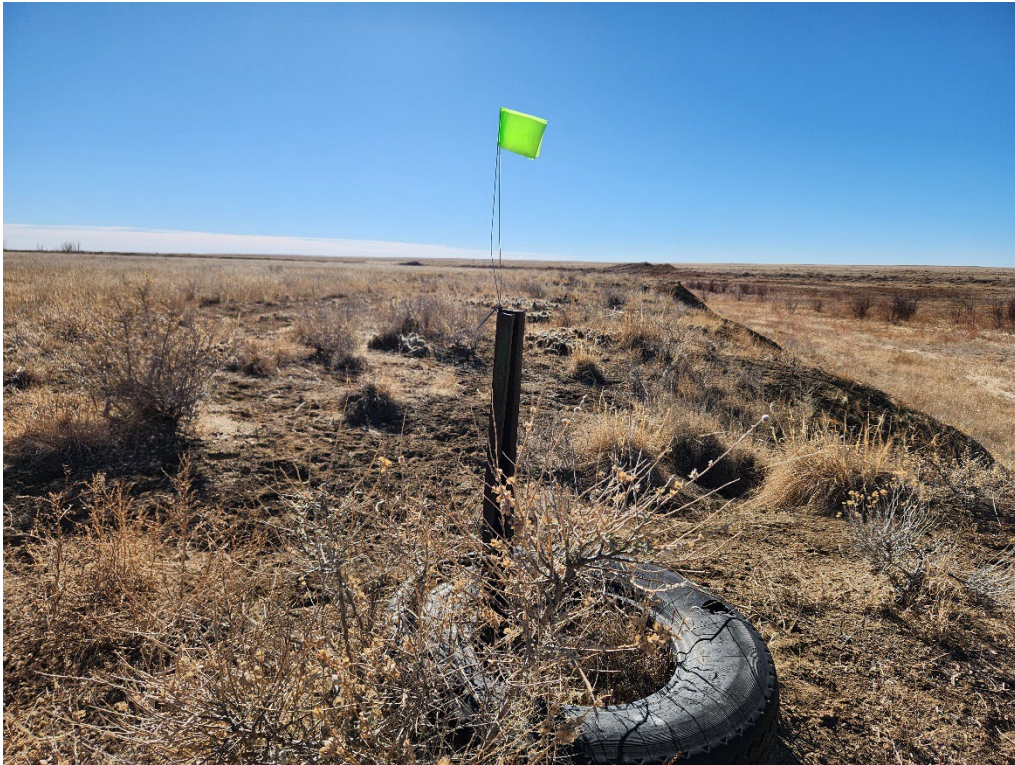
**Photo 3.** Permit boundary marker in the northeast corner looking west.

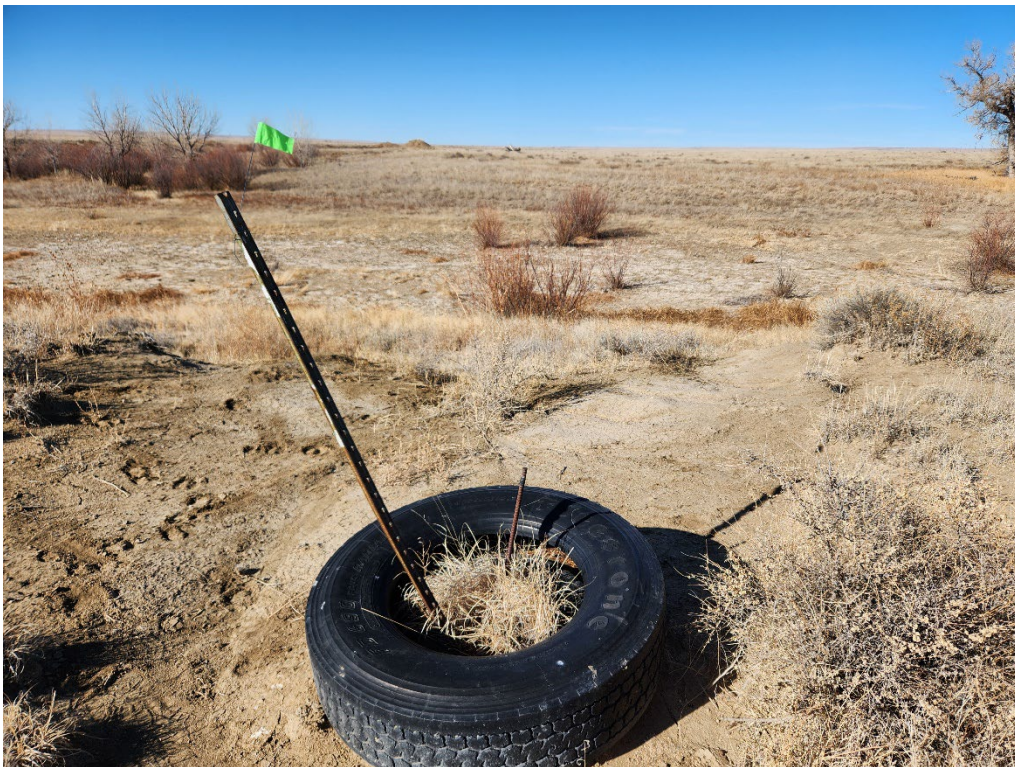
**Photo 4.** Permit boundary marker south of site looking north.

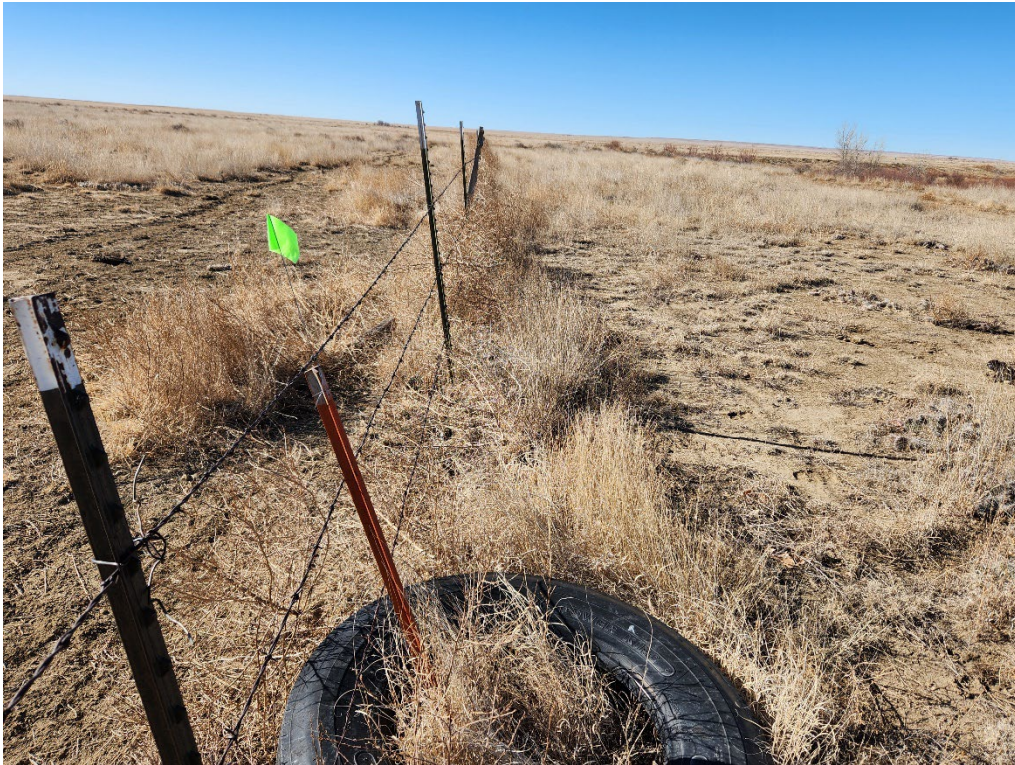
**Photo 5.** Permit boundary marker along the western edge of the site looking north.

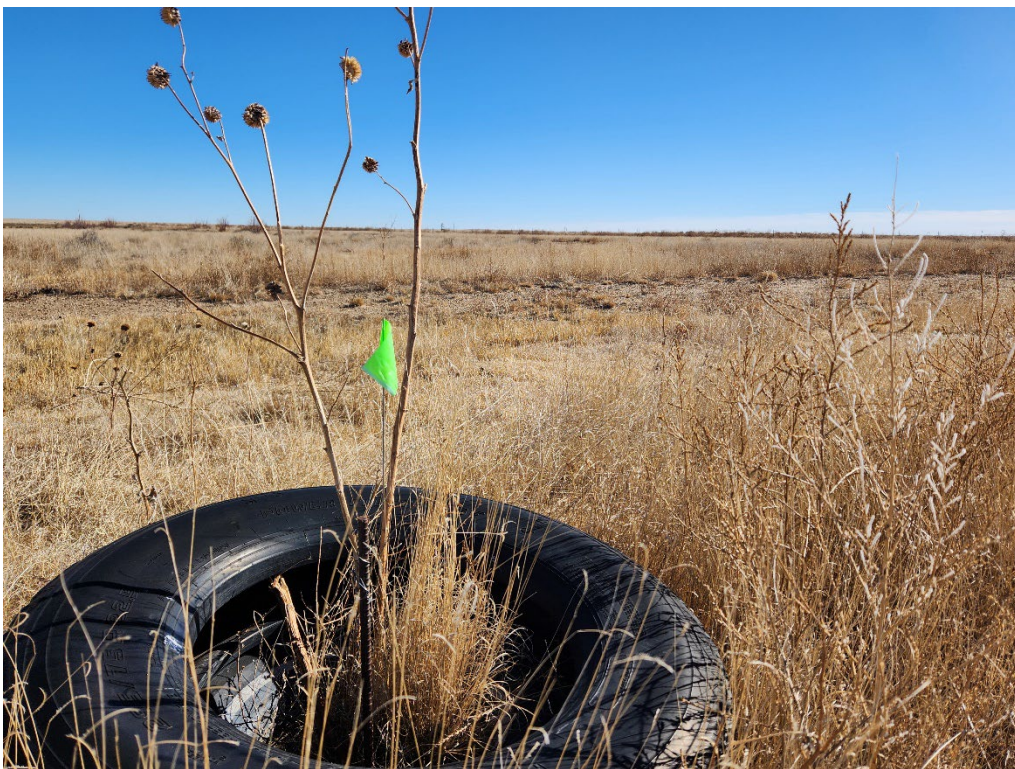
**Photo 6.** Permit boundary marker in northwest corner of the site looking north.

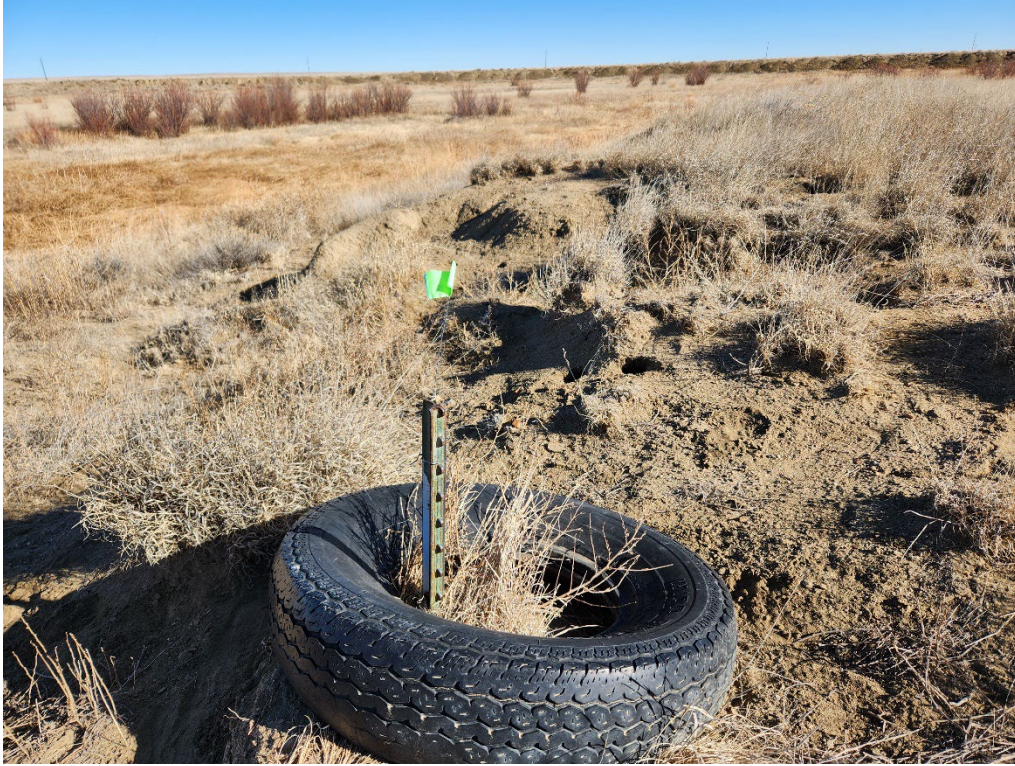
**Photo 7.** Permit boundary marker in north of site looking north.

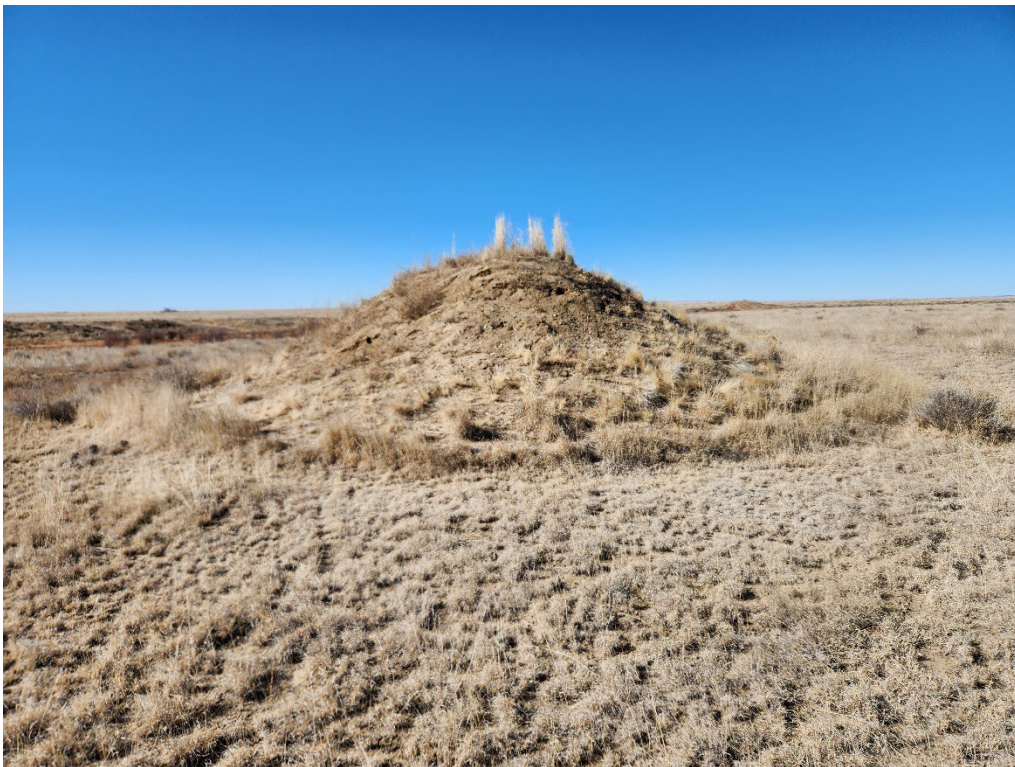
**Photo 8.** Topsoil stockpile located south of the site looking north.

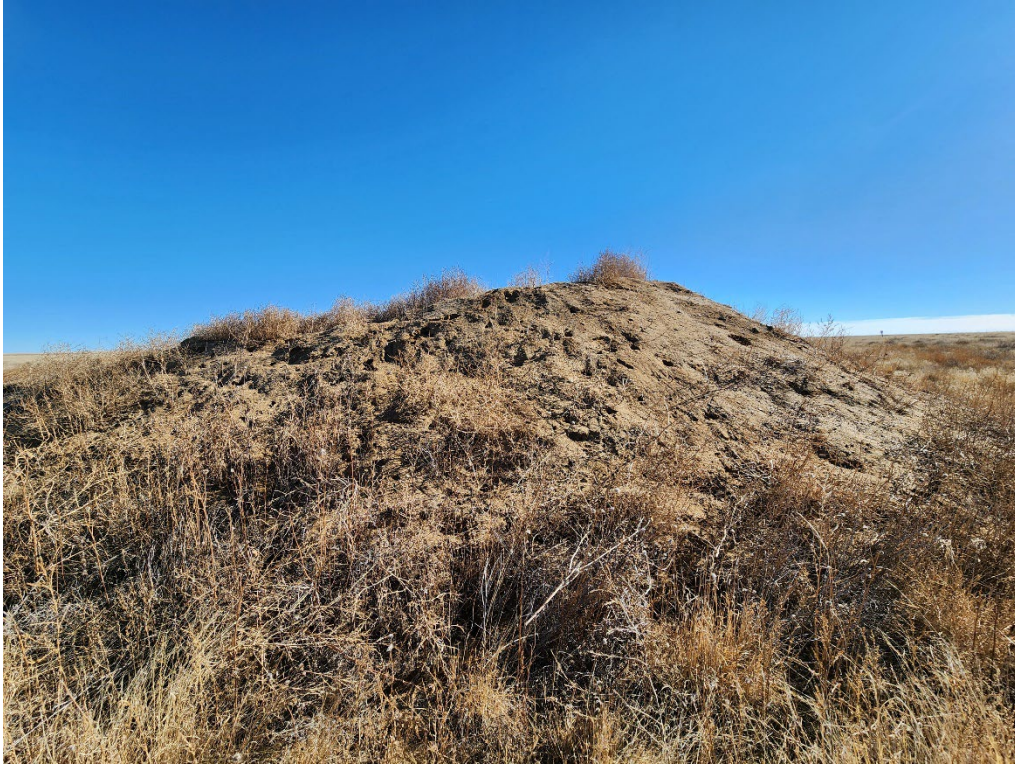
**Photo 9.** topsoil stockpile located in the north of the site.
