**MINERALS PROGRAM INSPECTION REPORT**  
**PHONE: (303) 866-3567**

<b>MINE NAME:</b> Barnett Pit	<b>MINE/PROSPECTING ID#:</b> M-1991-074	<b>MINERAL:</b> Gravel	<b>COUNTY:</b> Kiowa
<b>INSPECTION TYPE:</b> Monitoring	<b>WEATHER:</b> Clear	<b>INSP. DATE:</b> January 30, 2024	<b>INSP. TIME:</b> 11:30
<b>OPERATOR:</b> Kiowa County	<b>OPERATOR REPRESENTATIVE:</b> Allen Watts	<b>TYPE OF OPERATION:</b> 112c - Construction Regular Operation	
<b>REASON FOR INSPECTION:</b> Normal I&E Program	<b>BOND CALCULATION TYPE:</b> None	<b>BOND AMOUNT:</b> \$0.00	
<b>DATE OF COMPLAINT:</b> NA	<b>POST INSP. CONTACTS:</b> None	<b>JOINT INSP. AGENCY:</b> None	
<b>INSPECTOR(S):</b> Joel Renfro	<b>INSPECTOR'S SIGNATURE:</b>

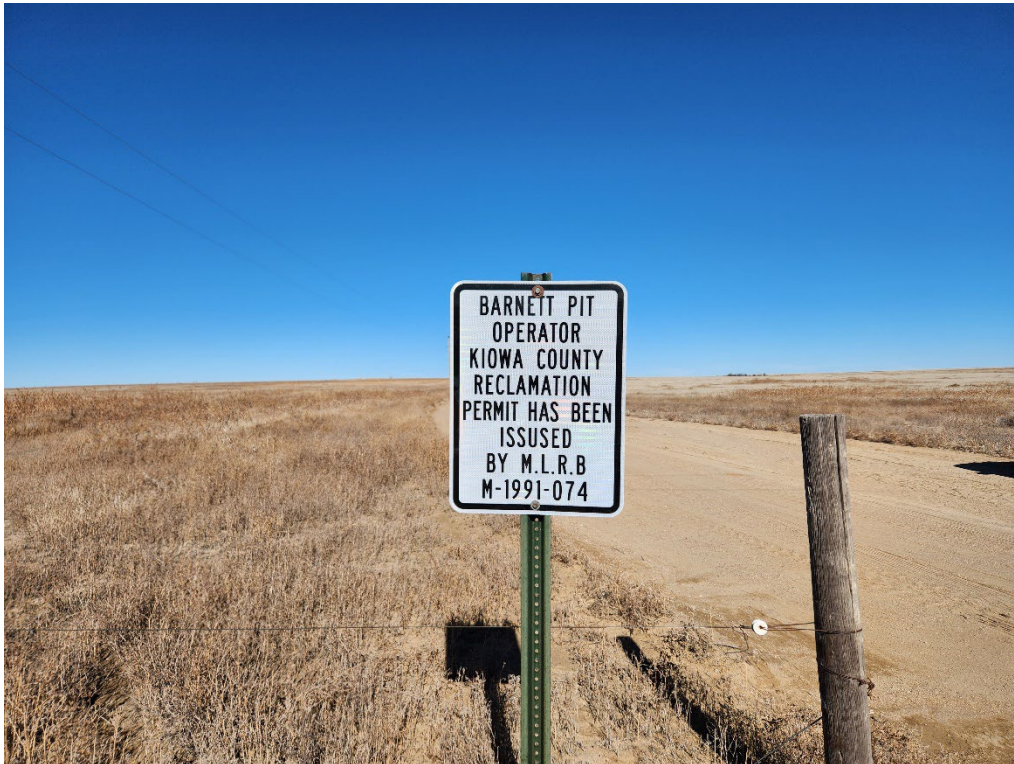
**Figure 1.** Mine entrance sign looking north.

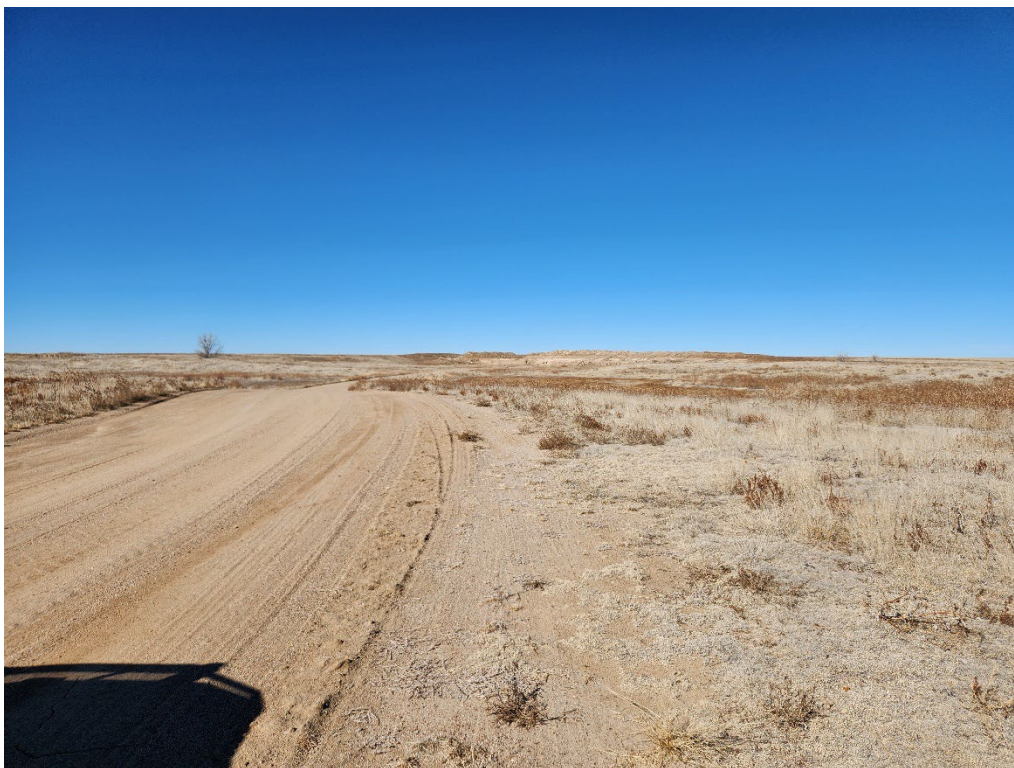
**Figure 2.** Access road to the mine looking north.

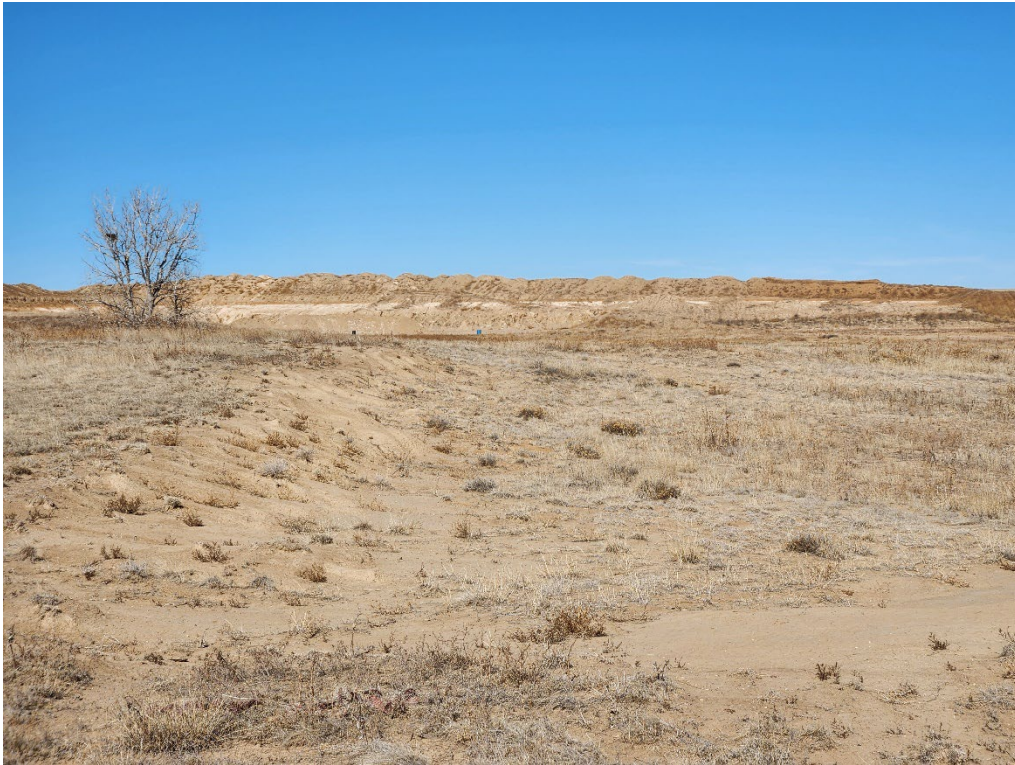
**Figure 3.** View of the site from the southern edge looking north.

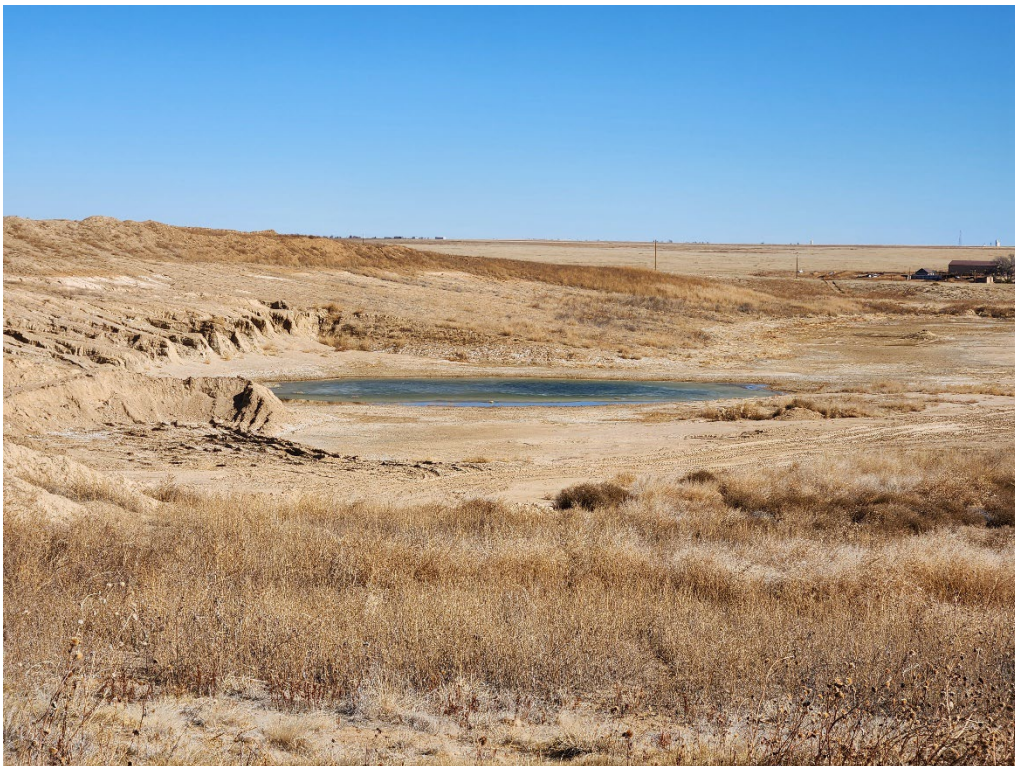
**Figure 4.** Active mined pit looking east.

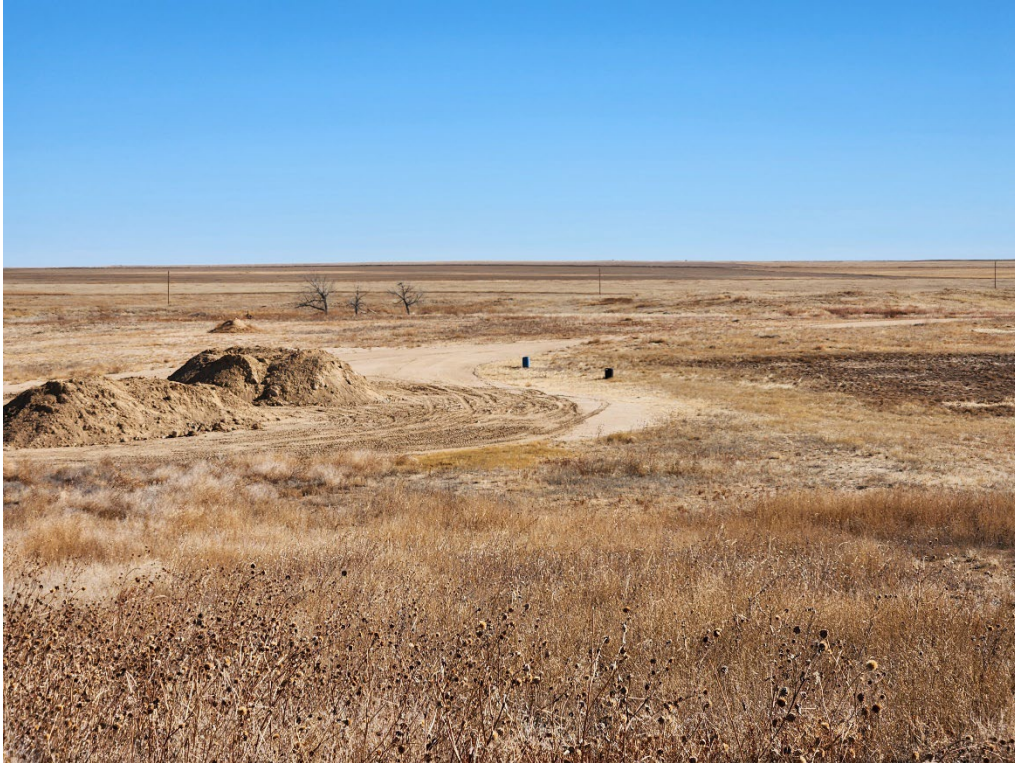
The approved post-mine land use is rangeland. Reclamation for this site will include backfilling and grading slopes to 3H:1V or flatter, placing 6 inches of topsoil, and planting a native grass seed mix. Fertilizer will be used as needed. Some area south of the active pit is in reclamation, where the grasses appear to be growing well and no weeds were found.

**Figure 5.** Product stockpiles on the left and area in reclamation to the right looking east

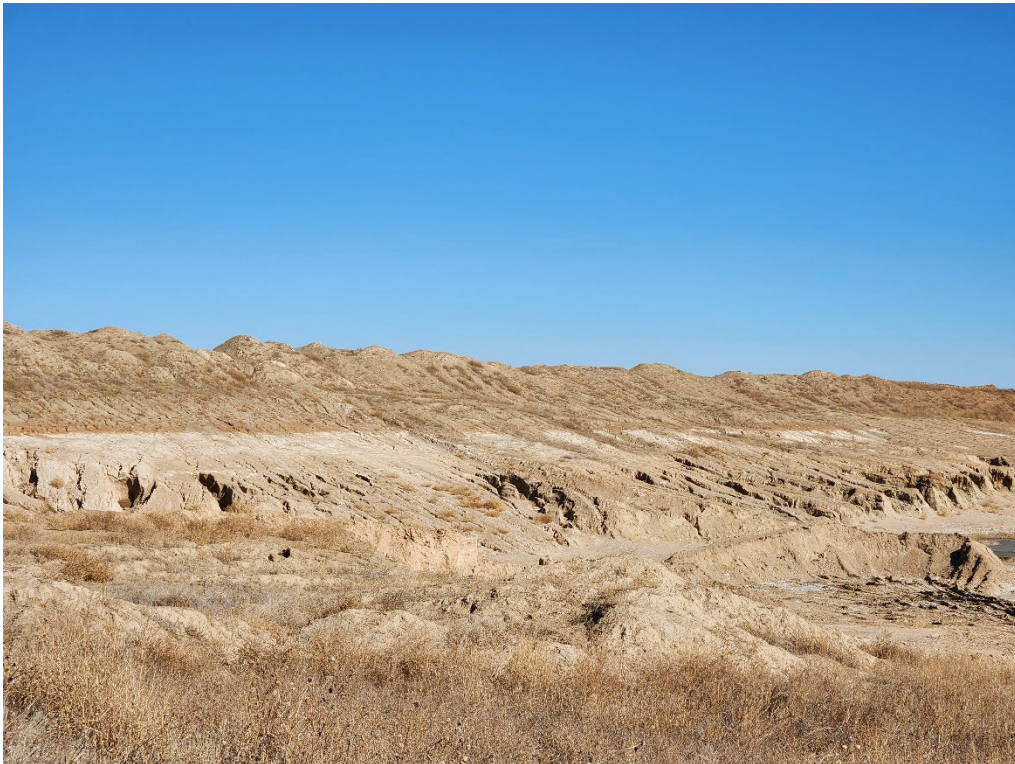
During the inspection, no mining was actively occurring, this site is active though with it last being mined in August 2023. The mining occurs from south to north along a highwall that is approximately 15 feet high, with an estimated slope of 2H:1V. The mined materials are stockpiled on the pit floor and transported as needed. Most of the remaining mining activity takes place in the northern part of the permit area with a 100-foot setback from the northern property fence being maintained by the operation. The topsoil stockpiles are located along the north, west, and eastern edges of the mined pit. During the inspection, some water was noticed in the pit. However, it was difficult to determine how long it had been there, as it had just melted due to snowfall in the area prior to the inspection.

**Figure 6.** Highwall to be mined north of the pit looking northeast.

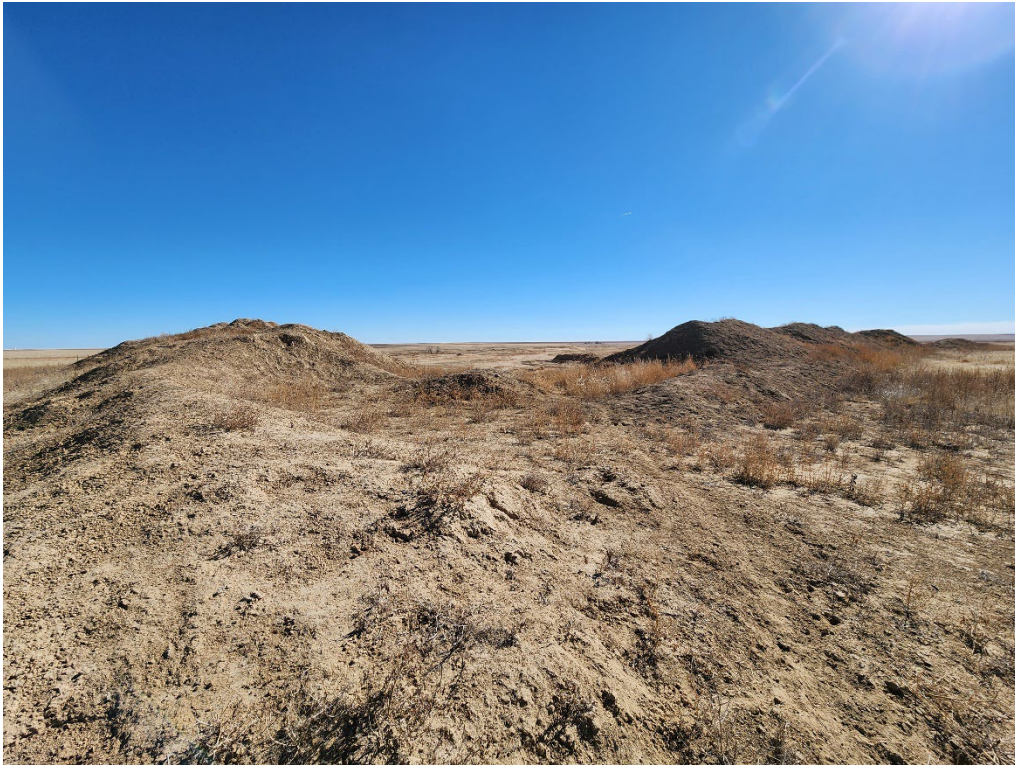
**Figure 7.** Topsoil stockpiles in the northwestern corner of the site looking southeast.

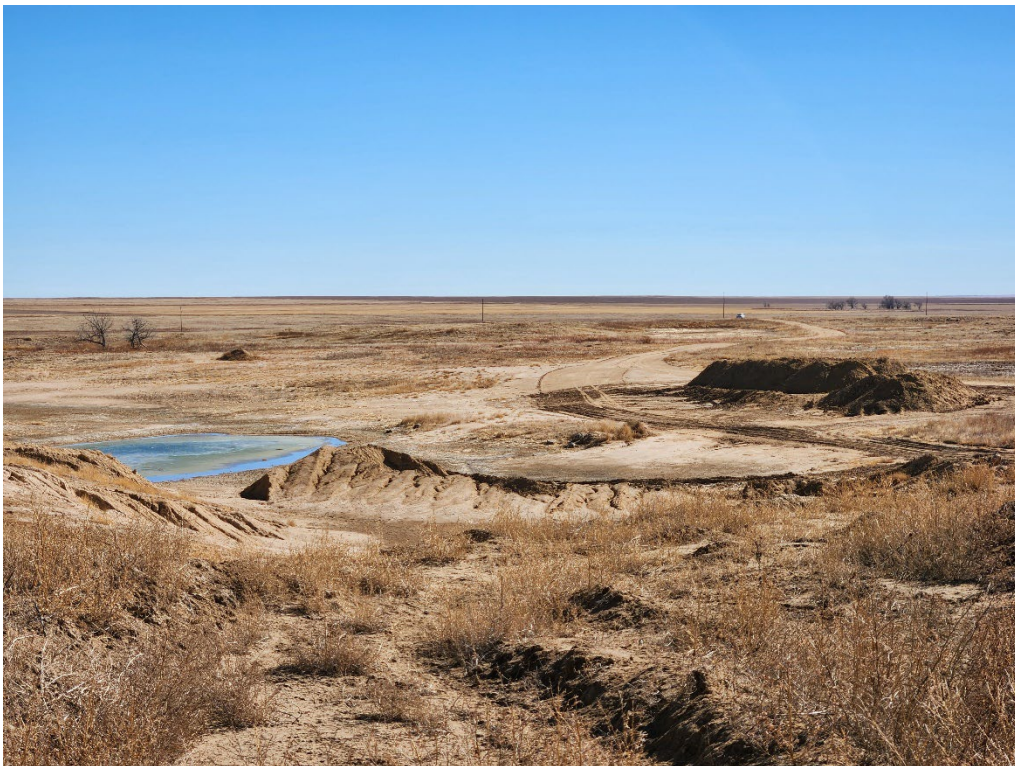
**Figure 8.** Mined pit looking southeast.

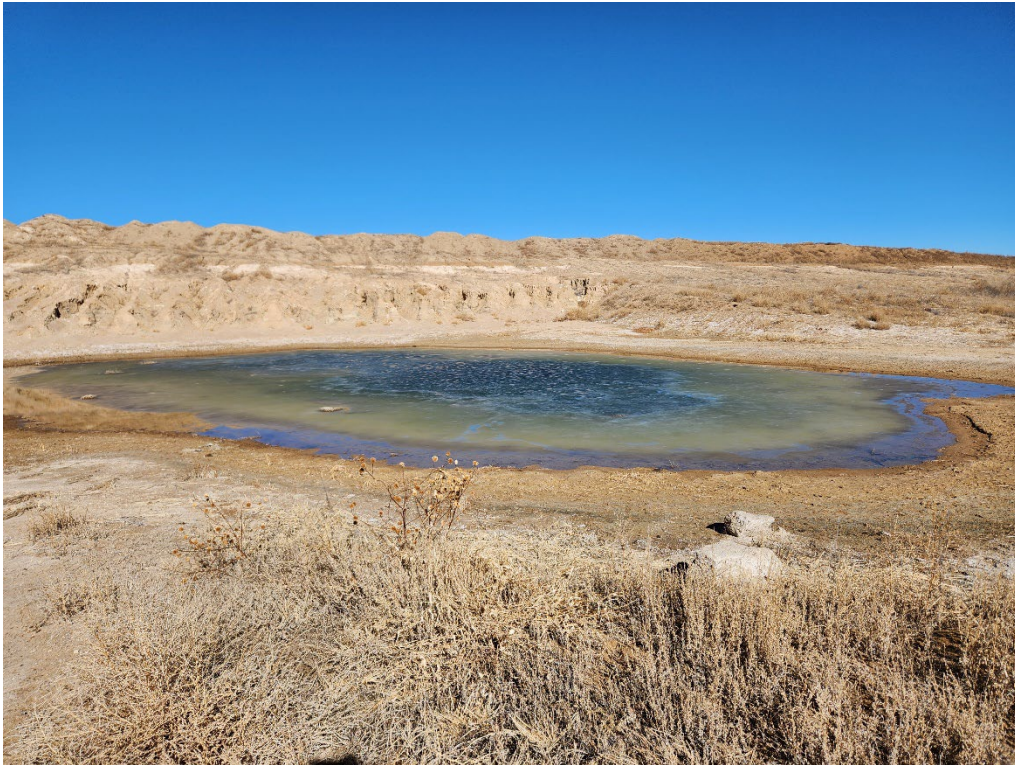
**Figure 9.** Water in the pit floor looking north.

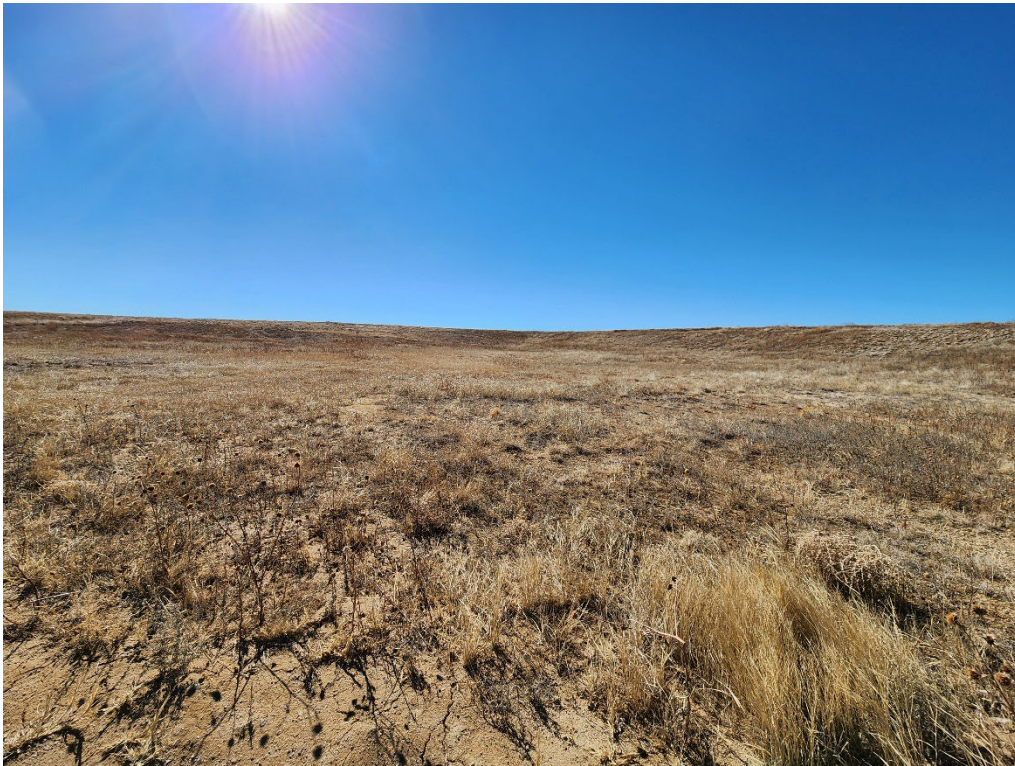
**Figure 10.** Area in reclamation looking south.
