**MINERALS PROGRAM INSPECTION REPORT**  
**PHONE: (303) 866-3567**

<b>MINE NAME:</b> Section 20 Mine	<b>MINE/PROSPECTING ID#:</b> M-2022-004	<b>MINERAL:</b> Overburden and sand	<b>COUNTY:</b> Weld
<b>INSPECTION TYPE:</b> Monitoring	<b>WEATHER:</b> Cloudy	<b>INSP. DATE:</b> March 7, 2024	<b>INSP. TIME:</b> 09:30
<b>OPERATOR:</b> Jalisco International, Inc.	<b>OPERATOR REPRESENTATIVE:</b> Pete Kubiak	<b>TYPE OF OPERATION:</b> 111 - Construction by Government Agency	
<b>REASON FOR INSPECTION:</b> Normal I&E Program	<b>BOND CALCULATION TYPE:</b> None	<b>BOND AMOUNT:</b> \$75,000.00	
<b>DATE OF COMPLAINT:</b> NA	<b>POST INSP. CONTACTS:</b> None	<b>JOINT INSP. AGENCY:</b> None	
<b>INSPECTOR(S):</b> Brock Bowles	<b>INSPECTOR'S SIGNATURE:</b>

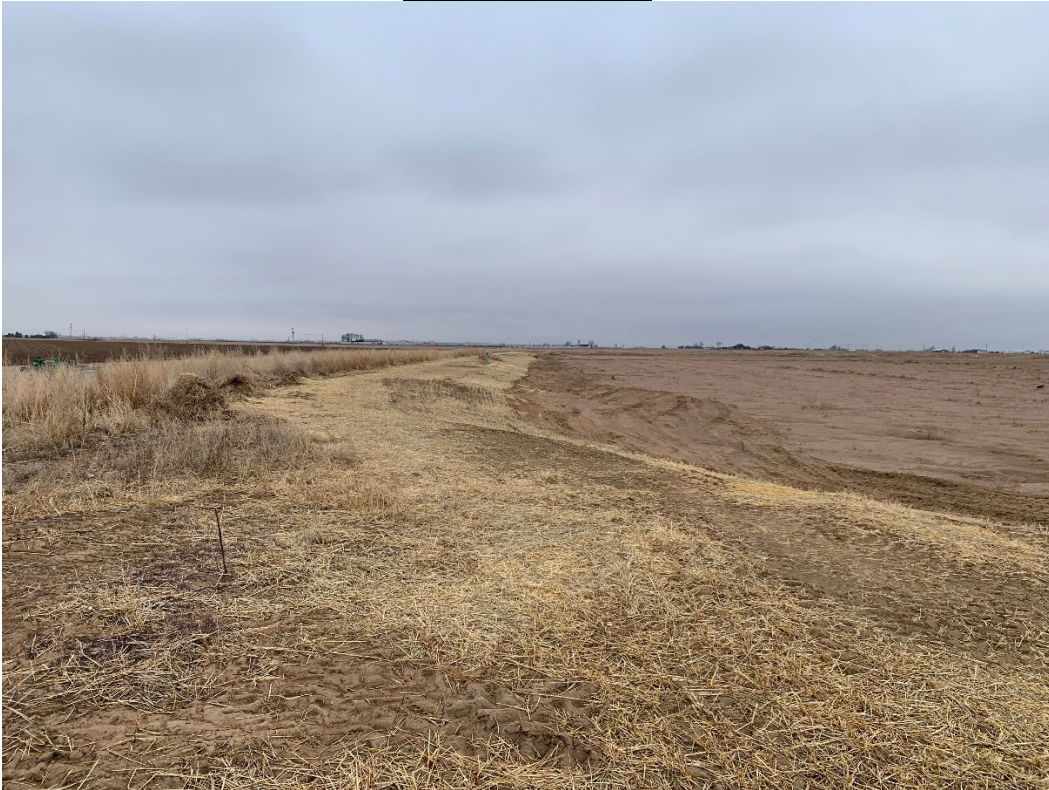
The banks of the pit were graded to 3h:1v or less on all sides (photo 1). The bottom of the pit mostly graded flat with some ridges left in place (photo 2). It was comprised of sandy loose material. No product stockpiles were noted on the site.

Photo 1 – East bank of mine pit facing south

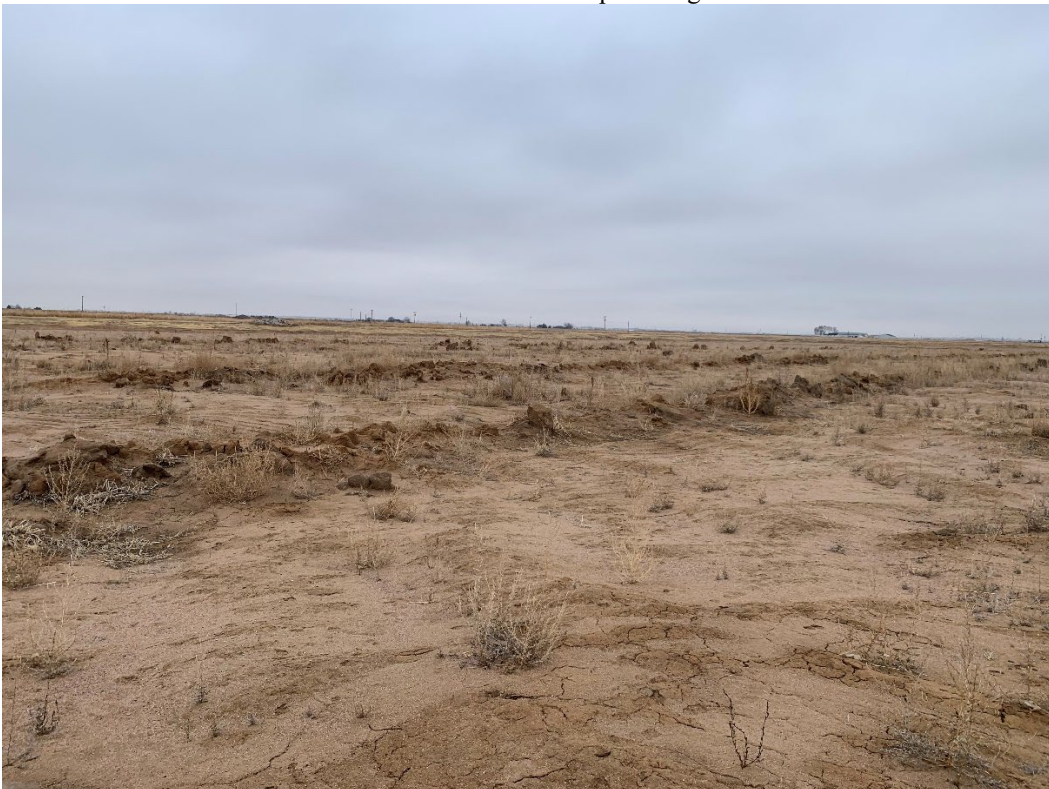
Photo 2 – The bottom of the pit facing southeast

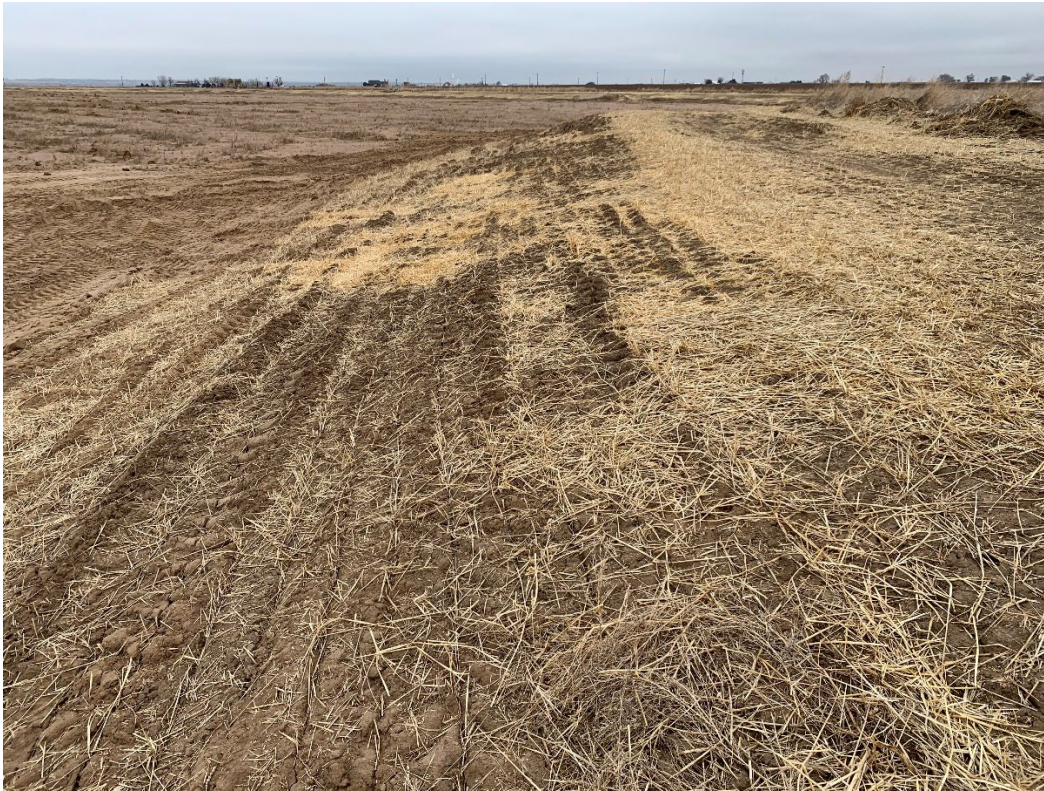
All the banks of the pit had been seeded and mulched in February 2024 (photo 3). The straw mulch had been crimped in.

Photo 3 – Seeded and mulched pit bank

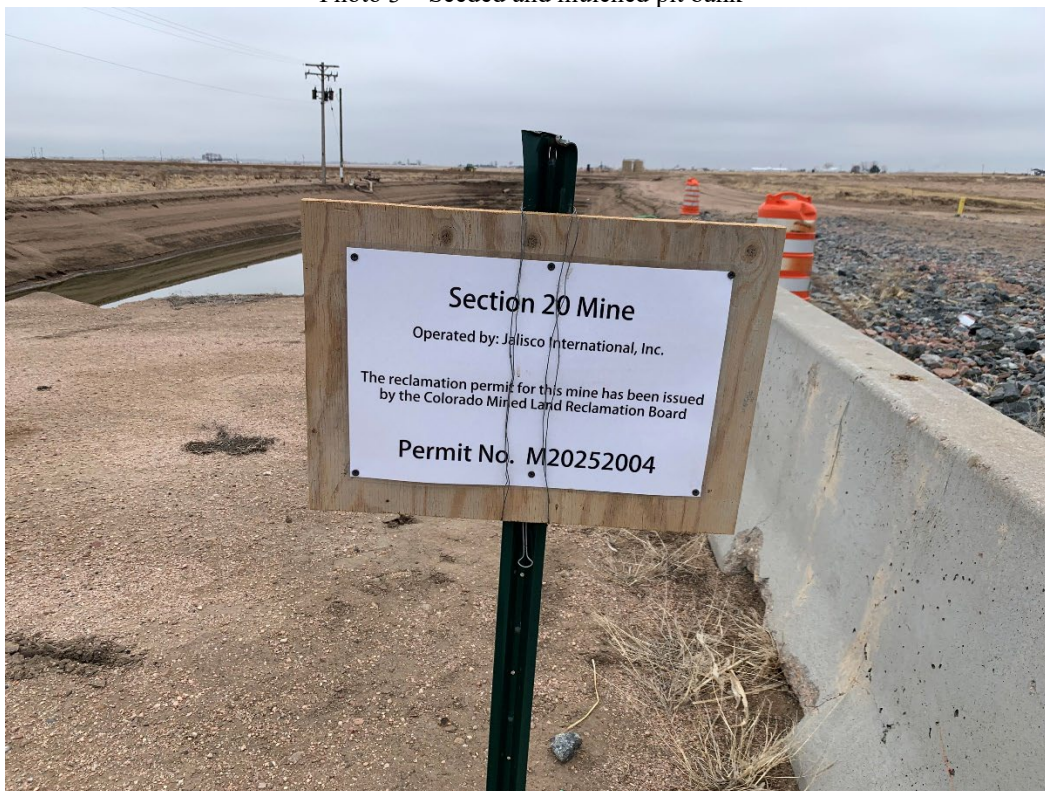
The mine entrance sign was in place at the mine entrance facing CR 44 (photo 4).

Photo 4 – Entrance sign facing CR 44
