MINERALS PROGRAM INSPECTION REPORT
PHONE: (303) 866-3567

MINE NAME: Pikeview Quarry	MINE/PROSPECTING ID#: M-1977-211	MINERAL: Limestone (general), granite gneiss and do	COUNTY: El Paso
INSPECTION TYPE: Monitoring	WEATHER: Clear	INSP. DATE: March 12, 2024	INSP. TIME: 10:00
OPERATOR: Riverbend Industries Inc.	OPERATOR REPRESENTATIVE: Jerry Schnabel	TYPE OF OPERATION: 112c - Construction Regular Operation	
REASON FOR INSPECTION: Normal I&E Program	BOND CALCULATION TYPE: None	BOND AMOUNT: \$13,389,784.00	
DATE OF COMPLAINT: NA	POST INSP. CONTACTS: None	JOINT INSP. AGENCY: None	
INSPECTOR(S): Zach Trujillo	INSPECTOR'S SIGNATURE:

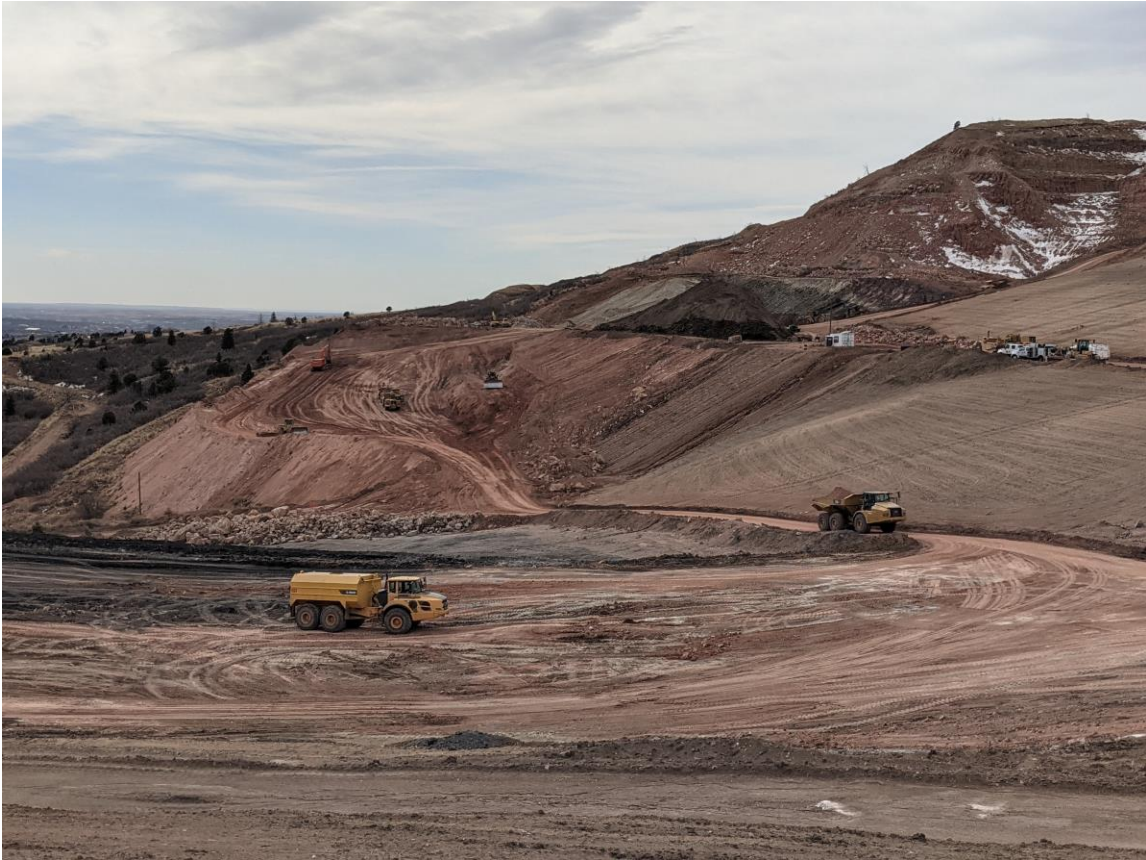
Backfill operations were occurring during the inspection. Current operations included excavator and haul truck teams taking backfill material from the Lower Borrow Area and staging it along the upper portions of the backfilled slope. Dozers were then grading the material in lifts. A circular traffic pattern was being used to ensure safety along the narrow travel corridor of the upper portion of the slope. While material was primarily being taken from the Lower Borrow Area, additional material exists within the other two borrow areas, the Shop Borrow Area and South Borrow Area. During the inspection it was discussed that the primary backfill material will come from the Lower Borrow and the South Borrow Areas. If necessary, additional material will be used from the Shop Borrow Area as needed in a limited manner due to a lack of suitable backfill material.

Lower and Shop Borrow Areas.

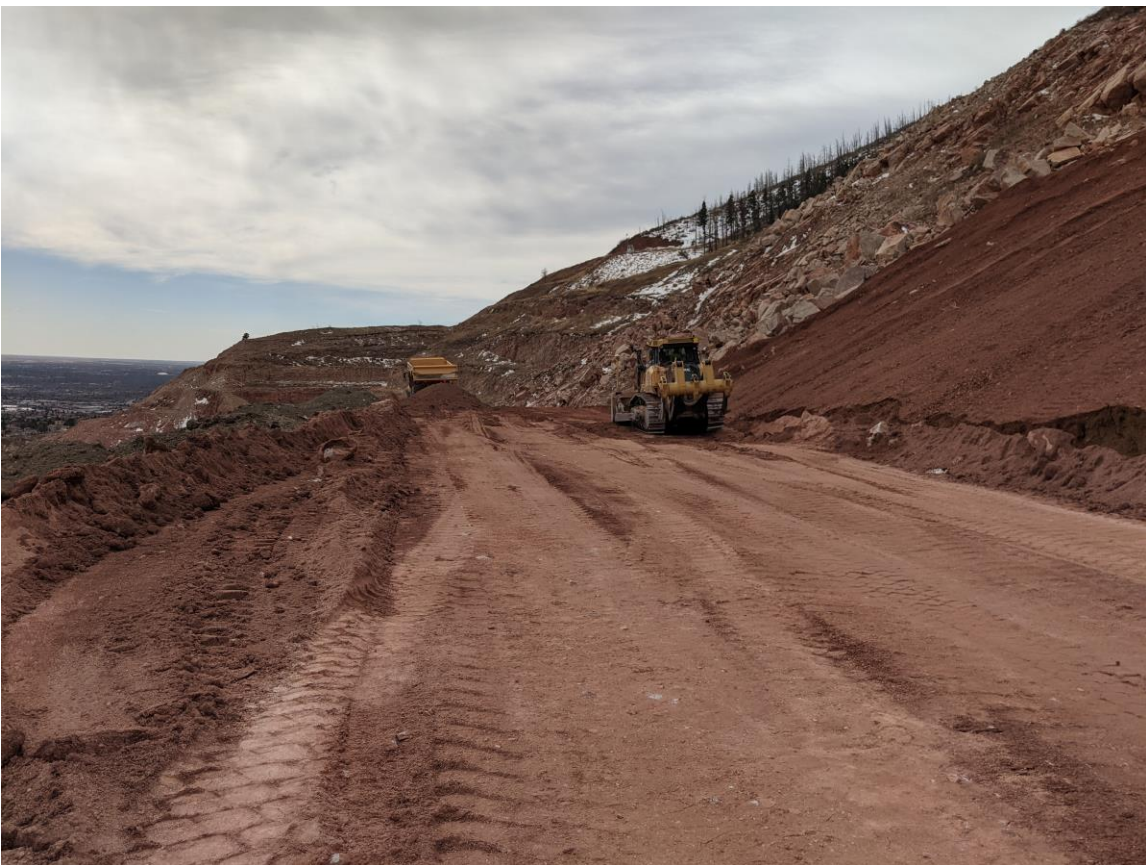
Backfill placement and regarding.

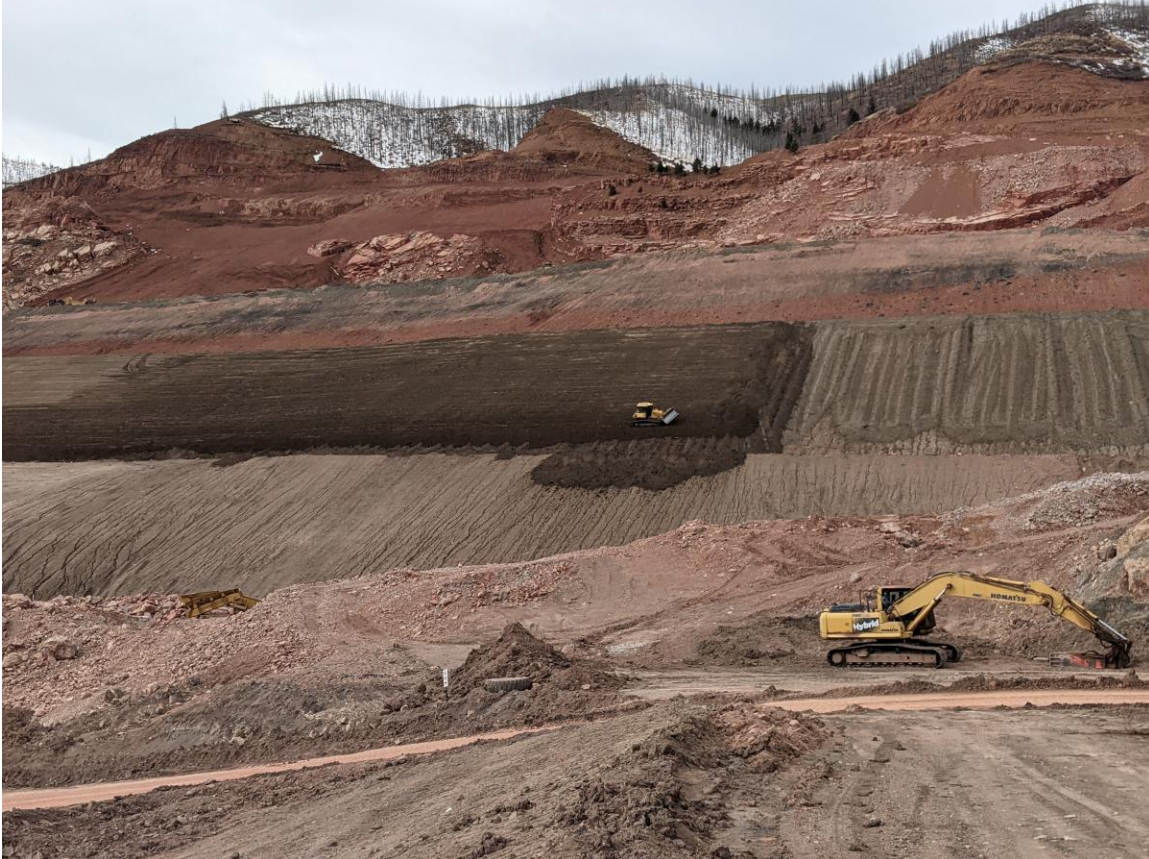
Topsoil placement and grading was occurring during the inspection along the completed benches of the backfilled slope. A primary stockpile for topsoil is observed along the staging area near the survey building.

Topsoil placement.

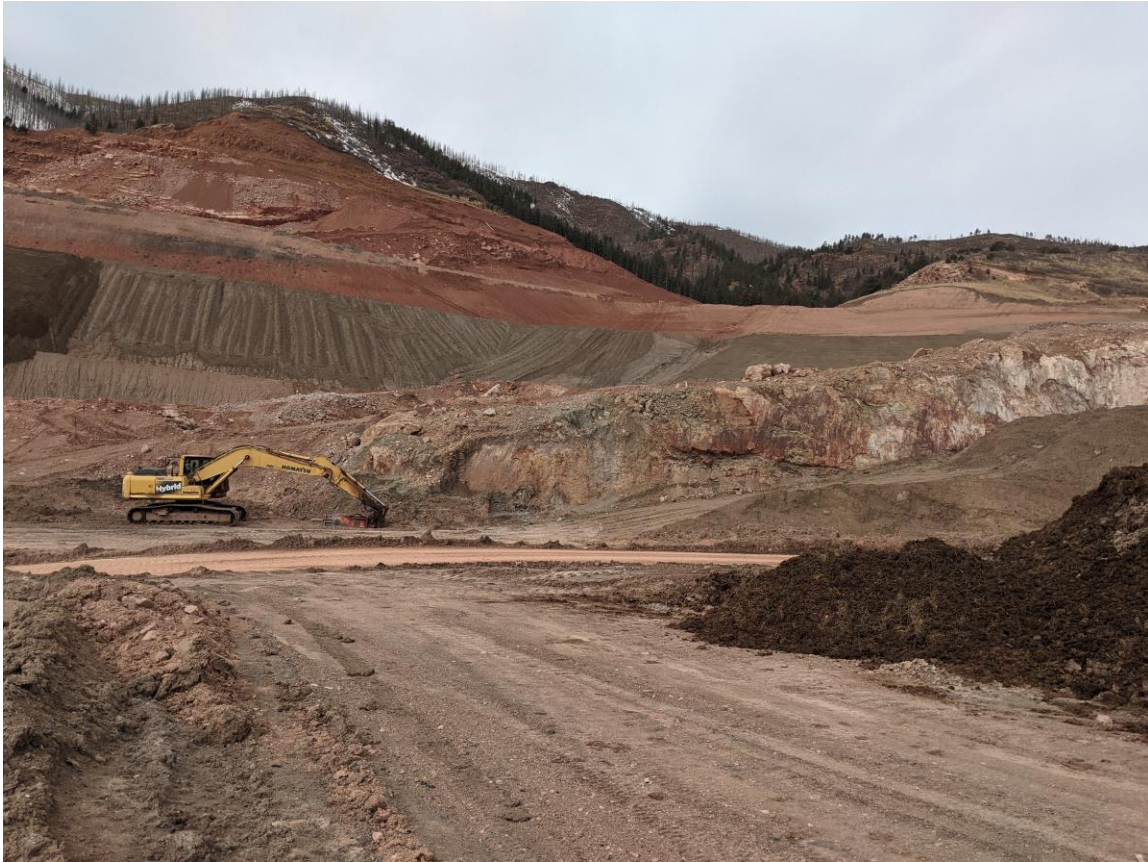
"Dragon Back"

Collection ditches along the face of the backfilled slope were inspected. All collection ditches along the face of the backfilled are sloped to north where it intersects with the North Ditch. It has been previously discussed that rock outcroppings have been encountered that will potentially impact the current hydrology design along the upper portions of the backfill. Currently the Mine is evaluating potential options and will submit a Technical Revision to update the hydrology of the site based on site conditions encountered. Additionally, as continued regrade work occurs along the North Ditch, the large bedrock feature ("Dragon's Back") that was encountered along the North Ditch pathing was discussed. Current plans are to remove as much of the bedrock feature as possible by mechanical means and will incorporate blasting as needed to establish the North Ditch route.
