Newmont Mining Corporation
 Cripple Creek & Victor Gold Mine
 Liner Repair CQA
 NewFields Job No. 475.0106.068
 Week Ending Friday, March 15, 2024

FIELD WEEKLY PROGRESS REPORT

PROJECT: VLF2 PHASE 3 STAGE A.1 LINER REPAIR
SITE: CRIPPLE CREEK & VICTOR GOLD MINE (COLORADO)
CONTRACTOR: NEWMONT CC&V MINING OPERATIONS
 JHL CONSTRUCTORS
WEEK ENDING: FRIDAY, MARCH 15, 2024

REPORTING PERIOD: 03.09.2024 THROUGH 03.15.2024

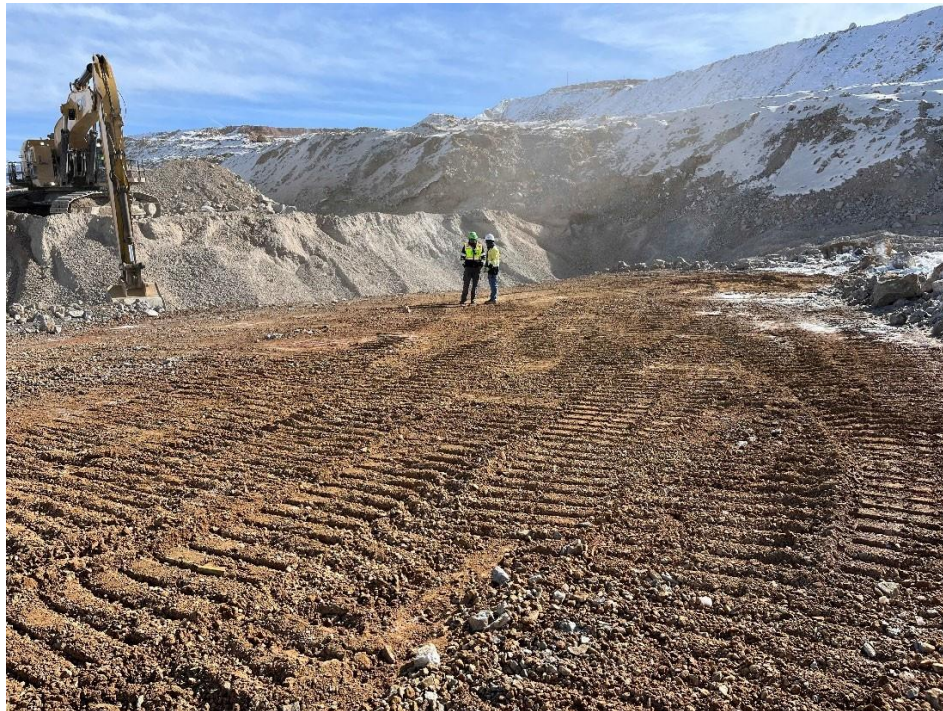
March 12, 2024 – DCF Surface after ROM removal.

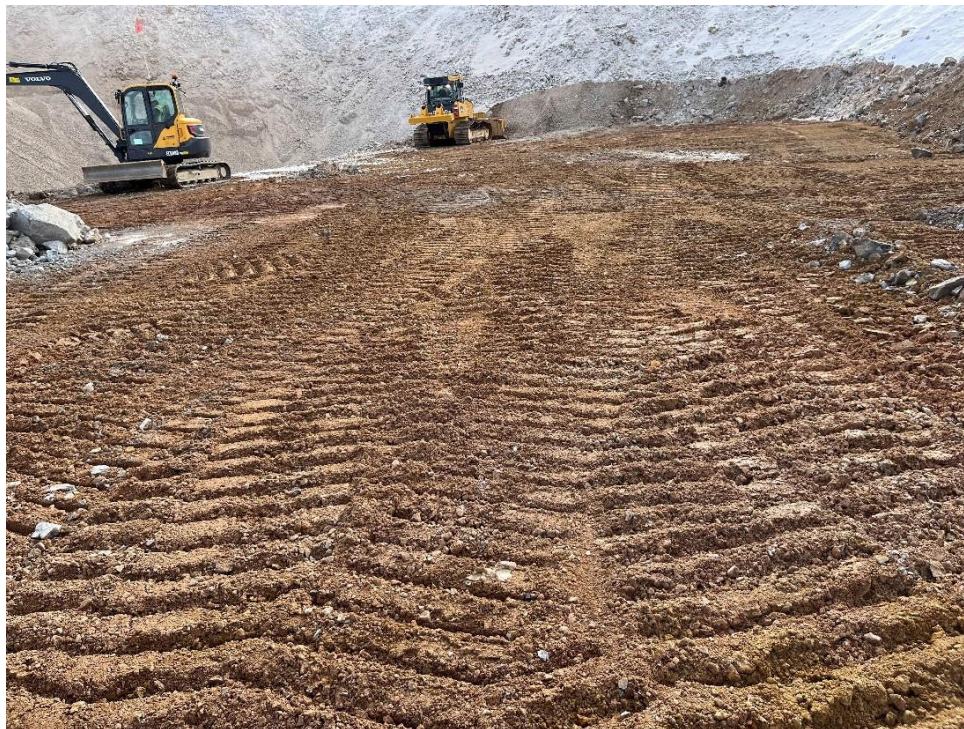
March 13, 2024 – DCF Surface after ROM removal.

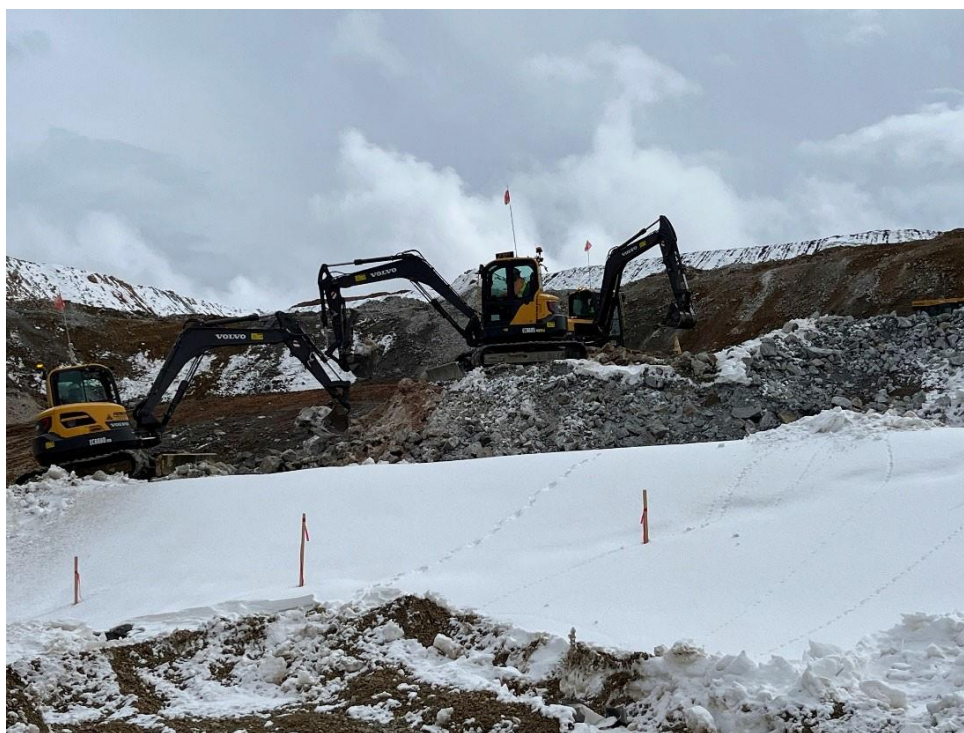
March 13, 2024 – Removal of ROM material up 2:1 slope.

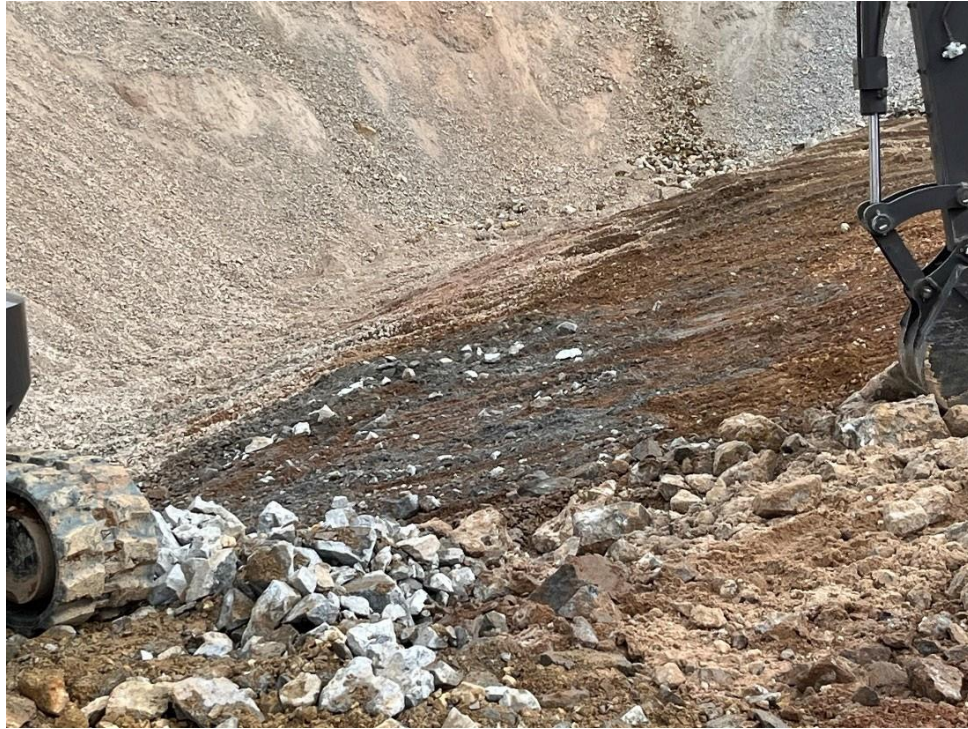
March 13, 2024 – DCF Surface on slope after ROM removal.
