**MINERALS PROGRAM INSPECTION REPORT**  
**PHONE: (303) 866-3567**

<b>MINE NAME:</b> Hunt Irrigation Pond	<b>MINE/PROSPECTING ID#:</b> M-2022-050	<b>MINERAL:</b> Sand and gravel	<b>COUNTY:</b> Weld
<b>INSPECTION TYPE:</b> Monitoring	<b>WEATHER:</b> Cloudy	<b>INSP. DATE:</b> March 7, 2024	<b>INSP. TIME:</b> 10:30
<b>OPERATOR:</b> J-2 Contracting Company	<b>OPERATOR REPRESENTATIVE:</b> Chris Leone	<b>TYPE OF OPERATION:</b> 111(1)(b) - Special One-Time Incidental	
<b>REASON FOR INSPECTION:</b> Normal I&E Program	<b>BOND CALCULATION TYPE:</b>	<b>BOND AMOUNT:</b> \$70,000.00	
<b>DATE OF COMPLAINT:</b> NA	<b>POST INSP. CONTACTS:</b> None	<b>JOINT INSP. AGENCY:</b> None	
<b>INSPECTOR(S):</b> Brock Bowles	<b>INSPECTOR'S SIGNATURE:</b>

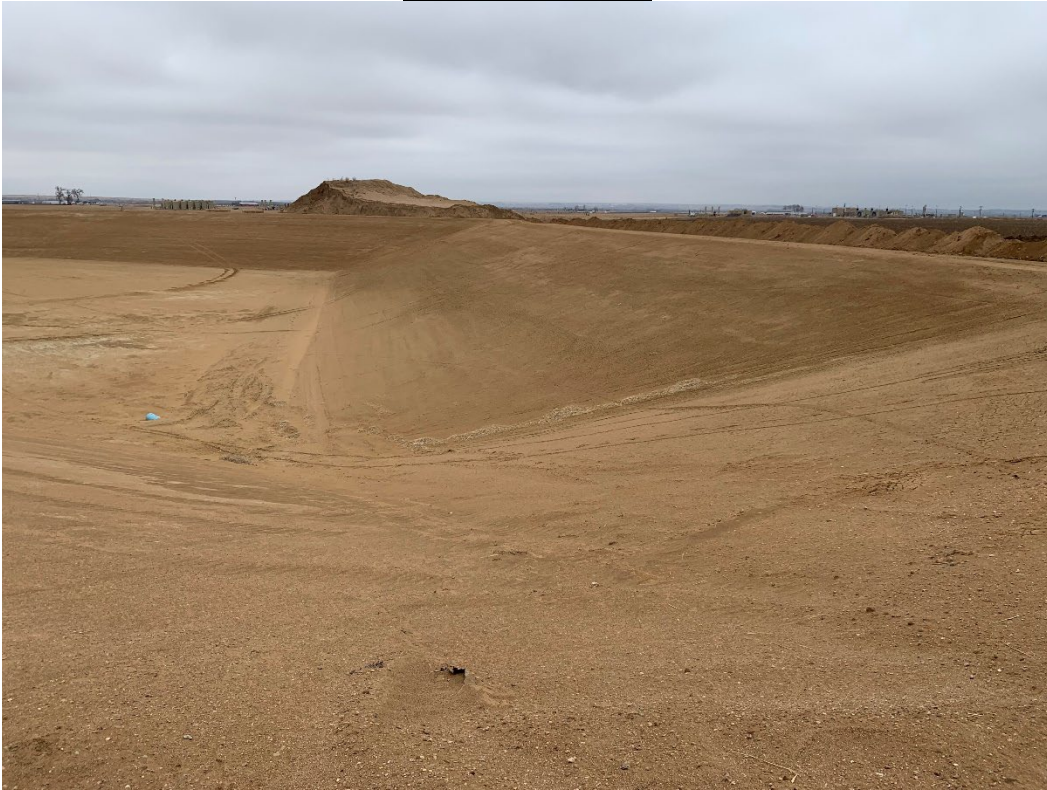
The pond has been excavated and all the interior slopes have been graded to 3h:1v (photo 1). The top of the berm is about 15 feet wide. The out slopes were also graded at 3h:1v.

Photo 1 – East bank of pond facing north

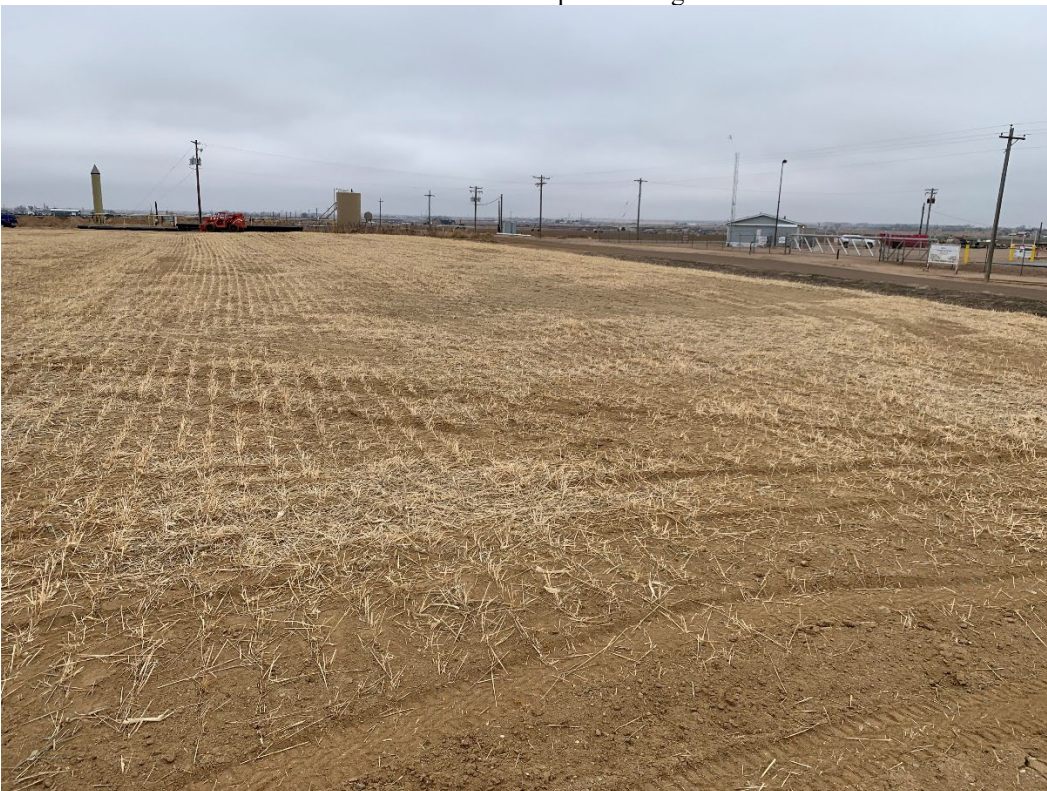
The southeast corner of the proposed pond area was not mined and is being reclaimed (photo 2). This unmined area is shown on the January 2024 Annual Report Map.

The southeast corner that was not mined was also topsoiled, seeded, mulched, and crimped in Nov 2023.

Photo 2 – Southeast corner of permit area that was not mined.

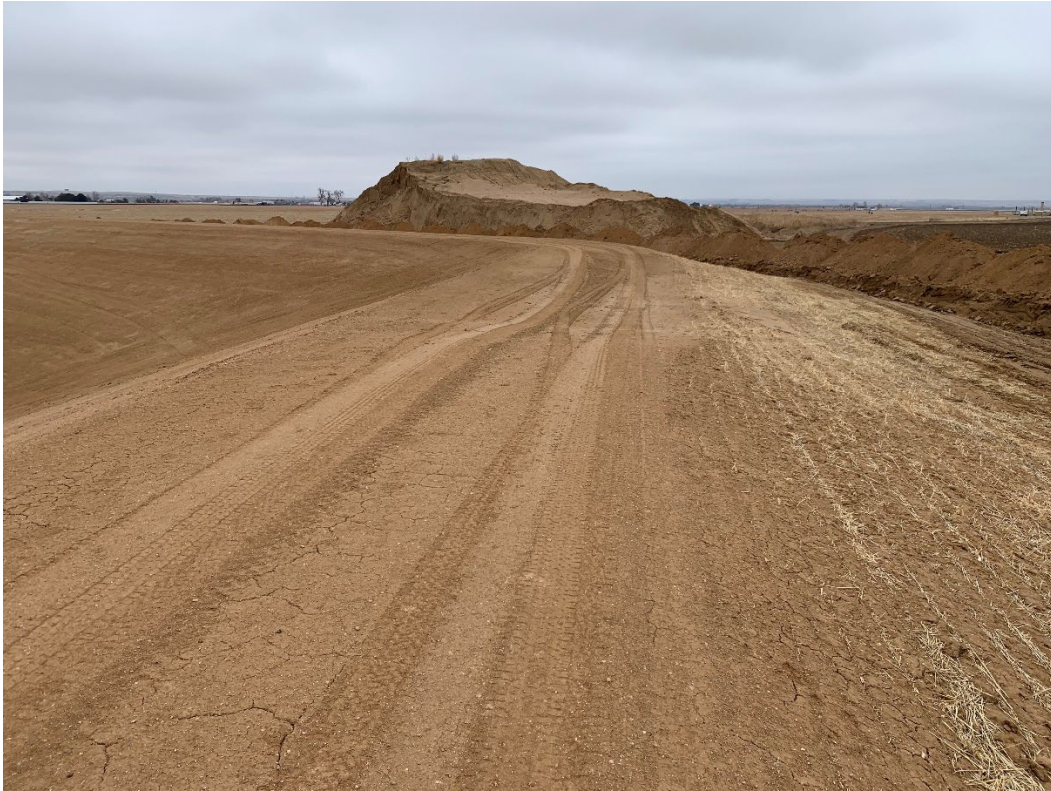
An overburden stockpile was located north of the pond (photo 3). This stockpile was approved in the permit application and is shown on Exhibit E.

Photo 3 – Overburden stockpile north of pond area.

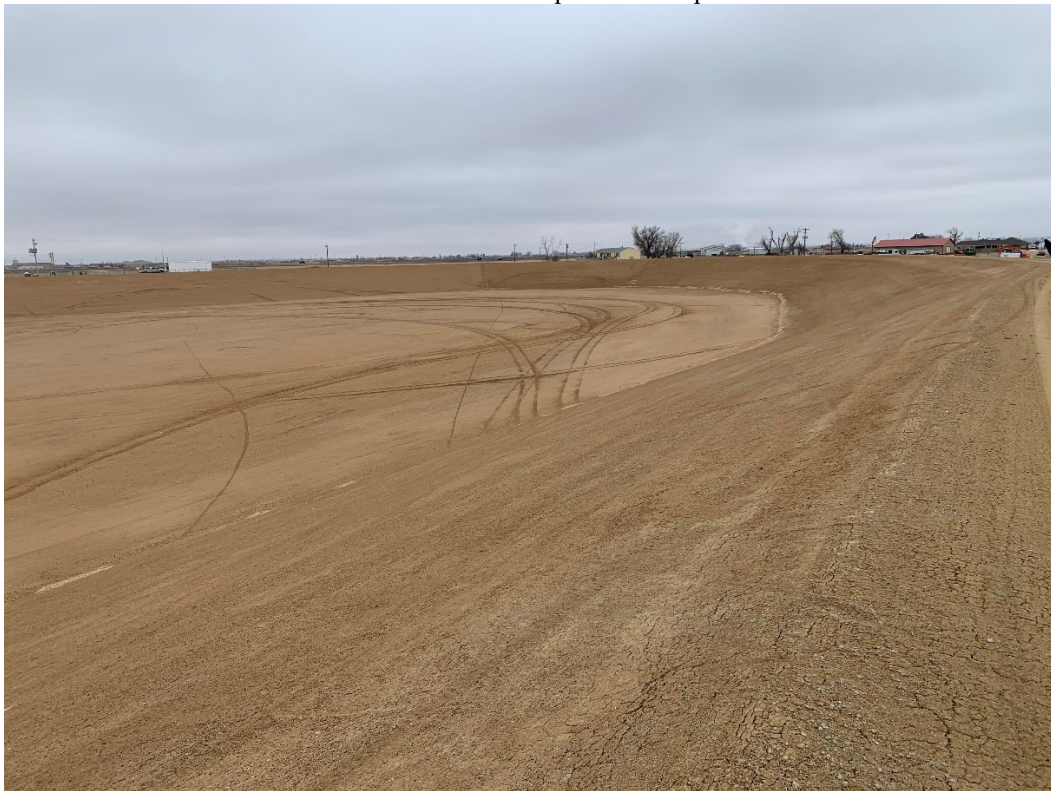
The mining permit states the bottom of the pond will be mined above the highest groundwater level and then be backfilled with 3 feet of impervious clay. The clay lining is complete according to Mr. Leone. The pit bottom and banks were graded smooth with a clay material (photo 4). No water or damp soil spots were seen.

Photo 4 – West side of pond facing southwest

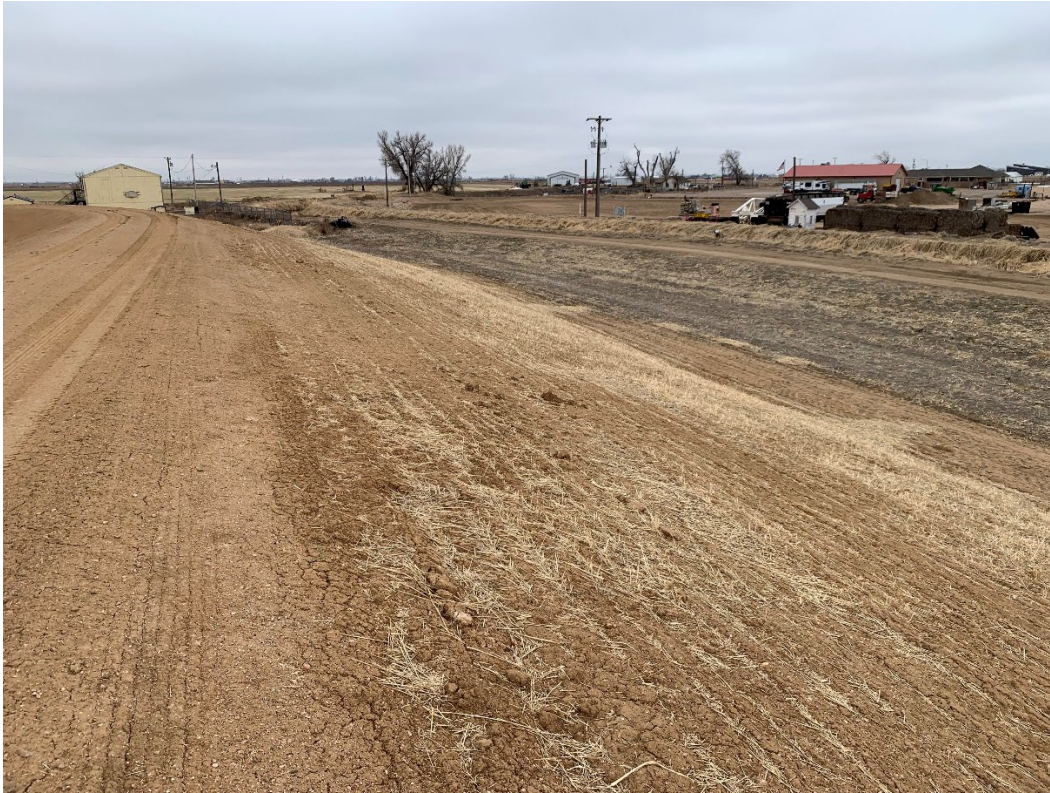
The out slopes of the pond bank were topsoiled, seeded, mulched, and crimped (photo 5).

Photo 5 – Pond out slope on west side of pond.
