RE: Emergency Notification Follow-up Notice March 2024; Permit No. M-1980-244

Cripple Creek and Victor Gold Mining Company (CC&V) herein provides the required follow-up notice for the Emergency Notification issued to DRMS on March 15, 2024, as part of Permit No. M-1980-244. This notice is to satisfy the requirements within the Colorado Mined Land Reclamation Board's Hard Rock/Metal Mining Rule 8, section 8.2.3. Requirements within are presented below in **bold** and CC&V's responses included in *italics*.

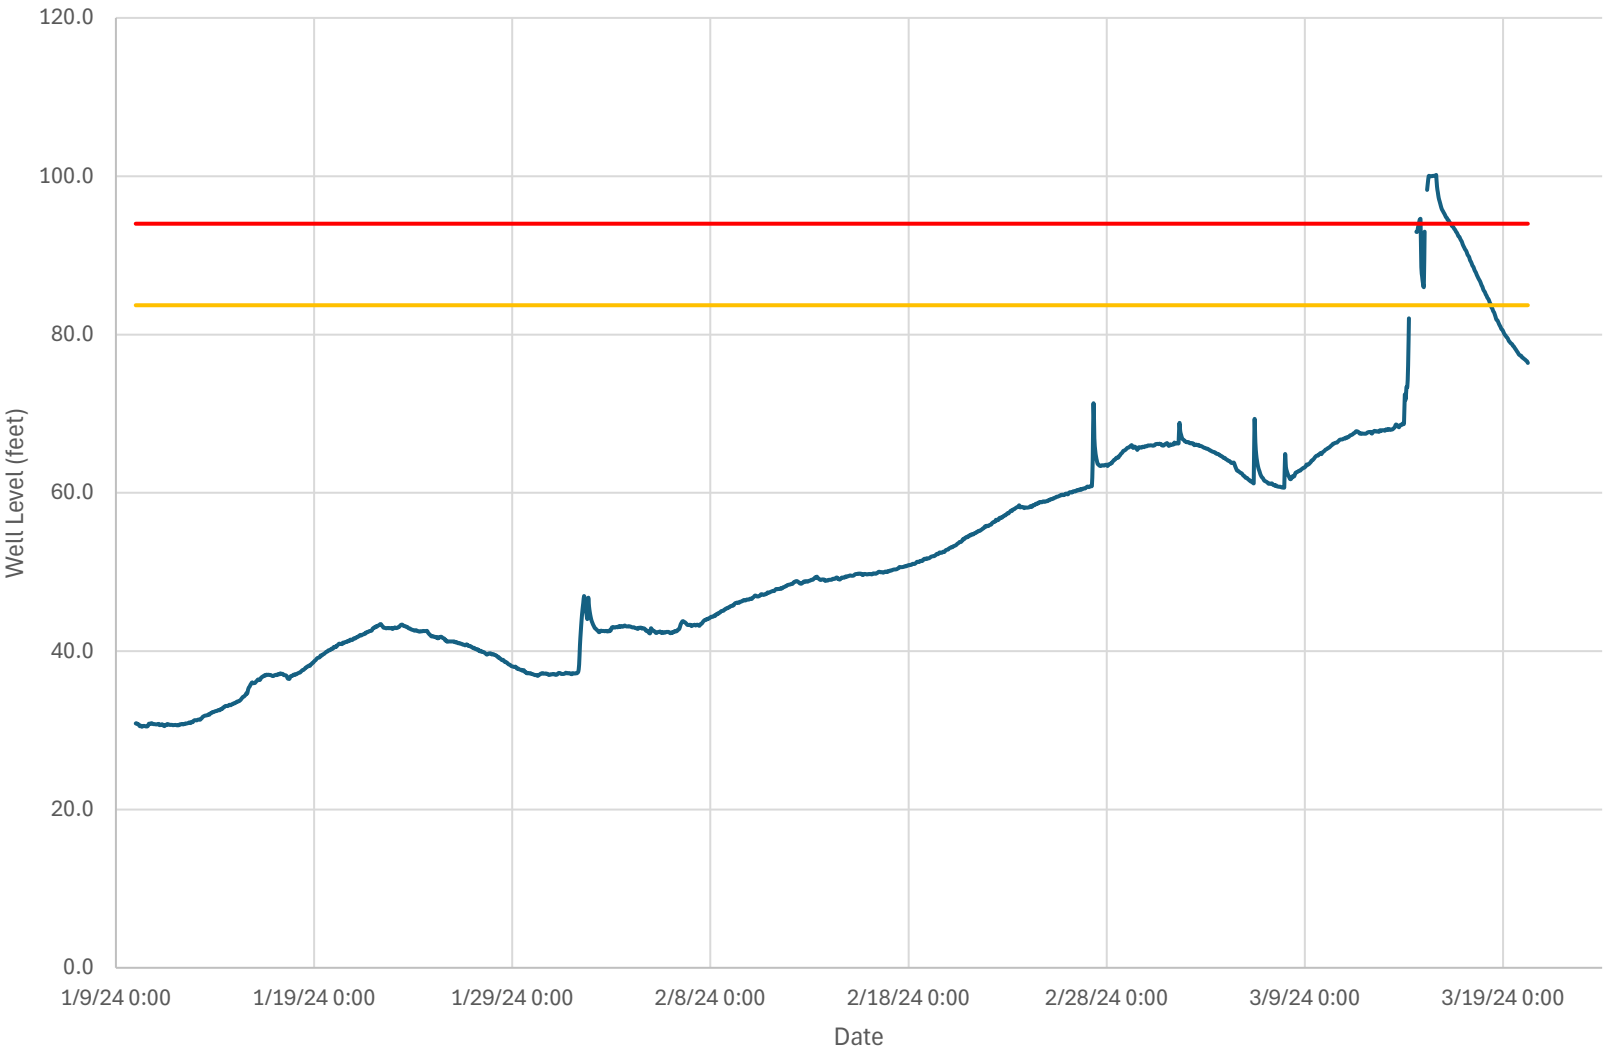
70-day trend, hourly resolution, VLF2 Phase 1 Well Level

- At approximately 6:00 pm MDT on March 14th, the pond level in the VLF2 Phase 1 PSSA reached the 94 ft reporting limit (80% capacity).
- At approximately 8:00 pm MDT on March 14th, the line power was restored and the pond level was pumped down to approximately 85 ft (below the reporting limit)

- Around 2:00 am MDT on March 15th, the pond level rose above the 94 ft reporting limit. It is estimated that around this time is when the failure of the two generators at ADR2 occurred.

- During the second outage, two generators at ADR2 failed and the pond level rose 36 ft between 6:00 am and 3:00 pm MDT on March 15th, reaching a height of 105 ft at approximately 1:30 pm MDT.

Additionally, DRMS has asked for an explanation of the rapid rise in pond levels and how it relates to the modeling conducted in TR 127. The well level in VLF2 Phase 1 never reached 100% capacity and the maximum height recorded was approximately 105' so the calculation to predict pond level and volume would be less than the calculated PSSA breach level. The filling of the PSSA's is an exponential curve and not linear due to the shape of the PSSA as well as decreasing head pressure as solution enters the PSSA from the leach pad. Its estimated that in-flow to the PSSA was around 17,500 gallons per minute around the time that shutdown occurred and no out-flow was occurring. Based on the conditions observed and the recorded data during the outage, the actual filling time of the PSSA that occurred is similar to the predicted filling time from the model.

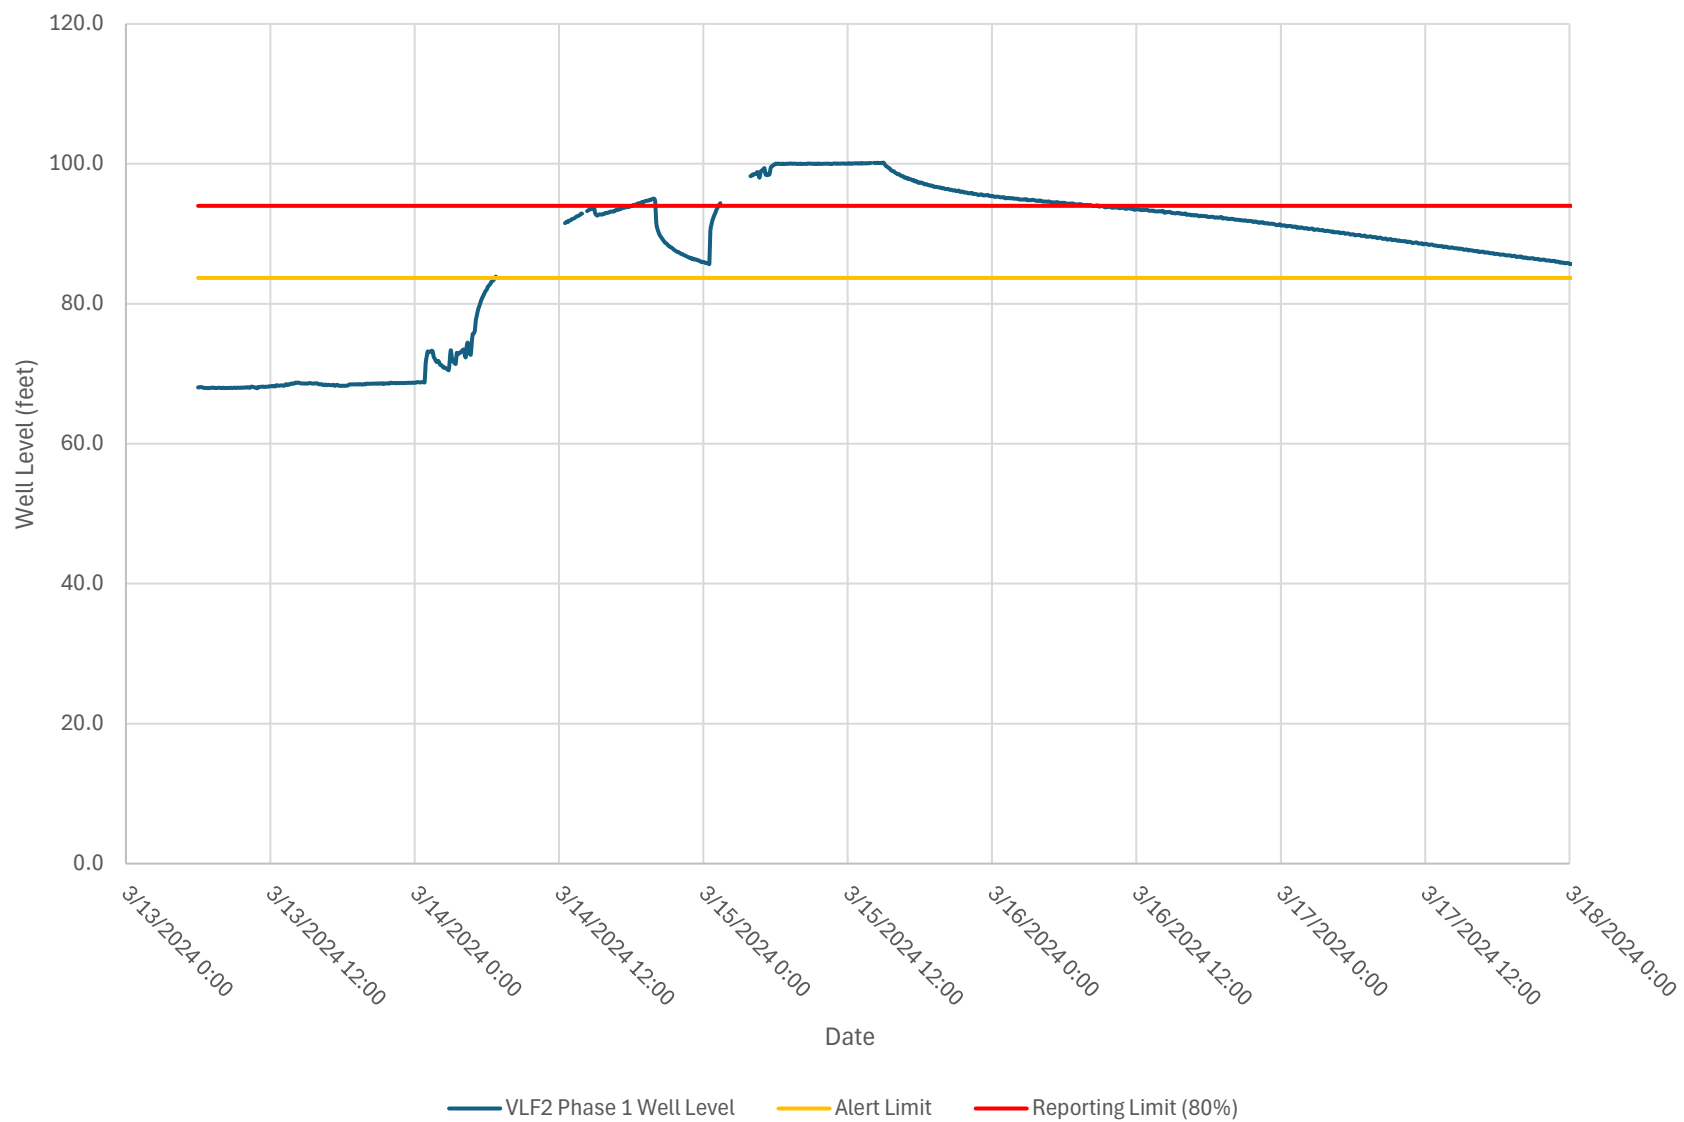
5-day trend, VLF2 Phase 1 Well Level

- At approximately 3:30 pm MDT on March 15th, line power was restored and Operations began pumping down the pond level in VLF2 Phase 1 PSSA.
- At approximately 8:30 am MDT on Saturday, March 16, 2024, the pond level returned below the 94 ft reporting limit.

- At approximately 8:30 am MDT on Monday, March 18th, the pond level returned below the 83.7 ft internal alert limit and continues to decline.
