MINERALS PROGRAM INSPECTION REPORT
PHONE: (303) 866-3567

MINE NAME: Eagle-Gypsum Mine	MINE/PROSPECTING ID#: M-1984-041	MINERAL: Anhydrite, gypsum	COUNTY: Eagle
INSPECTION TYPE: Multi Person Inspection	WEATHER: Clear	INSP. DATE: March 12, 2024	INSP. TIME: 10:00
OPERATOR: American Gypsum Company LLC	OPERATOR REPRESENTATIVE: Tim Strack	TYPE OF OPERATION: 112c - Construction Regular Operation	
REASON FOR INSPECTION: Surety Related	BOND CALCULATION TYPE: Partial Bond	BOND AMOUNT: \$2,614,549.39	
DATE OF COMPLAINT: NA	POST INSP. CONTACTS: None	JOINT INSP. AGENCY: None	
INSPECTOR(S): Amy Yeldell Leigh Simmons	INSPECTOR'S SIGNATURE:

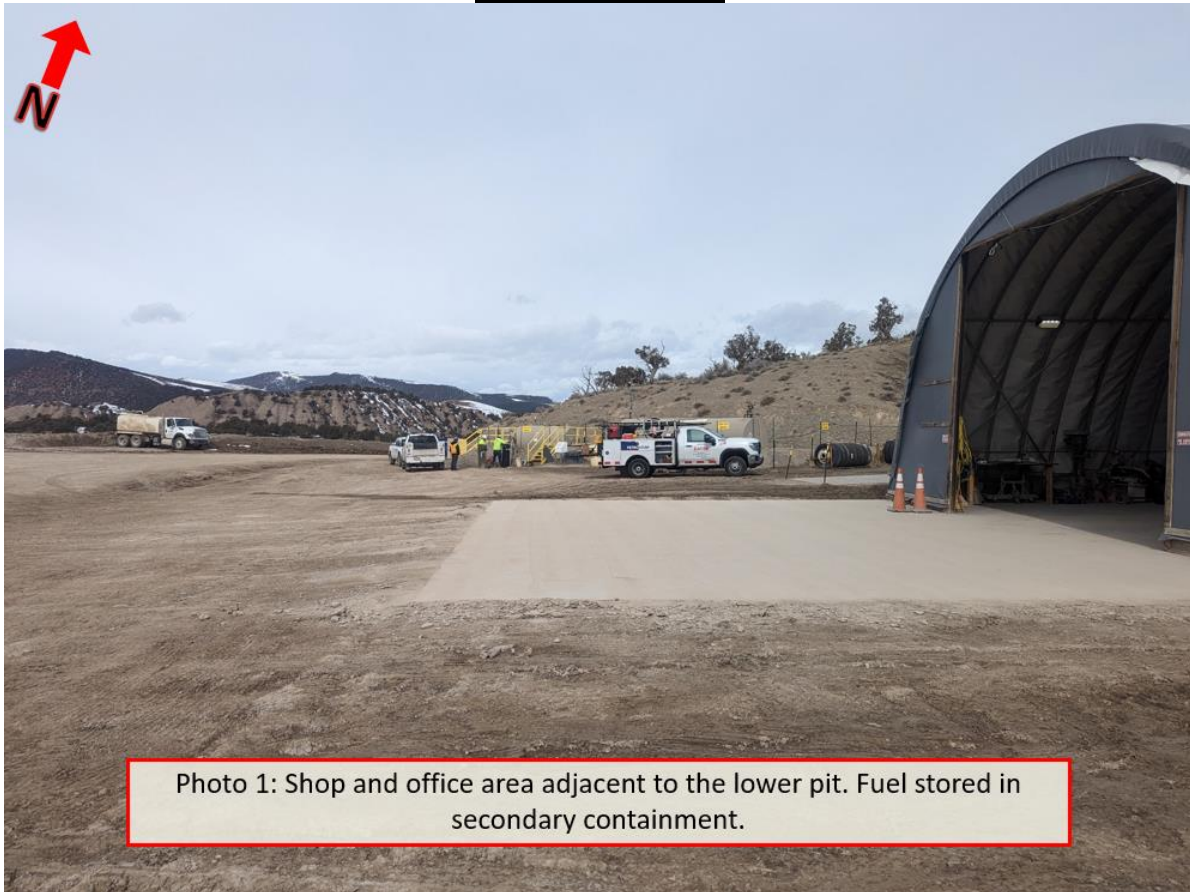
Fuel storage was observed at the shop office area above the Lower Pit (Photo One). All hazardous materials were stored within secondary containment.

Photo 1: Shop and office area adjacent to the lower pit. Fuel stored in secondary containment.

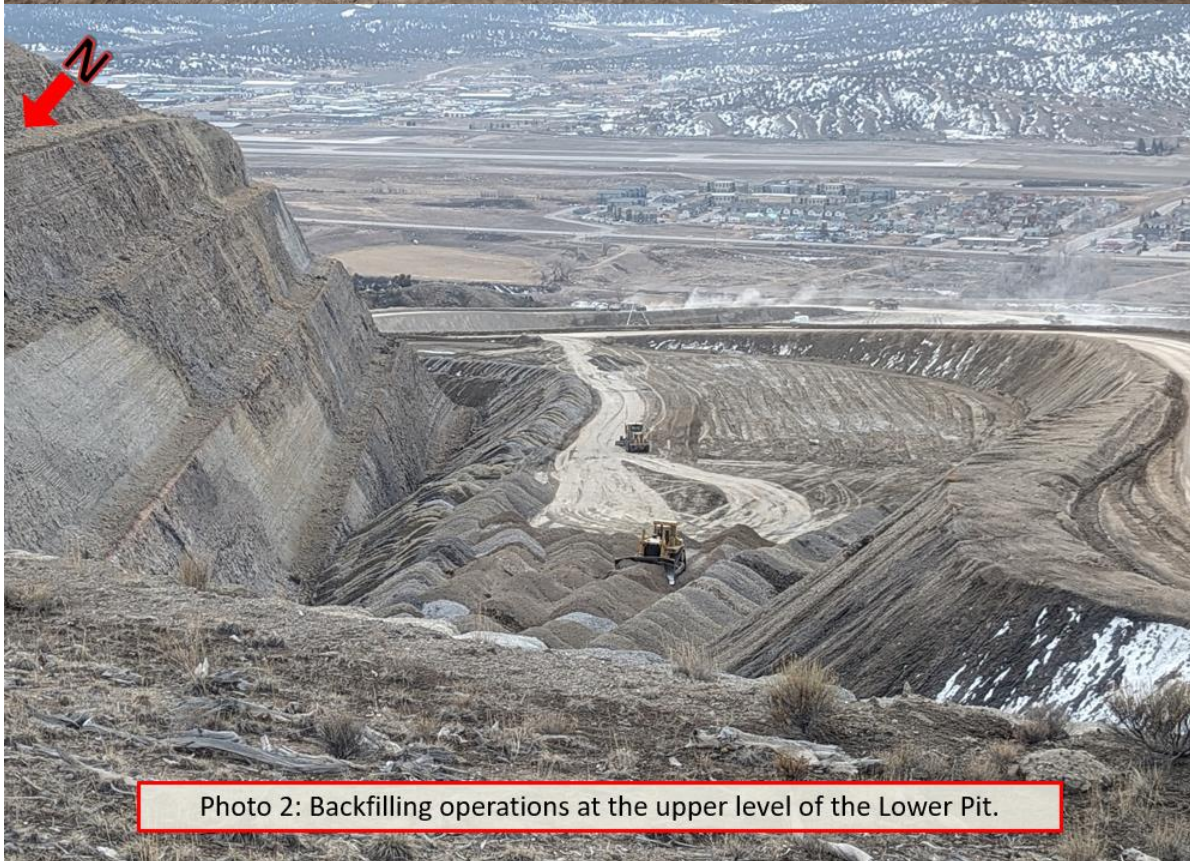
The northeastern portion of the Lower Pit was actively being backfilled at the time of the inspection (Photo Two). The eastern haul road has been re-aligned so that once backfilled and sloped to a 3H: 1V the road will be at the base of the ridge (Photo Three).

Photo 2: Backfilling operations at the upper level of the Lower Pit.

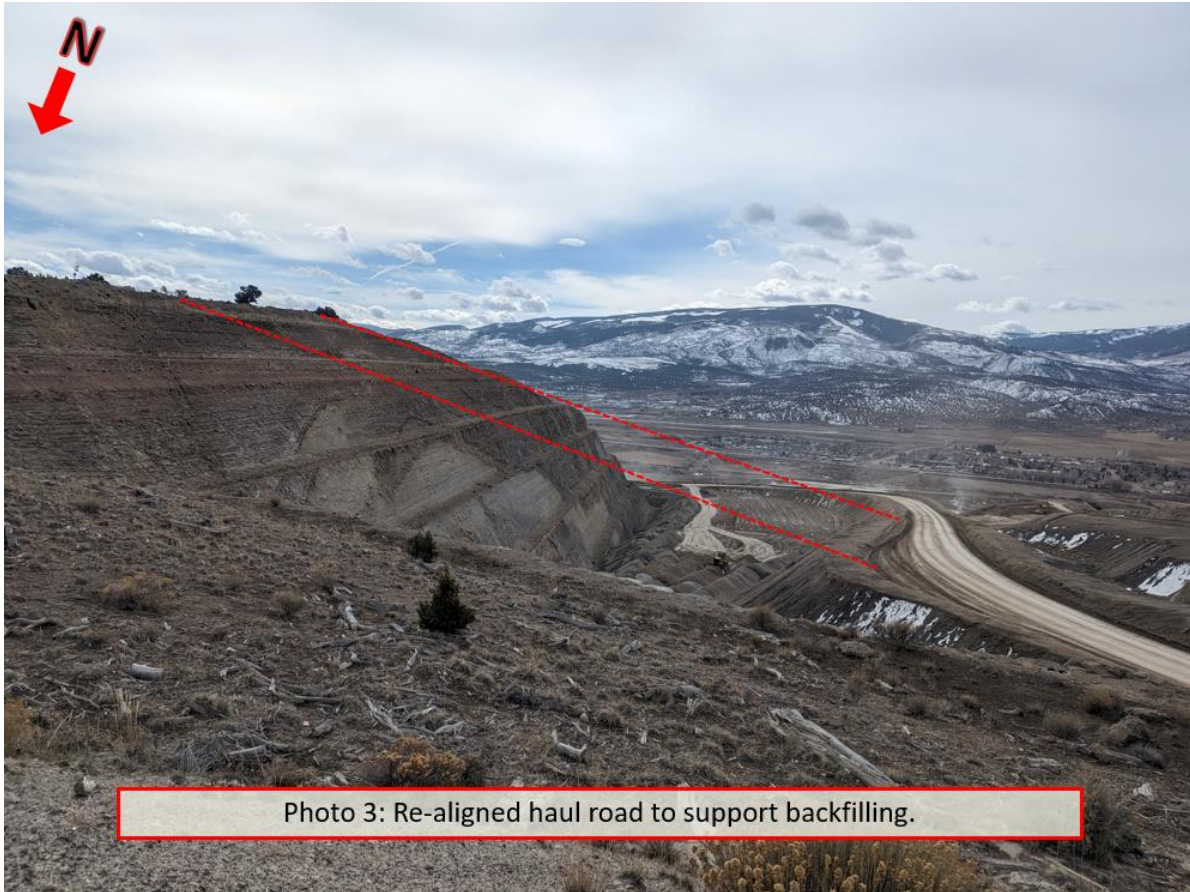
Photo 3: Re-aligned haul road to support backfilling.

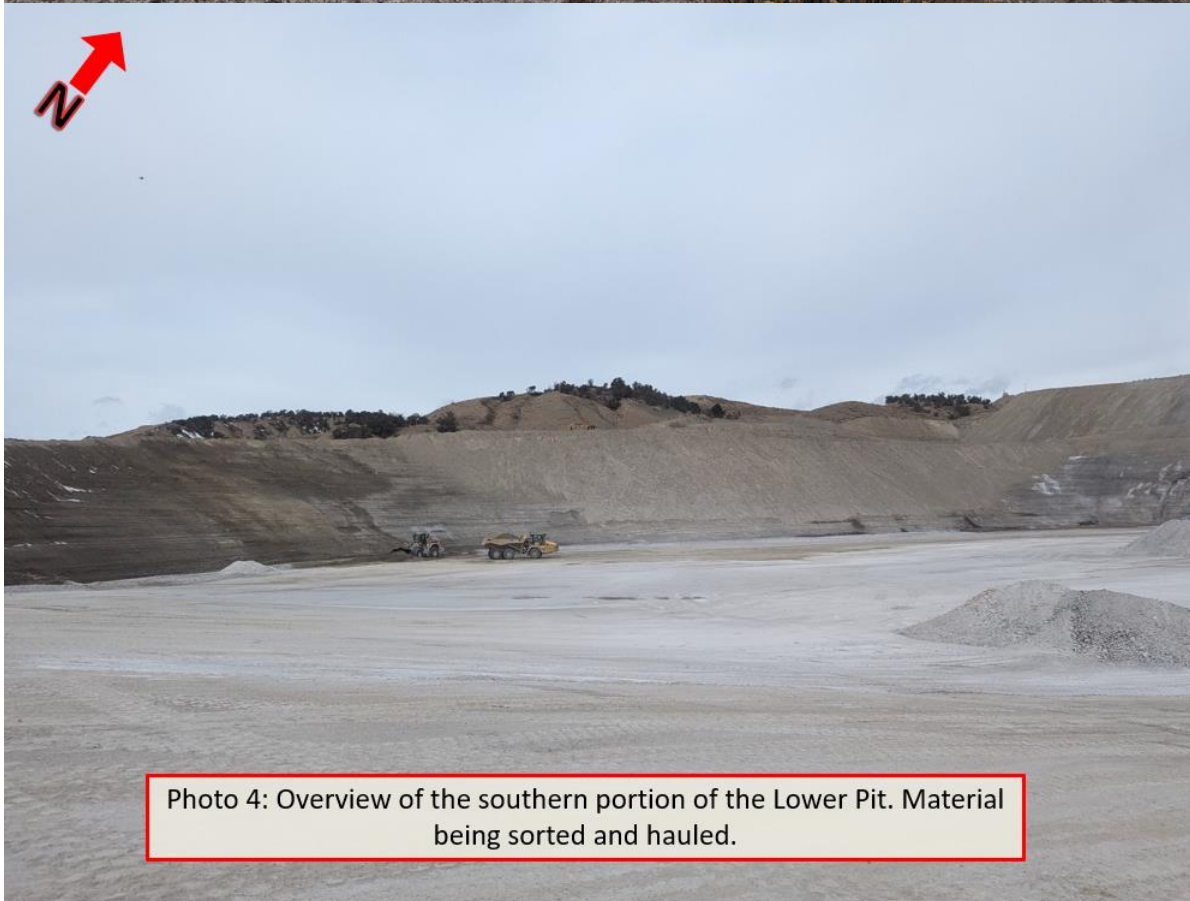
The Lower Pit was active at the time of the inspection. One rotomill was working in the lower part of the pit. The other was being worked on in the pit floor. Two loaders were sorting and stockpiling material for transport. Several trucks were observed hauling Gypsum to the wall board plant in town. As well as transporting overburden and waste material (Anhydrite) to the northeastern portion of the Lower Pit to be used as backfill. (Photos Four – Eight)

Photo 4: Overview of the southern portion of the Lower Pit. Material being sorted and hauled.

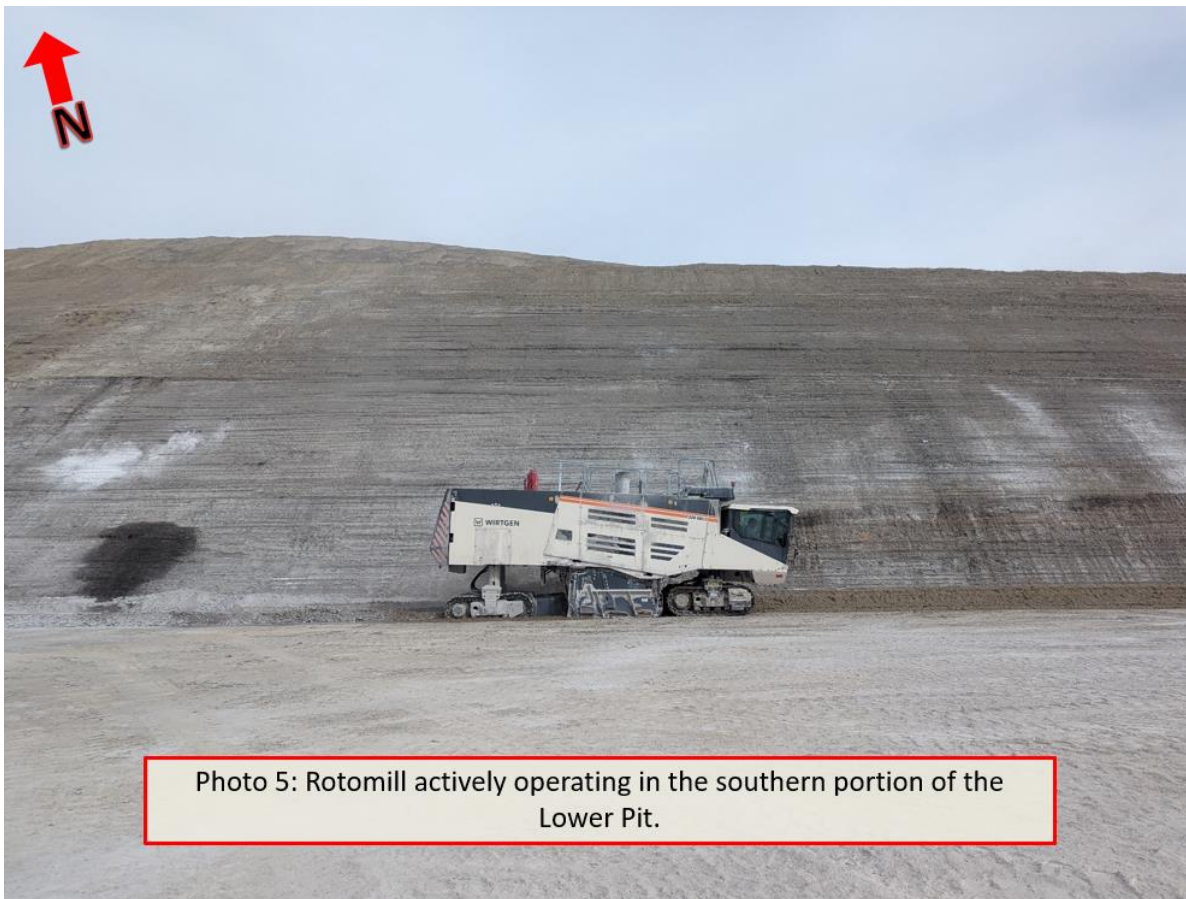
Photo 5: Rotomill actively operating in the southern portion of the Lower Pit.

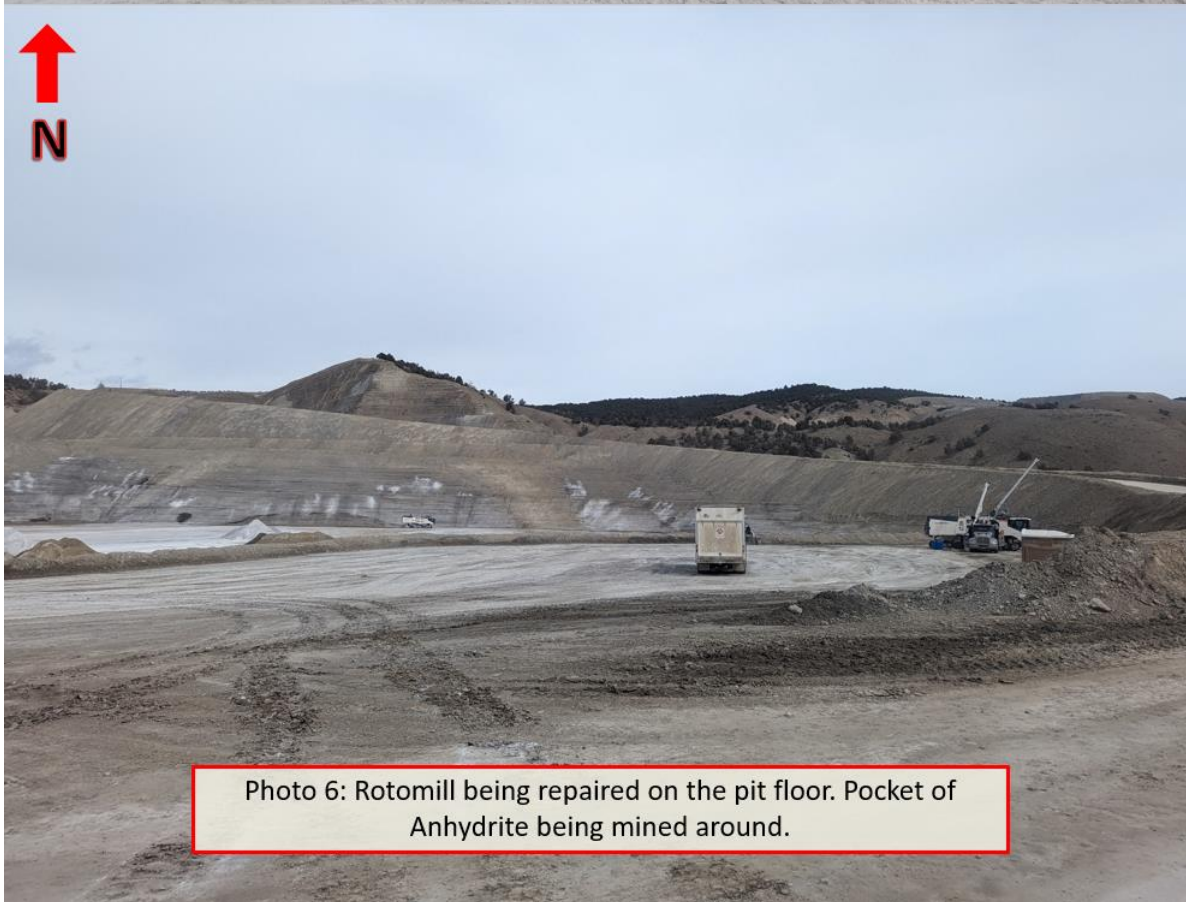
Photo 6: Rotomill being repaired on the pit floor. Pocket of Anhydrite being mined around.

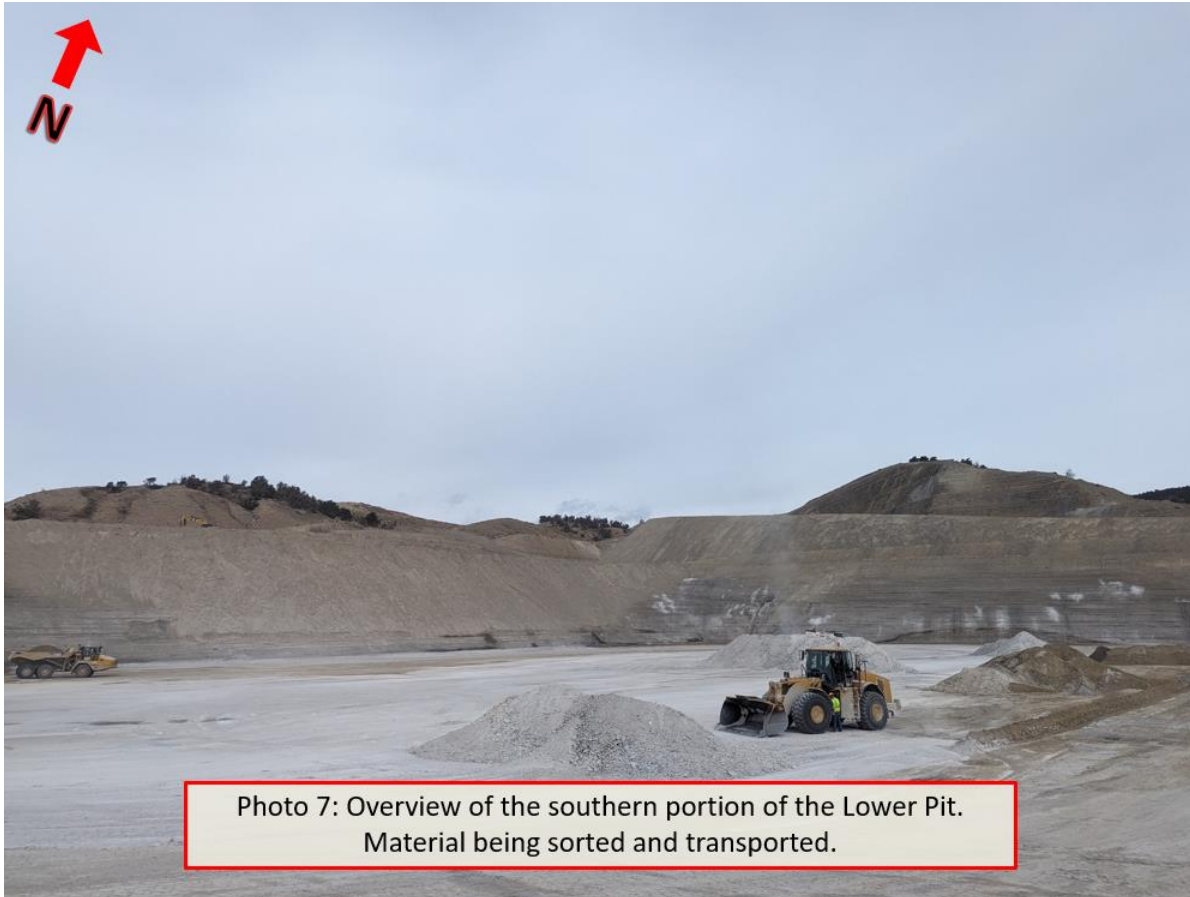
Photo 7: Overview of the southern portion of the Lower Pit.
Material being sorted and transported.

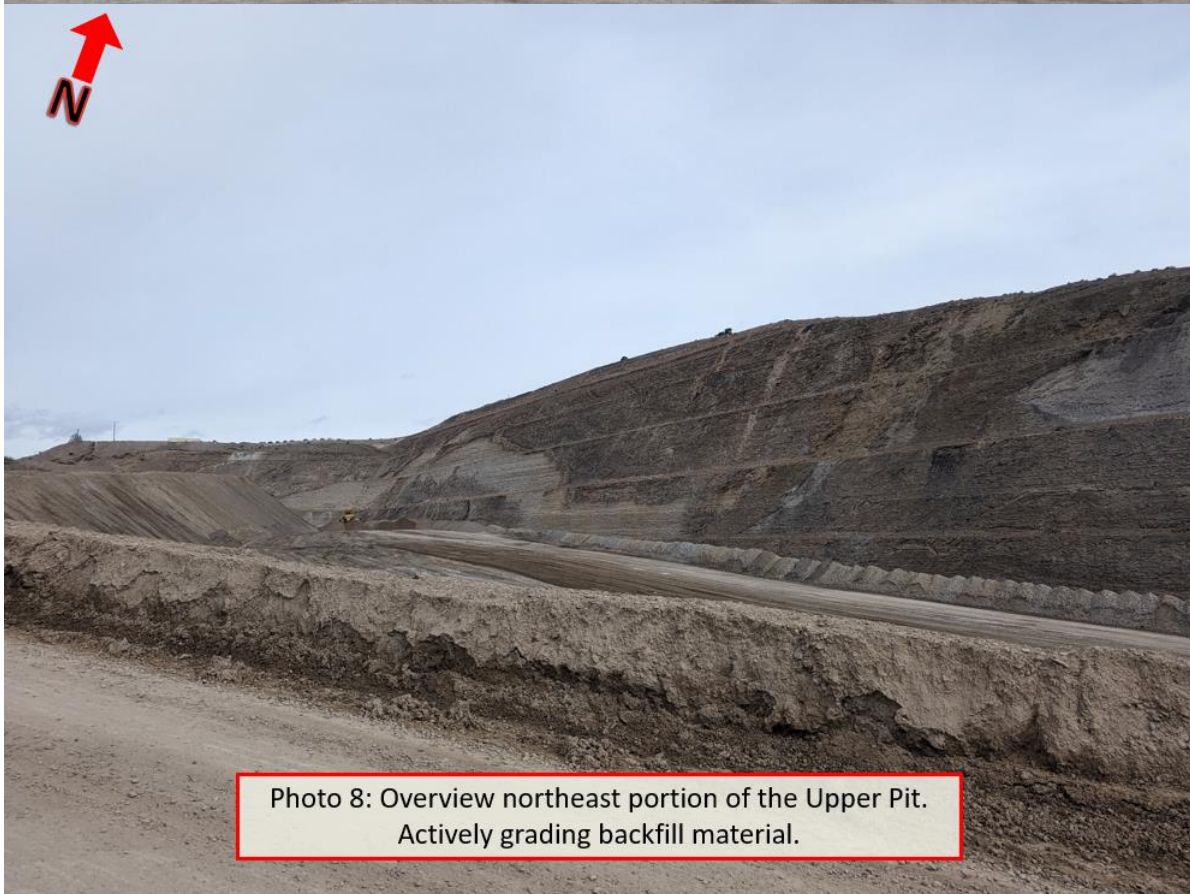
Photo 8: Overview northeast portion of the Upper Pit.
Actively grading backfill material.

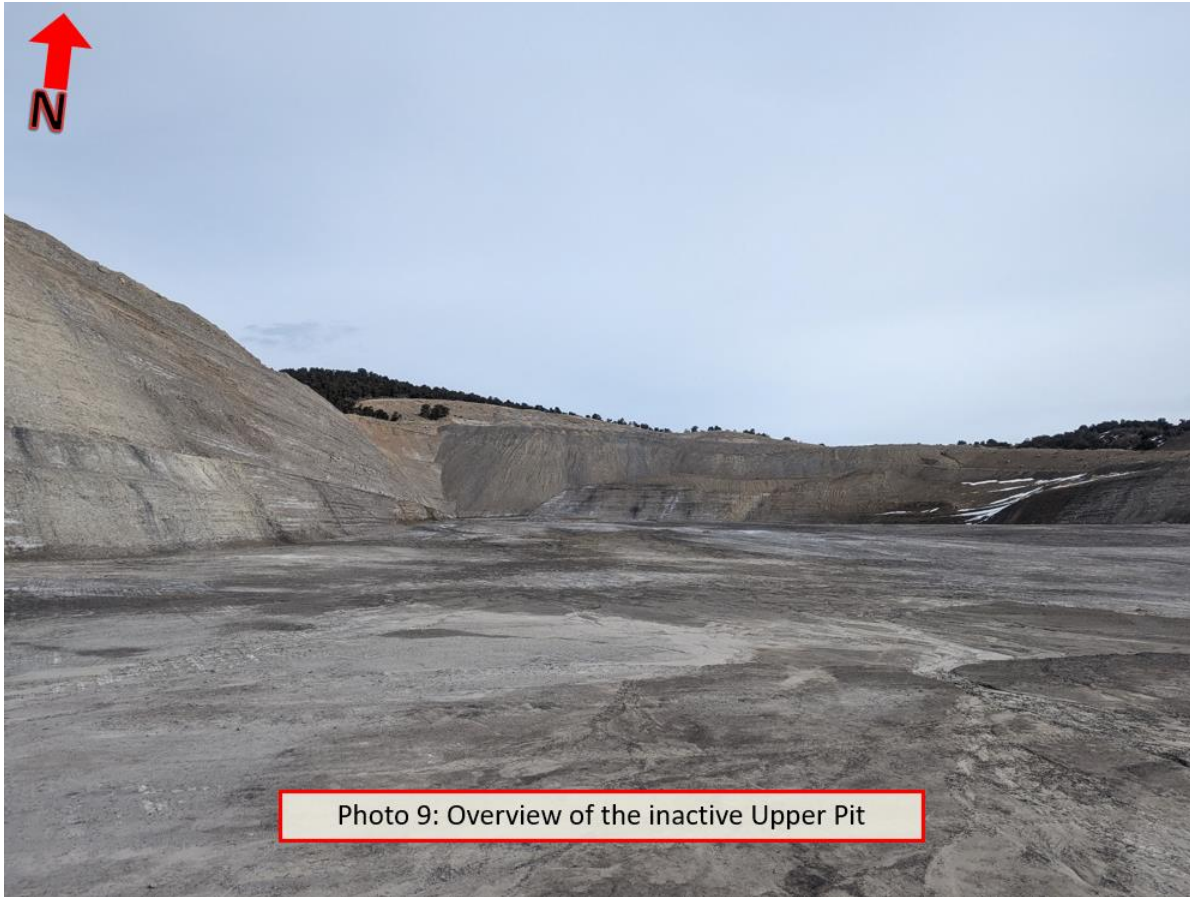
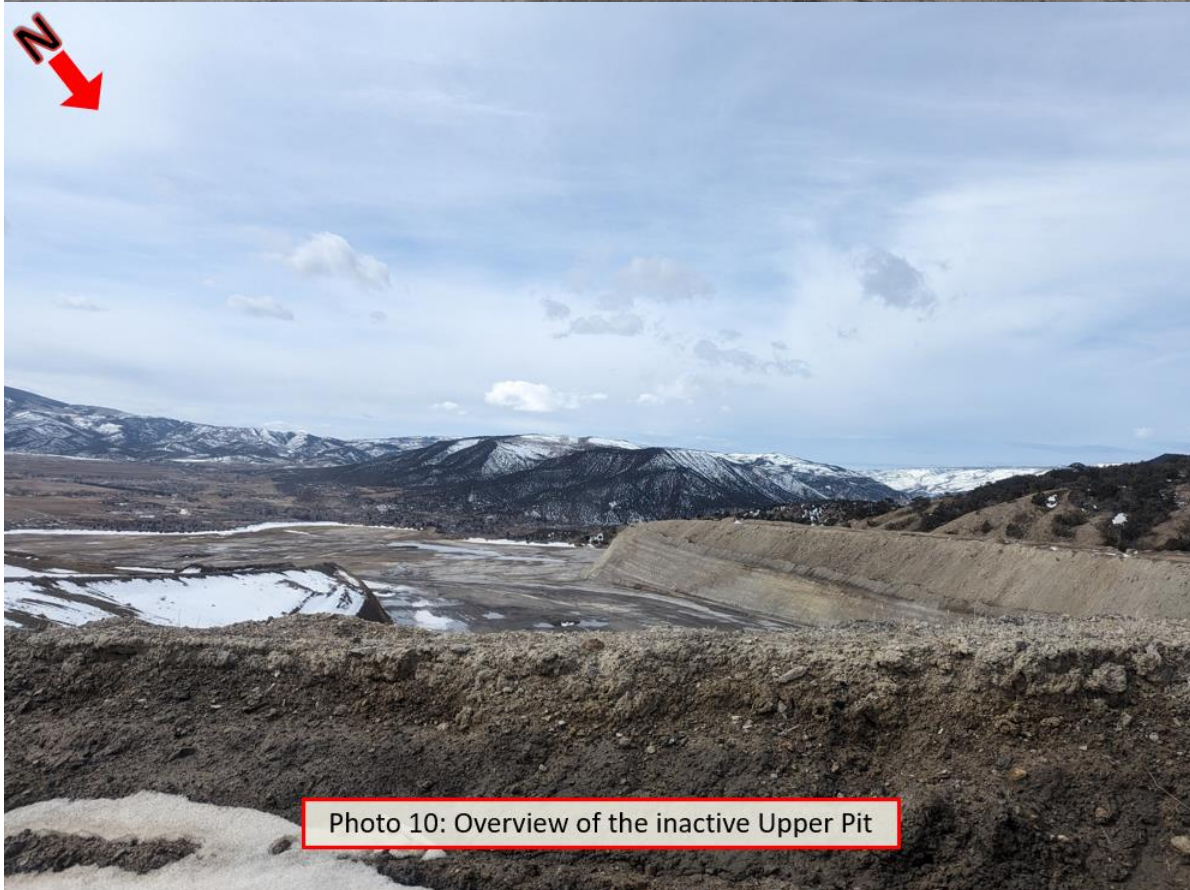
At the time of the inspection the Upper Pit was inactive (Photos Nine and Ten). It has previously been disturbed however no activity has happened in approximately 6 yrs. when operations switched back down to the Lower Pit. No Mining has occurred to date on the East Pit.

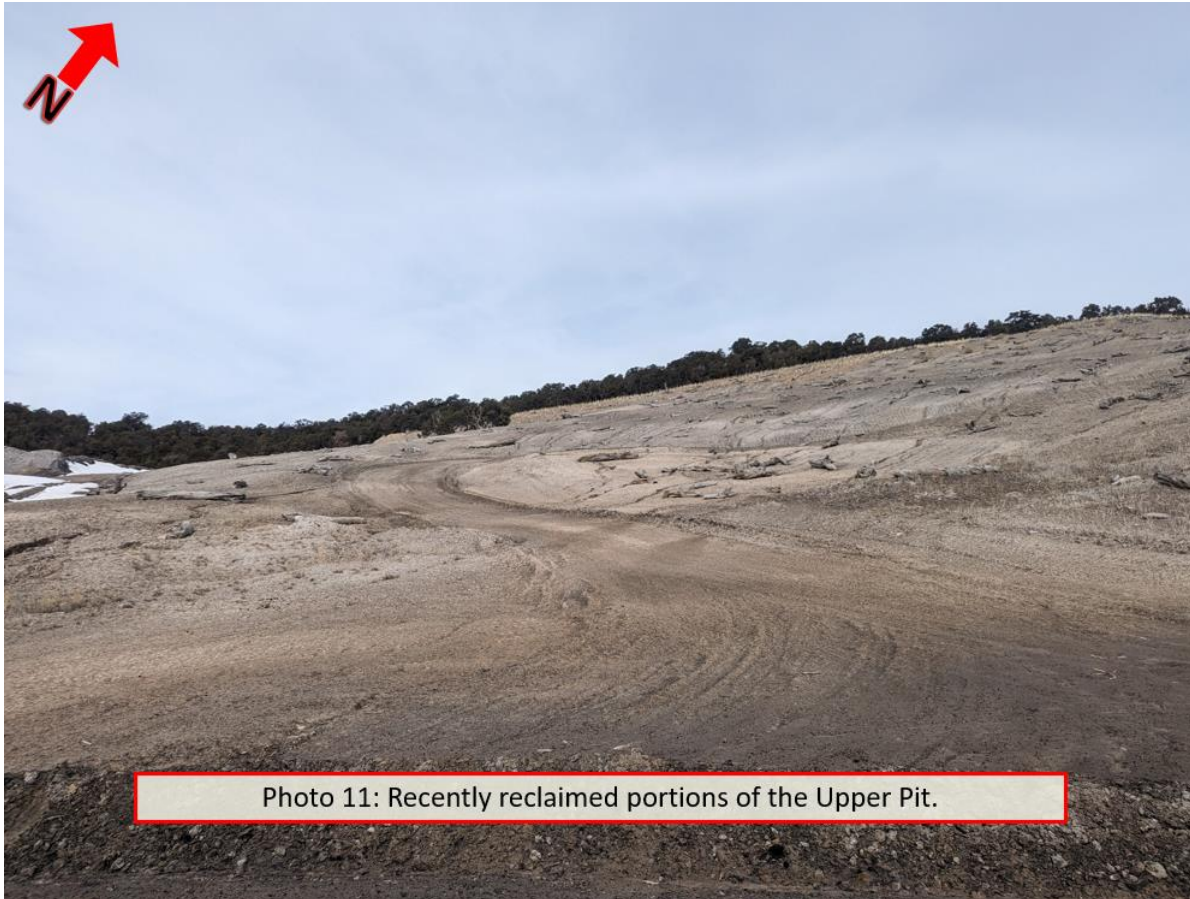
to the arid nature and poor soils. Recent revegetation efforts at the Upper Pit are generally sparse, while (Photo Eleven). While the topsoil stockpile area and the hillsides near the main stockpile area are quite successful and appear similar compared to adjacent undisturbed areas (Photo Twelve).

Photo 11: Recently reclaimed portions of the Upper Pit.

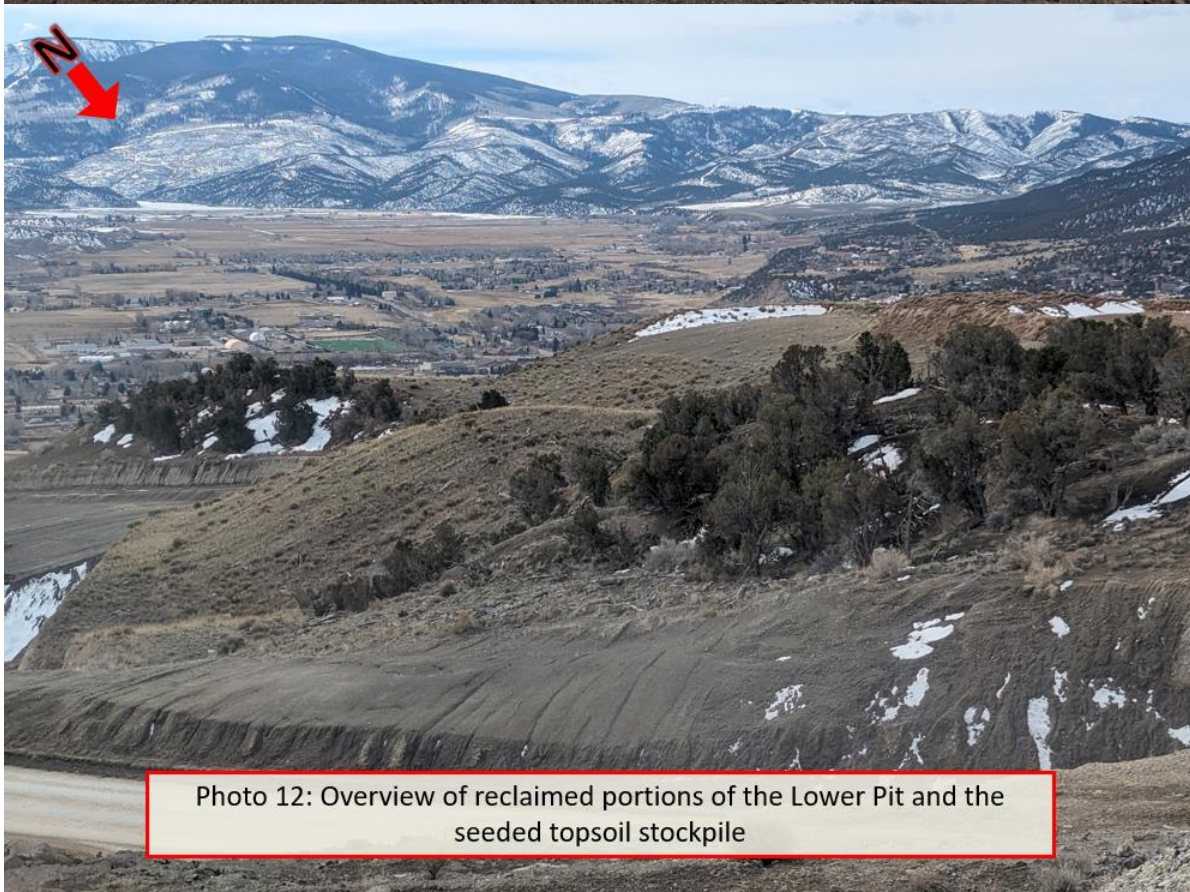
Photo 12: Overview of reclaimed portions of the Lower Pit and the seeded topsoil stockpile

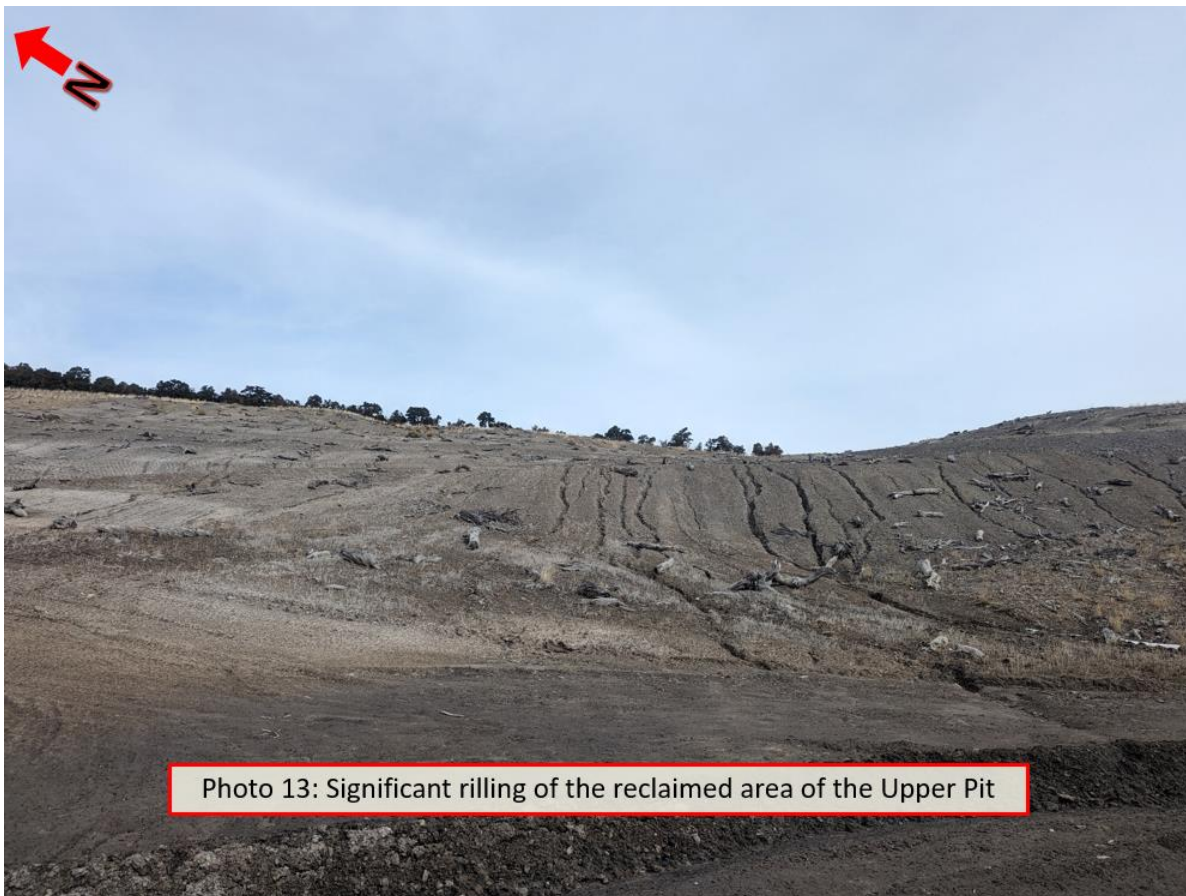
The recently reclaimed area to the north of the Upper Pit had a significant amount of rilling (Photo Thirteen). This area will likely need to be regraded and revegetated. The Operator indicated this is the result of a timing issue where topsoil was placed, but they could not get the seeder out right away. Other reclaimed areas do not have these same erosional issues. This area does not pose a risk to off-site impacts and therefore is not cited as a problem at this time.

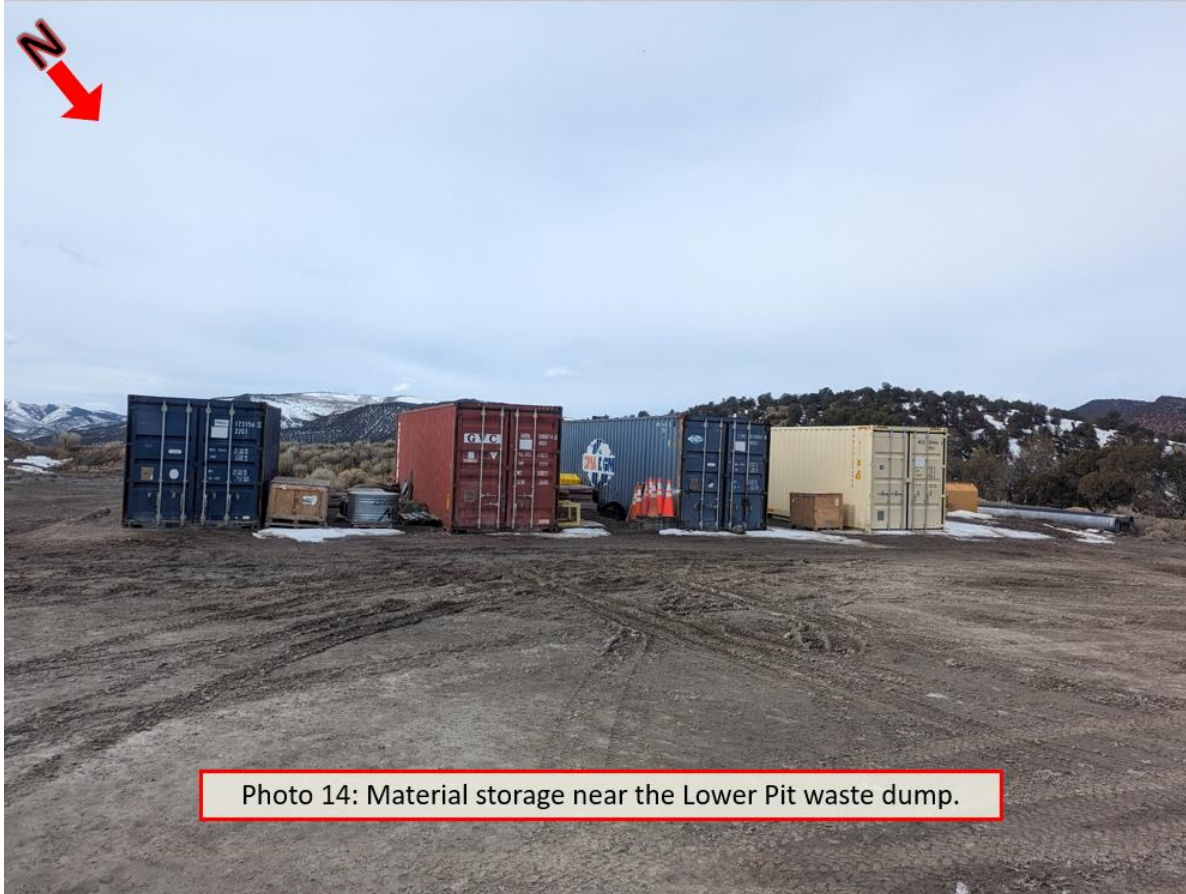
Given the size of the operation the amount of support facilities located onsite are minimal. Where possible the Operator utilizes Conex to store supplies (Photo Fourteen). All misc. materials and facilities areas are organized and well kept. The Mine Plan appears to accurately reflect the structures currently on site and their building materials (Photos Fifteen and Sixteen). Per the Reclamation Plan all structures are to be removed and hauled off site.

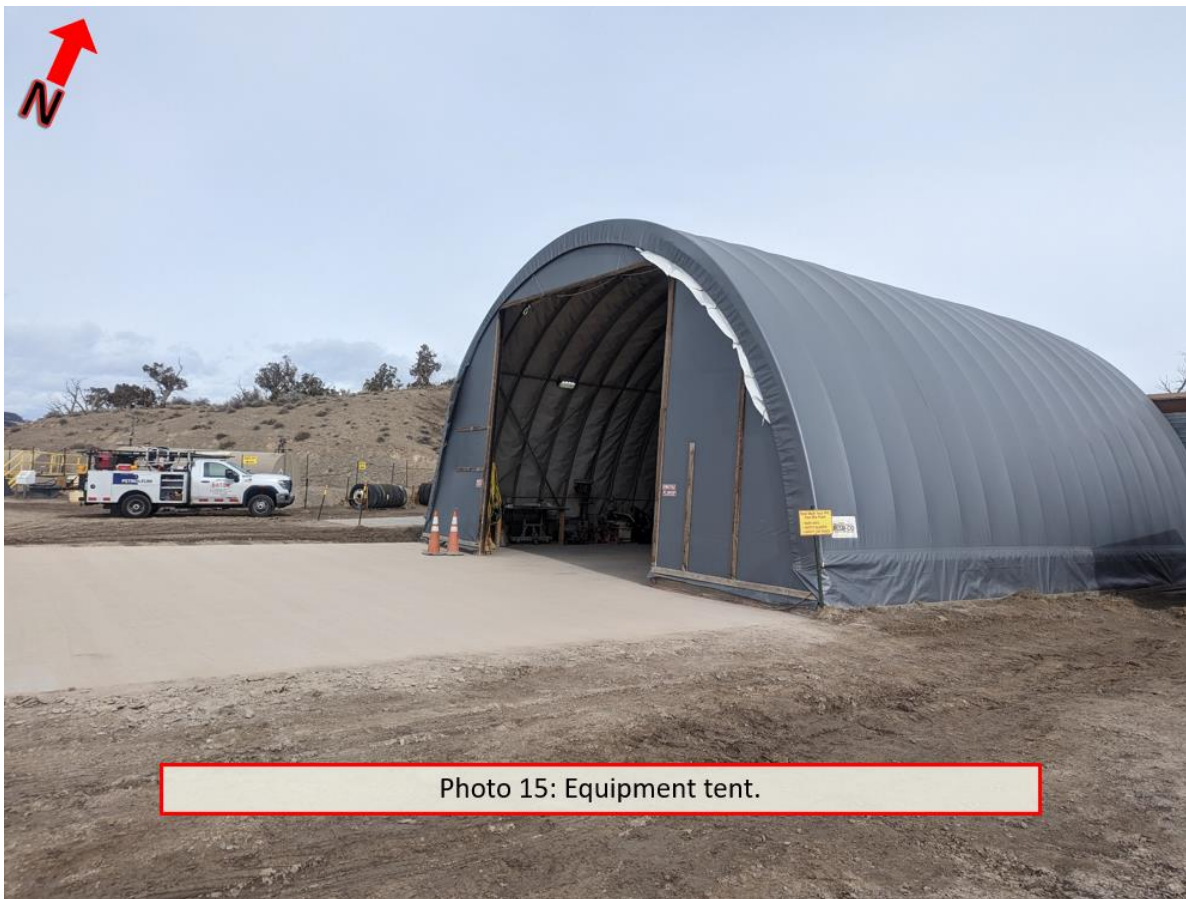
Photo 15: Equipment tent.

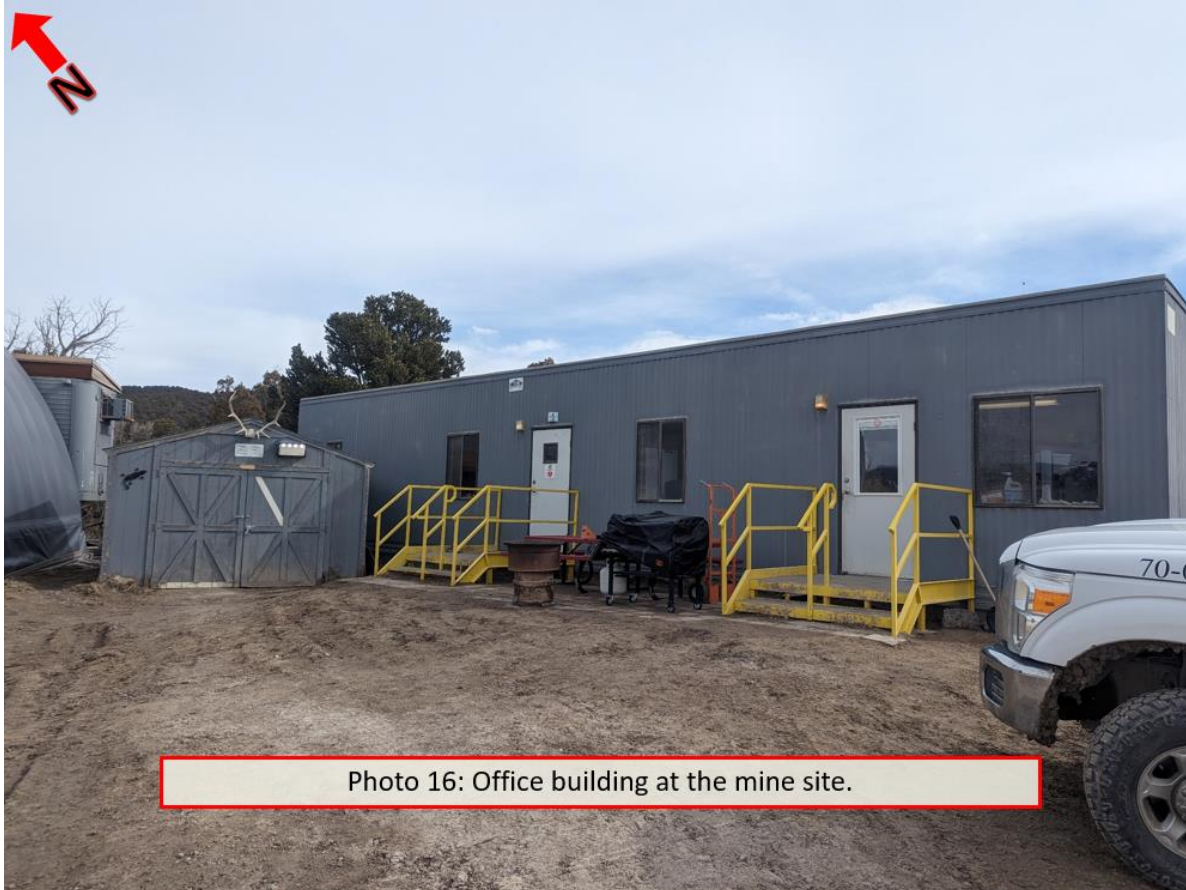
Photo 16: Office building at the mine site.
