MINERALS PROGRAM INSPECTION REPORT
PHONE: (303) 866-3567

MINE NAME: Cross Gold Mine	MINE/PROSPECTING ID#: M-1977-410	MINERAL: Gold, copper, silver,	COUNTY: Boulder
INSPECTION TYPE: Monitoring	WEATHER: Clear	INSP. DATE: March 21, 2024	INSP. TIME: 09:30
OPERATOR: Grand Island Resources LLC	OPERATOR REPRESENTATIVE: Je'an-Paul Brewer	TYPE OF OPERATION: 110(2) - Hard Rock Limited Impact	
REASON FOR INSPECTION: Normal I&E Program	BOND CALCULATION TYPE: None	BOND AMOUNT: \$546,751.00	
DATE OF COMPLAINT: NA	POST INSP. CONTACTS: None	JOINT INSP. AGENCY: None	
INSPECTOR(S): Patrick Lennberg	INSPECTOR'S SIGNATURE:

RE: Idaho Tunnel Effluent Water Management System – Existing Pipeline from Pond 3c to Pond #1 Extension Upgradient - Cross Gold Mine, Permit No. M-1977-410.

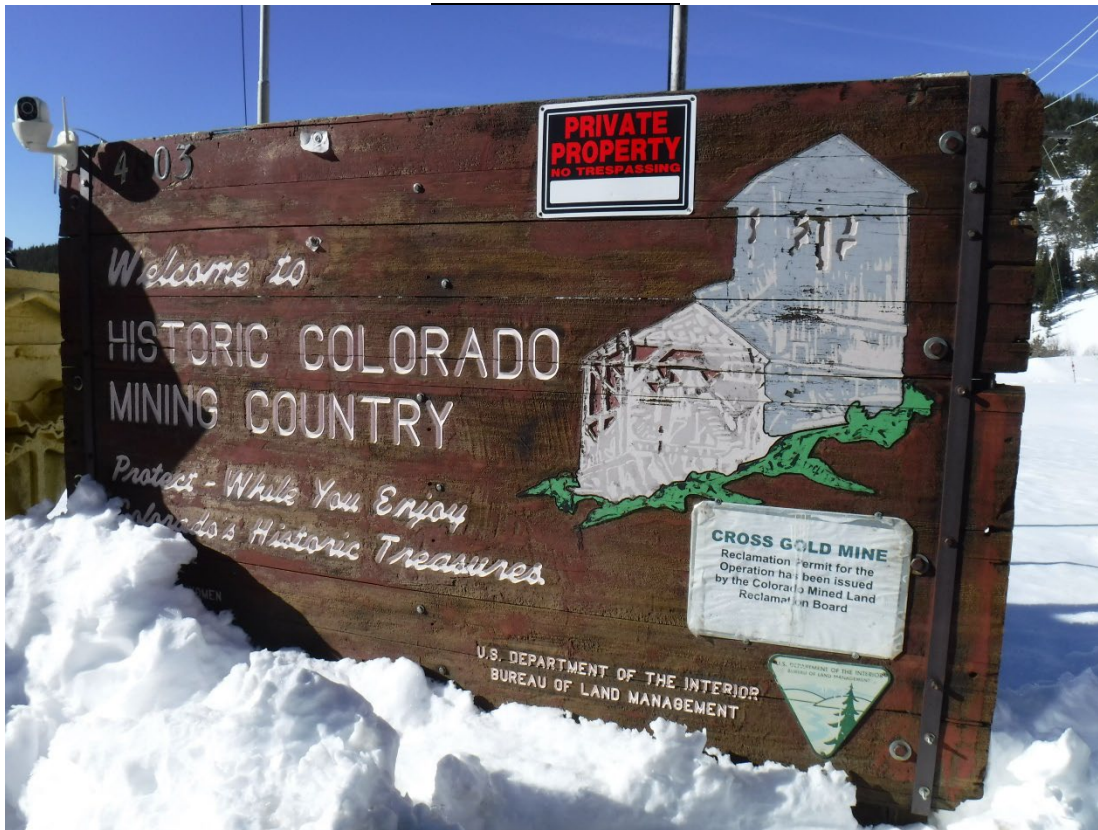
Photo 1: Primary mine entrance

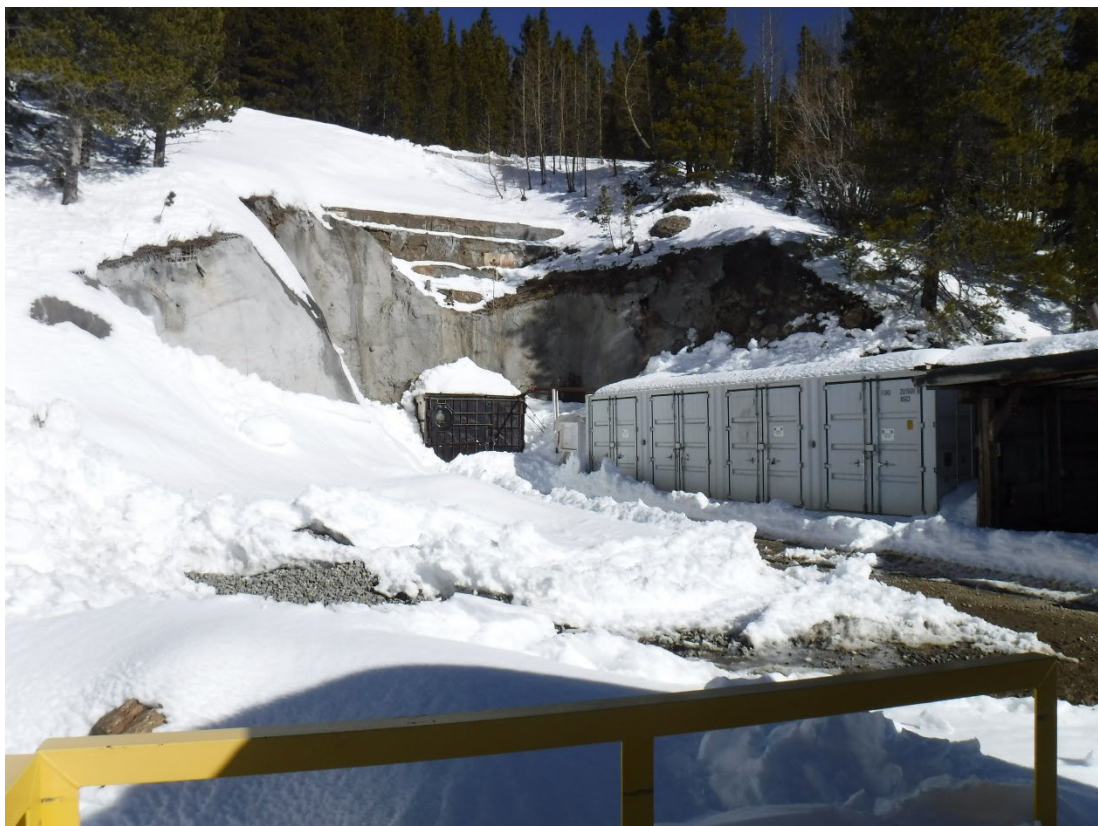
Photo 2: Idaho Tunnel entrance

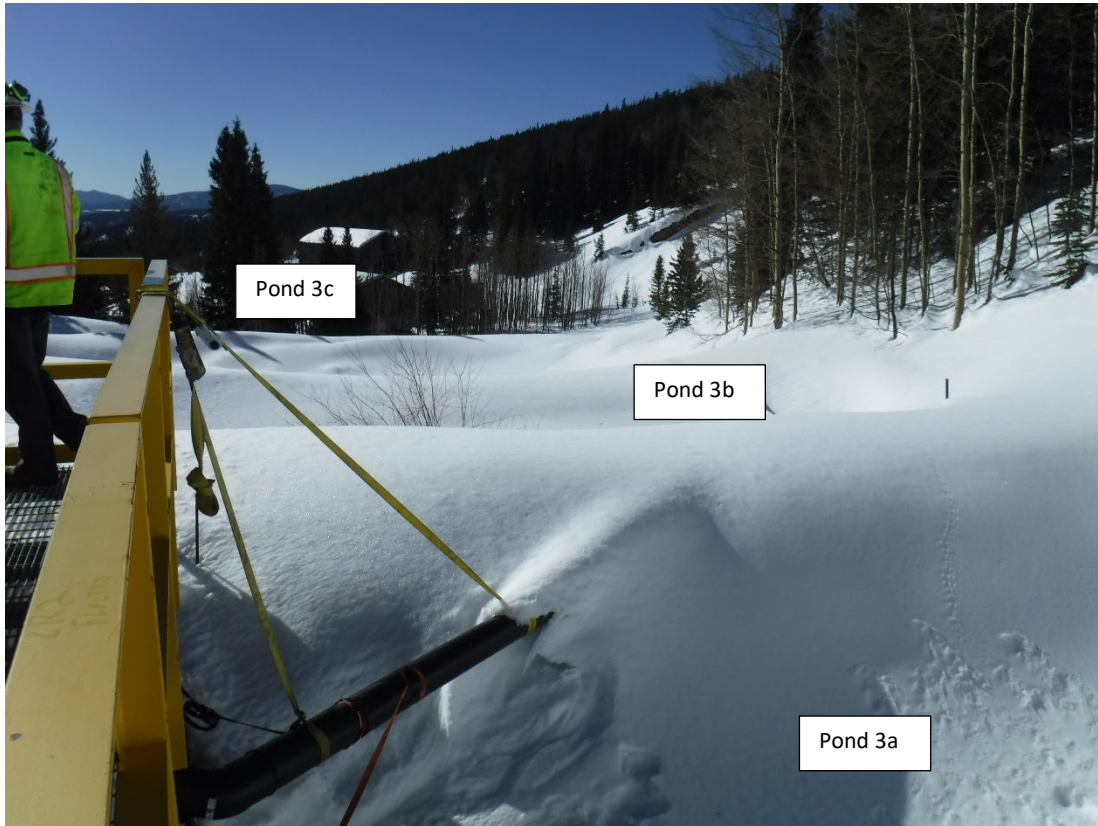
On March 7, 2024 the Division received email communication from the Operator (attached) stating deep snow and low temperatures at the site were causing the 3 series settling ponds to freeze. Ponds 3a, 3b, and 3c were accumulating ice on the surface of the ponds interfering with water flow from one pond to the other. The ice was also restricting flow from Pond 3c to Pond 1. In order to prevent the pipes from clogging with ice and potentially causing a release of water prior to water treatment the Operator by-passed all the 3 series ponds with a pipe that directed effluent directly to Pond 1. Water is treated from Pond 1 before being directed to the approved discharge point. In the event of another storm event or high runoff, water can be directed to the Joliet Raise for storage prior to being treated and released.

Photo 3: Ponds 3a, -3b, and -3c

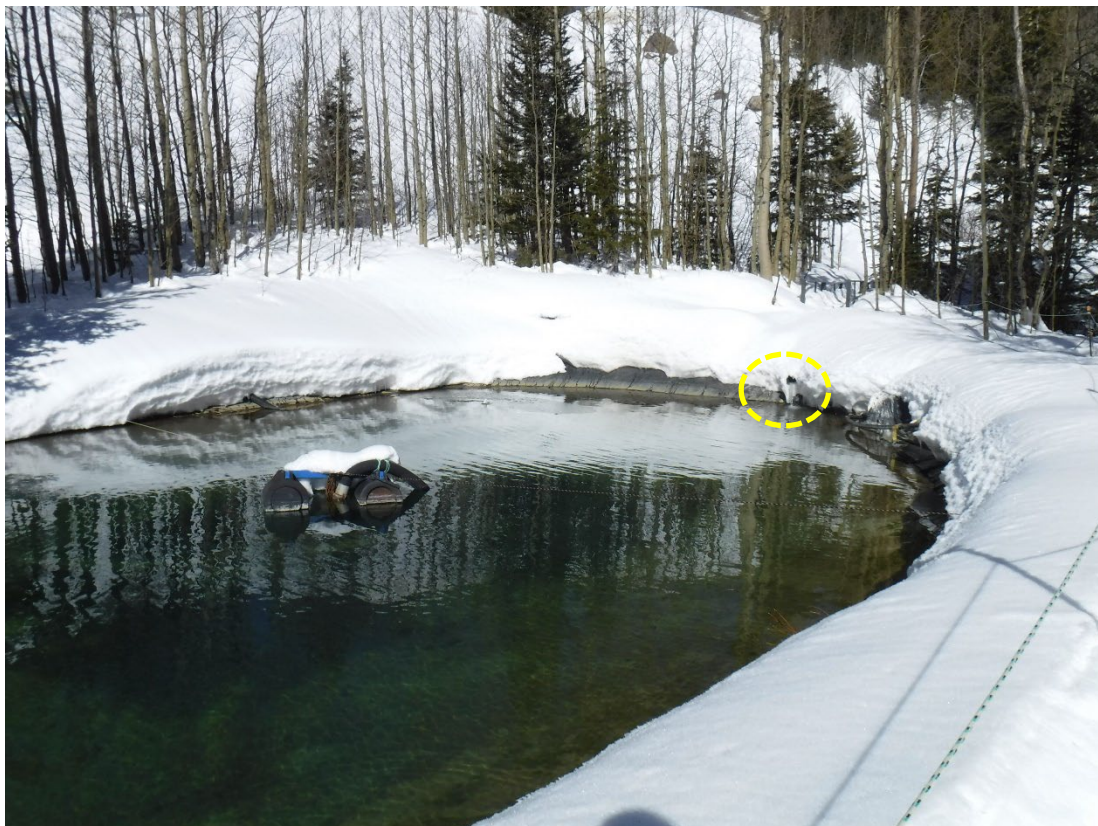
Photo 4: Pond 1 discharge from Idaho Tunnel circled in yellow

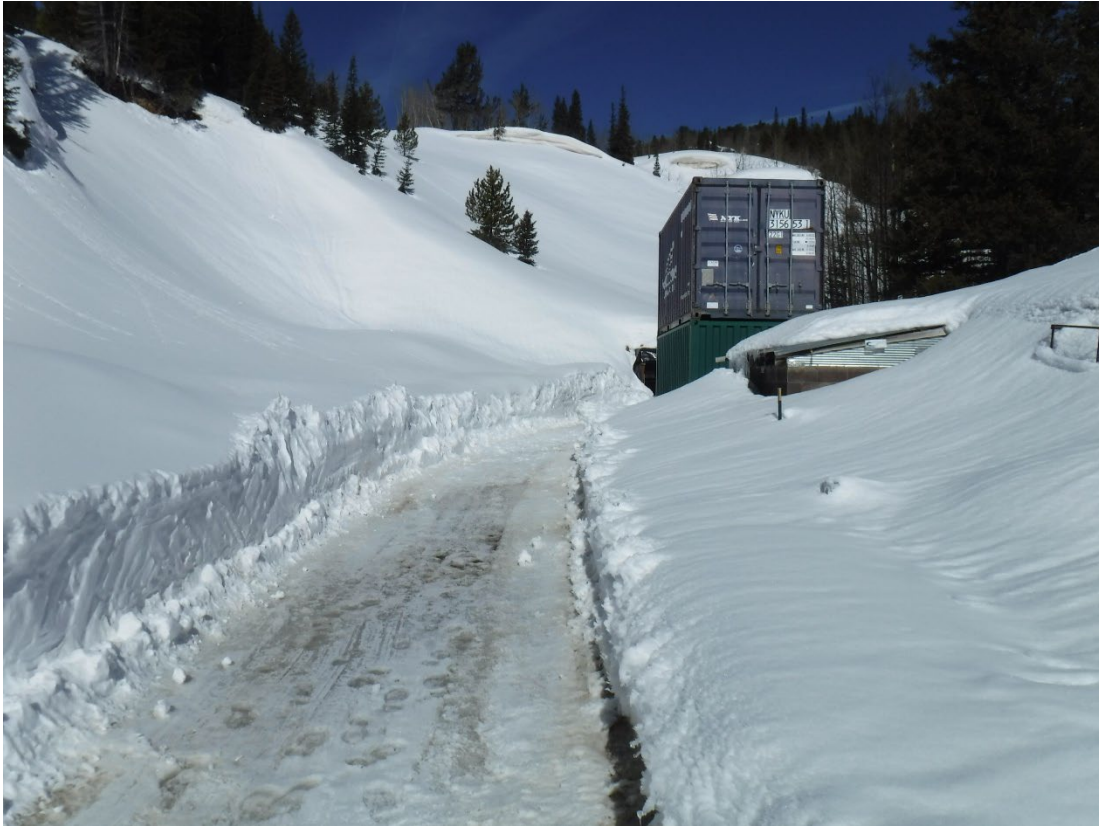
Photo 5: Looking towards Cross Mine Tunnel entrance

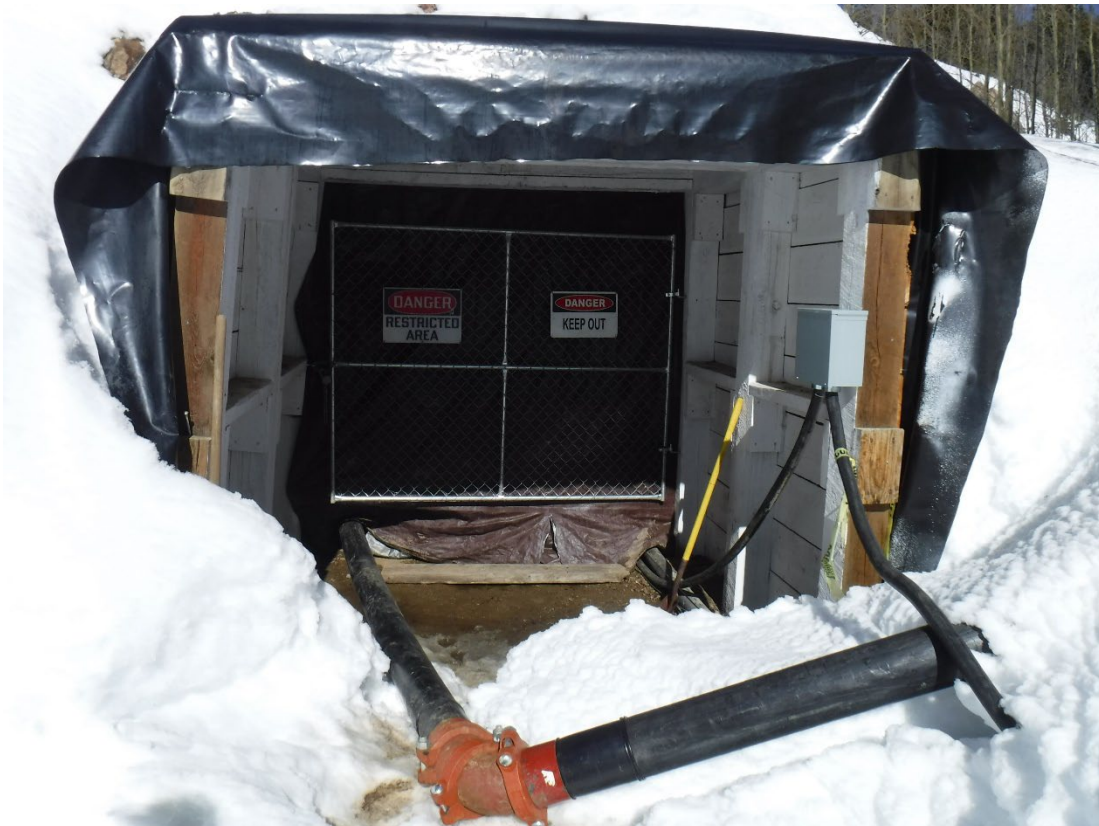
Photo 6: Cross Mine Tunnel entrance

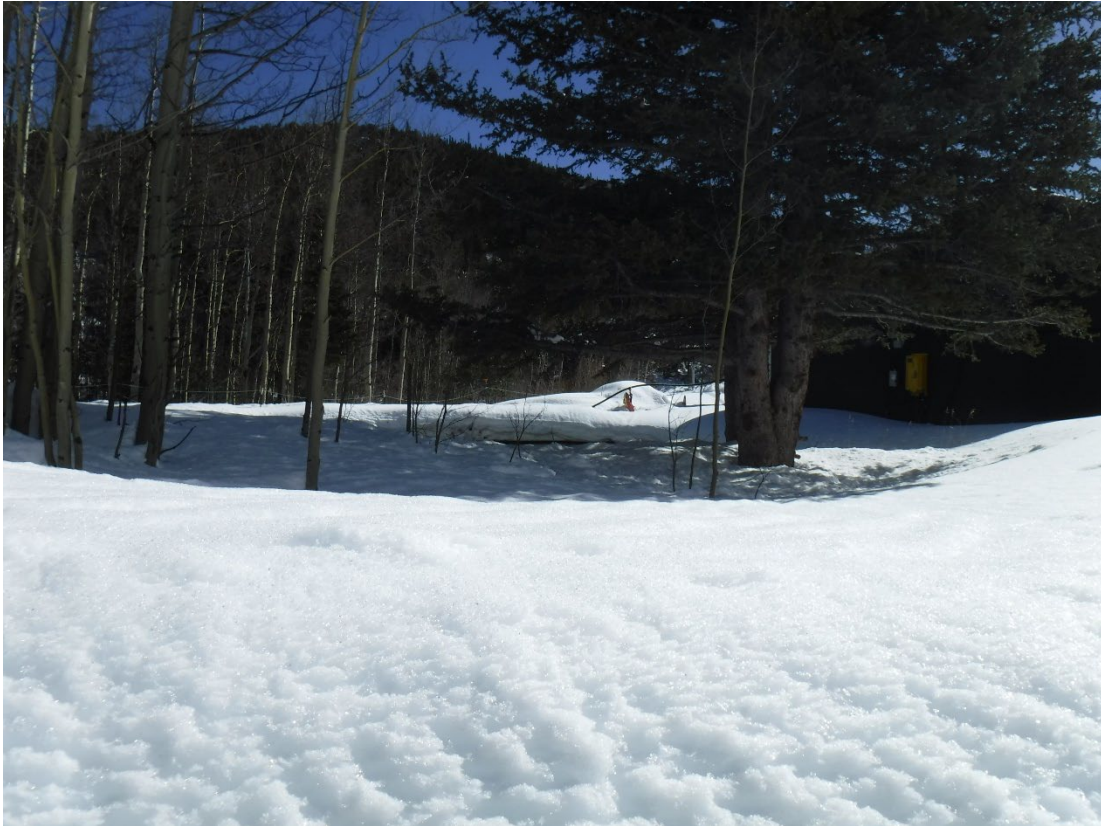
Photo 7: Looking from the Cross Mine Tunnel entrance to Pond 1

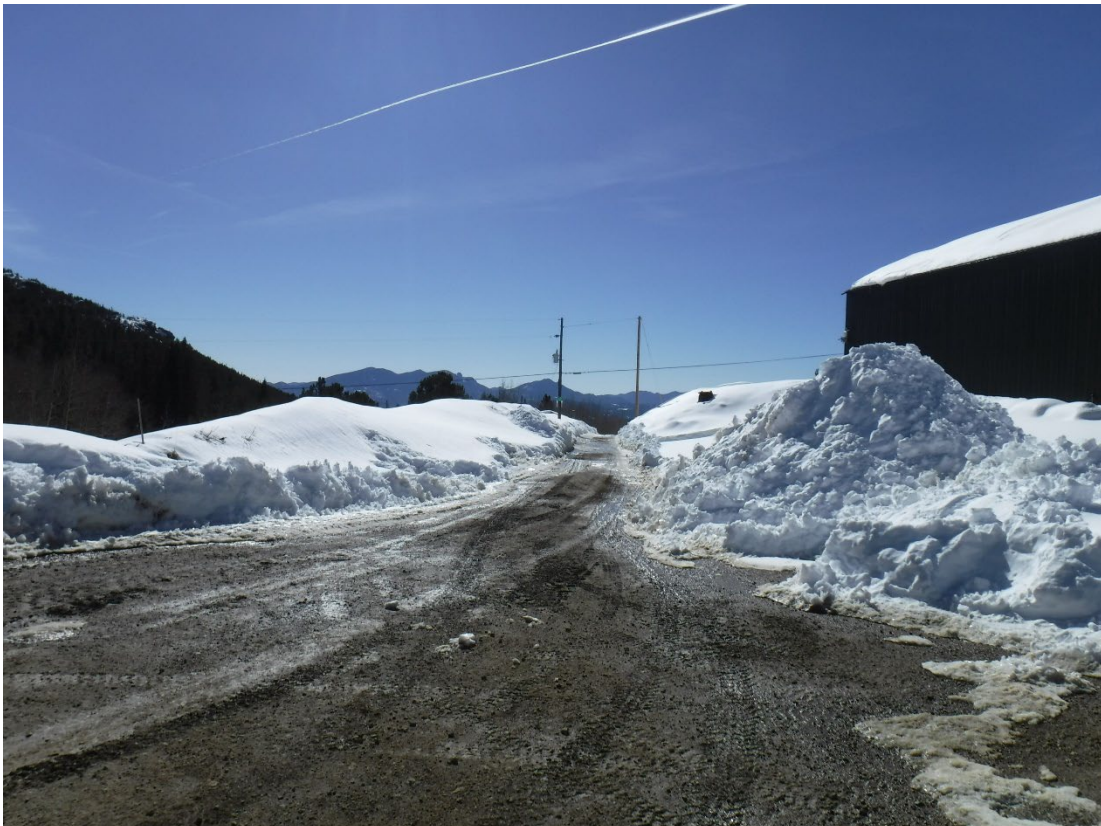
Photo 8: Looking south from the Cross Mine shop area.

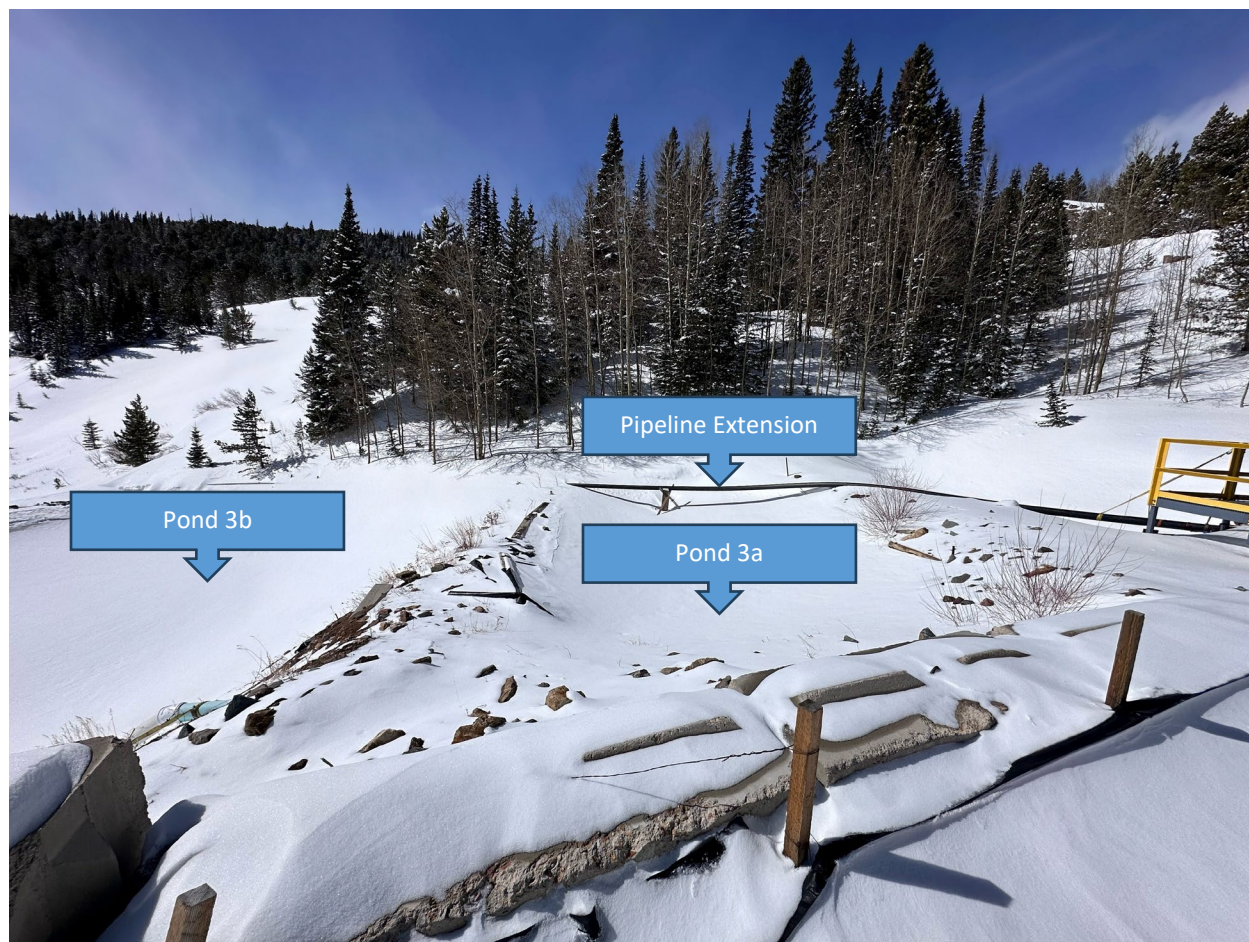
2023/2024 (current) winter climatic conditions on site (high snow precipitation and very low temperatures) have resulted in ponded water freezing and snow accumulation over the frozen Ponds 3a, 3b and 3c. GIR has been managing Idaho Tunnel flow through the system in harsh conditions this winter and has recently considered essential to by-pass the Pond 3 system by extending Pipeline #9 inlet (Pond 3c) upgradient and connect directly to Pipeline #3 Idaho Tunnel effluent pipeline, such that effluent management is viable. The attached photographs depict the pipeline extension and current field conditions.

Photograph 1 – Looking West Across Pond 3a

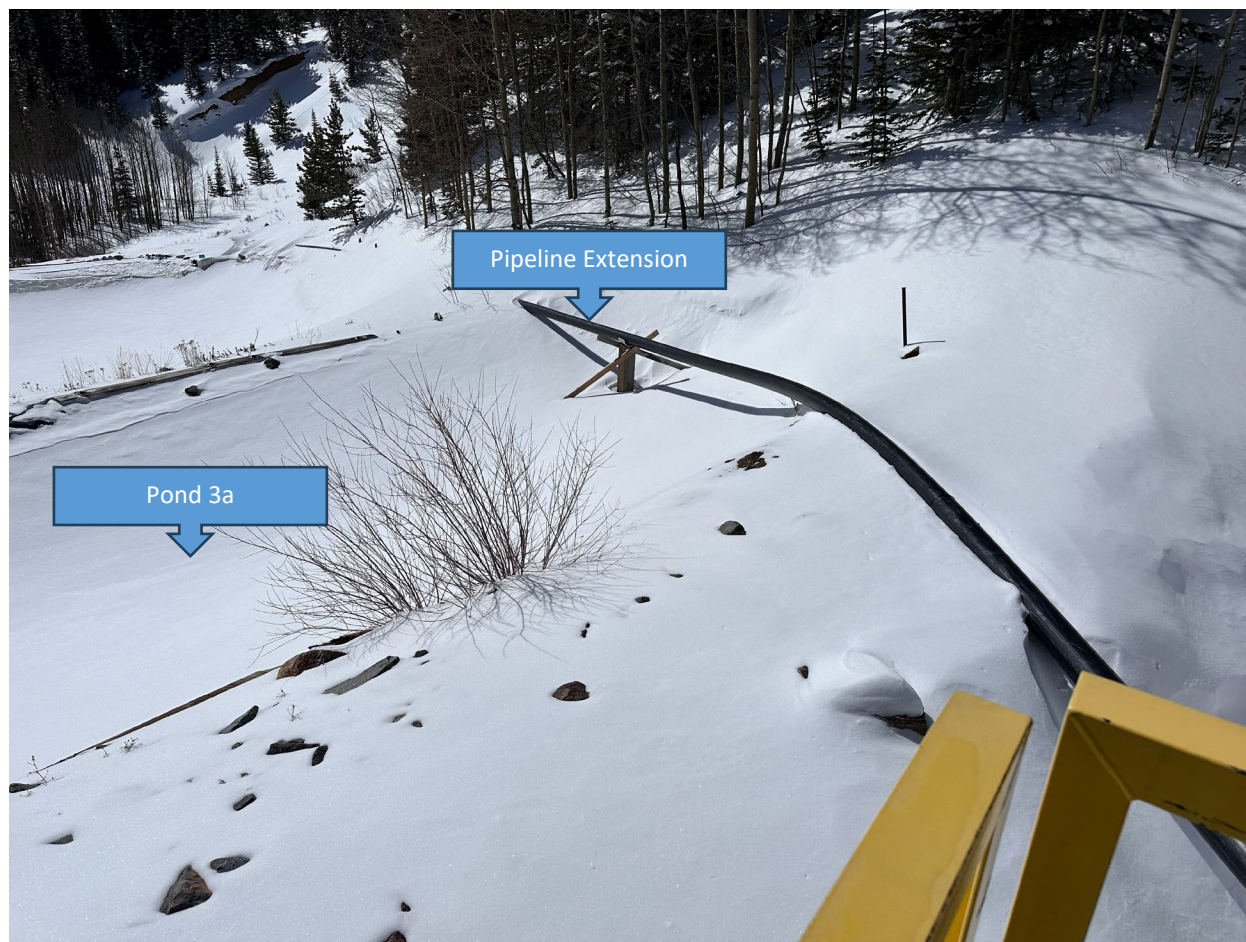
Photograph 2 – Looking Southwest Downstream from Pond 3a
