MINERALS PROGRAM INSPECTION REPORT
PHONE: (303) 866-3567

MINE NAME: Jemadojin Sand Mine	MINE/PROSPECTING ID#: M-2006-017	MINERAL: Sand	COUNTY: El Paso
INSPECTION TYPE: Surety-Related Inspection	WEATHER: Clear	INSP. DATE: March 19, 2024	INSP. TIME: 10:00
OPERATOR: Hourglass Sands LLC	OPERATOR REPRESENTATIVE: Maria Jindra & Scott McGuire	TYPE OF OPERATION: 112c - Construction Regular Operation	
REASON FOR INSPECTION: Surety Related	BOND CALCULATION TYPE: Complete Bond	BOND AMOUNT: \$128,878.00	
DATE OF COMPLAINT: NA	POST INSP. CONTACTS: None	JOINT INSP. AGENCY: None	
INSPECTOR(S): Hunter Ridley	INSPECTOR'S SIGNATURE:

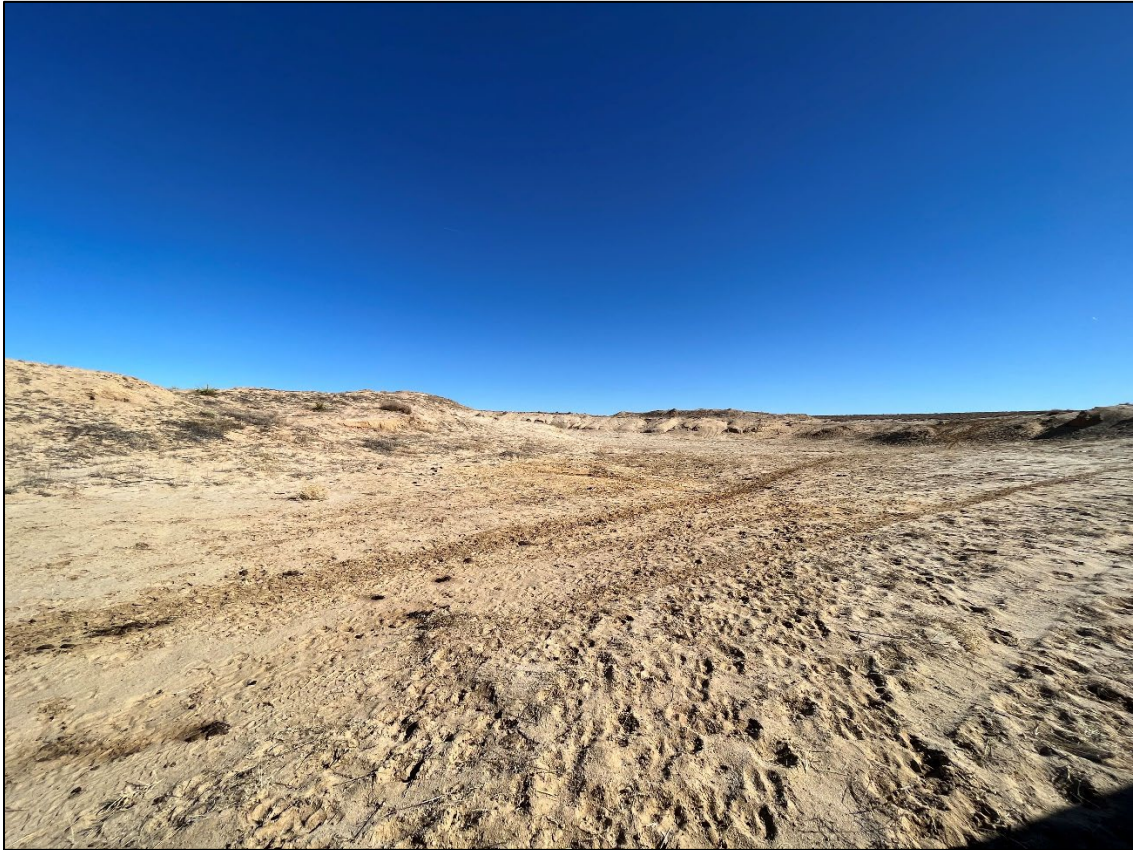
Excess Spoil and Dev. Waste: Overburden piles were observed on the northern end of the site (Photo 1).

Topsoil: There are two, labeled topsoil piles located on site. These were observed to be adequately vegetated pursuant to Rule 3.1.9 (Photos 1 and 2).

Photo 1: View northeast of the main pit, topsoil and overburden are piled separately to the east.

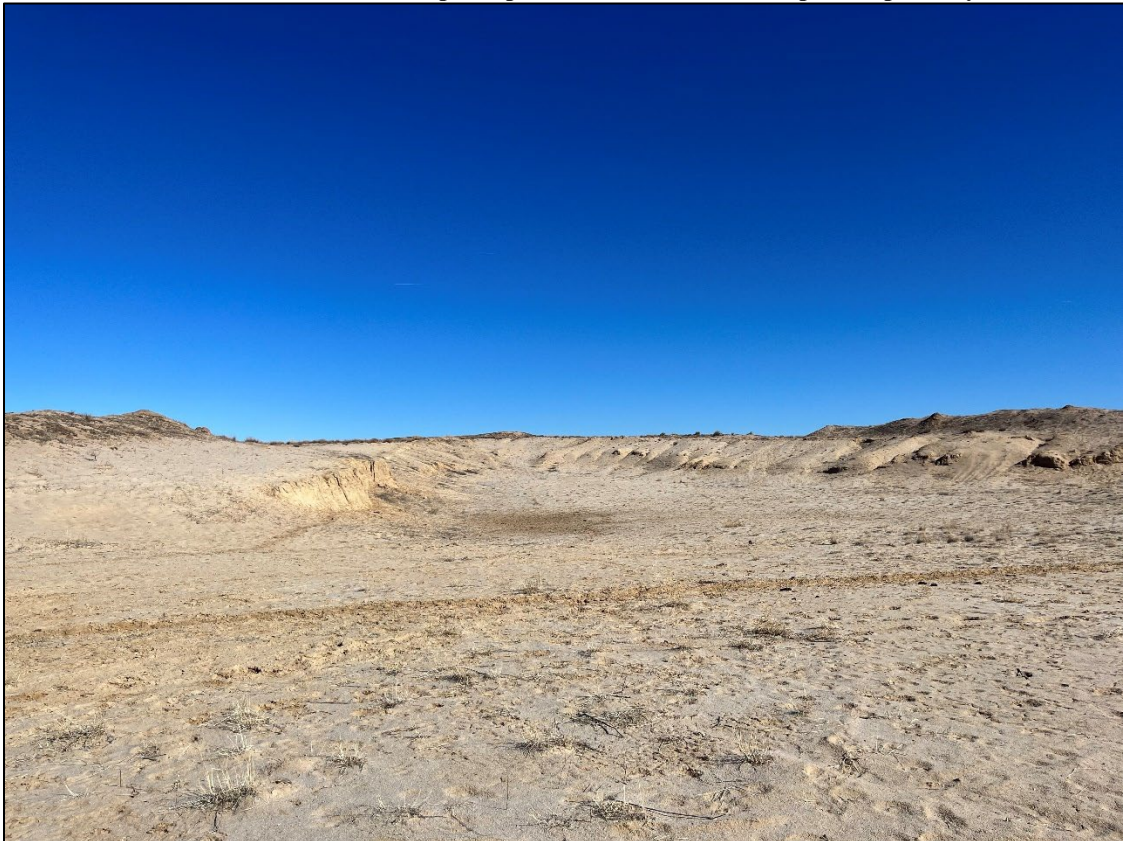
Backfilling and Grading: Final grading is to be 3H:1V or flatter. As there is sufficient distance from the affected area boundary, a push down approach could be used to flatten the slopes, therefore sufficient backfill material is available. West facing highwalls are nearly at the required final slope (Photos 2 and 3), but east facing highwalls require flattening (Photo 2)

Photo 2: View north of the main pit, topsoil is piled to the southwest.

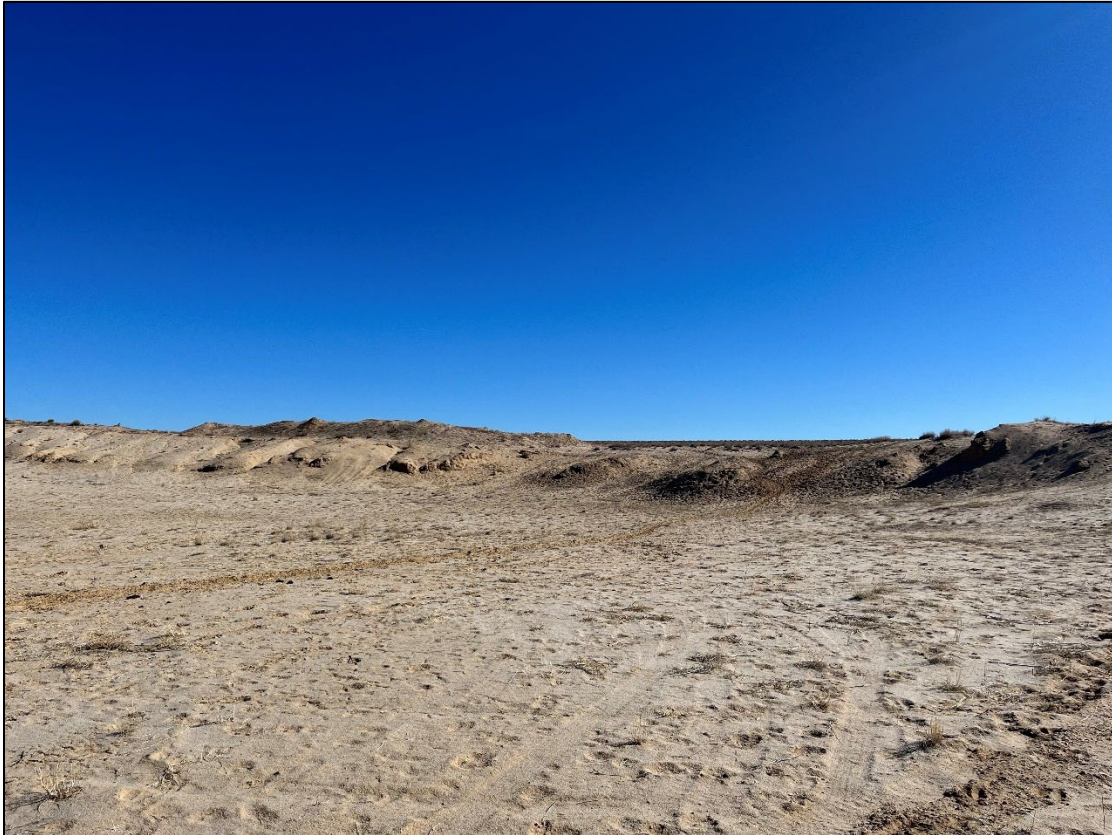
Reclamation Success: Grading and topsoiling are complete in the south pit and far northern end of the main pit. The main pit requires minimal slope flattening (Photo 3).

Photo 3: View east of the main pit, topsoil and overburden piles are visible, minimal grading work is required for final reclamation.

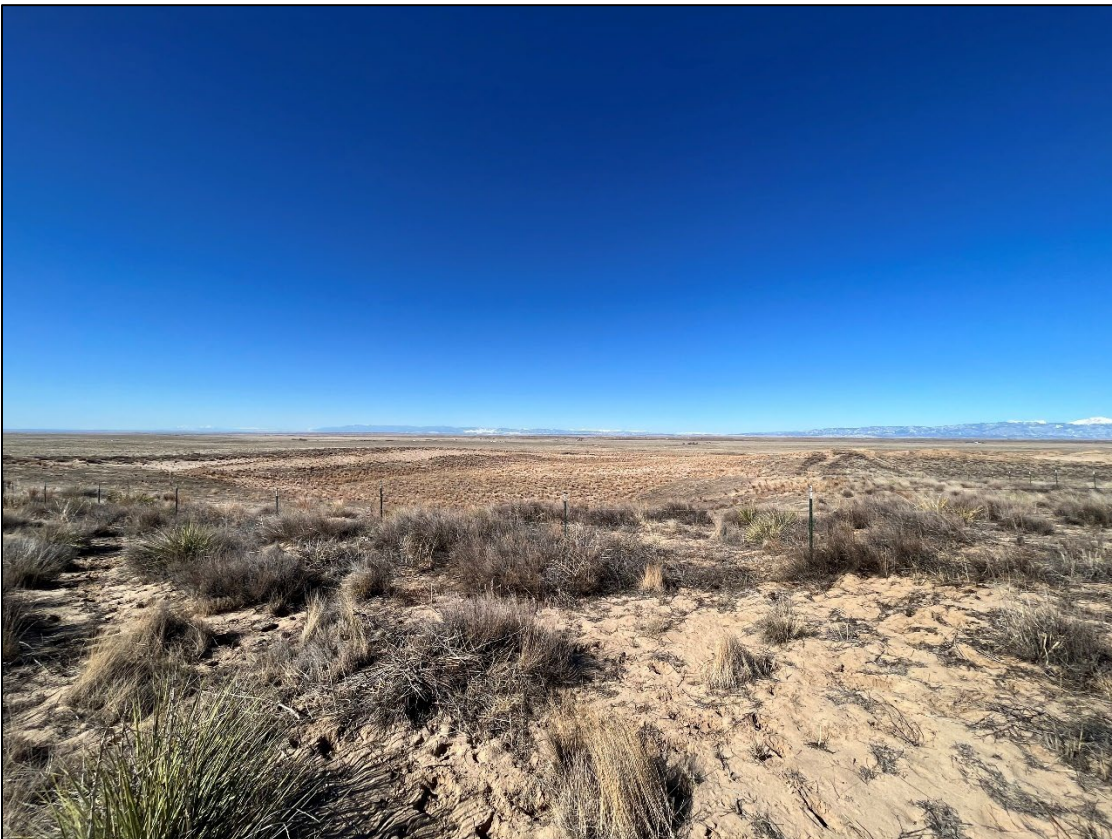
Revegetation: Both the south pit and the diversion cut areas looked to be adequately revegetated and releasable (Photos 4 and 5). No revegetation efforts have occurred in the north / main pit and no noxious weeds were observed.

Signs and Markers: The permit sign was fixed to the main gate entrance, located on the access road. Berms were observed to delineate the affected area and fences delineated the permit boundary (Photos 4 and 5).

Photo 4: View southwest of the older portion of the permit, this area has been adequately reclaimed.

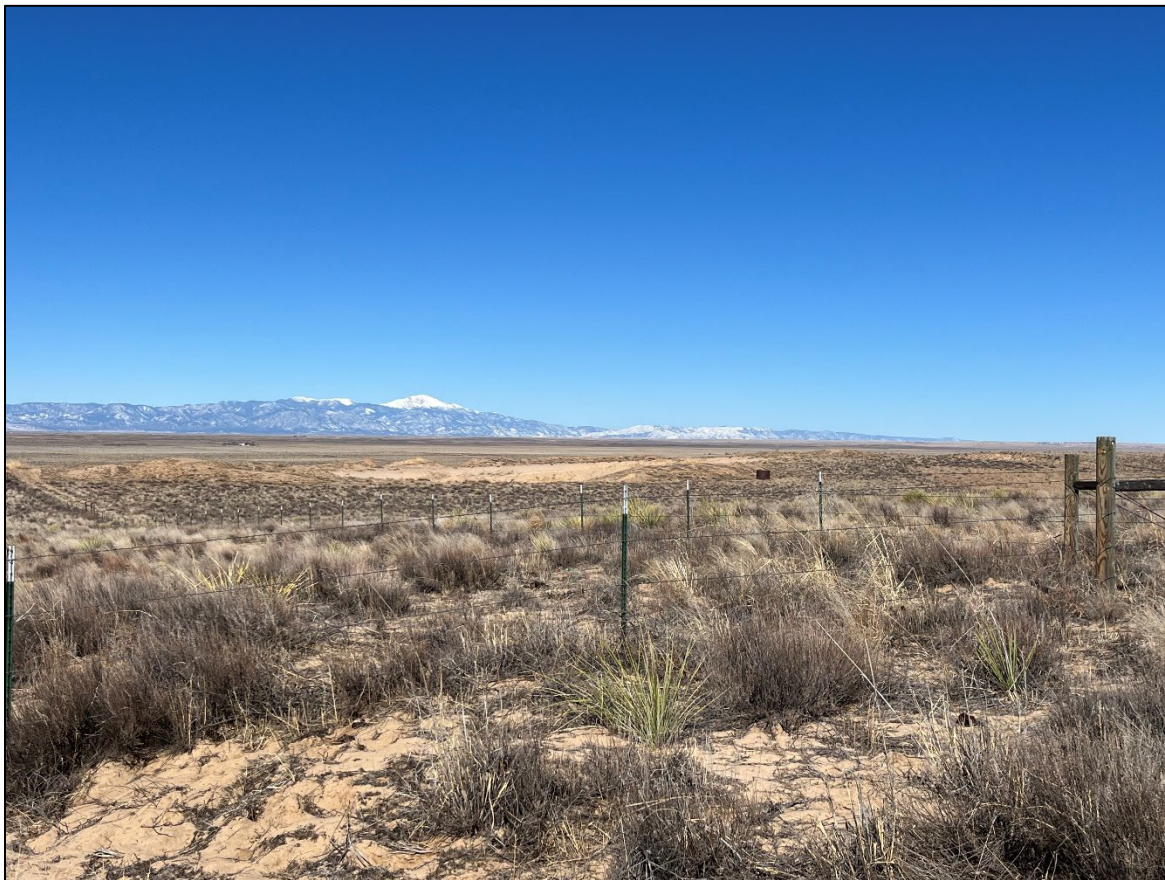
Photo 5: View northwest of the main pit, taken from the affected area boundary's eastern extent.
