Keenesburg inspection report

PERMIT INFORMATION

Permit Number: C-1981-028 Mine Name: Keenesburg Strip Mine Operator: Coors Energy Company Operator Address: Mr. Ben Moline P.O. Box 4030 Golden, CO 80402	County: Weld Operation Type: Surface Permit Status: Permanent Cessation Ownership: Private
	Operator Representative Present: None
Operator Representative Signature: (Field Issuance Only)

Inspection Start Date: March 21, 2024 Inspection Start Time: 09:10 Inspection End Date: March 21, 2024 Inspection End Time: 10:40	Inspection Type: Coal Partial Inspection Inspection Reason: Normal I&E Program Weather: Clear
Joint Inspection Agency: None	Joint Inspection Contacts:
Post Inspection Agency: None	Post Inspection Contacts:
Inspector(s): Robert Zuber, P.E.	Inspector's Signature:

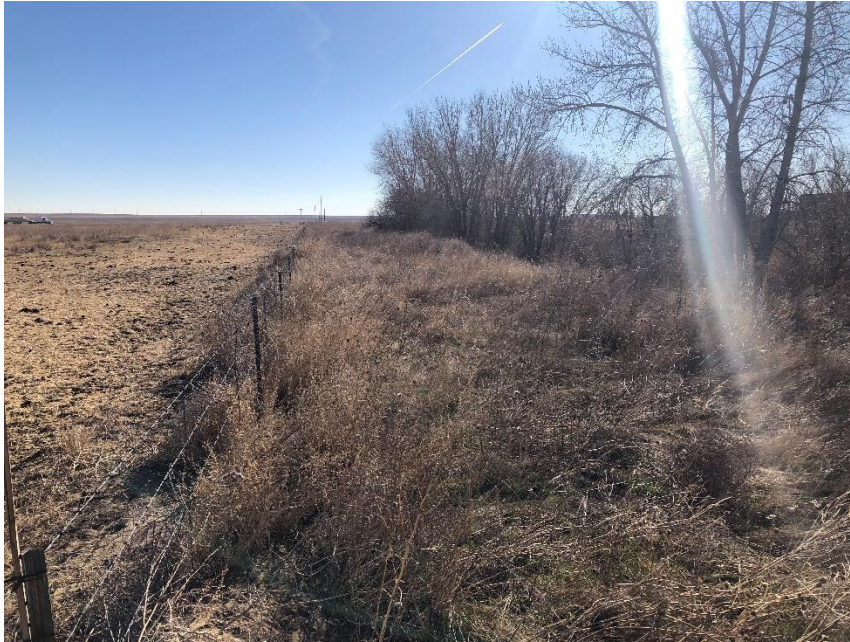
No water was visible in the sediment ponds, Sediment Pond 2 and the Dugout Pond. Both ponds contain thick vegetation that obscures their bottoms. They were not discharging during the inspection. There were no signs that either pond had discharged recently. No problems were observed with structures for the ponds.

Sediment Pond 2 embankment

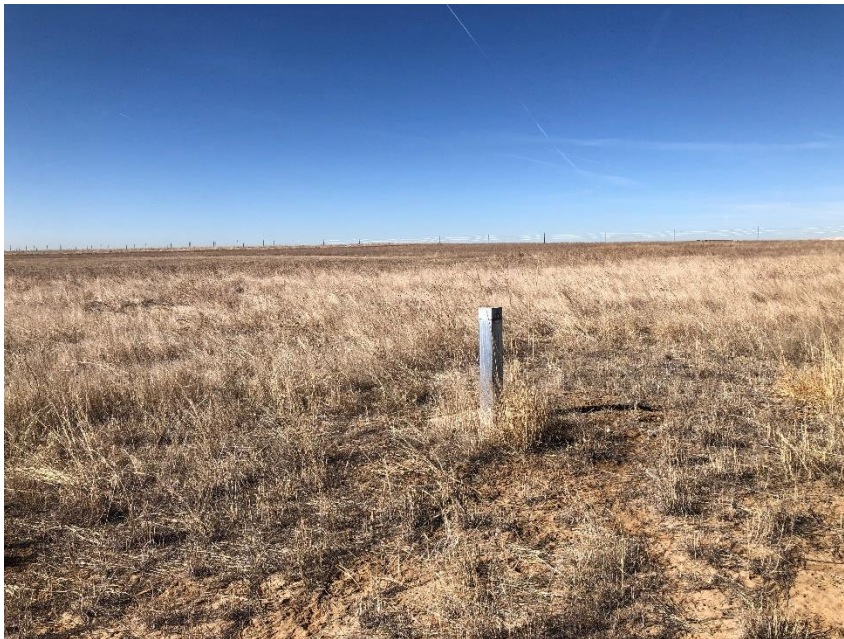
The surficial structures for monitoring wells were seen in Areas 36 and 37. No problems were observed.

Southwest corner of Area 37, with monitoring well

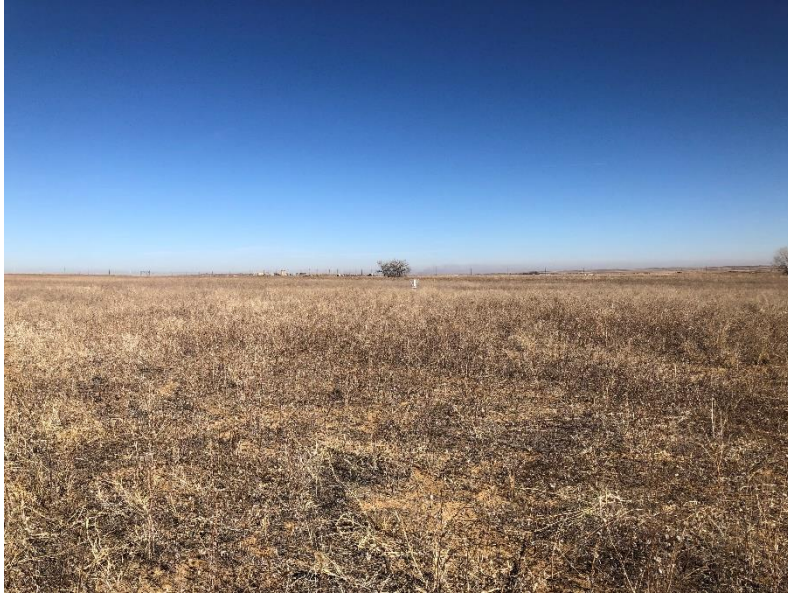
East side of Area 36 (note weather station in center of photo)

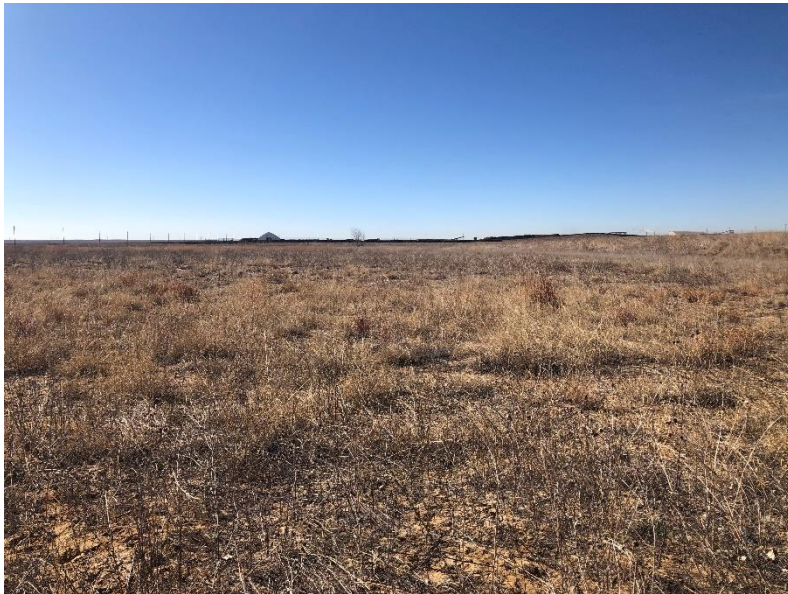
Area 34 (southwest corner of site), looking south
