MINERALS PROGRAM INSPECTION REPORT
PHONE: (303) 866-3567

MINE NAME: Lindsey Canyon LLC	MINE/PROSPECTING ID#: M-2000-072	MINERAL: Borrow material	COUNTY: Montrose
INSPECTION TYPE: Monitoring	WEATHER: Clear	INSP. DATE: March 12, 2024	INSP. TIME: 11:30
OPERATOR: Lindsey Canyon, LLC	OPERATOR REPRESENTATIVE:	TYPE OF OPERATION: 110c - Construction Limited Impact	
REASON FOR INSPECTION: Normal I&E Program	BOND CALCULATION TYPE: Complete Bond	BOND AMOUNT: \$20,460.00	
DATE OF COMPLAINT: NA	POST INSP. CONTACTS: None	JOINT INSP. AGENCY: None	
INSPECTOR(S): Dustin Czapla	INSPECTOR'S SIGNATURE:

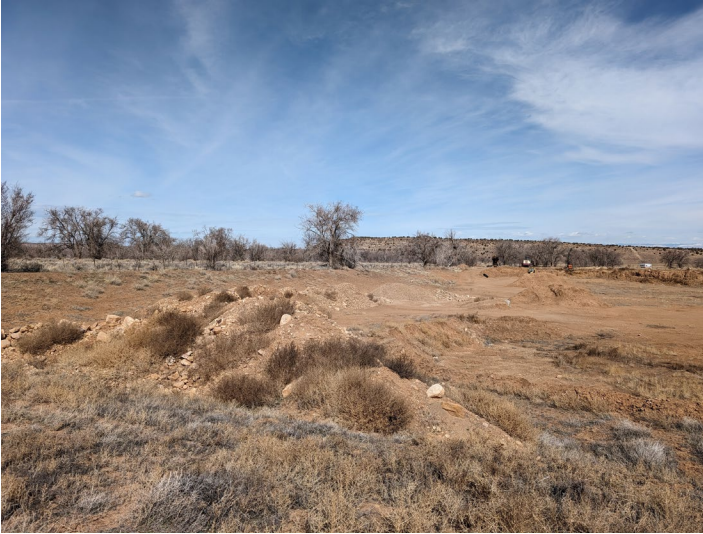
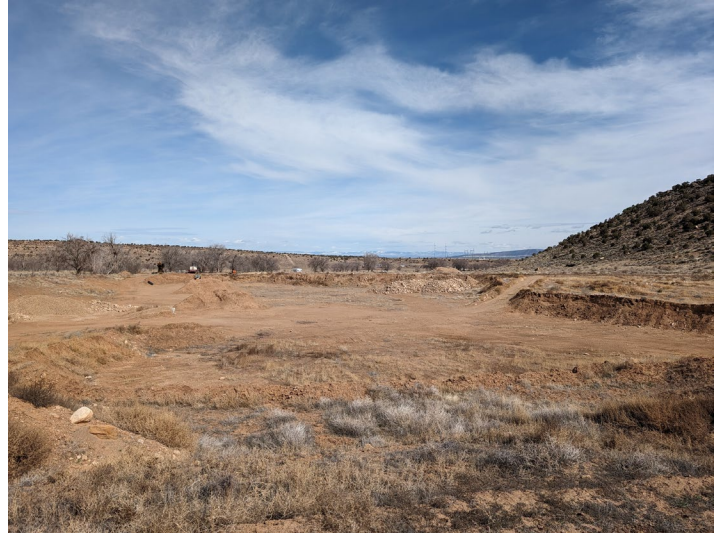
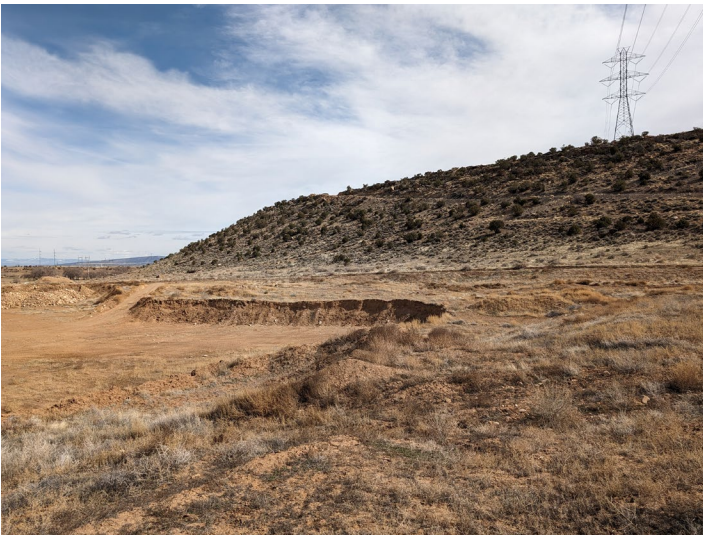
Adequate mine identification signage was noted at the entrance to the site.

The affected area was marked by posts and fencing that was clearly visible and adequate to delineate the affected area boundary.

The pit is excavated to a depth of approximately 10 feet. The pit wall on the west is graded to approximately 3H:1V. The remainder of the pit slopes, approximately 1,000 linear feet, have sloughed to roughly 1H:1V. Several construction material stockpiles are located in the pit, along with several pieces of excavation equipment. Approximately 3 acres are currently disturbed.
