MINERALS PROGRAM INSPECTION REPORT
PHONE: (303) 866-3567

MINE NAME: Base Products Gravel Pit 2	MINE/PROSPECTING ID#: M-2022-025	MINERAL: Aggregate	COUNTY: Montrose
INSPECTION TYPE: Preoperation Inspection	INSPECTOR(S): Dustin Czapla	INSP. DATE: March 12, 2024	INSP. TIME: 10:50
OPERATOR: BDF, LLC	OPERATOR REPRESENTATIVE: None	TYPE OF OPERATION: 112c - Construction Regular Operation	
REASON FOR INSPECTION: Normal I&E Program	BOND CALCULATION TYPE: Complete Bond	BOND AMOUNT: \$193,346.00	
DATE OF COMPLAINT: NA	POST INSP. CONTACTS: None	JOINT INSP. AGENCY: None	
WEATHER: Clear	INSPECTOR'S SIGNATURE:

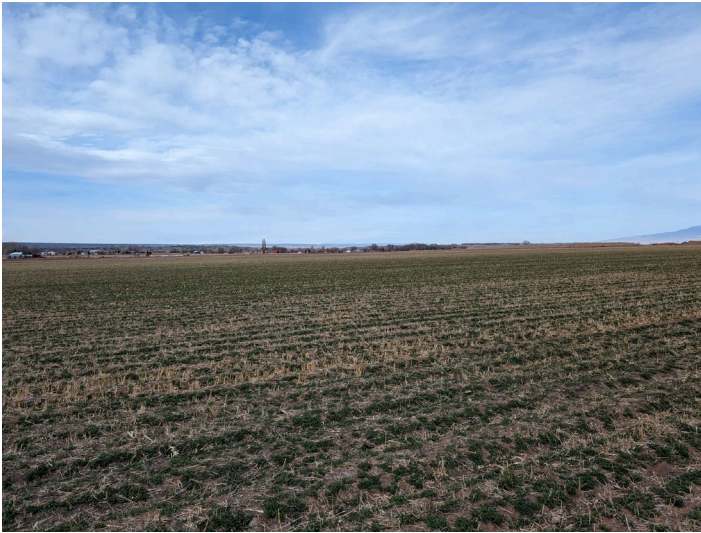
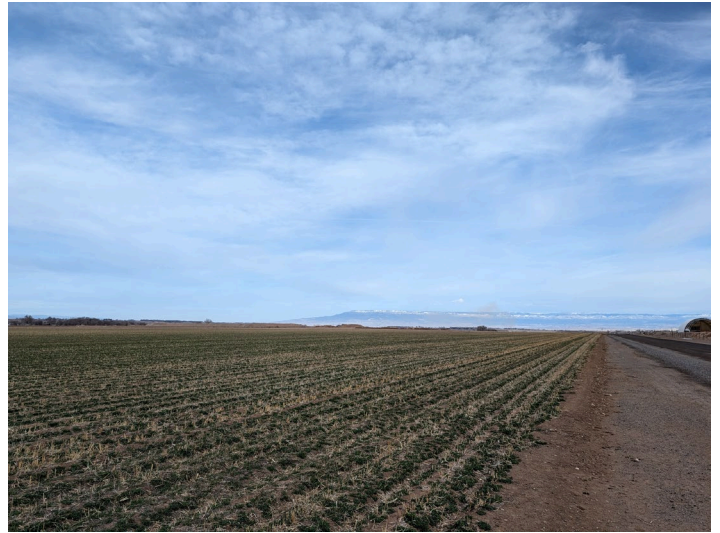
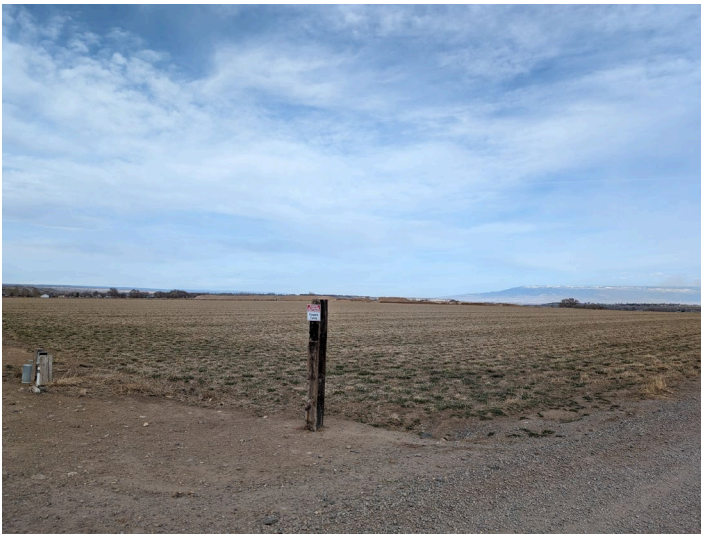
Mining has not yet commenced at this site. The site is currently undisturbed by mining operations. The area is currently utilized as irrigated farm land.

No problems were noted.
