QUARTERLY SEDIMENTATION POND INSPECTION REPORT

Mine: New Elk WP Containment #1

Inspection Period: First Quarter 2024

Inspection Date: 03/26/24

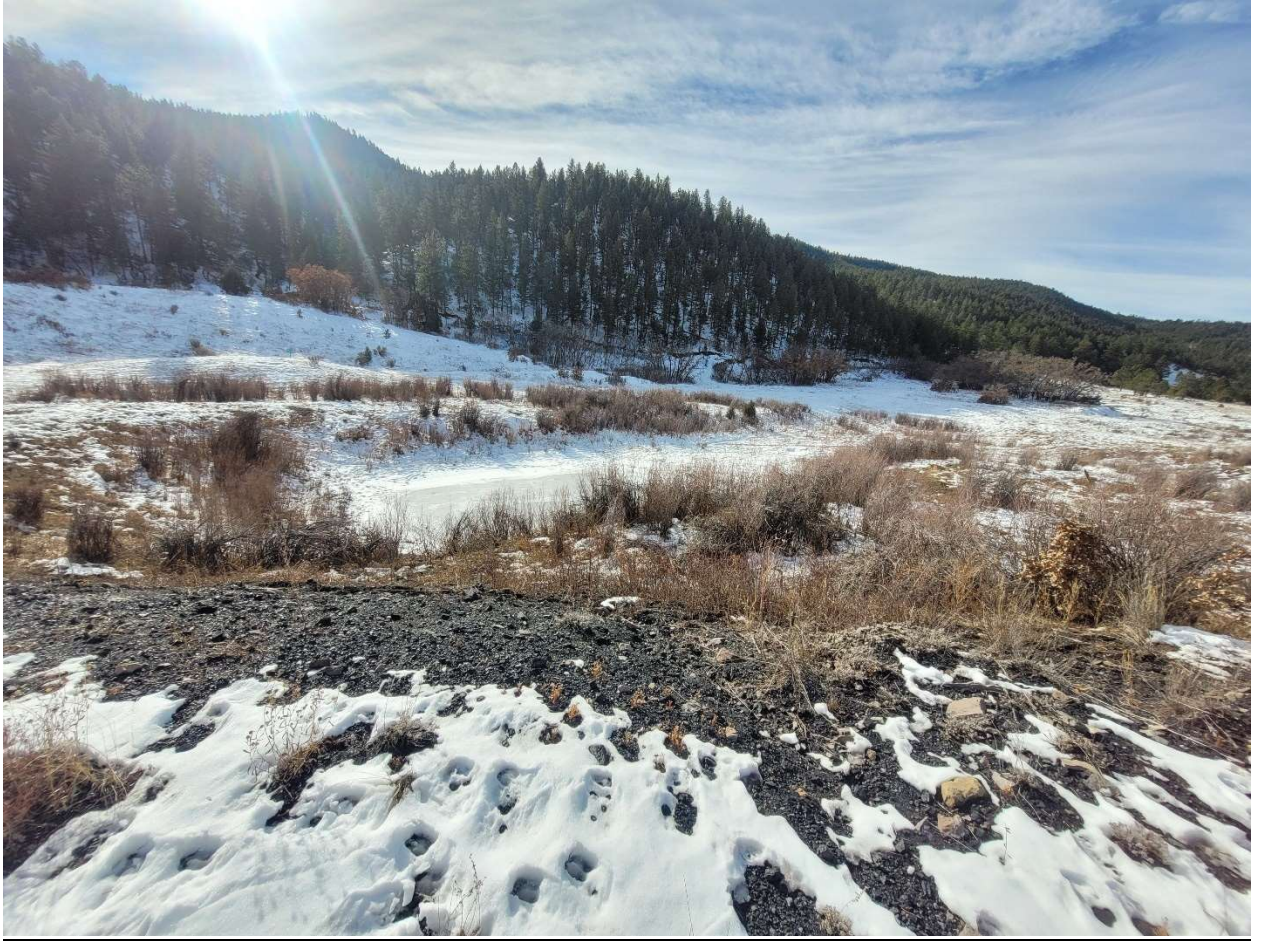
Containment was holding water and was Frozen at the time of inspection.

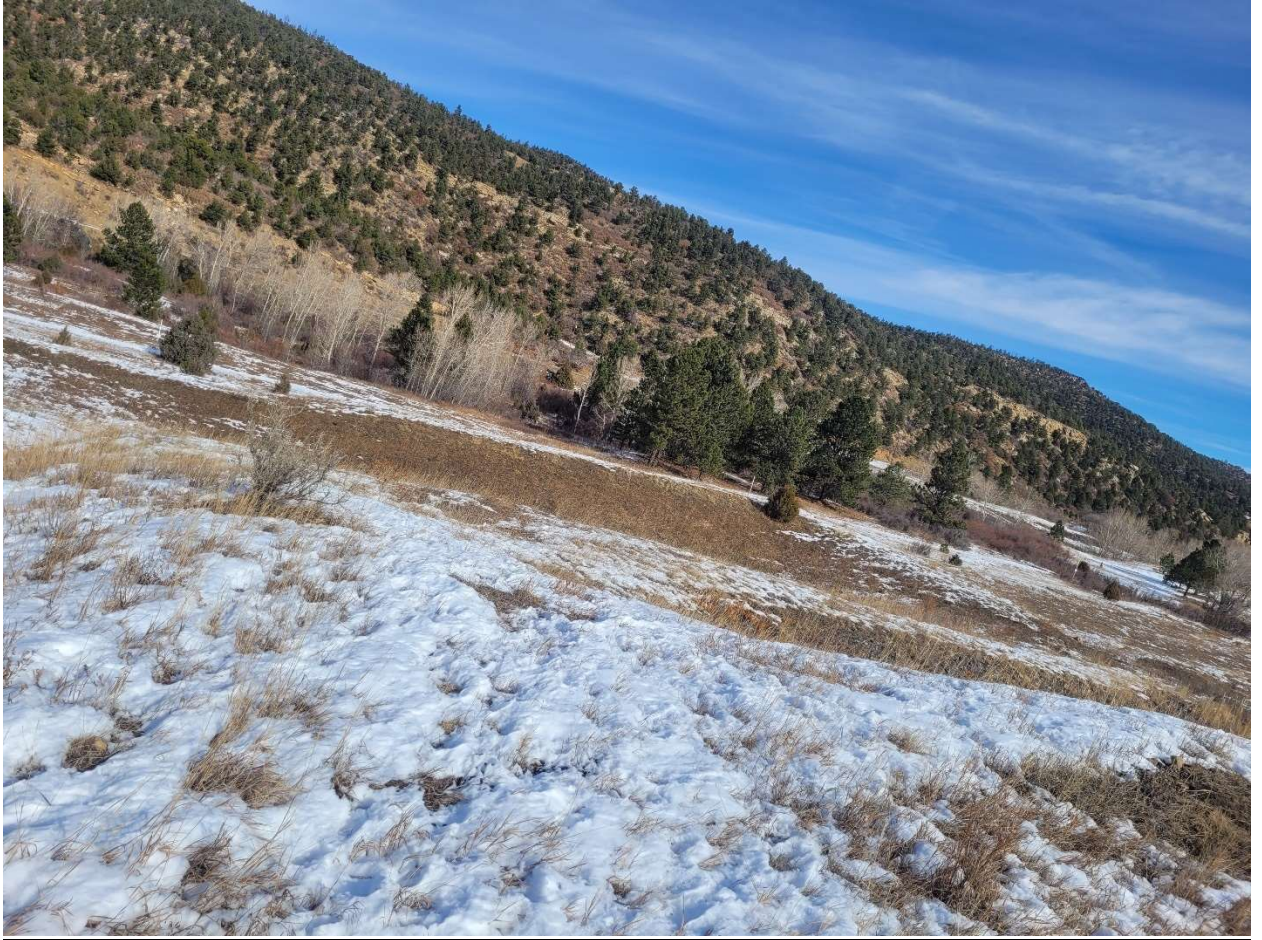
Mine: New Elk WP Containment #2

Containment was empty at time of inspection.

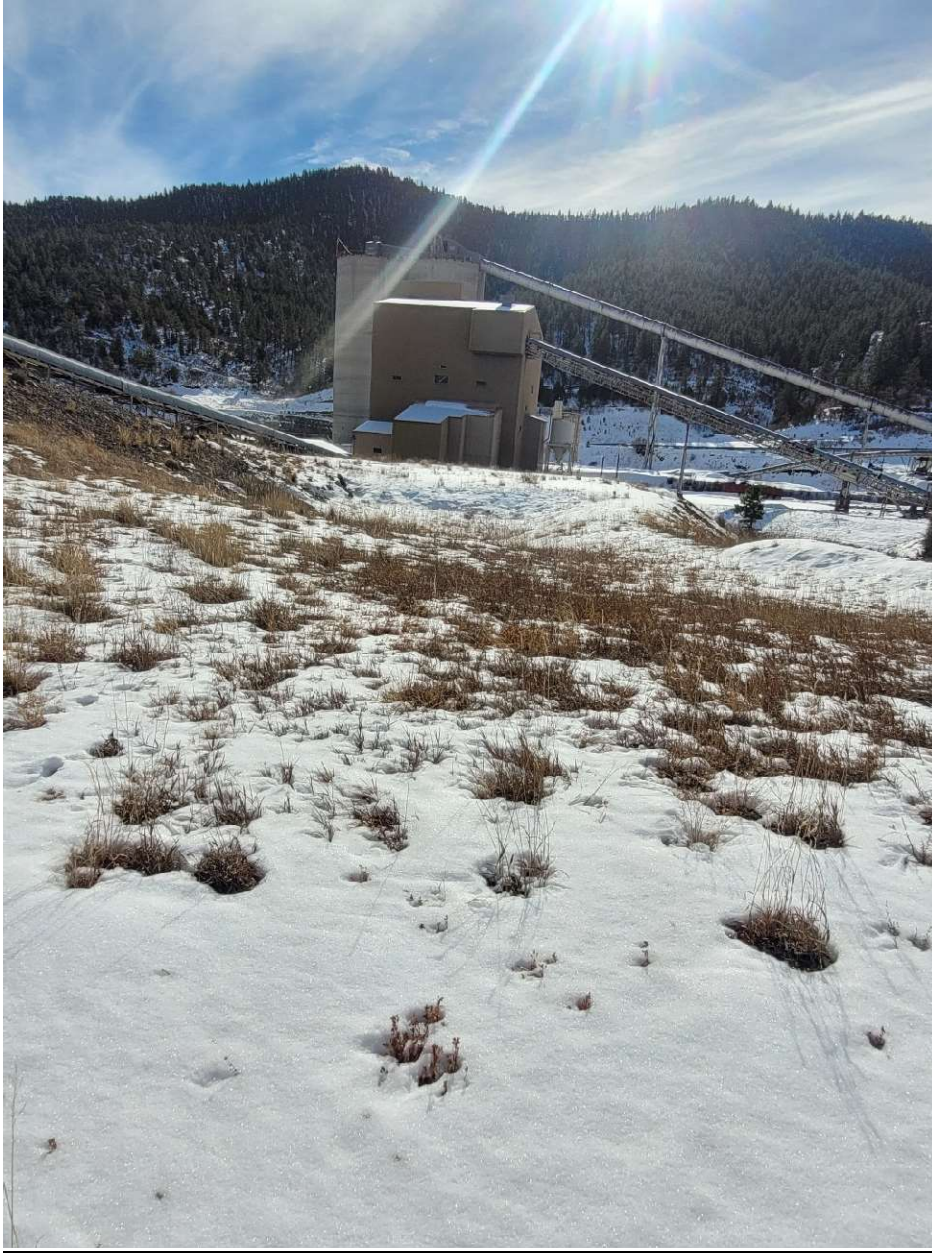
Mine: New Elk Containment #3

Containment Area was holding water and was frozen at time of inspection.

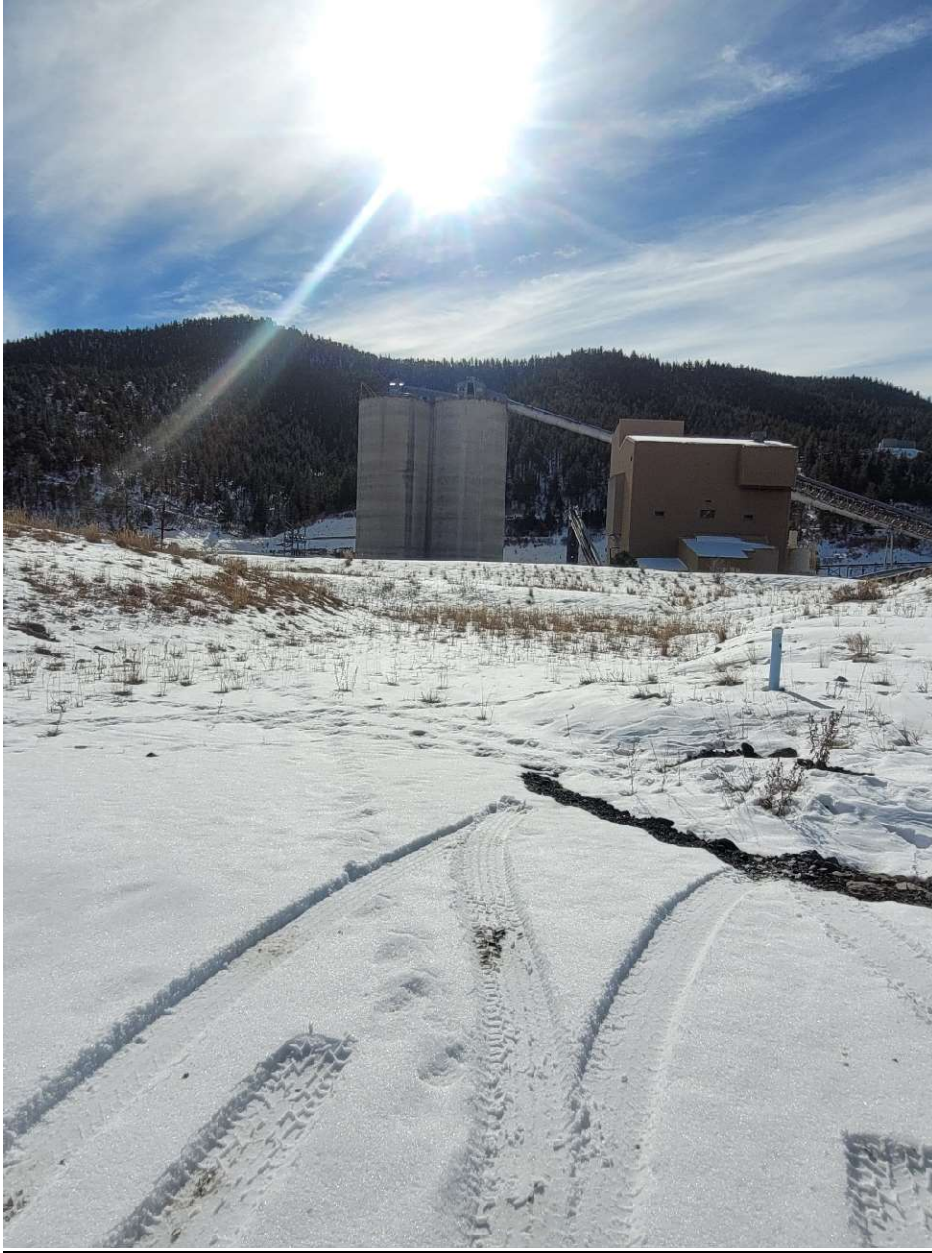
Mine: New Elk Containment #4

Containment Area was cover with snow at time of inspection.

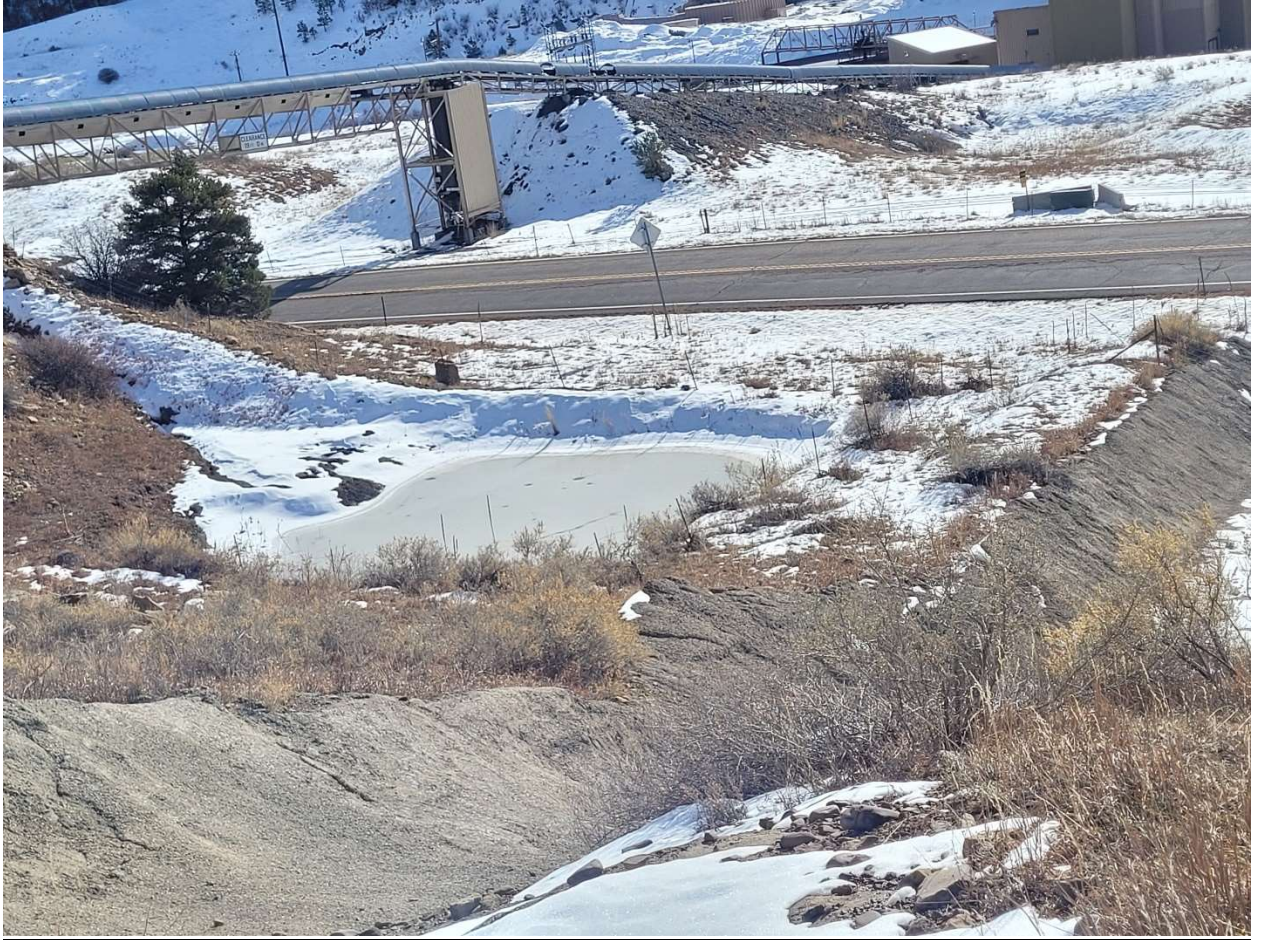
Mine: New Elk Containment #5

Containment Area was holding water and was Frozen over at time of inspection. It was cleaned in 2022 and will need to be cleaned of sediment in the coming months.

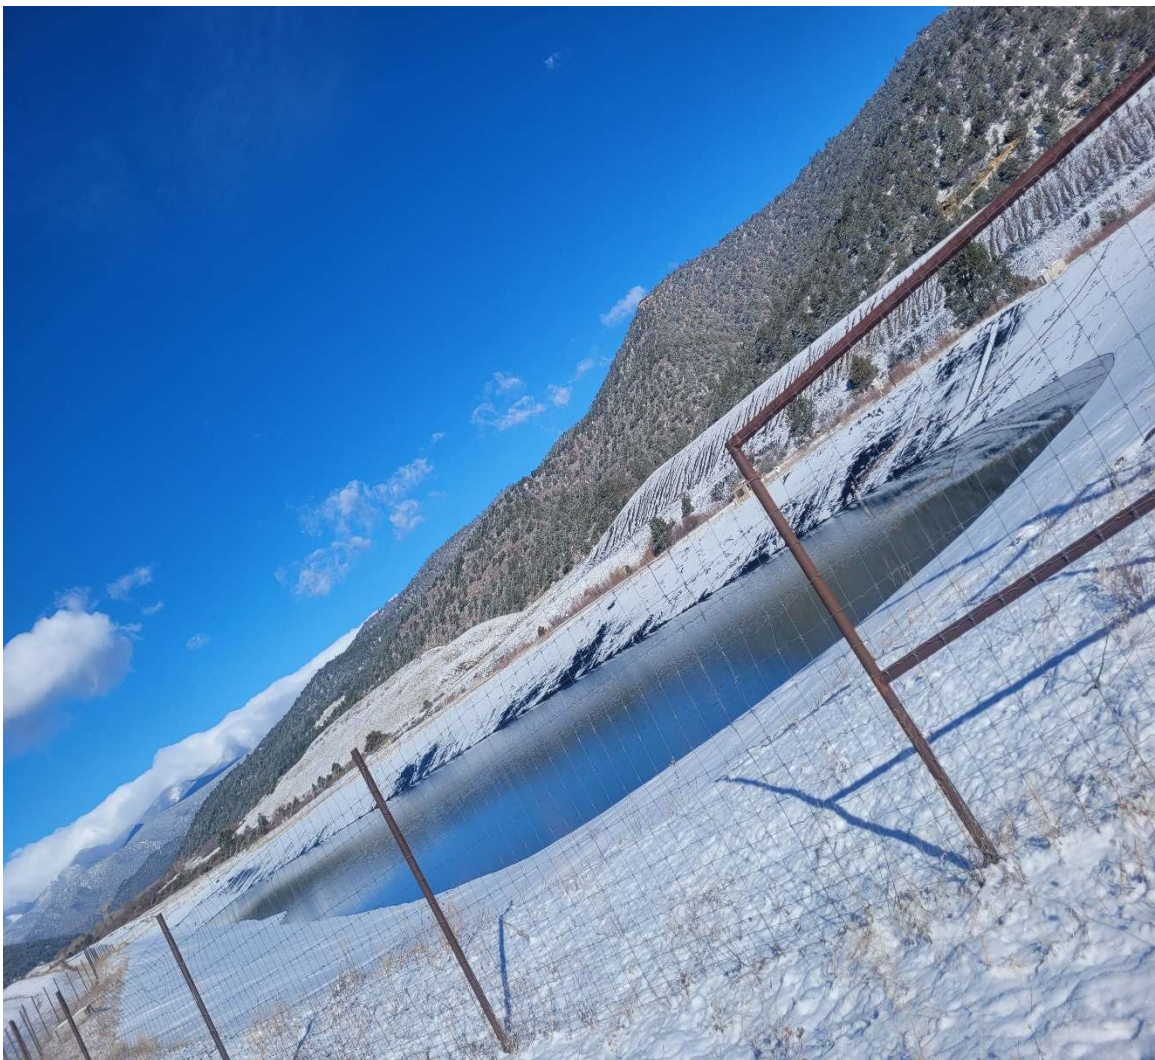
NPDES ID. No.: Pond #1

Pond liner is in good working condition at time of inspection. Pond was holding water and was frozen at time of Inspection. No issues observed.

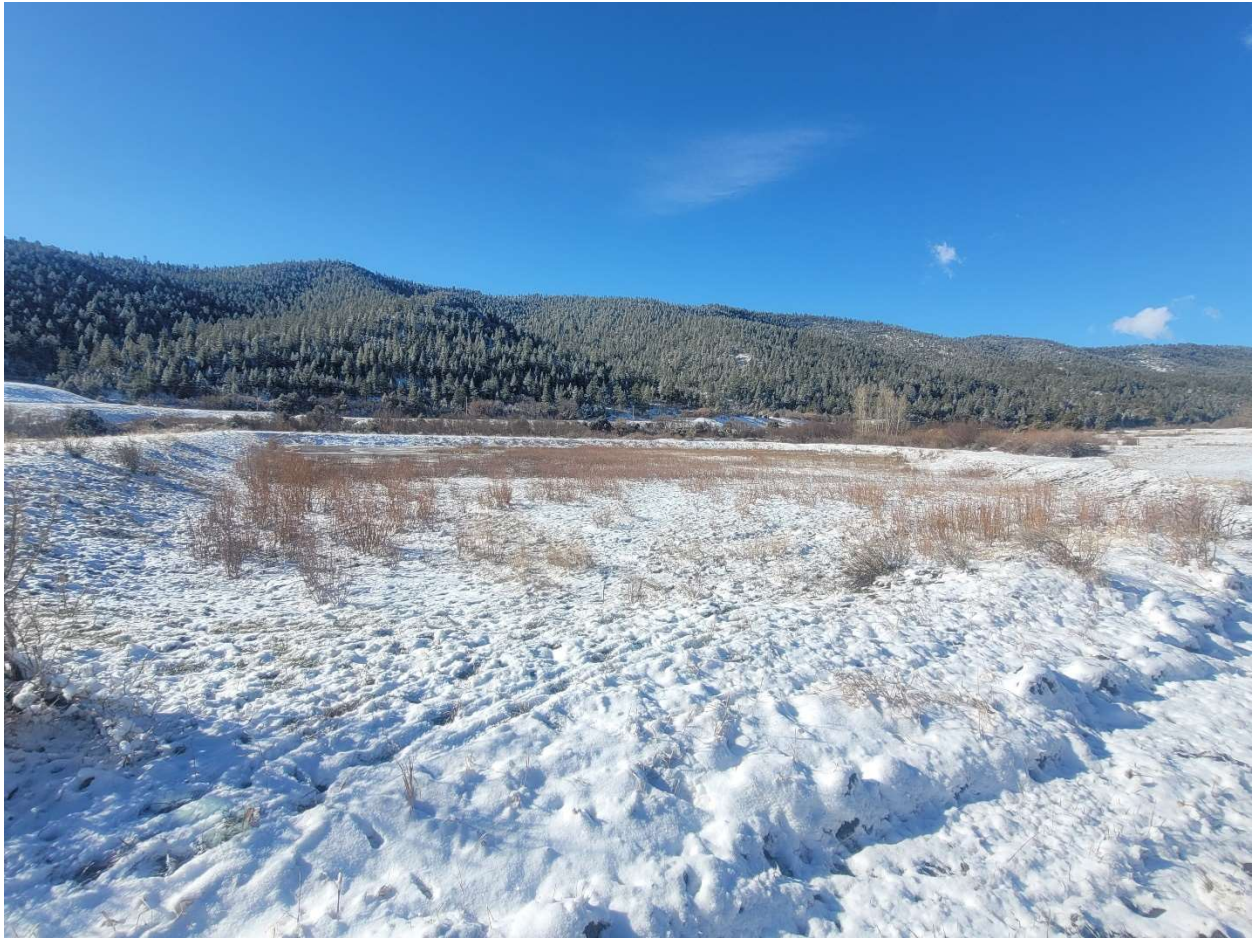
NPDES ID. No.: Pond #4

Pond was holding water and was frozen over at the time of inspection, not near the discharge level. No Issues observed. Water has been pumped into the pond recently from pond 7 and pond 6.

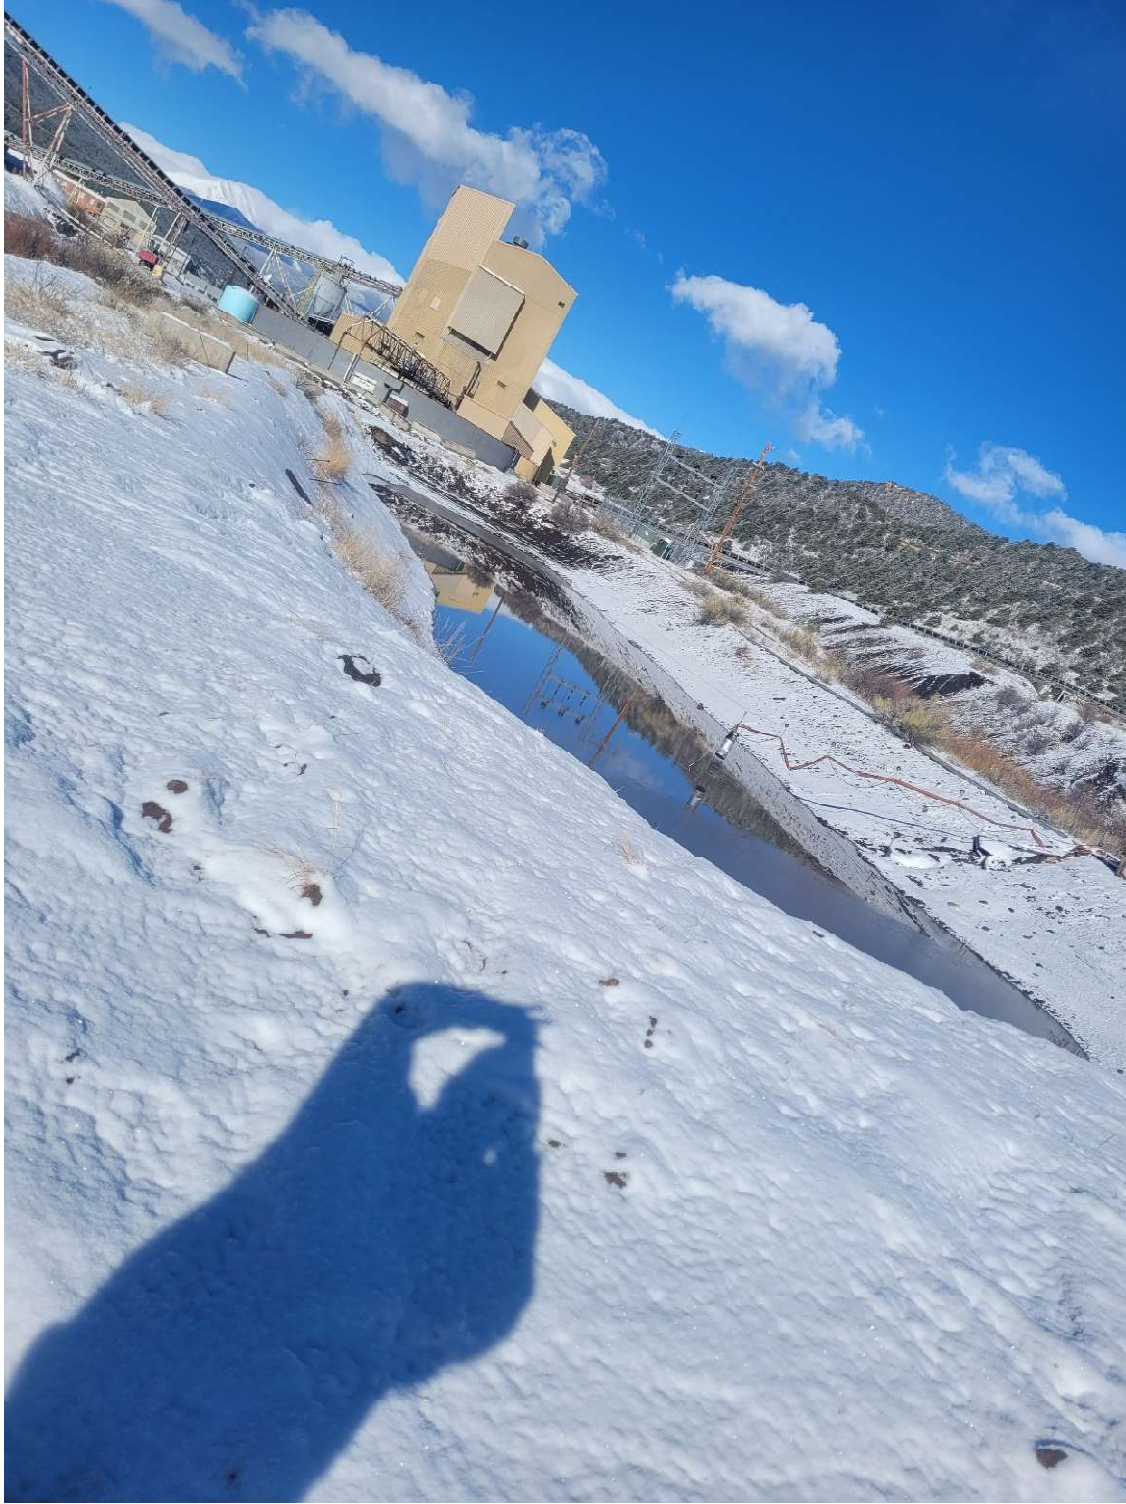
Mine: New Elk Pond 6

Pond is holding water at time of inspection; Water has been pumped to pond 4.

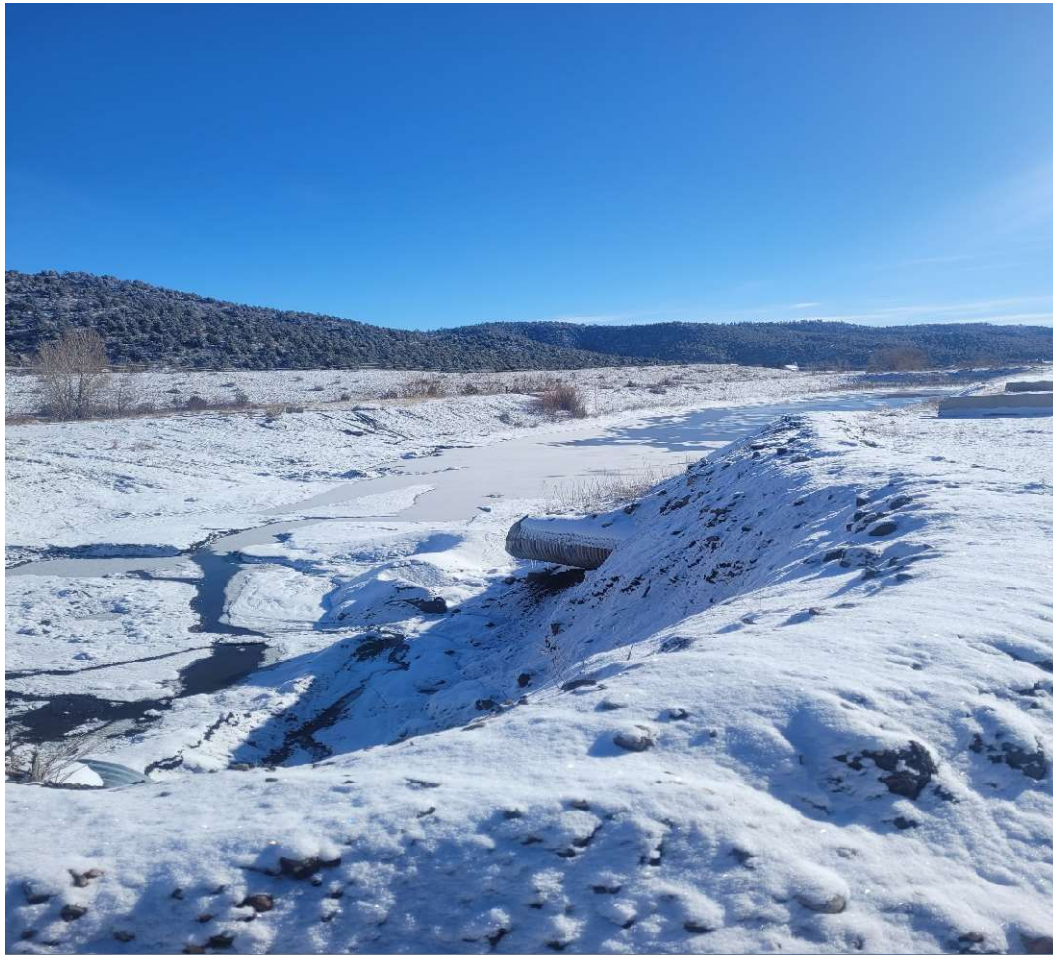
NPDES ID. No.: Pond #7

Pond is holding water and frozen at time of inspection. No issues observed.

No discharges have occurred.

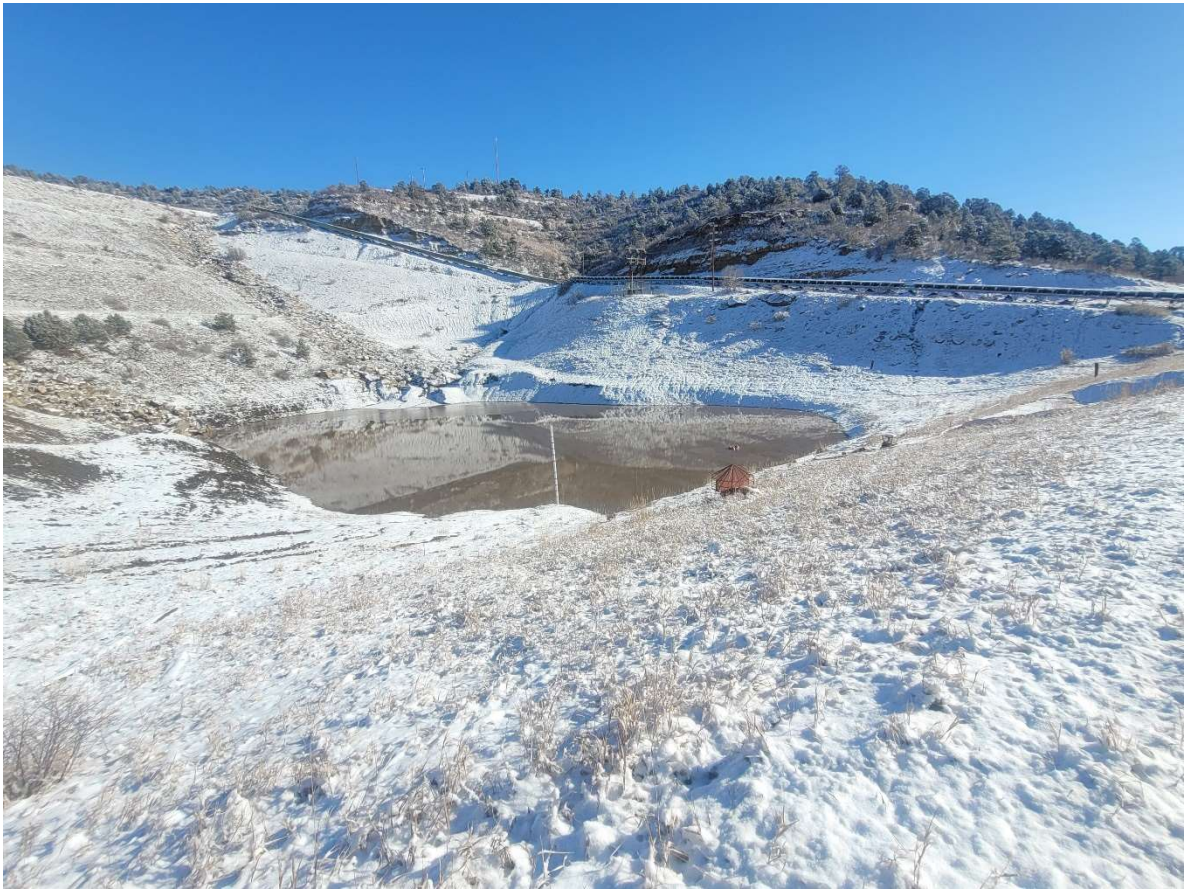
NPDES ID. No.: Pond #8

Pond is holding water and is frozen over. The water level is now about 1 to 2 feet below the measuring device and has more than the design compacity. No discharges have occurred and No issues were found during the inspection.
