### MINERALS PROGRAM INSPECTION REPORT

<b>MINE NAME:</b> Motorcross Borrow Pit	<b>MINE/PROSPECTING ID#:</b> M-2022-006	<b>MINERAL:</b> Borrow material for	<b>COUNTY:</b> Weld
<b>INSPECTION TYPE:</b> Monitoring	<b>WEATHER:</b> Cloudy	<b>INSP. DATE:</b> March 7, 2024	<b>INSP. TIME:</b> 13:00
<b>OPERATOR:</b> SEMA Construction, Inc.	<b>OPERATOR REPRESENTATIVE:</b> Paul Weinzirl	<b>TYPE OF OPERATION:</b> 111 - Construction by Government Agency

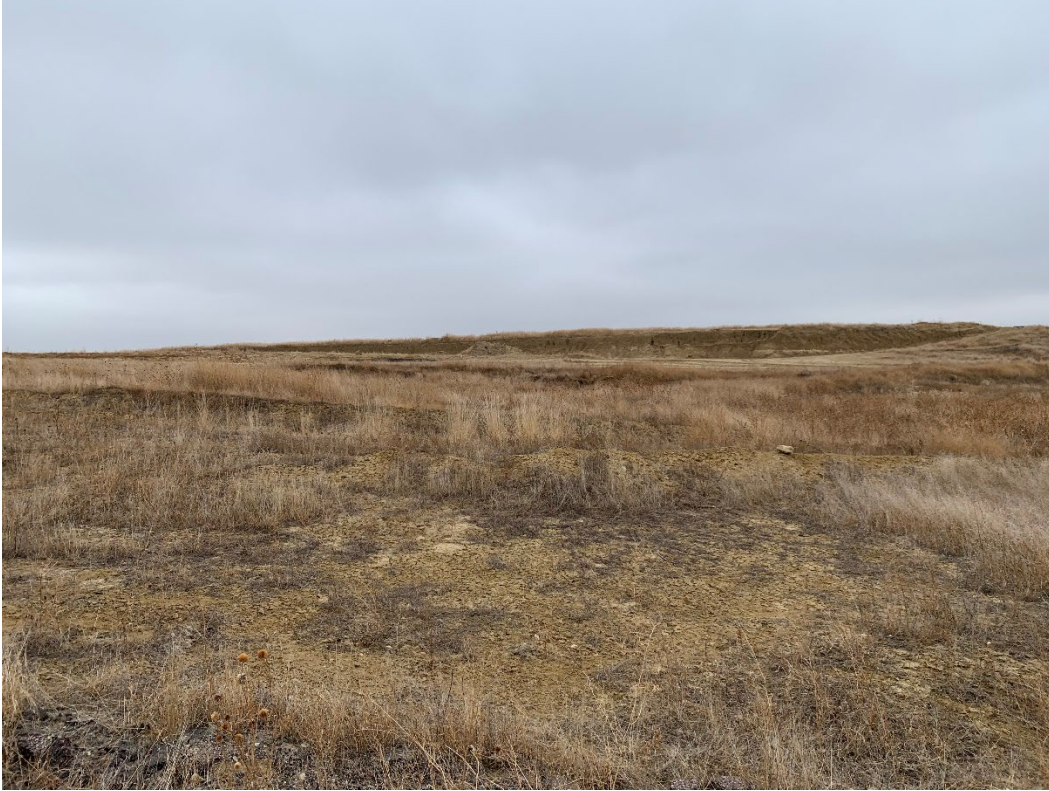
The pit is situated on a hill top and is mined from north to south (photo 1). The highwall is about 300 feet long with an average height of 15 feet and is aligned east to west (photo 2). The pit floor is gently sloped to the northwest allowing for drainage to the naturally occurring drainages in the area. There was no evidence of ponding water in the pit area.

Photo 1 – View of highwall from north permit boundary, facing south.

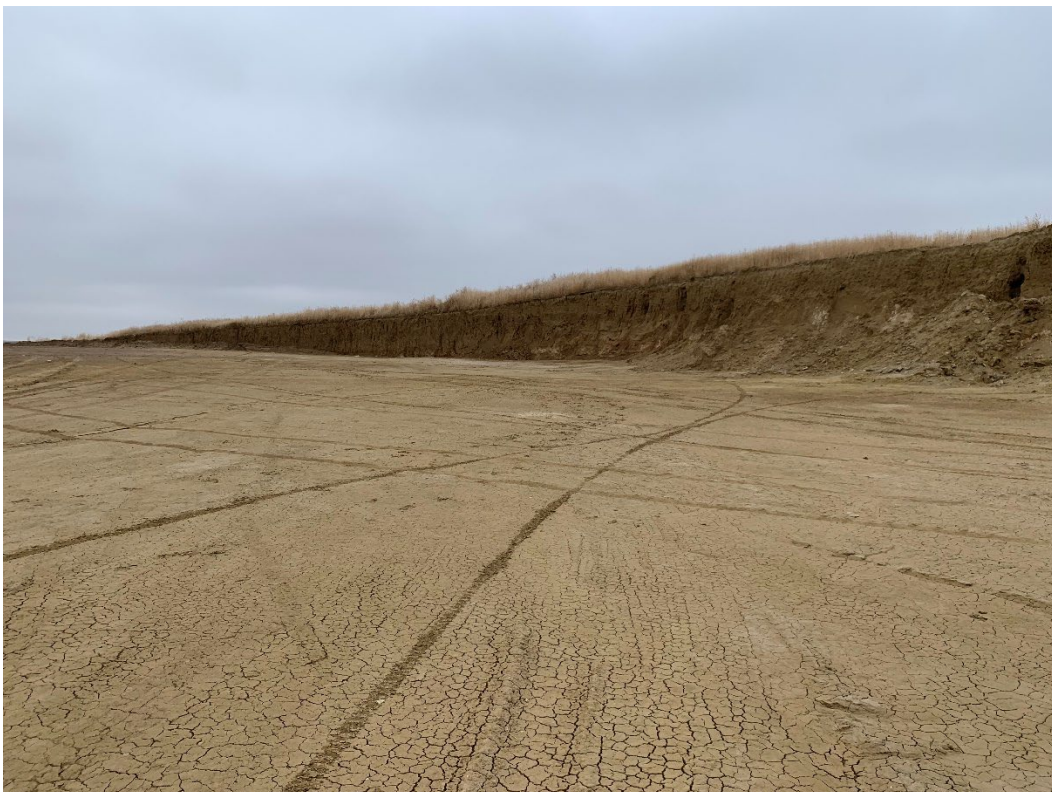
Photo 2 – View of highwall from pit floor facing east.

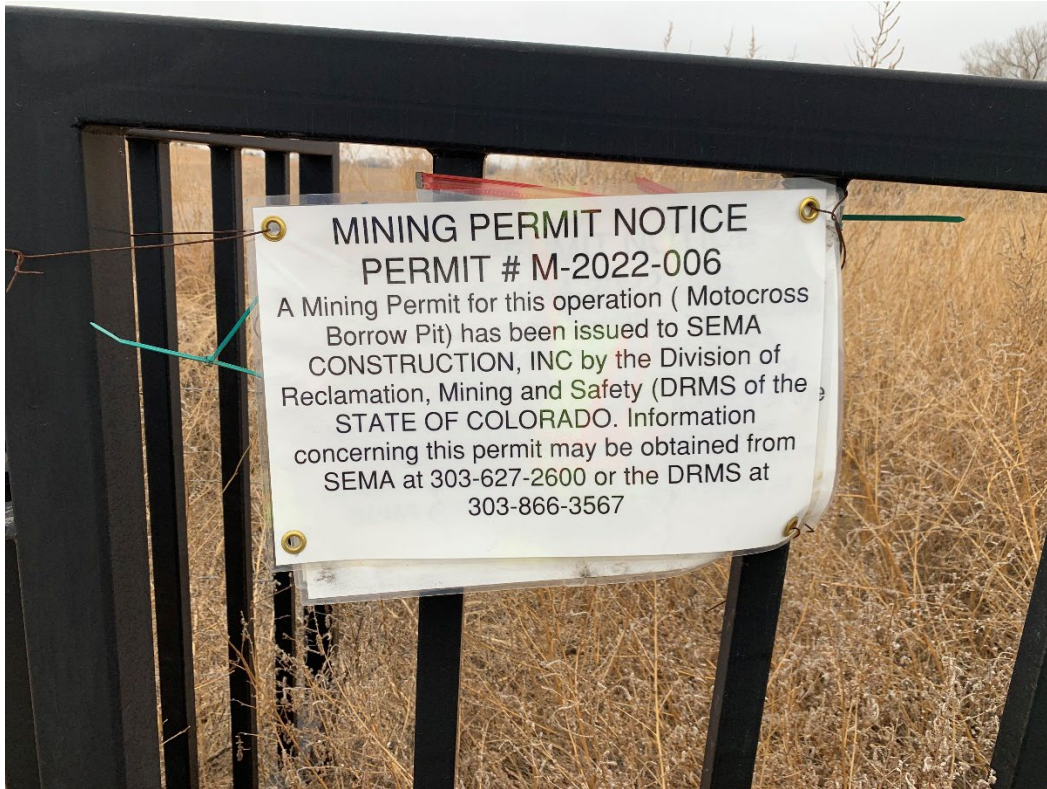
The mine entrance sign was in place at the Weld County Road 7 entrance (photo 3).

Photo 3 – Mine entrance sign facing Weld County Road 7

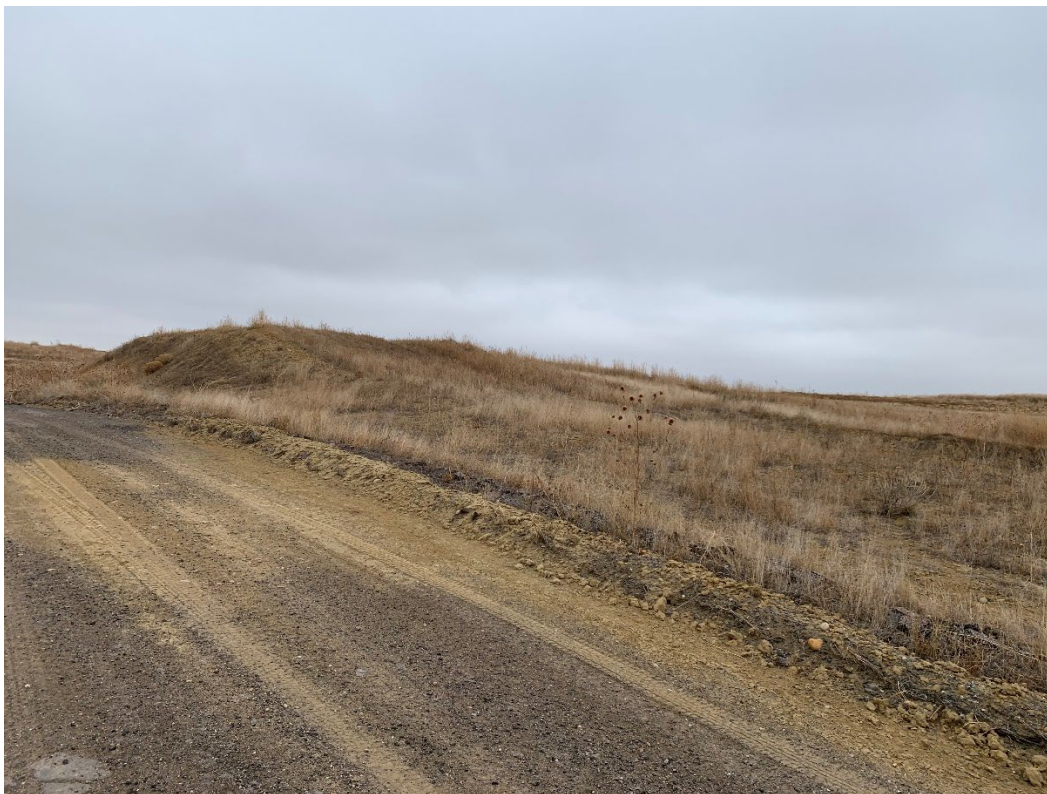
The topsoil stockpile is located north of the pit area alongside the access road (photo 4). The pile had vegetation on it and there were no signs of erosion.

Photo 4 – Topsoil stockpile along the norther access road, facing east.
