**MINERALS PROGRAM INSPECTION REPORT**  
**PHONE: (303) 866-3567**

| <b>MINE NAME:</b><br>Friederichs Pit 112 | <b>MINE/PROSPECTING ID#:</b><br>M-2010-080 | <b>MINERAL:</b><br>Gravel and sand | <b>COUNTY:</b><br>Prowers |
| <b>INSPECTION TYPE:</b><br>Monitoring | <b>WEATHER:</b> Clear | <b>INSP. DATE:</b><br>March 13, 2024 | <b>INSP. TIME:</b><br>10:00 |
| <b>OPERATOR:</b><br>City of Lamar | <b>OPERATOR REPRESENTATIVE:</b><br>Patrick Mason | <b>TYPE OF OPERATION:</b><br>112c - Construction Regular Operation | |

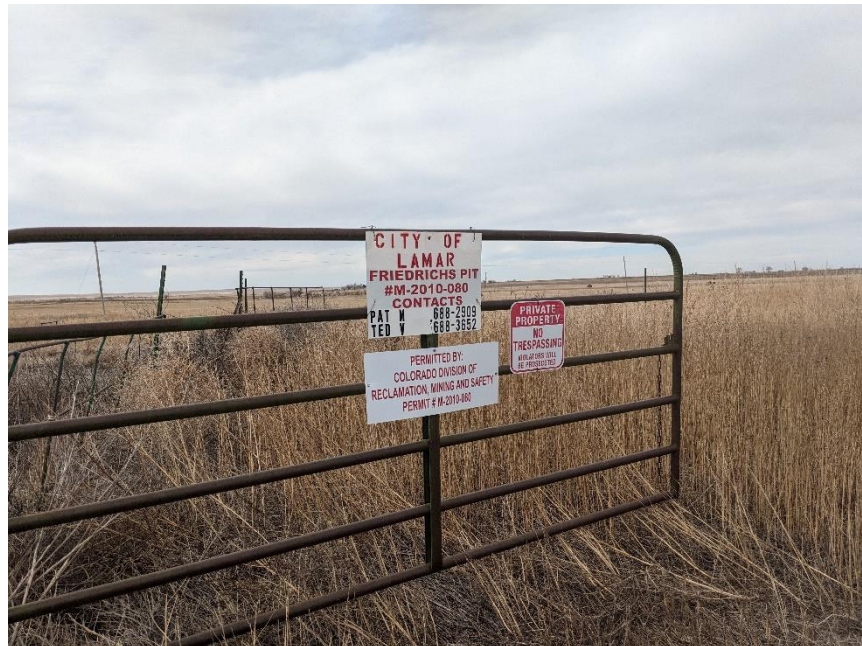
A mine identification sign was located at the entrance to the site. The permit boundary is delineated by the surrounding fence line.

Mine identification sign at entrance.

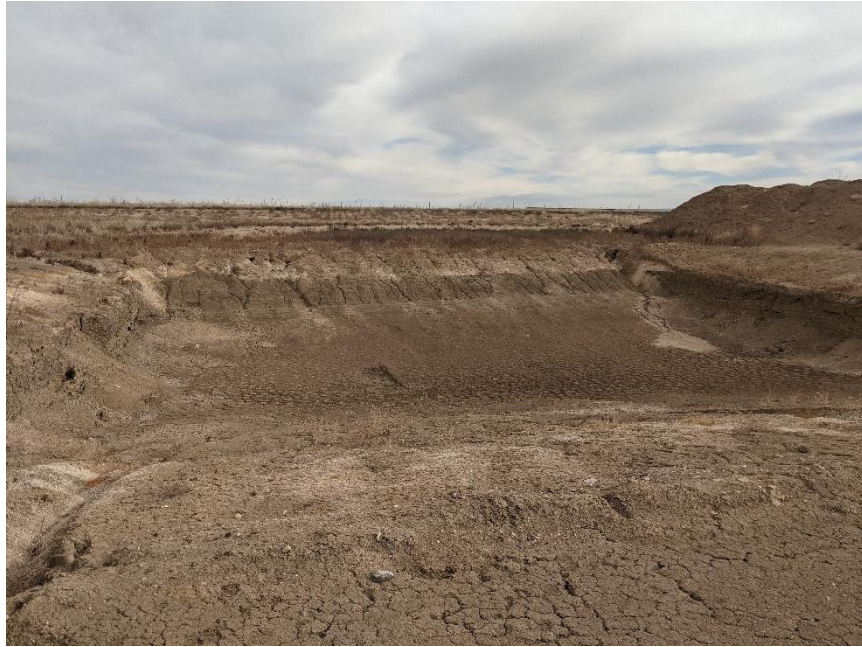
Current pit area.

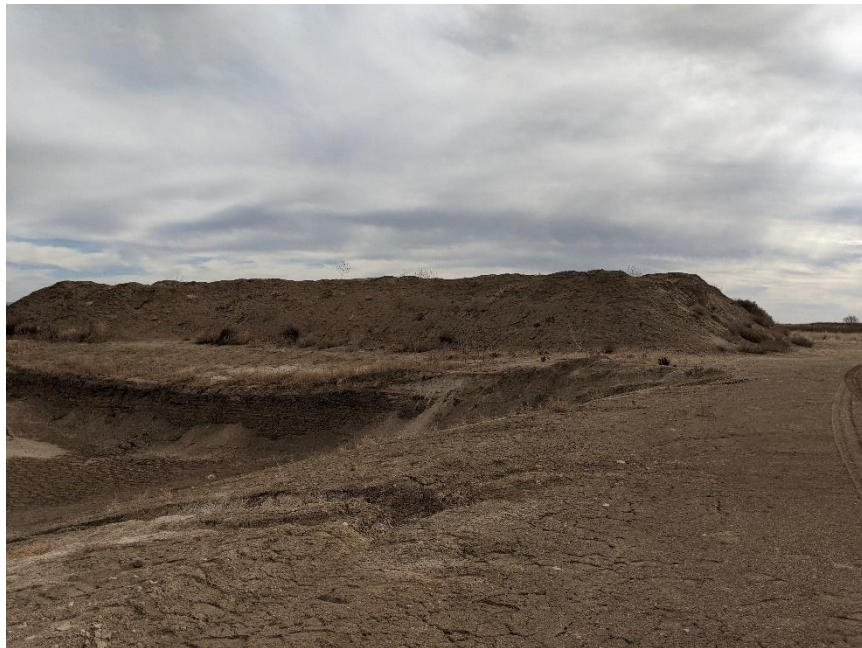
Based on discussion with the Operator, the site is used to mine clay as a liner for the local landfill. As hauling activities occur with the material on site, suitable excess backfill material is being imported from the landfill area on the return trip. The imported material was free of debris and vegetation. A single stockpile of the imported material was placed directly adjacent and to the east of the current pit area. As the pit progresses, the pit will be backfilled contemporaneously with the use of the import material. Mined material stockpiles were observed to the south of the pit area and are pulled from as needed for the landfill.

Backfill material stockpile.

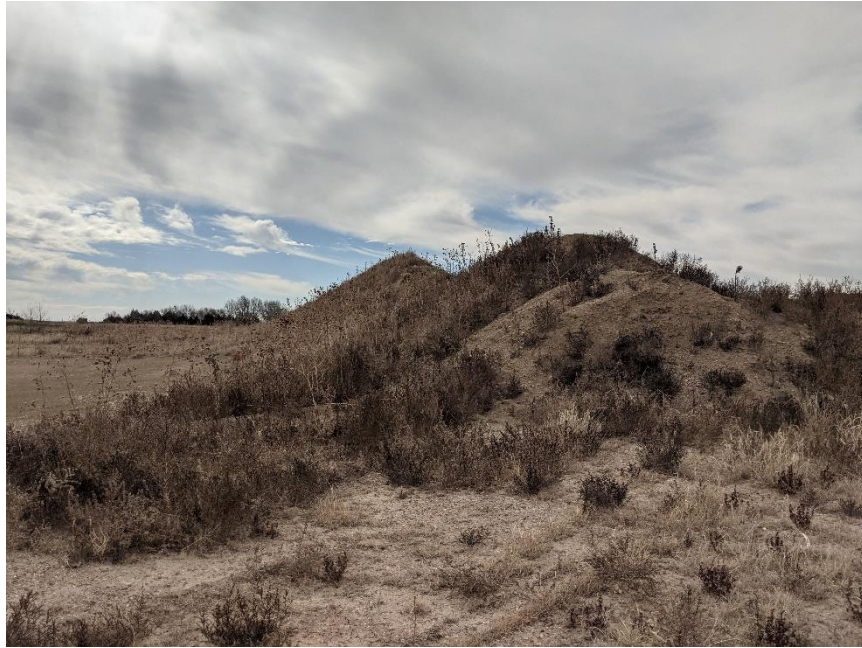
Multiple topsoil stockpiles were observed on site. These piles were stable however sparsely vegetated. The topsoil pile located just south of the pit area is new based upon the topsoil stripping activities with the reopening of the pit after the previous reclamation. Vegetation is expected to increase along the pile over time as additional growing seasons are encountered.

New topsoil pile.
