**MINERALS PROGRAM INSPECTION REPORT**  
**PHONE: (303) 866-3567**

<b>MINE NAME:</b> County Line Pit	<b>MINE/PROSPECTING ID#:</b> M-1987-016	<b>MINERAL:</b> Sand and gravel	<b>COUNTY:</b> Lincoln
<b>INSPECTION TYPE:</b> Monitoring	<b>WEATHER:</b> Clear	<b>INSP. DATE:</b> February 29, 2024	<b>INSP. TIME:</b> 11:00
<b>OPERATOR:</b> Lincoln County	<b>OPERATOR REPRESENTATIVE:</b> Ty Stogsdill	<b>TYPE OF OPERATION:</b> 110c - Construction Limited Impact	
<b>REASON FOR INSPECTION:</b> Normal I&E Program	<b>BOND CALCULATION TYPE:</b>	<b>BOND AMOUNT:</b> \$0.00	
<b>DATE OF COMPLAINT:</b> NA	<b>POST INSP. CONTACTS:</b> None	<b>JOINT INSP. AGENCY:</b> None	
<b>INSPECTOR(S):</b> Jocelyn Carter Jared Ebert	<b>INSPECTOR'S SIGNATURE:</b>

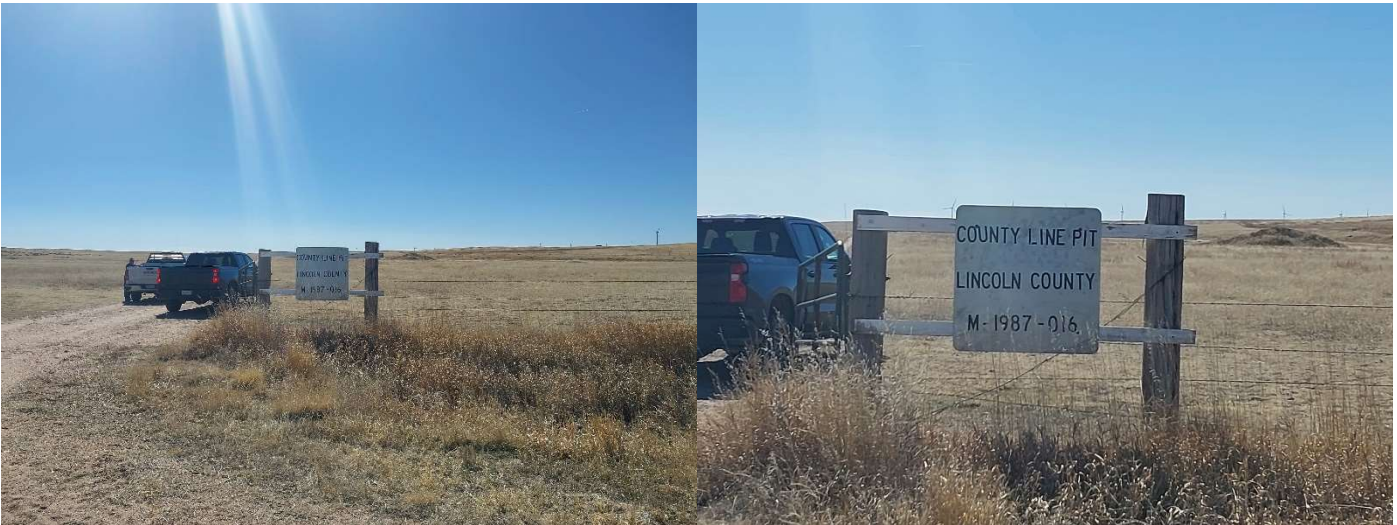
**Photos #1 & #2:** Posted sign per Rule 3.1.12 off Lincoln County Road 4D.

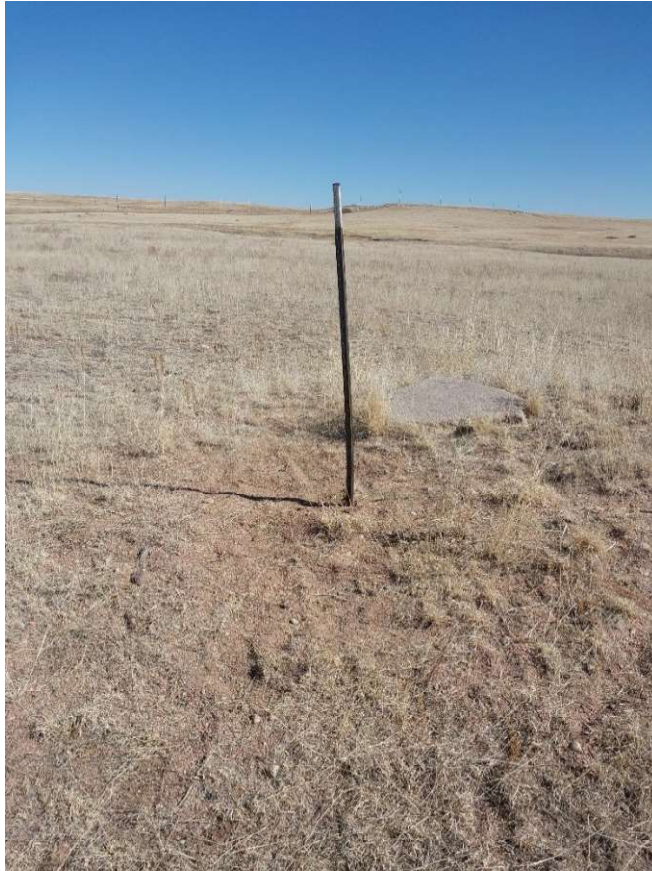
**Photo #3:** Northeast marker, east of the access road, looking northeast.

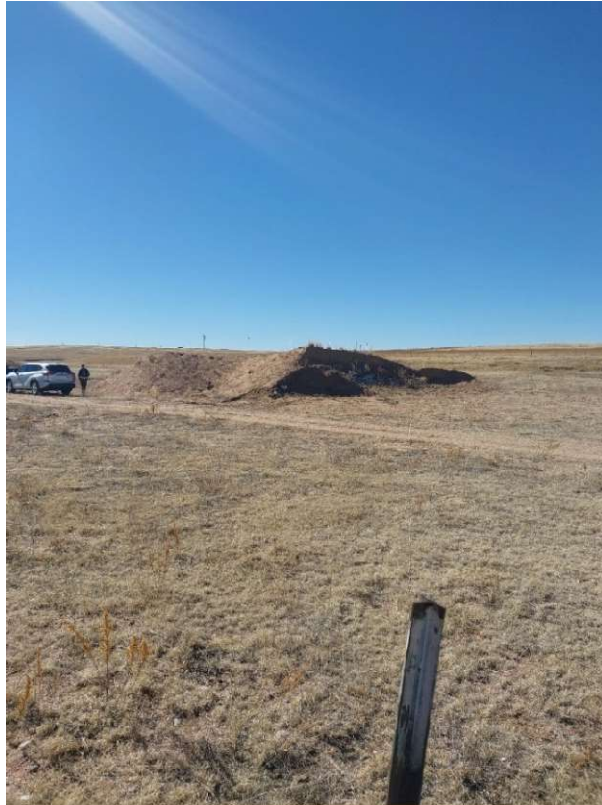
**Photo #4:** Taken from the northeast marker, east of the access road, looking southwest at the permitted area.

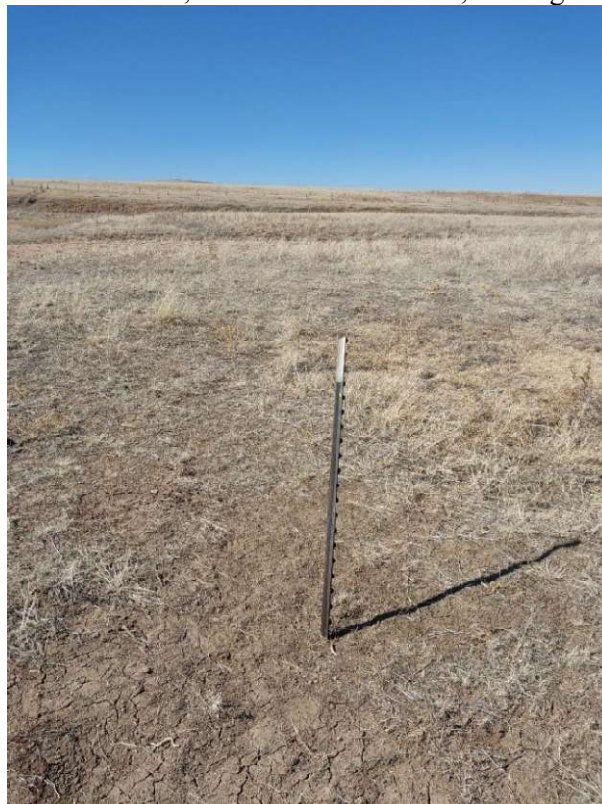
**Photo #5:** Corner marker, looking southwest at the permitted area.

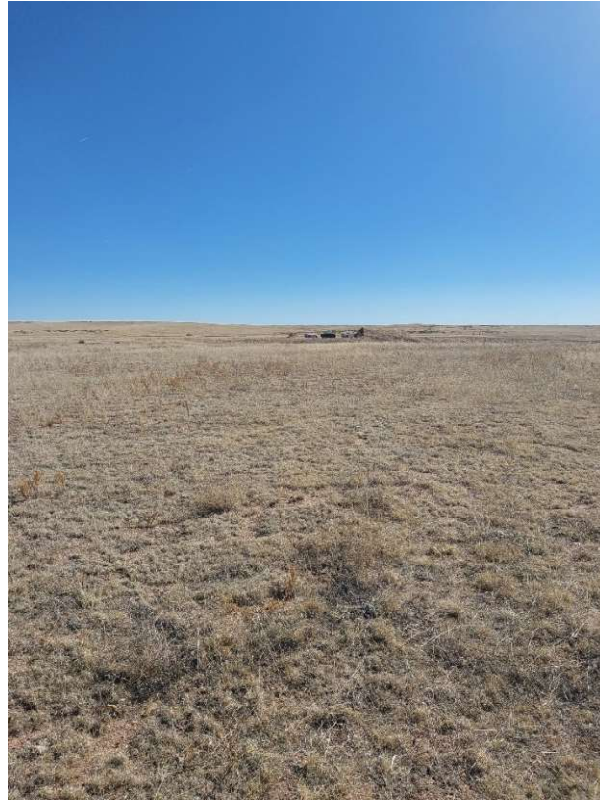
The two small screening stockpiles that were left by previous CDOT operations were still present north of the permit area. The stockpiles were left at the request of the landowners according to an acreage reduction (AR-01) that was approved by the Division May 21, 2001.

**Photo #6:** Taken from approximately where the northern most marker should have been located, looking to the north at stockpiles that were left by CDOT and remained on site at the request of the landowners.

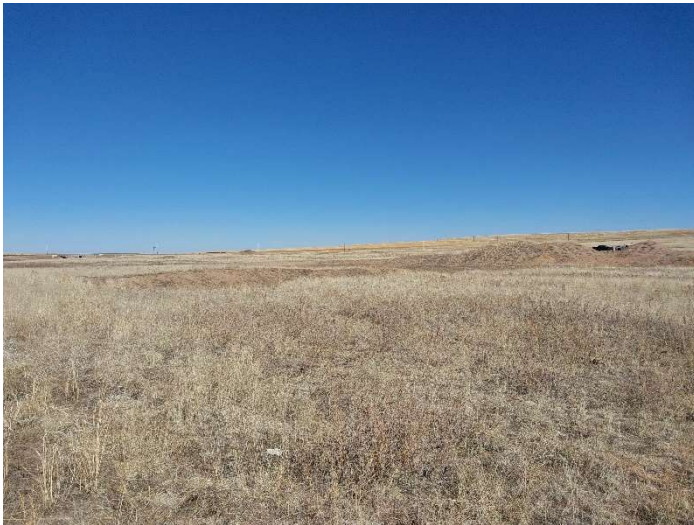
The perimeter was walked making note of the locations of the boundary markers. A marker in the northeast and the southwest corners were not observed at the time of the inspection. The operator was made aware of the missing markers and committed to replacing them. Since the inspection date and the completion of this inspection report, the operator has provided confirmation of the markers being replaced. The Division considers the issue of missing markers resolved.

**Left (#7):** Photo of permit area taken from the southwest corner, looking to the northeast; boundary marker was not observed in the area. **Right (#8):** View of affected area, a mined portion of the creek bed with material seen stockpiled on the opposite side of creek.

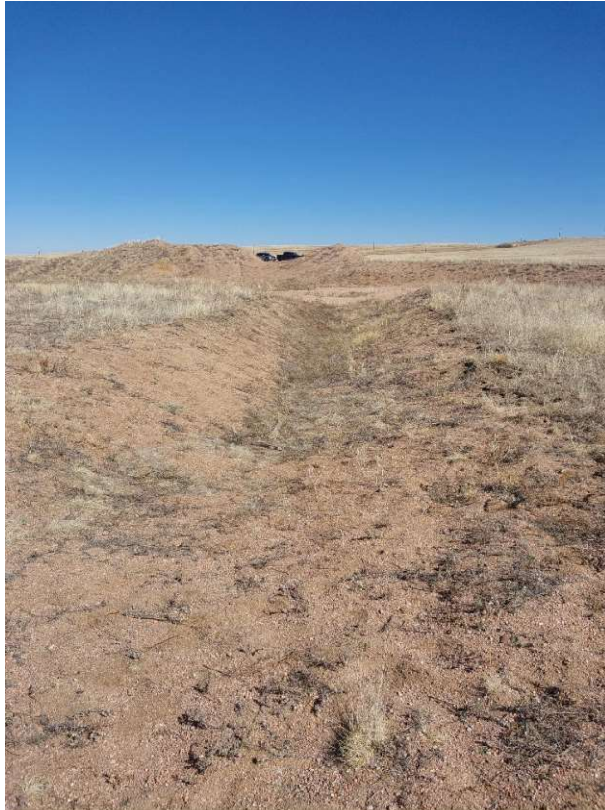
**Photo #9:** Most recently disturbed area, located just south of area in Photo #8, material stockpile can be seen on opposite side of creek.

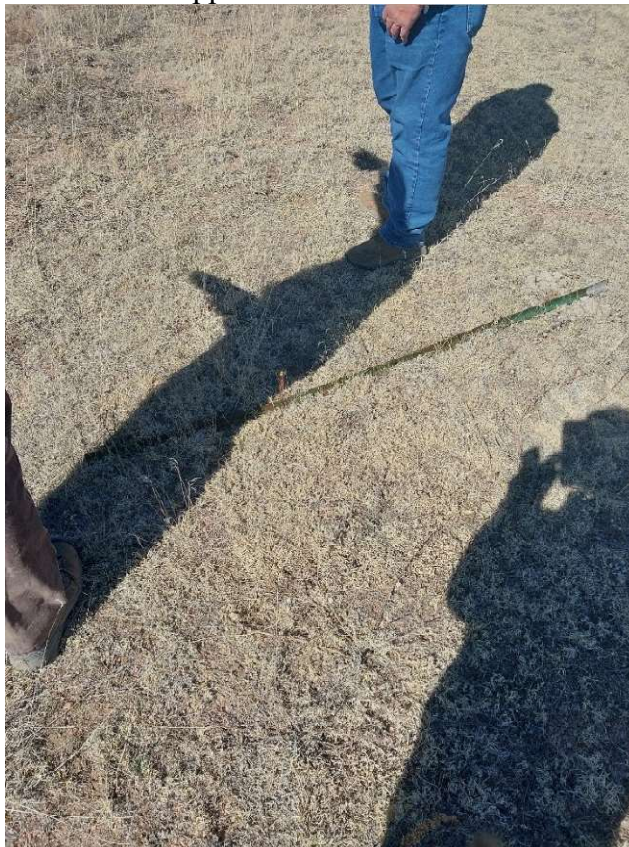
**Photo #10:** Boundary marker knocked down (most likely from cattle activity) on lower east central section.

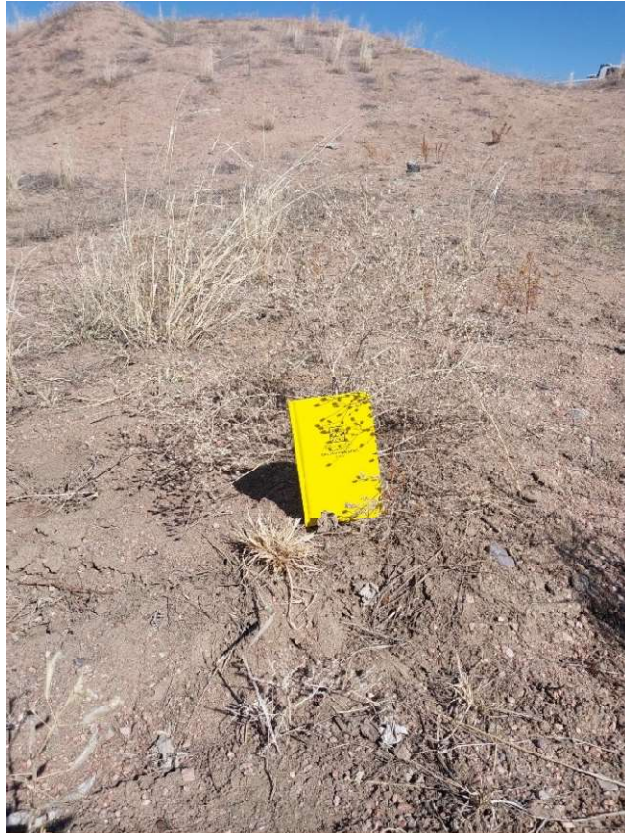
No equipment was on site and no mining activity was occurring at the time of inspection. The most recent activity appeared to have occurred in the southwest portion of the permit area, along the western banks of the Vega Creek. Material was stockpiled on the eastern banks of the creek. Knapweed was viewed on the southwest side of the stockpiled material. The operator was informed of the presence of the weed and stated that they will have it sprayed according to their weed control plan outlined in TR-1, issued July 12, 2010.

**Photo #11:** Knapweed observed on the southwest side of the material stockpile, the map below provides approximate location; a yellow field journal, 7 ½ in x 5 7/8 in, present for scale.

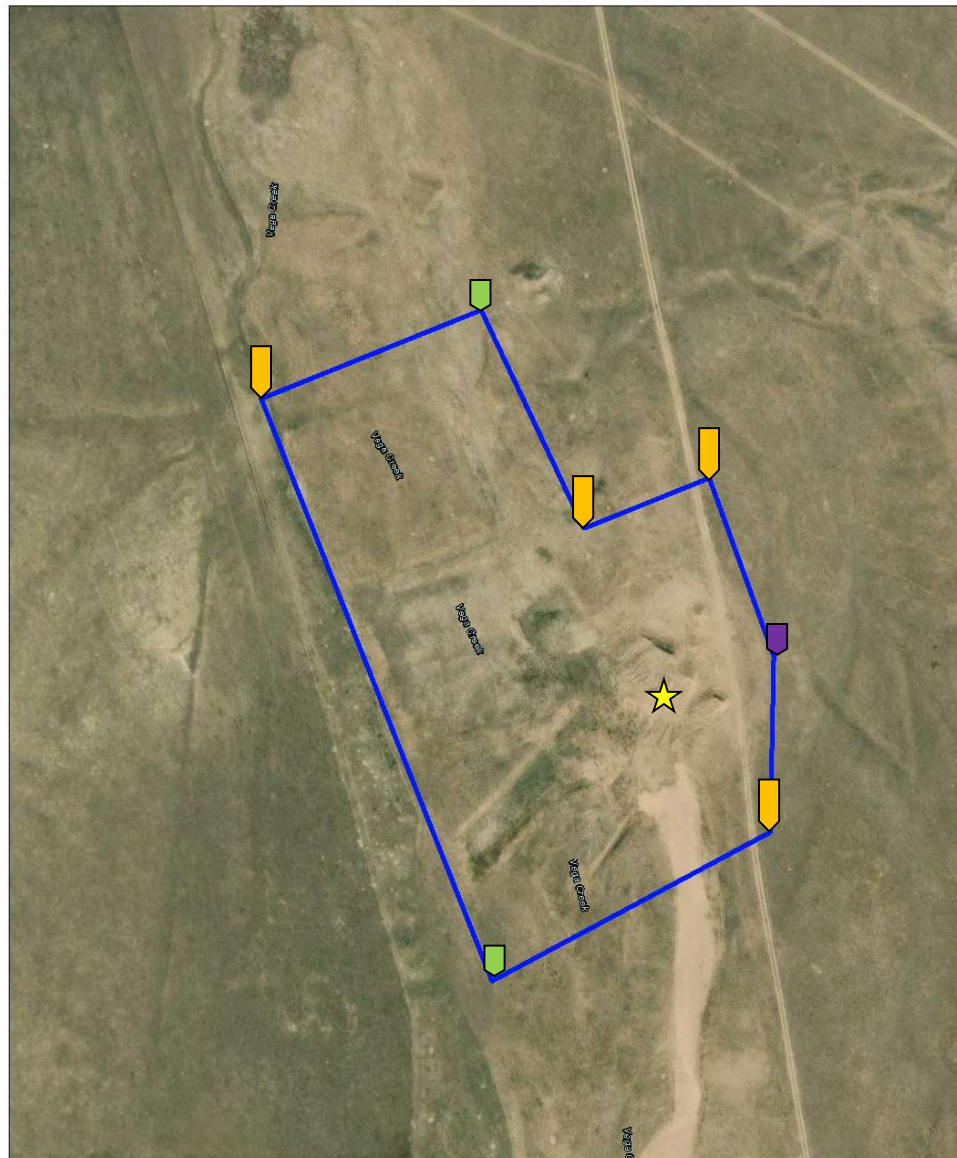
**Map:** Permit boundary shown in blue. The star indicates the approximate location of where the knapweeds were observed, the larger orange rectangular down arrow indicate approximately where permit boundary markers were observed, the green rectangular down arrow marks were permit boundary markers were not observed at the time of inspection, and the purple rectangular down arrow marks where the permit boundary marker was knocked to the ground.
