MINERALS PROGRAM INSPECTION REPORT
PHONE: (303) 866-3567

MINE NAME: O'Dwyer	MINE/PROSPECTING ID#: M-2002-017	MINERAL: Sand and gravel	COUNTY: Lincoln
INSPECTION TYPE: Monitoring	WEATHER: Clear	INSP. DATE: February 29, 2024	INSP. TIME: 10:00
OPERATOR: Lincoln County	OPERATOR REPRESENTATIVE: Ty Stogsdill	TYPE OF OPERATION: 110c - Construction Limited Impact	
REASON FOR INSPECTION: Normal I&E Program	BOND CALCULATION TYPE:	BOND AMOUNT: \$0.00	
DATE OF COMPLAINT: NA	POST INSP. CONTACTS: None	JOINT INSP. AGENCY: None	
INSPECTOR(S): Jocelyn Carter Jared Ebert	INSPECTOR'S SIGNATURE:

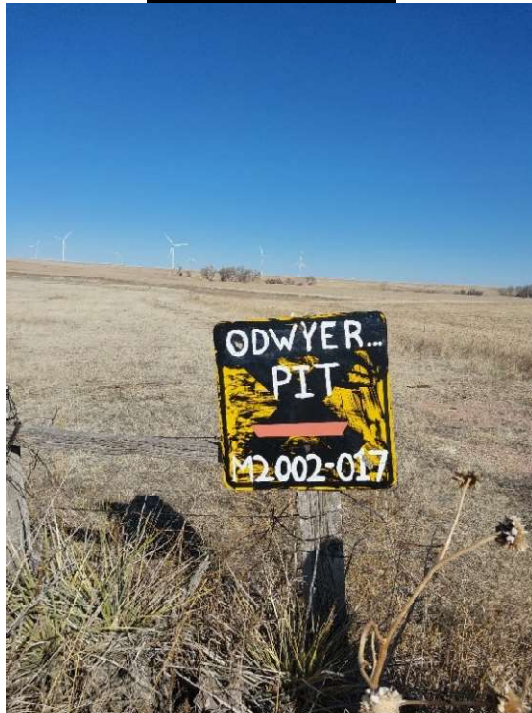
Photo #1: Per Rule 3.1.12, Sign at CR 3T and access road to mine site.

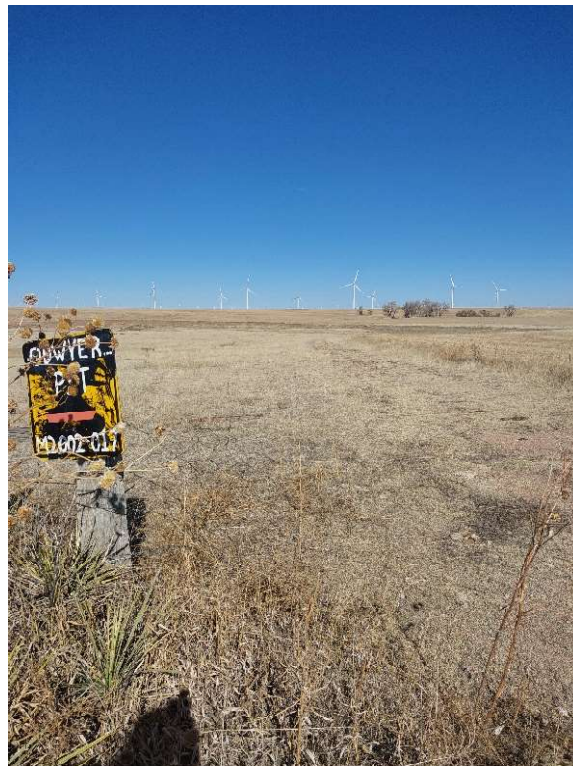
Photo #2: Posted sign of operation on left, access road to permit area on right.

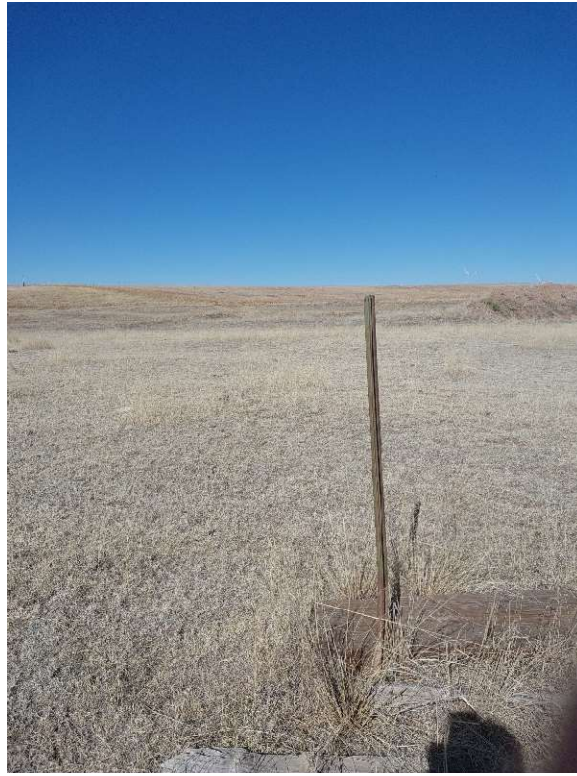
Photo #3: Southwest boundary marker looking north.

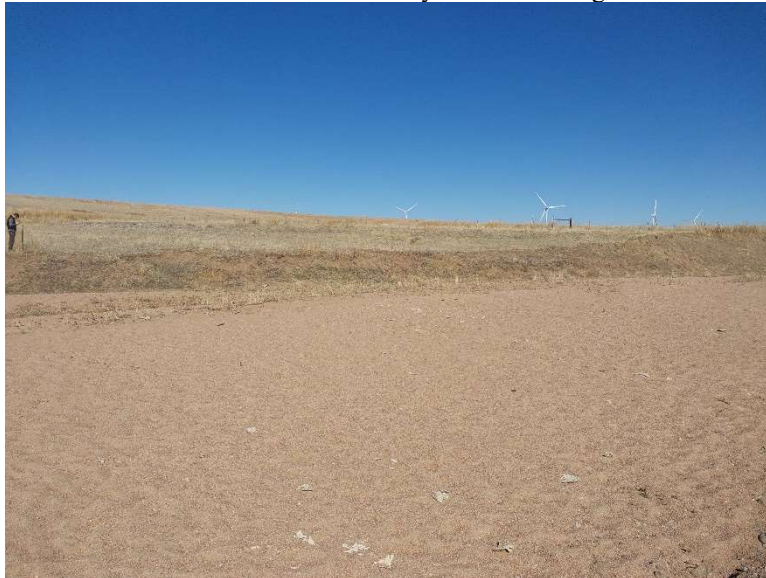
Photo #4: River channel, approximately along the southwestern boundary. Jared Ebert is seen at the southwest boundary marker in the center left of the photo.

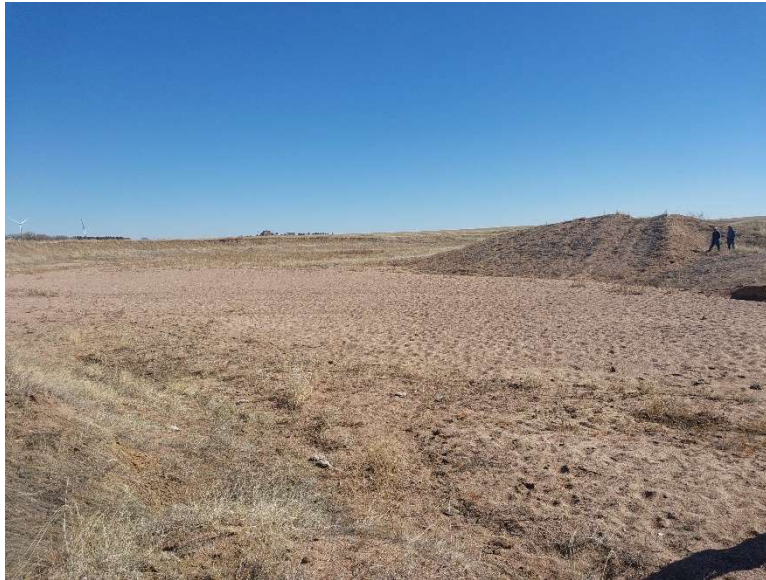
Photo #5: Taken from the southwestern permit marker, looking northeast at the permit area. Stockpile material is seen on the south bank of the river channel in the center right of the photo. Ty and Bruce are seen standing to the south of the stockpile.

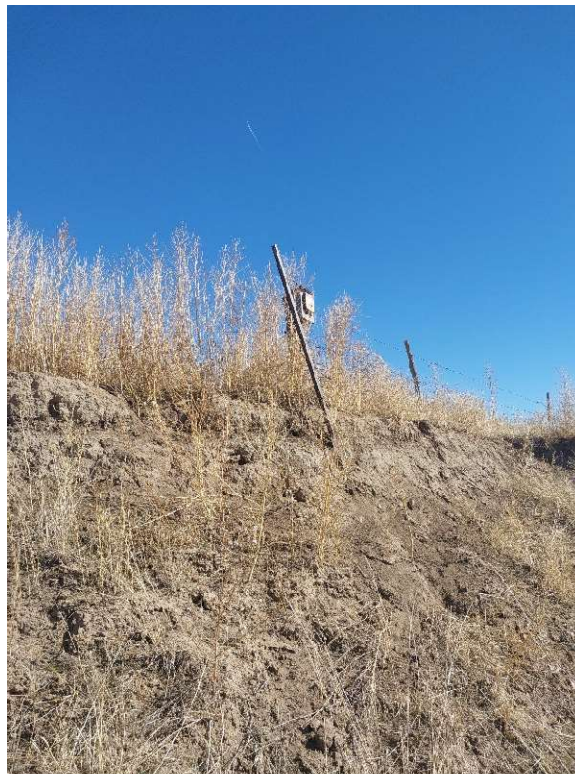
Photo #6: Permit boundary marker located on the west side of permit boundary, on the north side of the river channel.

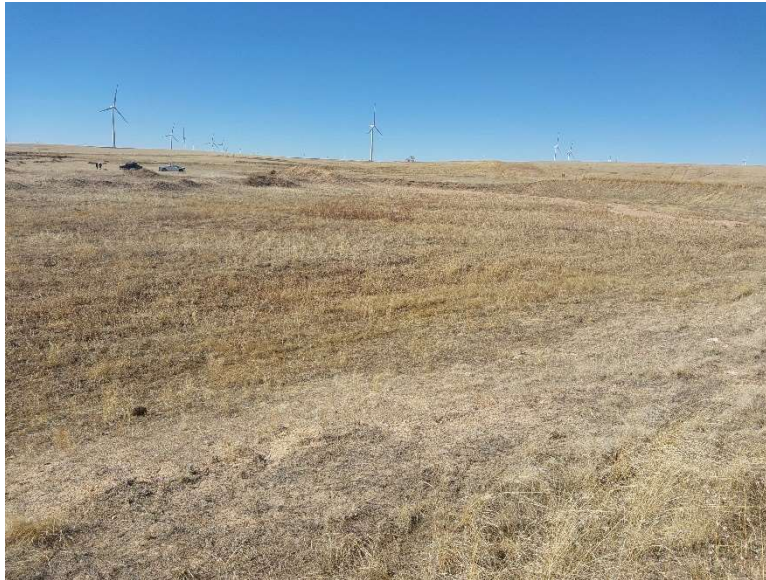
Photo #7: From the north side of river channel, along approximate permit boundary, looking south at permit area. Stockpiles, trucks, and Ty and Bruce can be seen in the upper left of the photo.

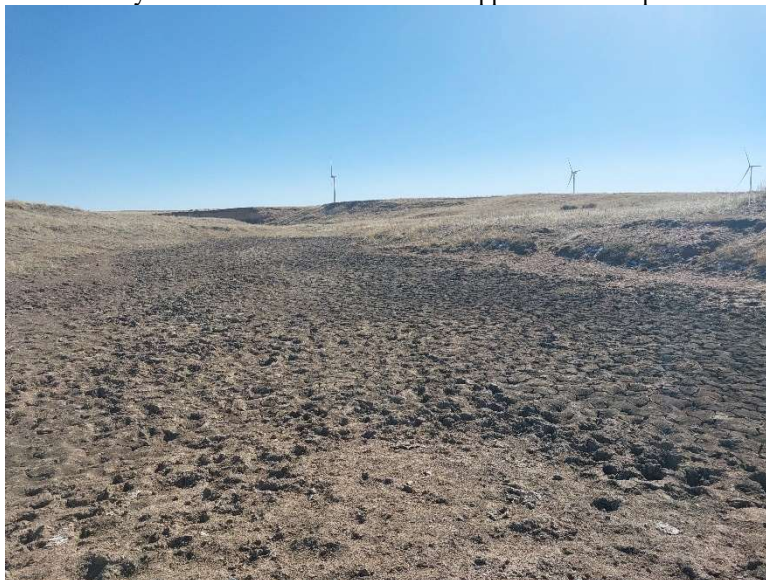
Photo #8: Taken from center of river channel in the east portion of the permit area. This area is the lowest section of the river channel in the permit area. Water appears to reside in this section for longer durations than in any other channel sections; the mud cracks indicate its dry state at the time of inspection.

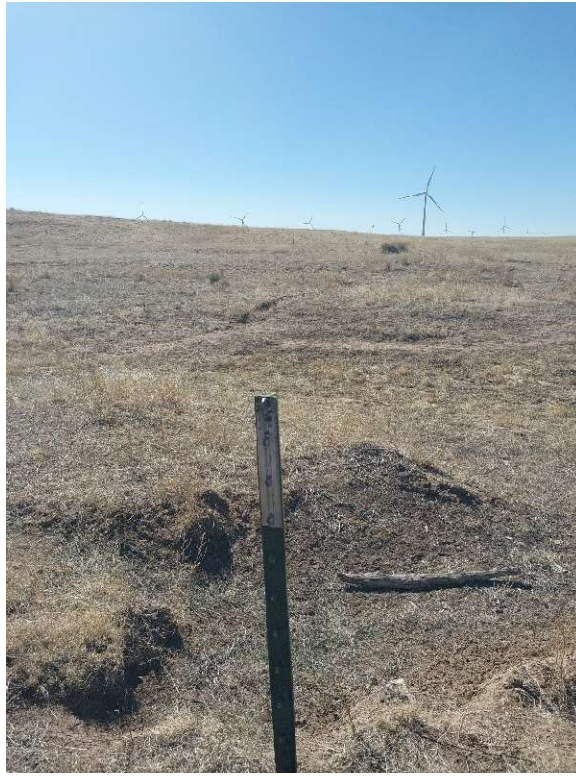
Photo #9: The northeast boundary marker looking east.

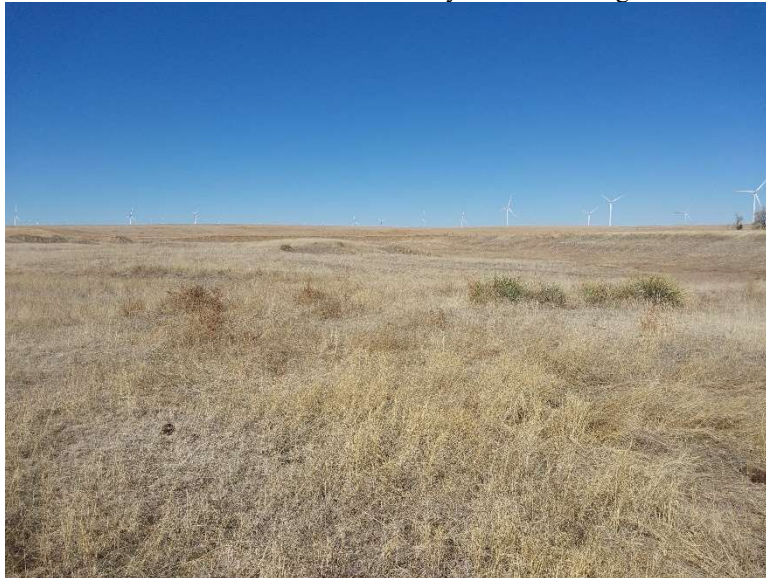
Photo #10: Taken from eastern boundary marker looking west northwest at permitted area.

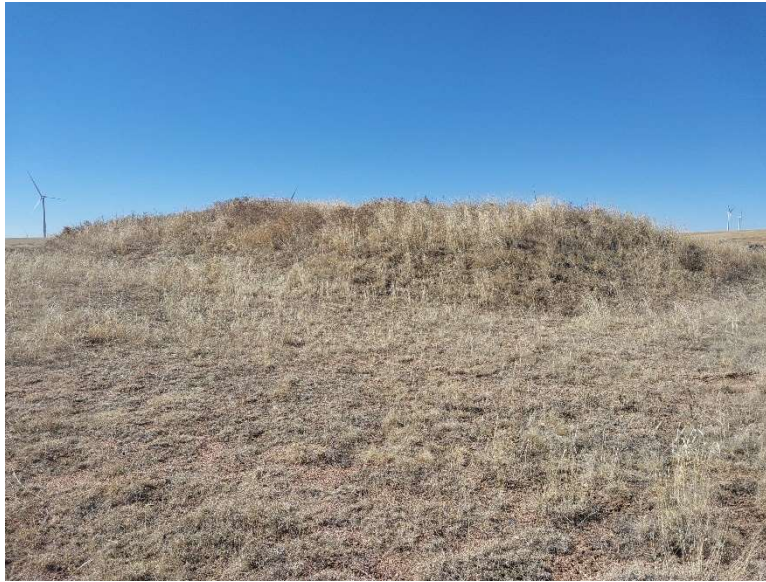
Photo #11: Stockpile #1, approximately 2:1 slope, 10-12 feet in height, and approximately 5,190 square feet (0.12 acres) in area.

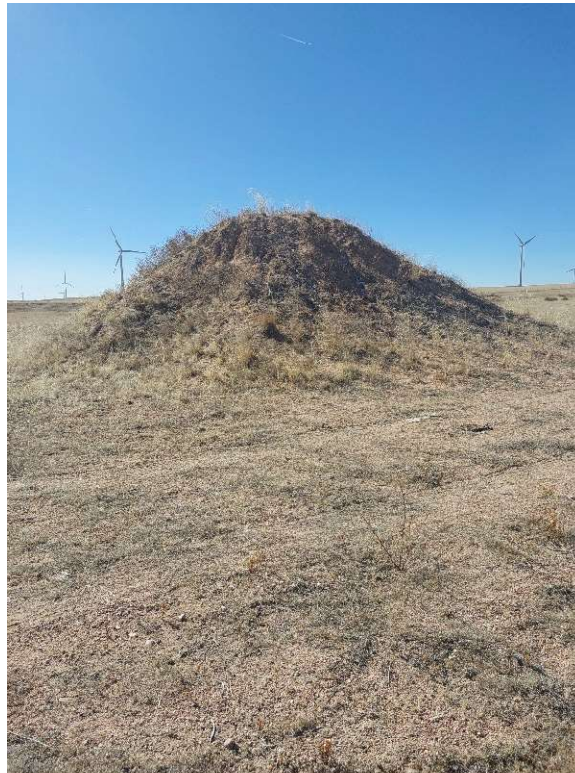
Photo #12: Stockpile #2, slope is at angle of repose, approximately 15 feet in height, and 1,773 square feet (0.04 acres) in area.

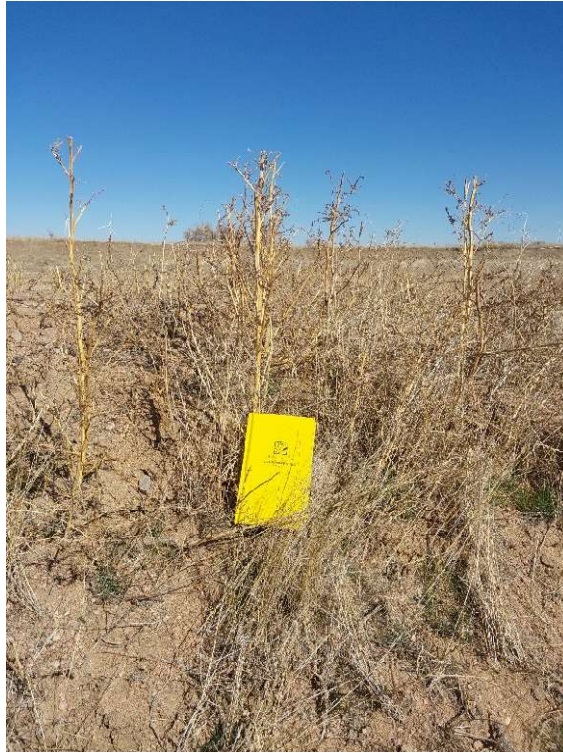
Photo of representative vegetation on berm and stockpiles with a yellow field journal for scale (7 ½ in x 5 ⅞ in), no noxious weeds noted at time of inspection.

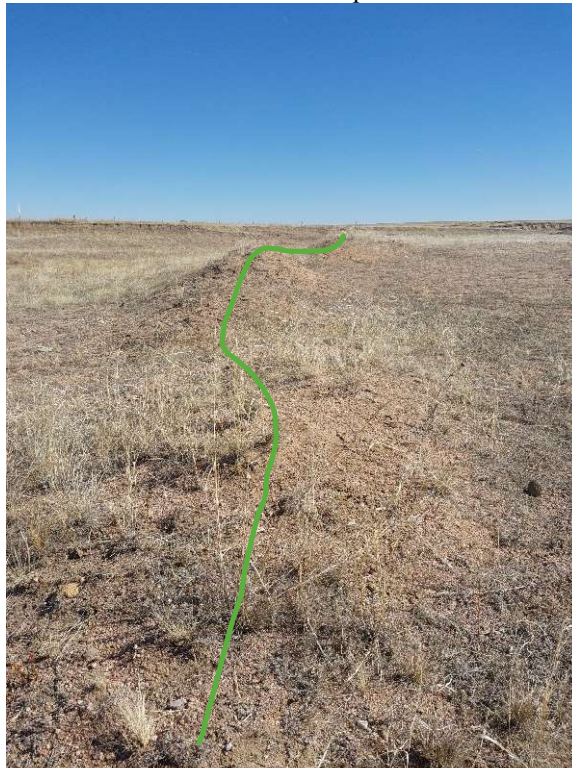
Photo #13: East berm, looking east, approximate berm ridge shown in green.

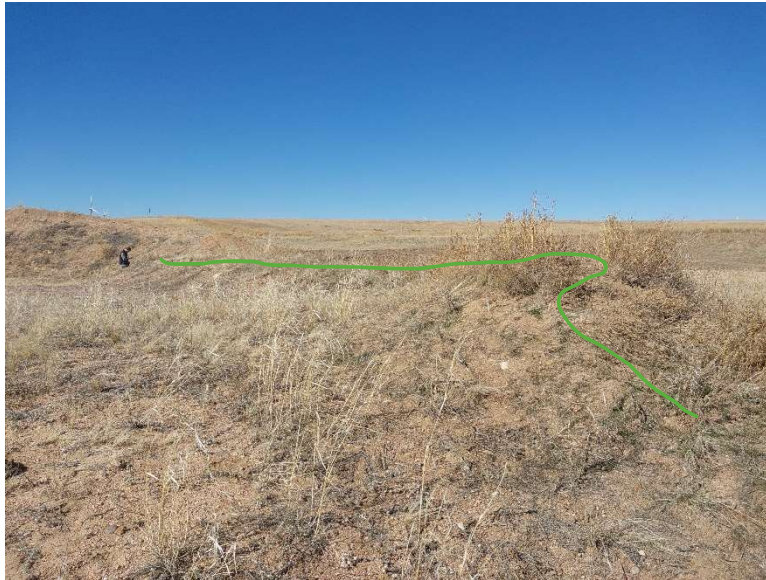
Photo #14: West berm, looking west, approximate berm ridge shown in green. Jared Ebert is seen in the center of the upper left quadrant of the photo. Jared is standing next to the material stockpile located on the south bank of the river.

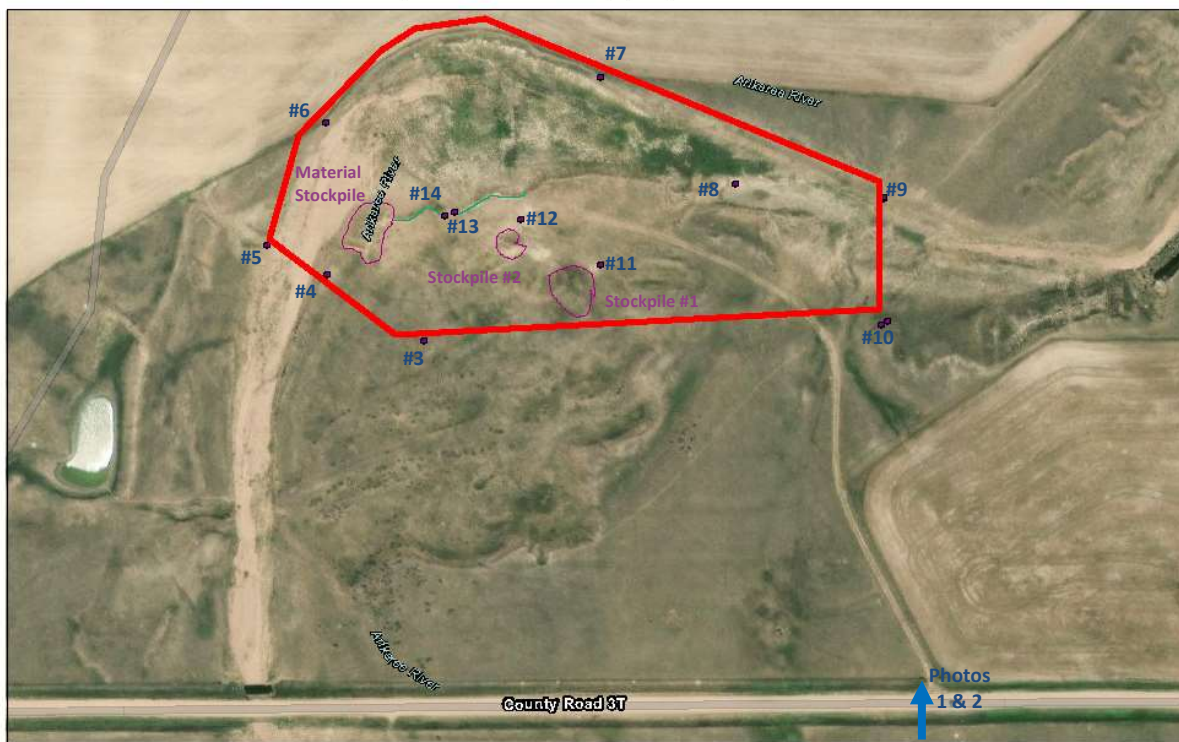
Map showing where photos were taken, locations of stockpiles, and berms. Approximate permit boundary is in red, purple dots correspond with photo numbers in this inspection report. The green lines correspond with the berms and the purple lines outline where stockpiles are located.
