Roadside Mine, C-1981-041, March Complete Inspection Report

PERMIT INFORMATION

Permit Number: C-1981-041 Mine Name: Roadside Portals Operator: Snowcap Coal Company, Inc. Operator Address: MS Tonya Hammond 743 Horizon Court, Suite 334 Grand Junction, CO 81506	County: Mesa Operation Type: Underground Permit Status: Active Ownership: Private
	Operator Representative Present: Tonya Hammond
Operator Representative Signature: (Field Issuance Only)

MINERALS PROGRAM INSPECTION REPORT
PHONE: (303) 866-3567

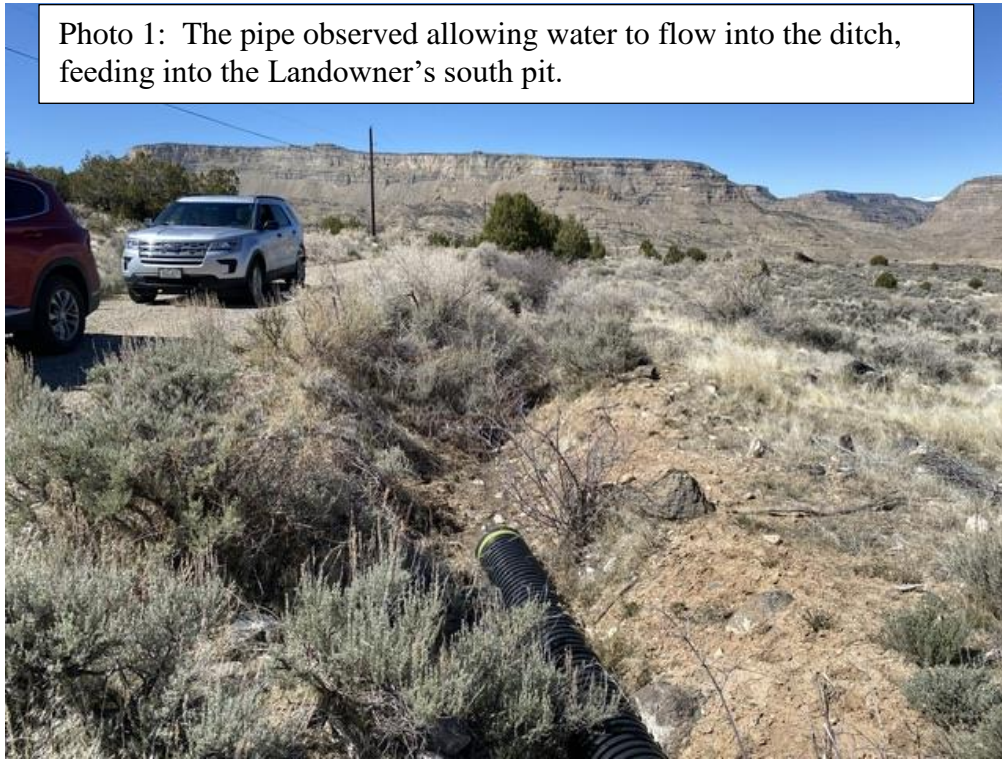
During the inspection, the Division inspected the landowner's southern gravel pit. It was brought to the Division's attention that water was discharging from the landowner's pipeline into the southern gravel pit (Photo 1 and 2). This portion of the gravel pit is permitted under the M-1996-076 Minerals Permit. The Minerals Permit and the current Roadside Mine permit boundary overlap each other. The Division observed water flowing out of a buried pipe into a surface trench extending into the south pit. Water was flowing at an approximate rate under 30 gallons per minute. Water from the trench entered an area that pooled the water before seeping into the pit's highwall (Photo 3). The water was observed seeping out of the loose material at the pits highwall at the pit floor. The water was then partly pooling on the pit floor and in a depression on the northwest side of the pit floor (Photo 4). The depth of water impounded in these areas was difficult to determine from the top of the southern boundary of the pit. The water impounded in the pit was clearly coming from the pipe and not as a result of any precipitation event.

Photo 1: The pipe observed allowing water to flow into the ditch, feeding into the Landowner's south pit.

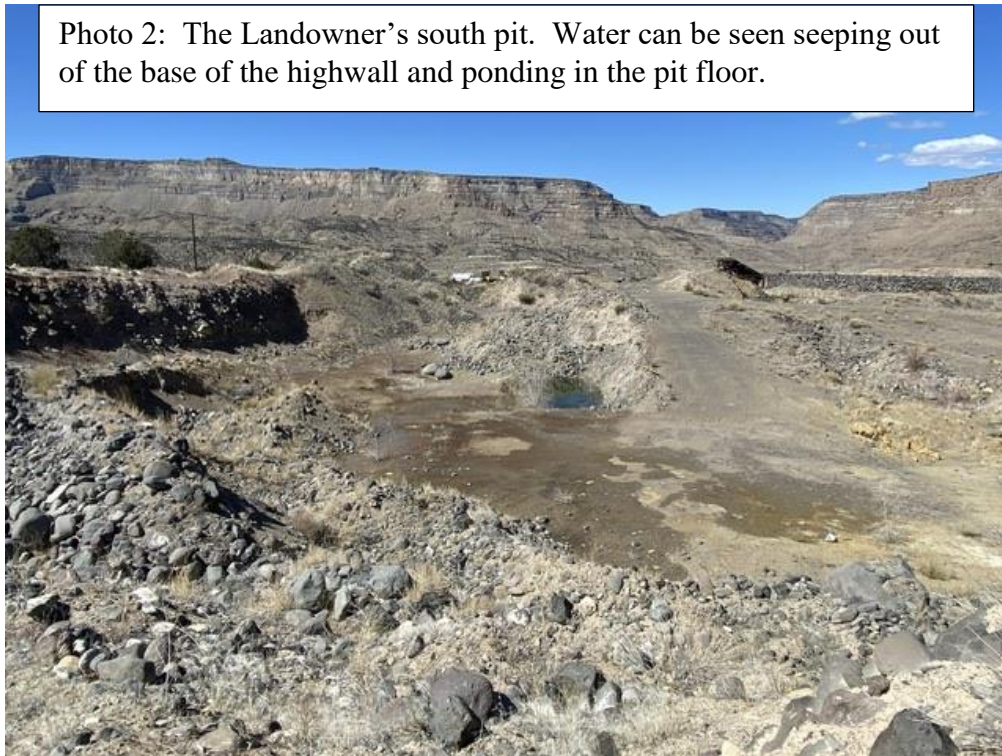
Photo 2: The Landowner's south pit. Water can be seen seeping out of the base of the highwall and ponding in the pit floor.

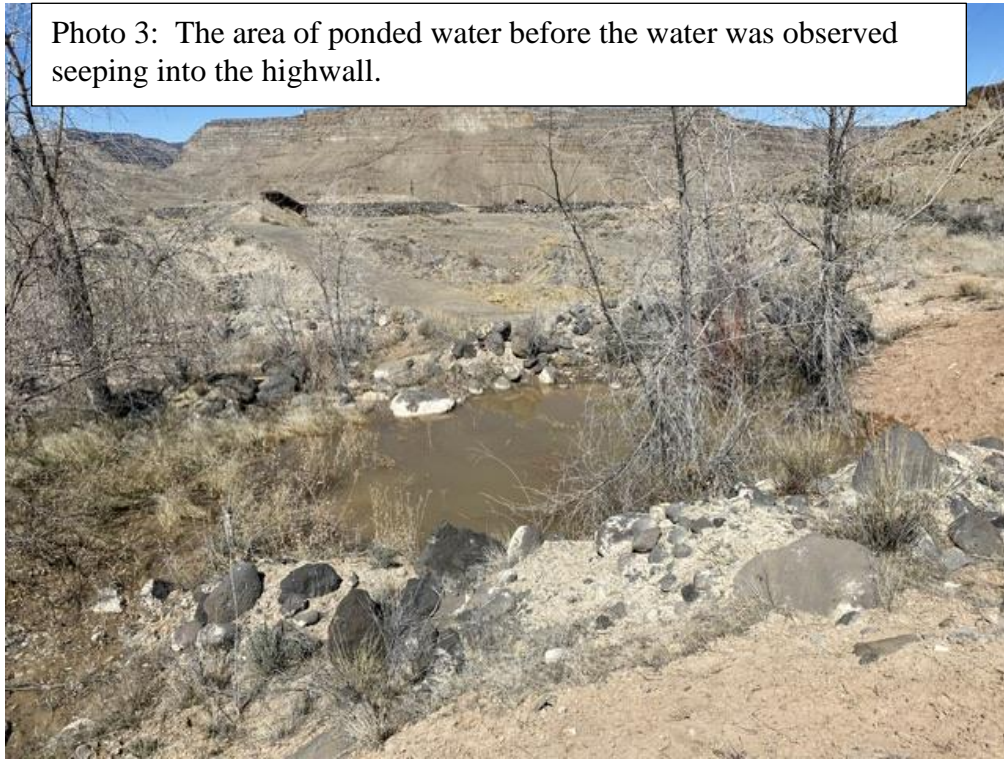
Photo 3: The area of ponded water before the water was observed seeping into the highwall.

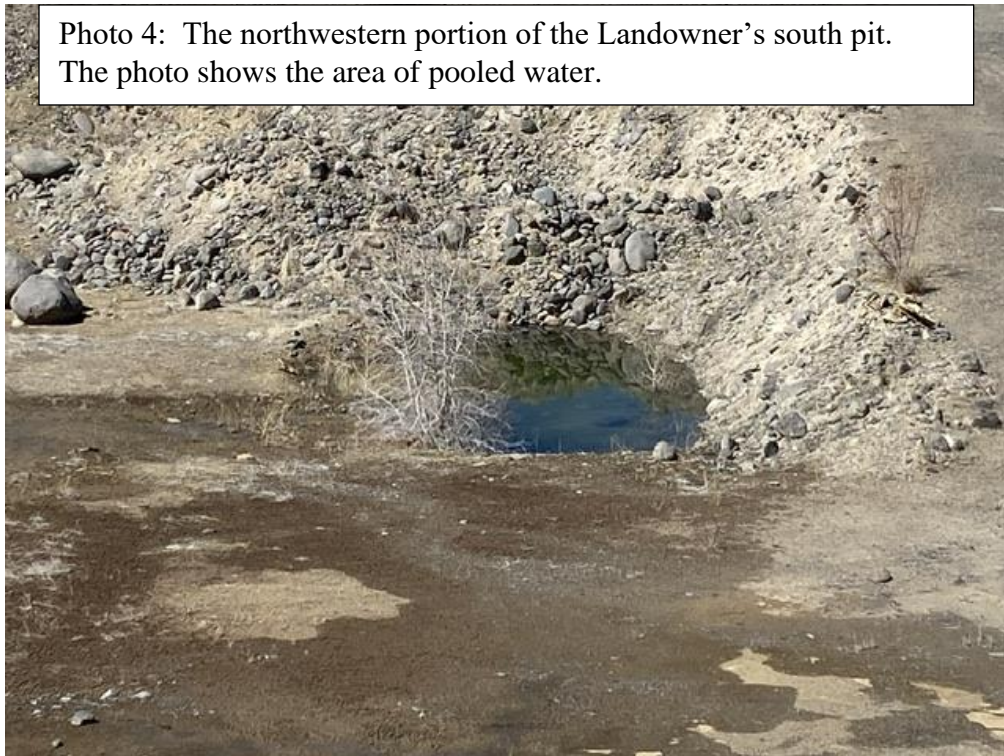
Photo 4: The northwestern portion of the Landowner's south pit. The photo shows the area of pooled water.

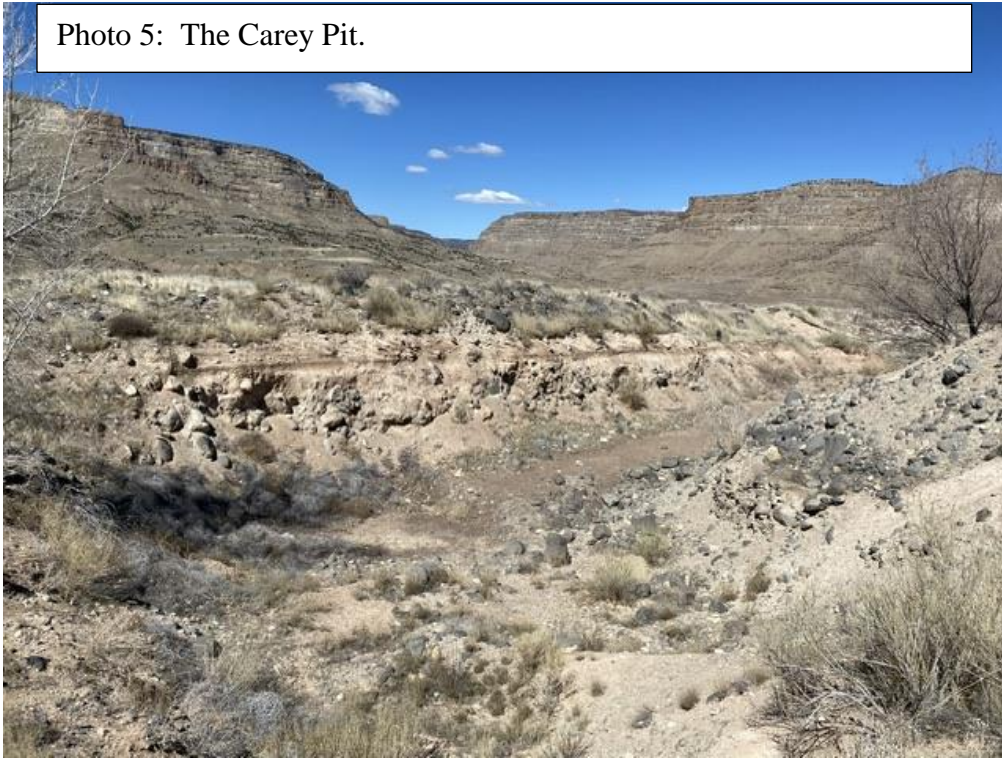
The Carey Pit is located in the southwestern portion of Tract 71. The pit was dry at the time of the inspection (Photo 5). There was no water flowing out of the landowner's buried pipe at this location.

Photo 5: The Carey Pit.

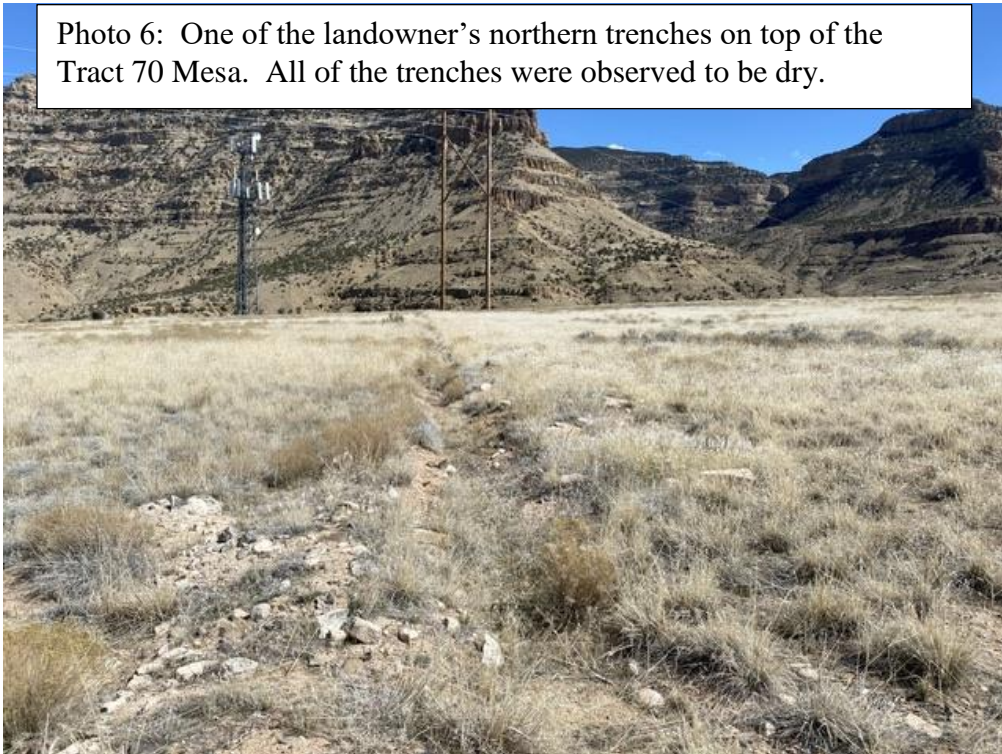
The landowner's trenches documented on top of the Tract 70 Mesa were also observed to be dry (Photo 6). The riser pipes feeding the trenches were not active during the inspection. There was no indication of recent application of water from the pipes to the trenches.

Photo 6: One of the landowner's northern trenches on top of the Tract 70 Mesa. All of the trenches were observed to be dry.

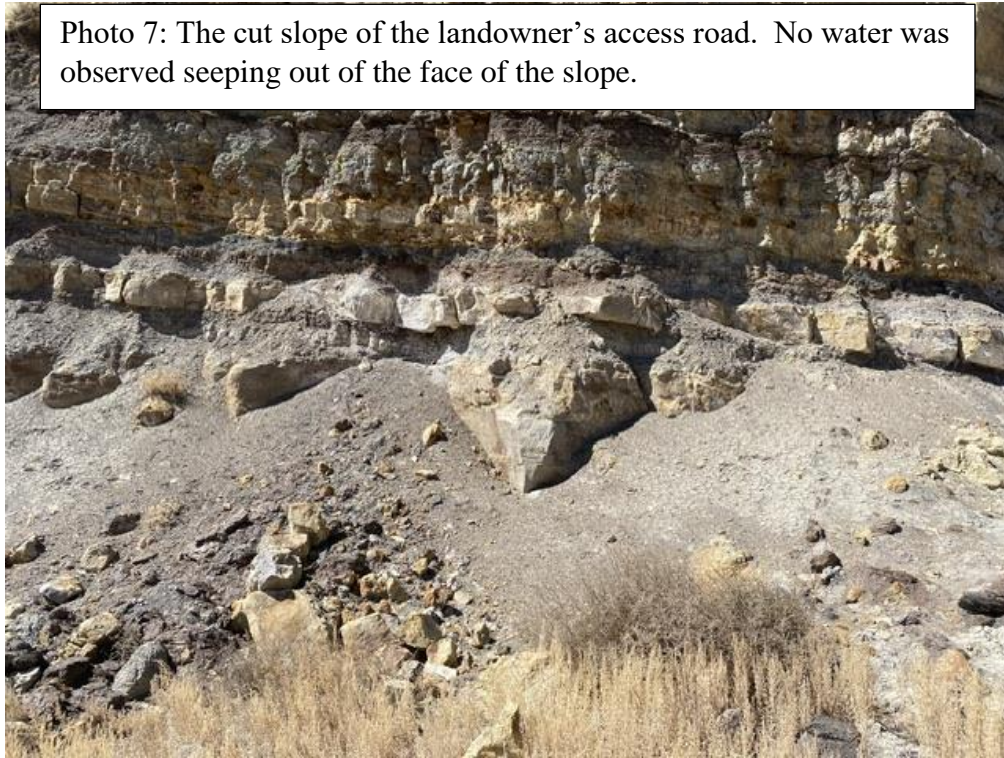
The landowner has an access road extending down from the Tract 70 Mesa north to the truck stop. The Division has documented in previous seasons small amounts of water seeping out of the cut slope of the road. During the inspection there was no water observed seeping out of the cut slope of the access road (Photo 7).

Photo 7: The cut slope of the landowner's access road. No water was observed seeping out of the face of the slope.

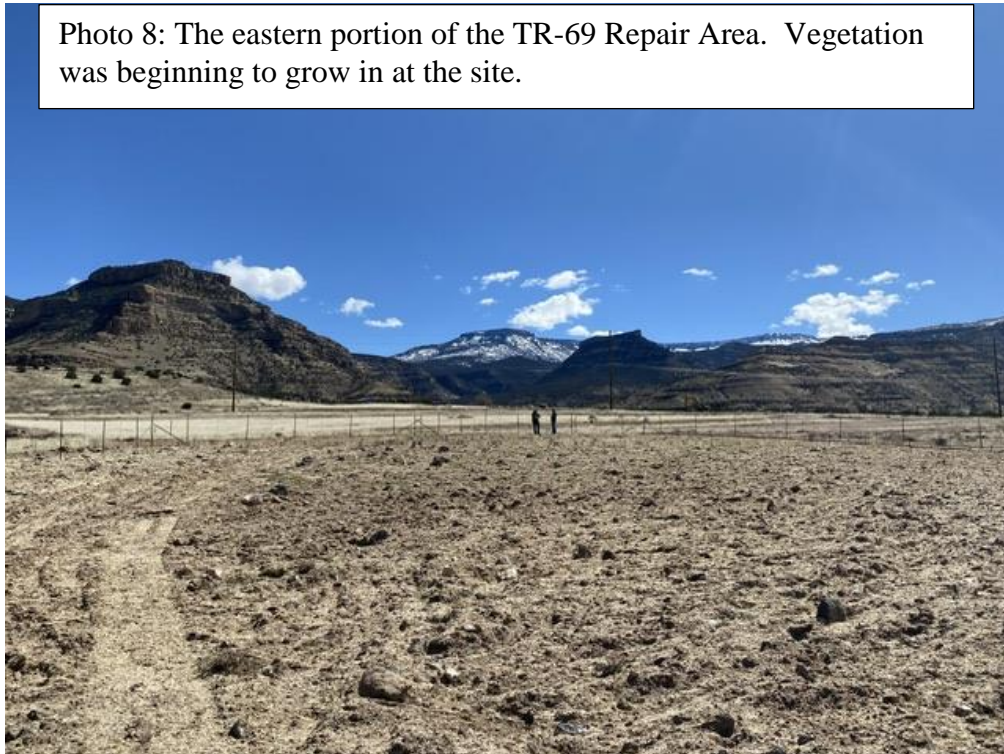
The TR-69 Repair Area is located in the northern portion of the area referred to as Tract 71. The area consists of approximately 0.4 acres of disturbance. The reclamation was disturbed by the Landowner in October of 2023 and subsequently re-graded and seeded in November of 2023. The site was stable with no erosional features observed (Photos 8, and 9). There were no indications of differential settling. The disturbed area is delineated by a wire fence. A mine identification sign was observed on one of the south facing fence posts. Straw waddles were located on the down-gradient sections of the repair area. The waddles were in good condition and no off-site impacts were observed. Vegetation was beginning to sprout from the seeds planted last fall.

Photo 8: The eastern portion of the TR-69 Repair Area. Vegetation was beginning to grow in at the site.

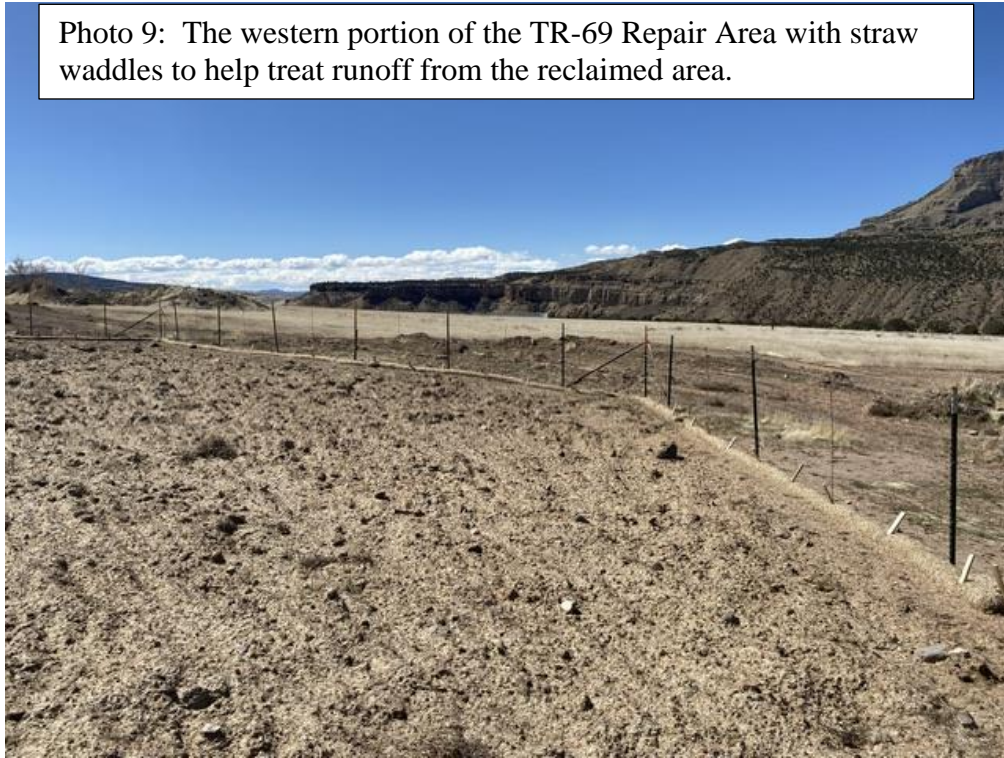
Photo 9: The western portion of the TR-69 Repair Area with straw waddles to help treat runoff from the reclaimed area.

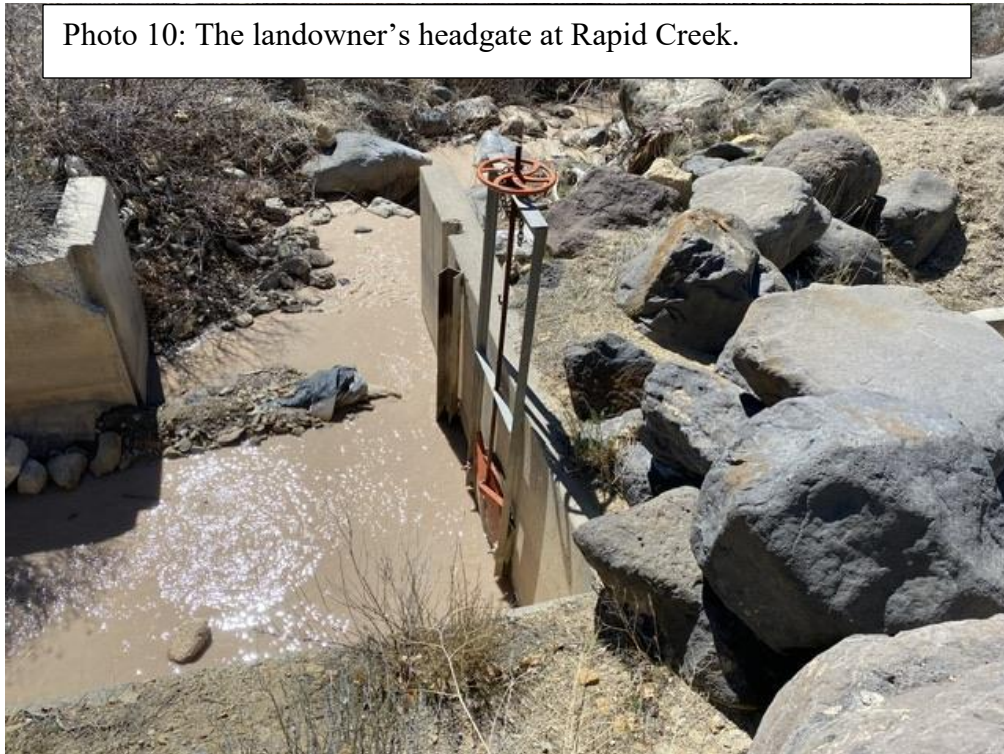
Photo 10: The landowner's headgate at Rapid Creek.

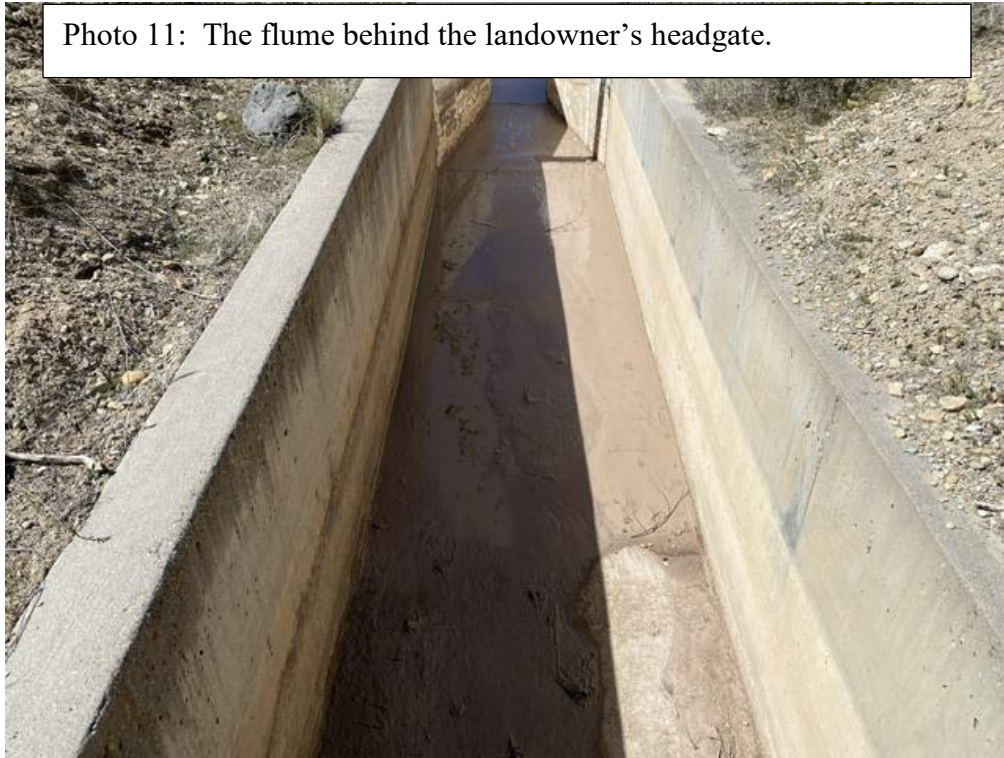
Photo 11: The flume behind the landowner's headgate.

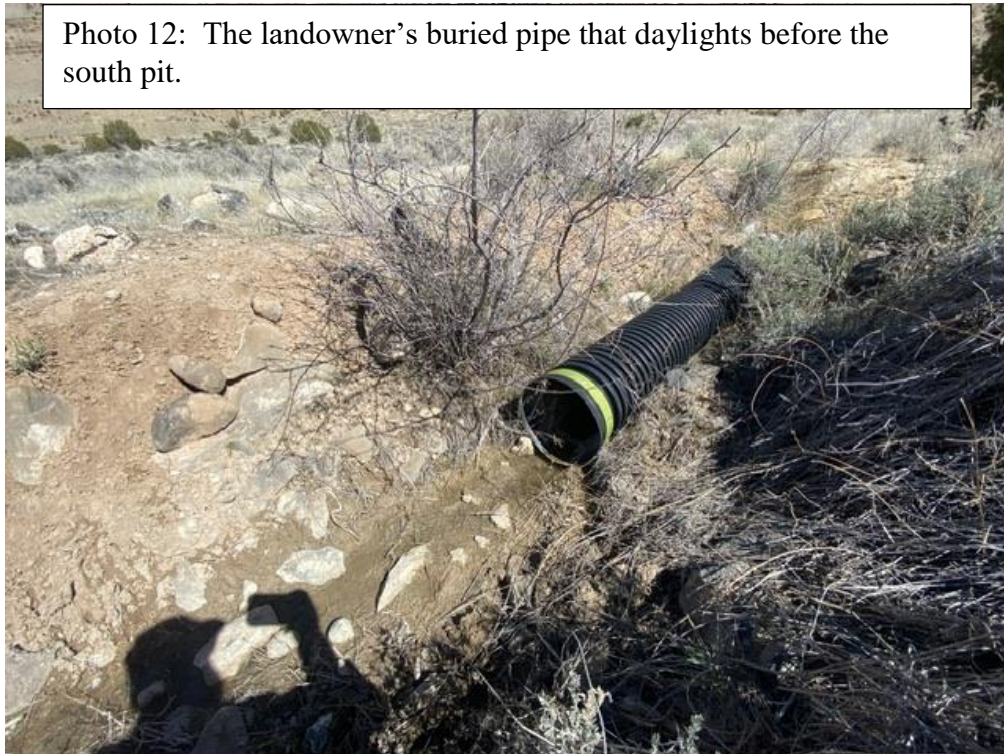
Photo 12: The landowner's buried pipe that daylights before the south pit.

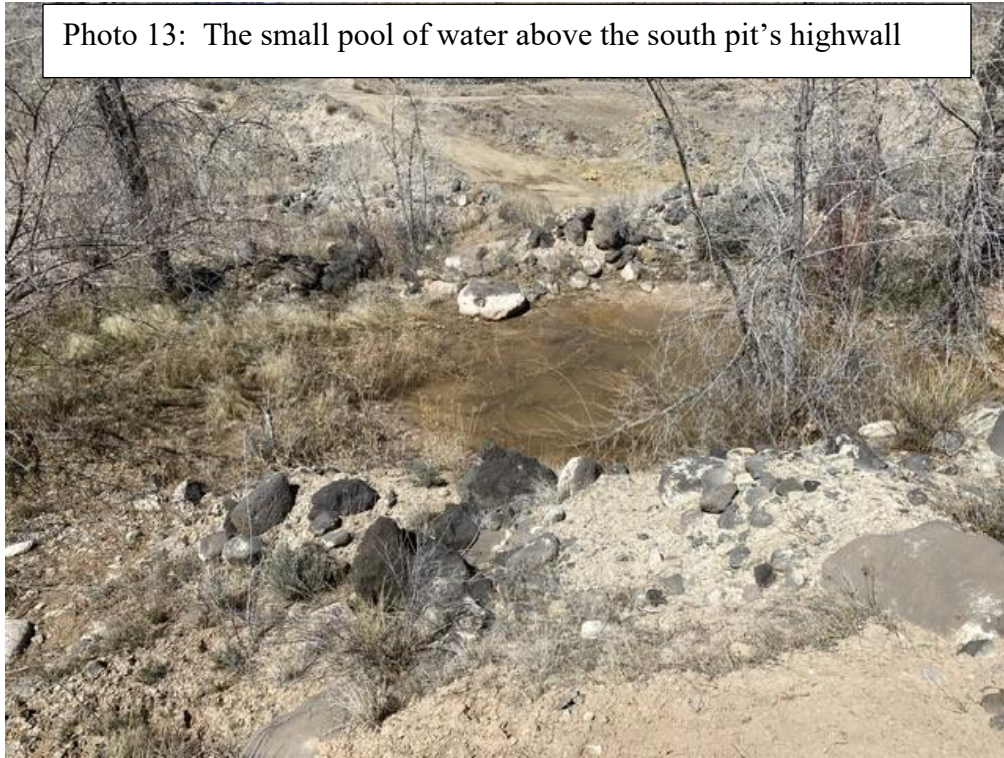
Photo 13: The small pool of water above the south pit's highwall

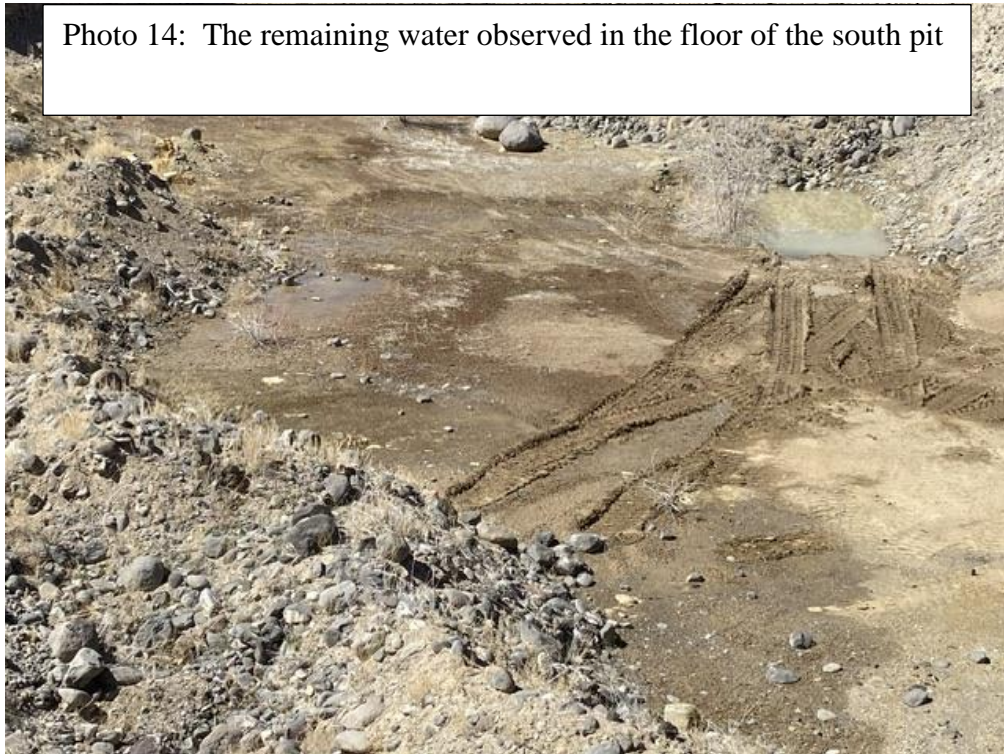
The Division contacted the Division of Water Resources (DWR) on March 19, 2024 in an effort to obtain additional information regarding the Landowner's water diversion system from Rapid Creek. The Division explained the observations taken in the field and estimated that the water may have been coming from a buried pipeline that received water from the landowner's headgate at Rapid Creek. Brian Sewell of DWR offered to meet the Division in the field on March 21, 2024 to investigate the source of the water that was entering the south pit. The Division started the inspection on March 21st at Rapid Creek. The Division observed fresh ATV tracks at the headgate's location and that the headgate was closed (Photo 10). The flume behind the headgate was damp and muddy, indicating that there had been recent flow through the landowner's diversion inlet (Photo 11). No water was observed flowing in the flume. The ATV track were observed following the landowner's buried water line up to the south pit. The pipe feeding into the open ditch and into the pit was almost dry (Photo 12). A small amount of water was observed trickling out of the pipe. Brian Sewell and the Division agreed that the water was likely residual flow as gravity flushes the remaining water out of the buried pipe. The level of water in the small ponded area above the south pit had decreased in size, but was still holding some water (Photo 13). Likewise, the amount of water in the pit floor appeared to have decreased since the March 19th inspection (Photo 14).

Photo 14: The remaining water observed in the floor of the south pit

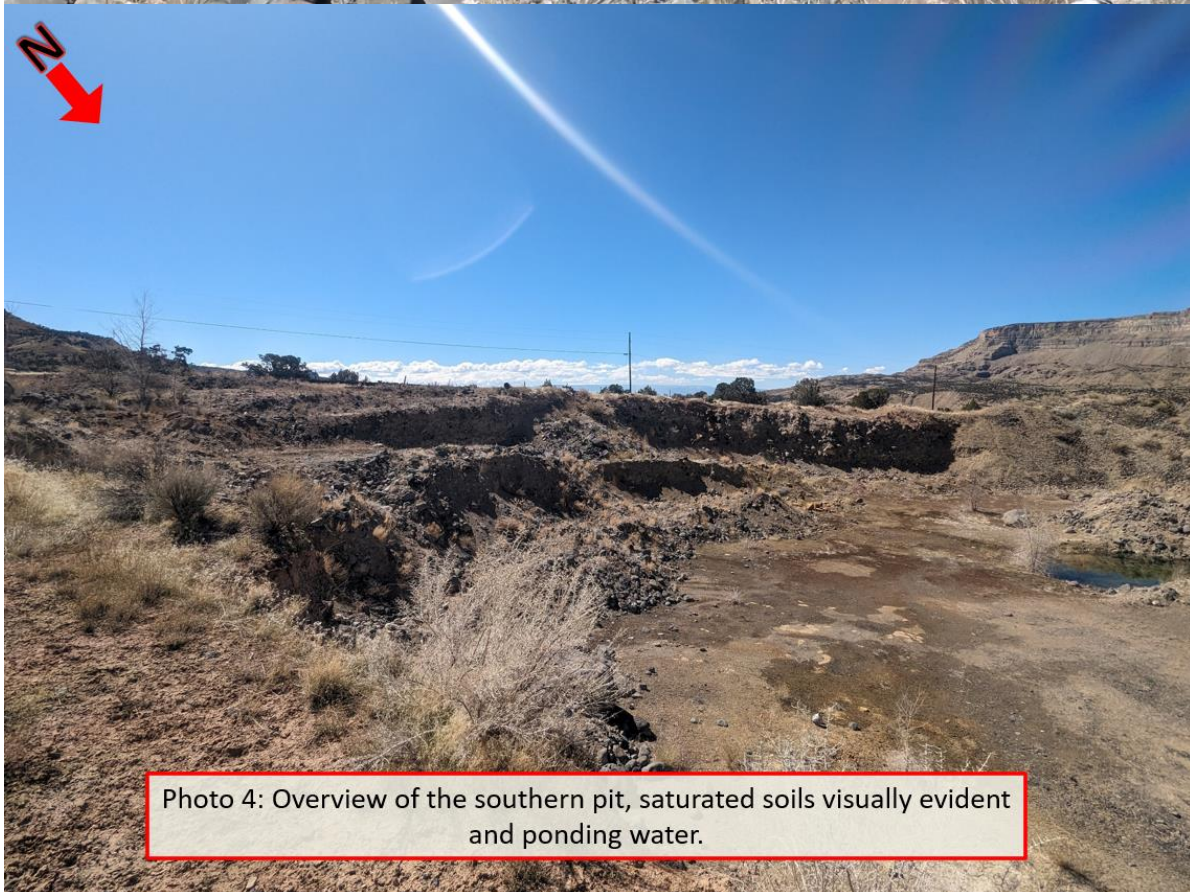
Water was observed discharging from a buried pipe* then being conveyed via an earthen ditch into the permit boundary ** (Photo 1). Water was estimated to be flowing at less than 30 gallons per minute. The discharging water resulted in ponding of water in two places within the southern pit area (Photos 2 and 3). Water infiltrated from the upper pool through the highwall and into the southern pit. The depth of the impounded water was not measured. Saturated soils on the southern pit floor were visually evident as the result of water flowing into the pit (Photo 4). The source of the water was believed to be from Rapid Creek above the Martin Crawford Ditch.

Photo 3: Pooled water on the floor of the southern pit.

Per the conditions of the permit, Exhibit G, no groundwater exists and no dewatering is necessary. Additionally, no water will be applied with the exception of dust suppression via truck. The water in the pits is not from existing groundwater or the result of a recent stormwater event. The Operator was directed via email to immediately turn off all water and provide the Division with photo documentation that water is no longer being discharged into the permit boundary (email enclosed).

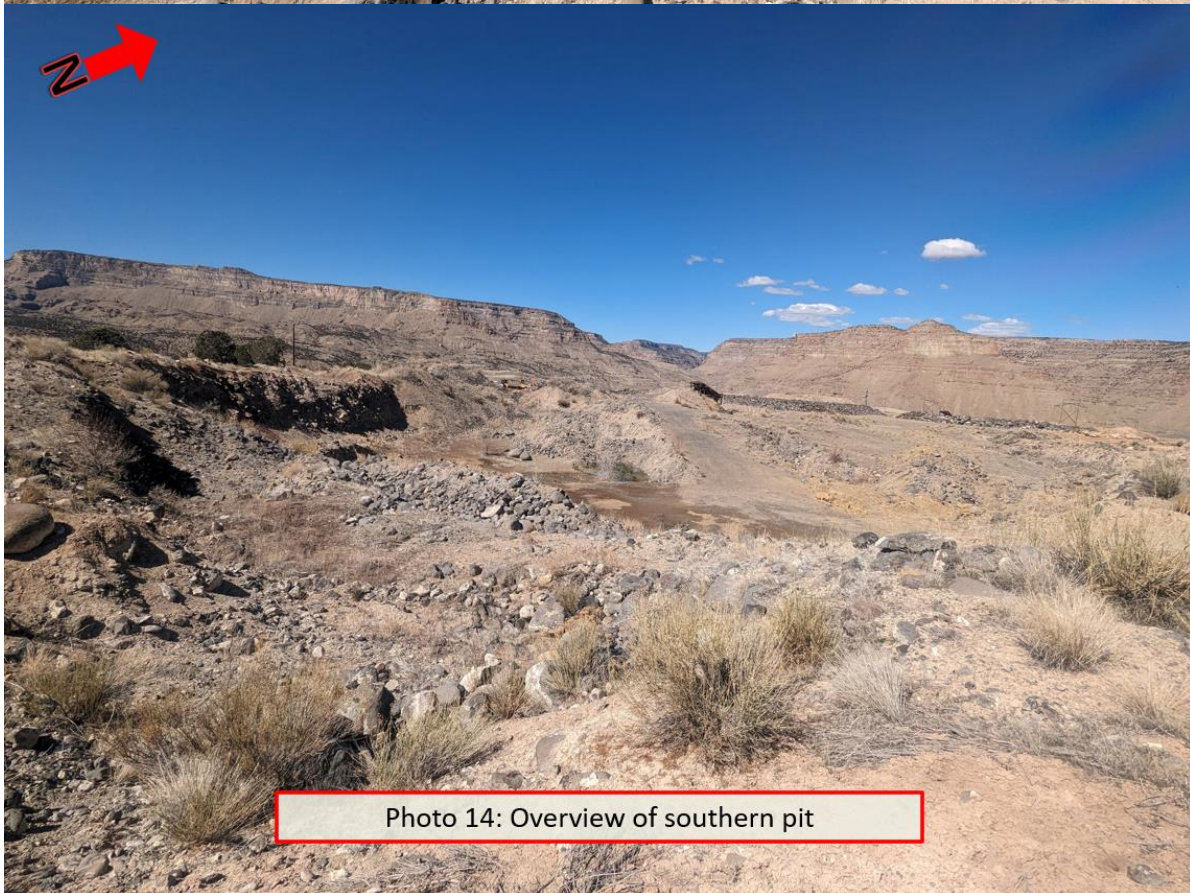
There appears to be no changes to stockpiles or highwall configurations since the previous inspection. The site was inactive at the time of the inspection. Several pieces of equipment and miscellaneous materials are on site on the west side of the southern pit. Several stockpiles remain on site at both the north and southern pits with no recent evidence of excavation. There were no vehicle/equipment tracks surrounding the processing area or pit floor to indicate recent activity. (Photos 13 -17)

Photo 13: Overview of southern pit.

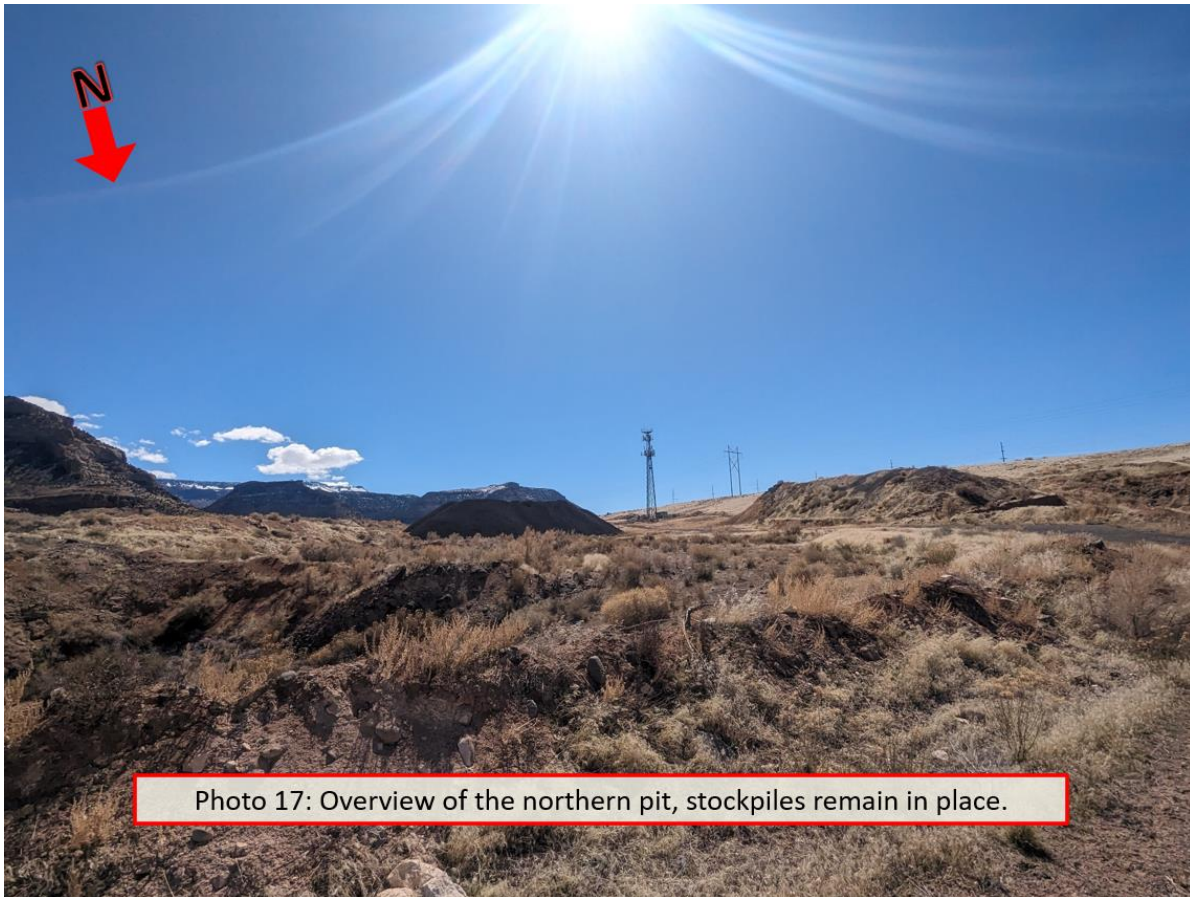
Photo 16: Misc. equipment and materials stored on the west side of the southern pit.

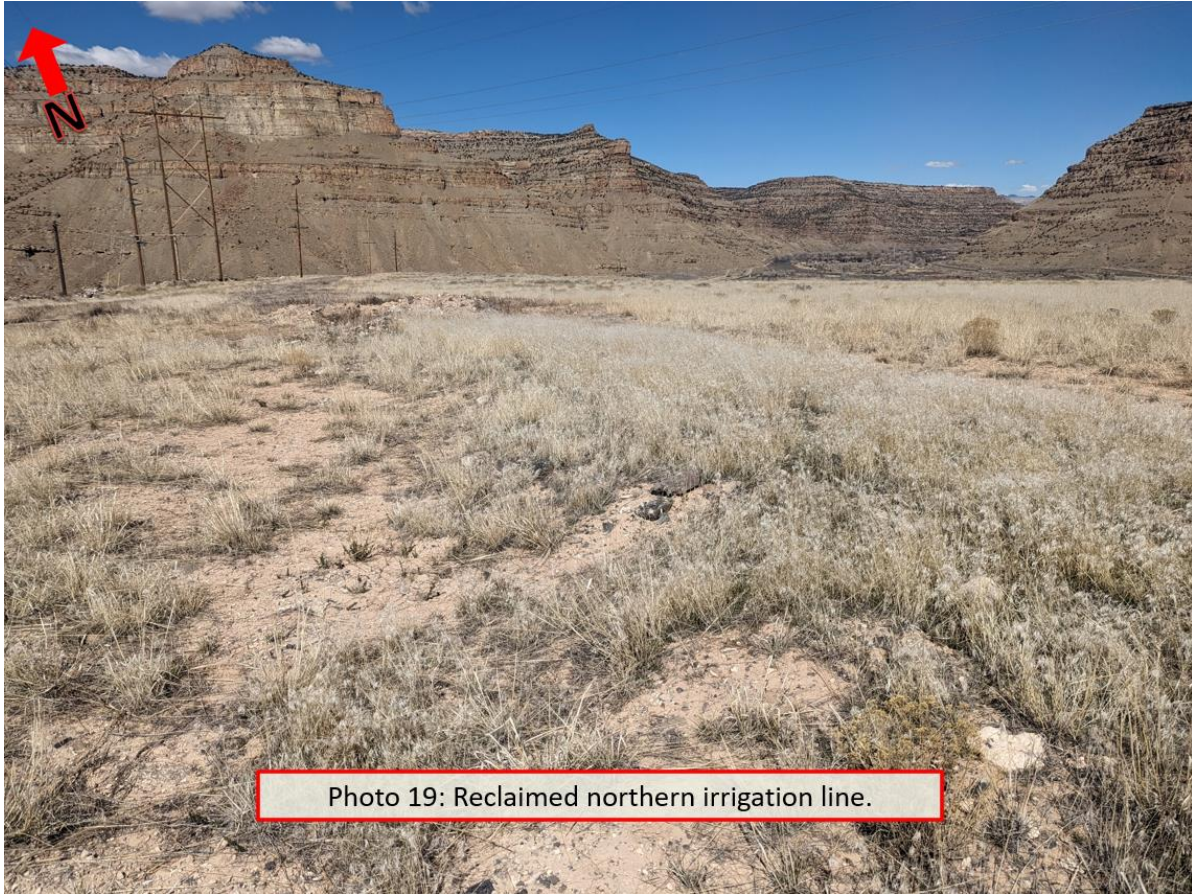
Staff observed two areas that were previously reclaimed. The first was the backfilled northwest pit. The previously inundated pit has been backfilled and sloped on the north side. Some highwalls remain on the south end. Little to no desirable vegetation was observed (Photo 18). Similarly, the area from where the northern irrigation line was removed has been reclaimed. Though vegetation is dense it is almost entirely Cheatgrass (Photo 19).

Photo 18: Reclaimed northwestern pit
