MINERALS PROGRAM INSPECTION REPORT
PHONE: (303) 866-3567

MINE NAME: Gentz Gravel Pit	MINE/PROSPECTING ID#: M-1983-116	MINERAL: Sand and gravel	COUNTY: Prowers
INSPECTION TYPE: Monitoring	WEATHER: Cloudy	INSP. DATE: March 13, 2024	INSP. TIME: 11:00
OPERATOR: Kiowa County	OPERATOR REPRESENTATIVE: Alan Watts	TYPE OF OPERATION: 110c - Construction Limited Impact	
REASON FOR INSPECTION: Normal I&E Program	BOND CALCULATION TYPE: None	BOND AMOUNT: \$0.00	
DATE OF COMPLAINT: NA	POST INSP. CONTACTS: None	JOINT INSP. AGENCY: None	
INSPECTOR(S): Zach Trujillo	INSPECTOR'S SIGNATURE:

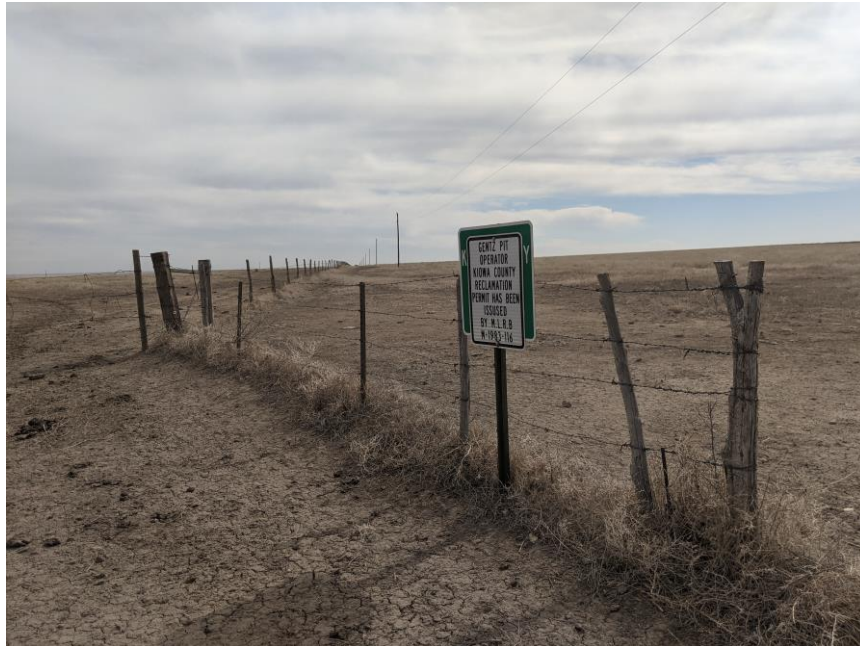
A mine identification sign was located at the entrance to the site with all required information. Permit boundary markers were also observed as a combination of t-posts and rock piles. All markers were visible from one another which delineated the boundary.

Mine identification sign.

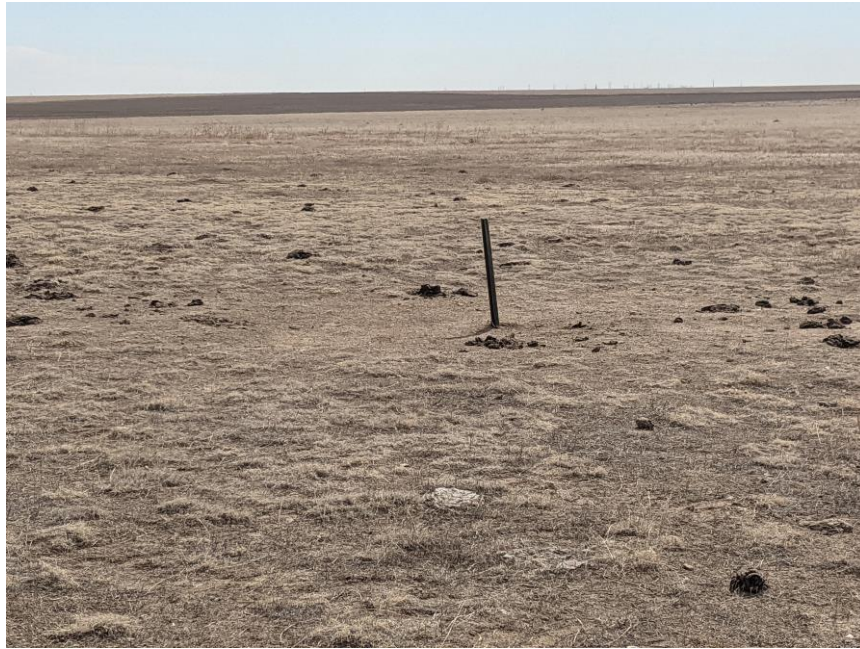
T-post boundary marker.

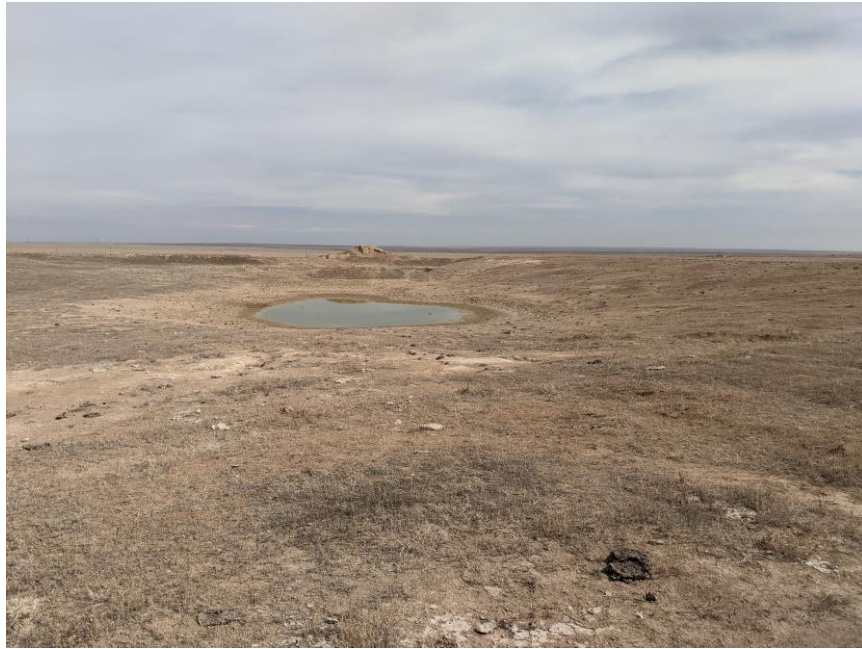
The south and eastern extent of the pit highwalls has been graded to approximately 3H:1V. A small portion of the north eastern pit highwall did not appear to have been graded yet. Also along the north eastern portion of the pit is a small topsoil pile which is sparsely vegetated. The pit overall is slightly sloped from the northwest to the southeast. Along the western section of the pit remains a small portion of the highwall as well. This highwall is approximately 3-4 feet in height and will need to be graded to conform the surrounding areas as approved by the reclamation plan. Based on the grade of the adjacent area, pit floor and regraded highwalls, a low spot exists in which water ponds. Minimal water was observed along this area and was most likely from snow melt from a recent precipitation event.

Regarded slopes along eastern end of pit.

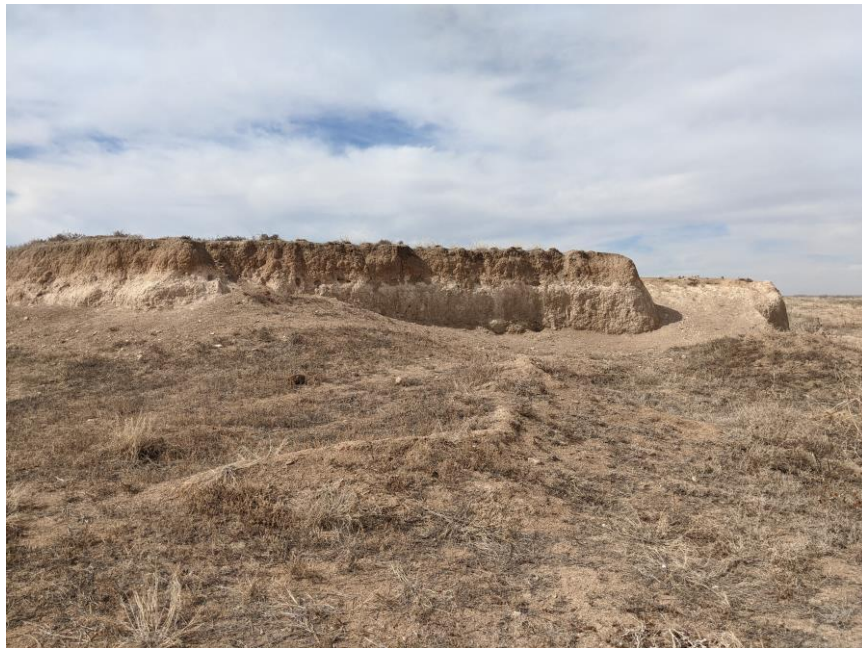
Remaining highwall along western portion of pit.

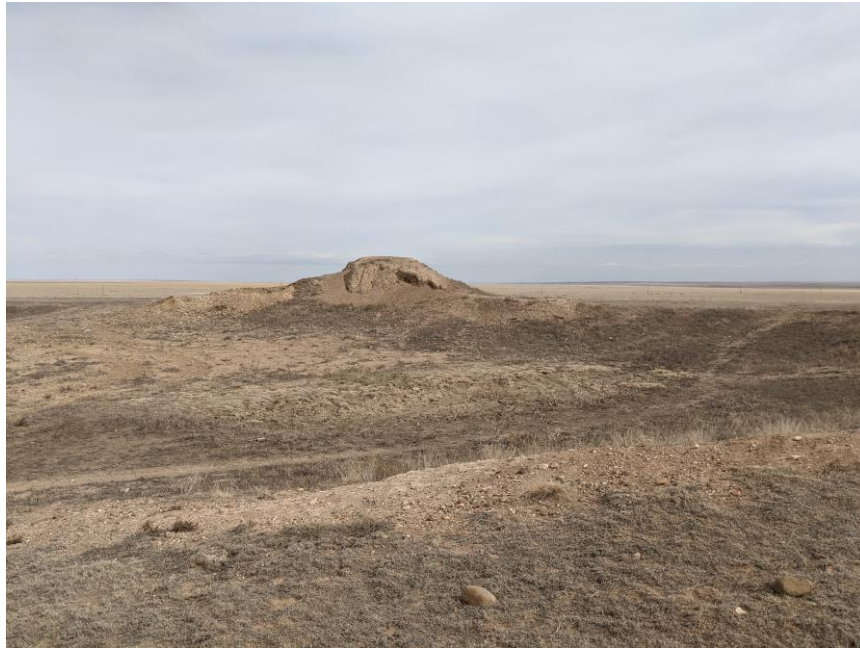
Topsoil pile and remaining north east portion of pit in need of regrading.
