**MINERALS PROGRAM INSPECTION REPORT**  
**PHONE: (303) 866-3567**

<b>MINE NAME:</b> Edmundson Clay Mine	<b>MINE/PROSPECTING ID#:</b> M-1985-203	<b>MINERAL:</b> Clay (general)	<b>COUNTY:</b> Pueblo
<b>INSPECTION TYPE:</b> Surety-Related Inspection	<b>WEATHER:</b> Cloudy	<b>INSP. DATE:</b> March 13, 2024	<b>INSP. TIME:</b> 08:30
<b>OPERATOR:</b> Summit Brick & Tile Co.	<b>OPERATOR REPRESENTATIVE:</b> Julie Welte	<b>TYPE OF OPERATION:</b> 110c - Construction Limited Impact	
<b>REASON FOR INSPECTION:</b> Surety Related	<b>BOND CALCULATION TYPE:</b> Complete Bond	<b>BOND AMOUNT:</b> \$19,350.00	
<b>DATE OF COMPLAINT:</b> NA	<b>POST INSP. CONTACTS:</b> None	<b>JOINT INSP. AGENCY:</b> None	
<b>INSPECTOR(S):</b> Jocelyn Carter Jared Ebert	<b>INSPECTOR'S SIGNATURE:</b>

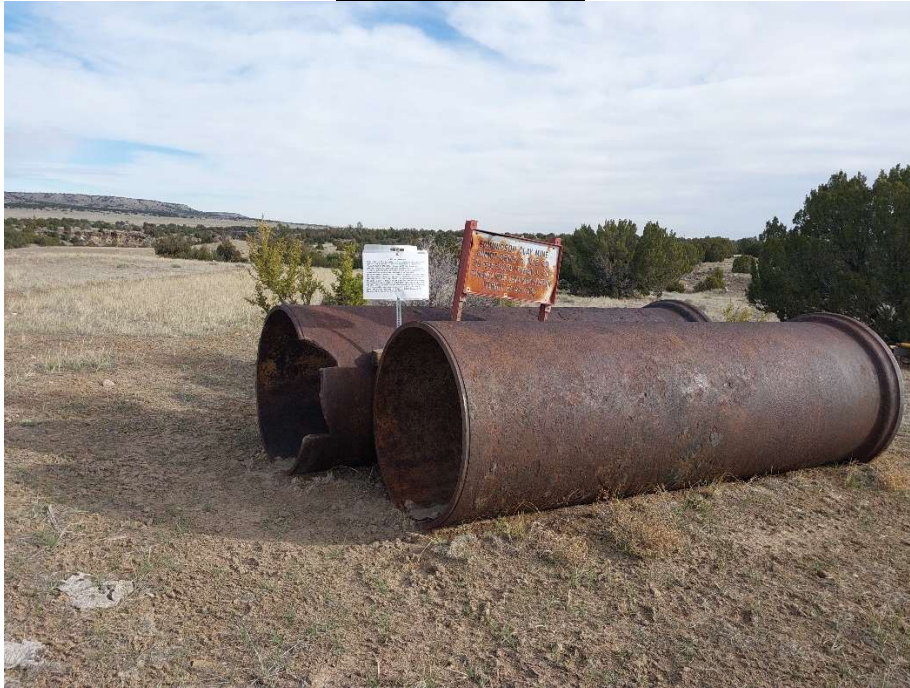
There is an old fuel truck located in the east central portion of the permit and a few large pipes located at the site entrance that were observed on site during the inspection. These items were observed and noted by Amber Michels during an inspection on June 22, 2023. The Division recommends that the operator removes the items from the site or submit documentation to the Division stating that the landowner wants these items to stay on the site.

Photo #1: Sign at entrance, compliant with Rule 3.1.12. The pipes noted in the report as an issue under reclamation plan and compliance can be seen.

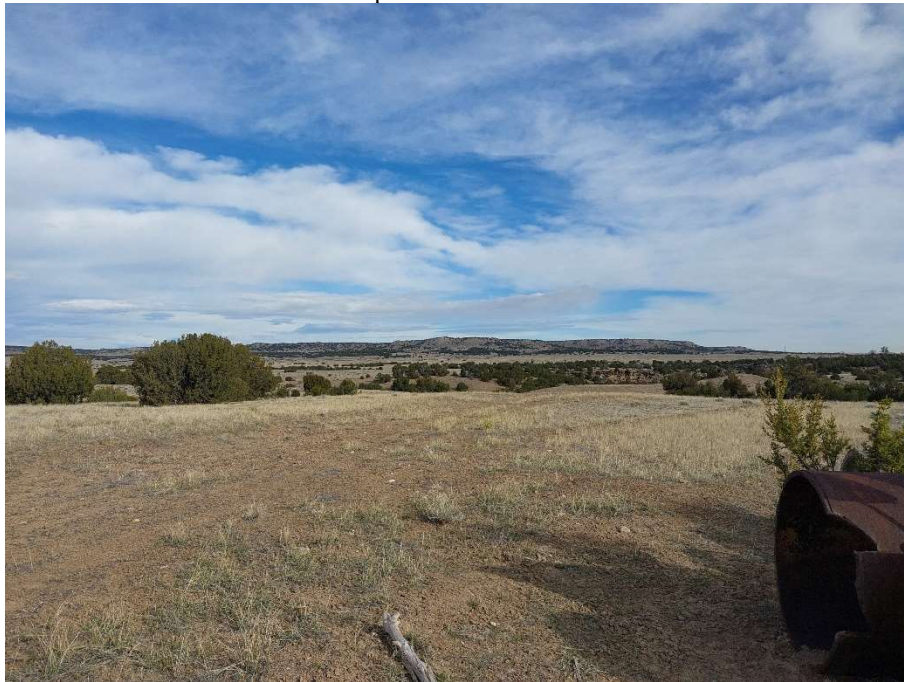
Photo #2: View of mine site from the entrance, looking north.

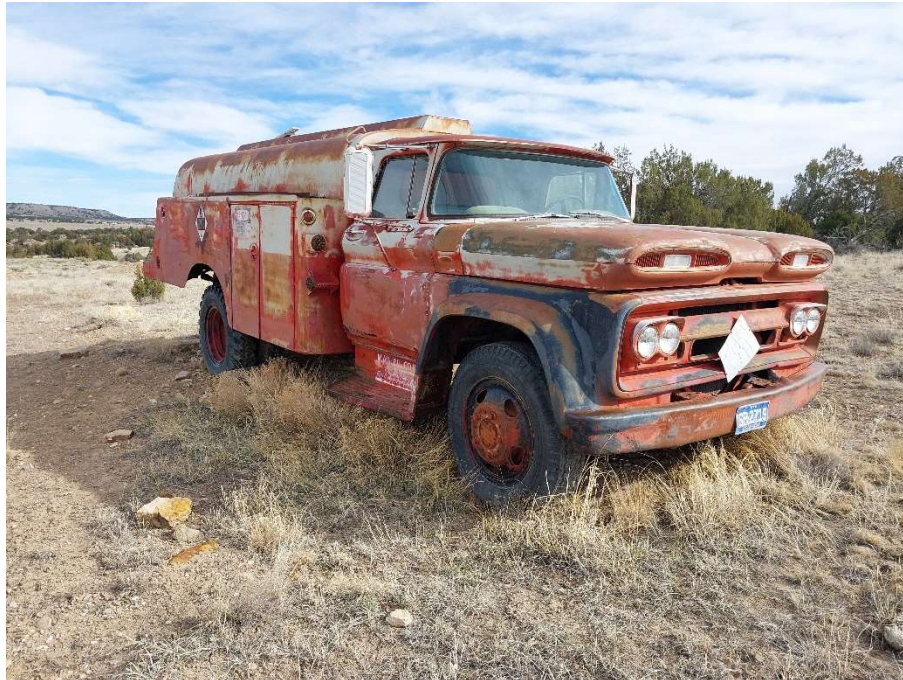
Photo #3: The old fuel truck noted as an issue under the reclamation plan and compliance section of the report, the location of the truck is noted in the map below.

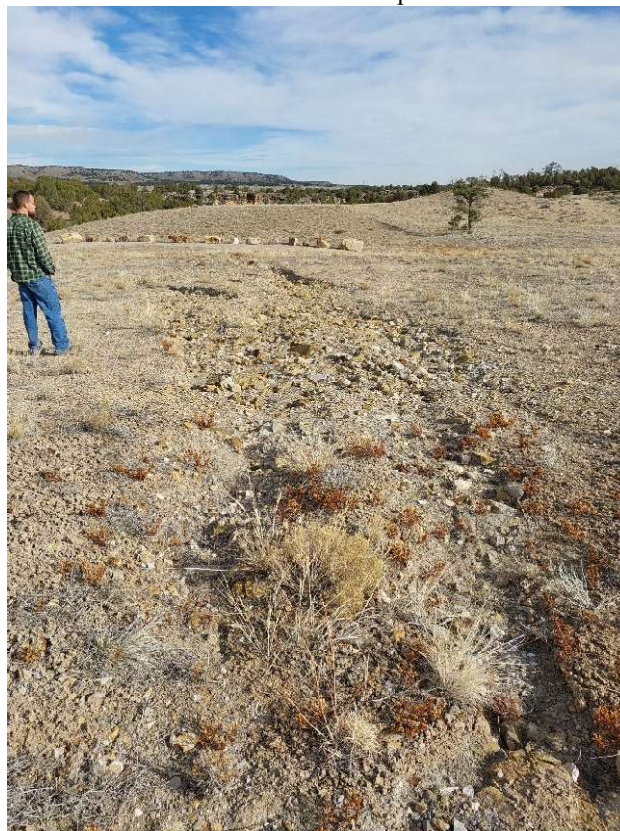
There was an erosion issue located in the east central portion of the permit area. The erosion begins south with sediment being transported downslope to the north. At the start of the erosion, on the south end, the affected is wide, approximately 10 feet in width and only a few inches in depth. As the slope steepens towards the north, the land becomes more incised while the span decreases, measuring about 4 feet wide and approximately 2 feet deep. Sediment is depositing at the north point where the erosion issue is marked on the map provided at the end of this report. The Division recommends installing erosion control structures. The issue was discussed with Julie during the inspection, she said she would address the erosion in this section.

Photo #4: Starting point of erosion and sedimentation observed, viewed from the south portion looking north and down slope. Jared Ebert is standing to the west of the erosion path.

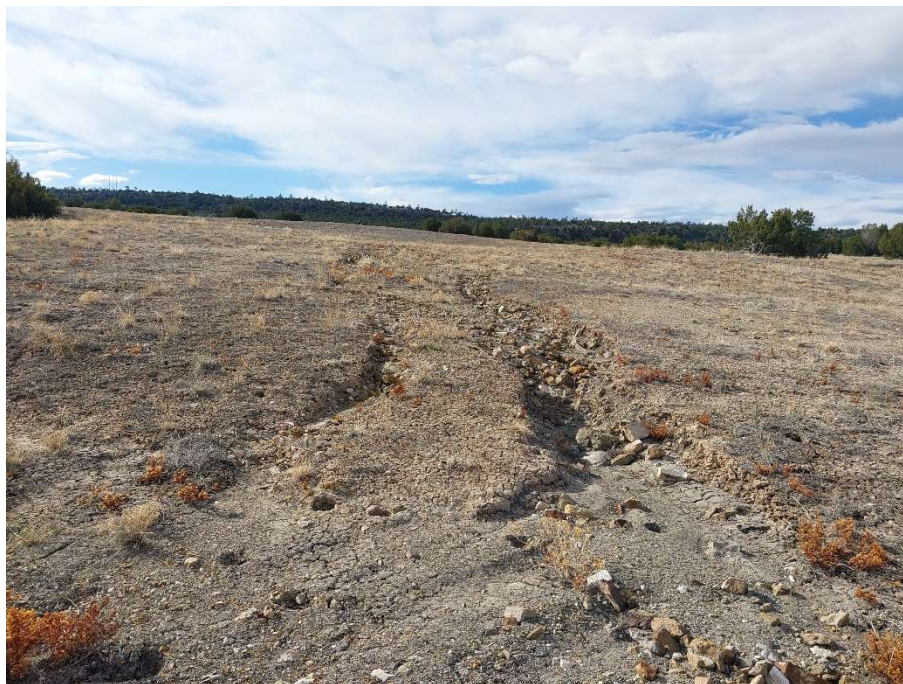
Photo #5: Terminating point of the erosion observed, built up sedimentation can be seen in the lower portion of the photo; view from the north downslope portion looking to the south.

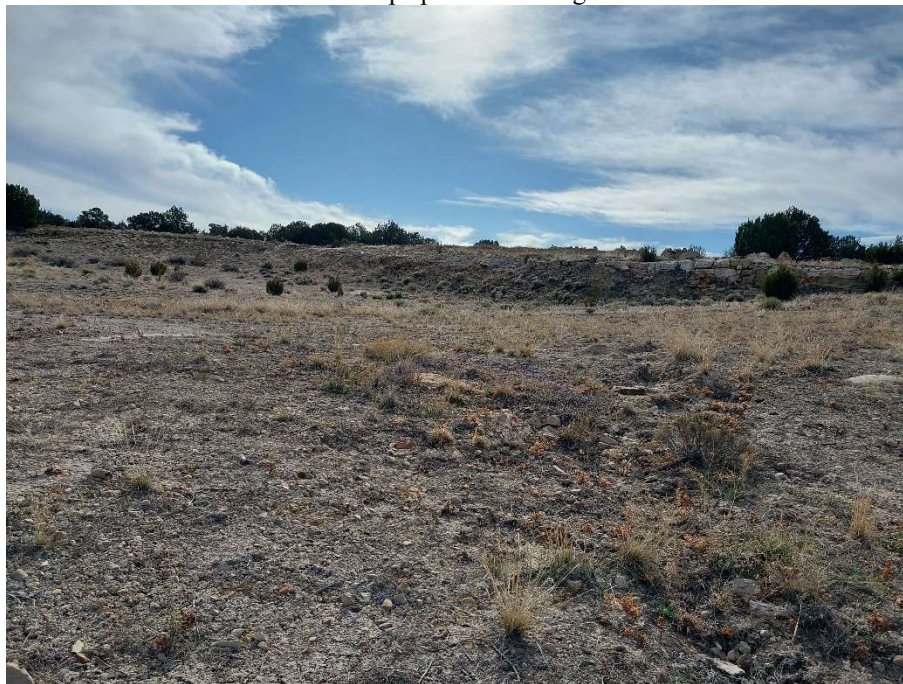
Photo #6: View of the approved highwall, photo taken from the north central portion of the permit area looking to the southeast.

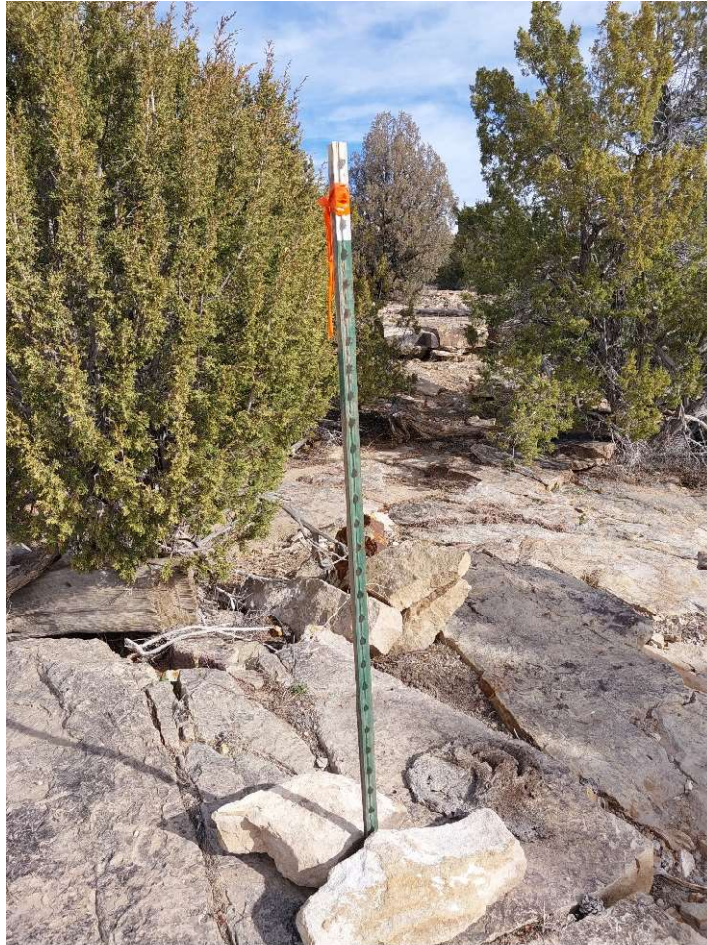
Photo #7: Permit boundary marker, eastern offset marker along the western boundary.

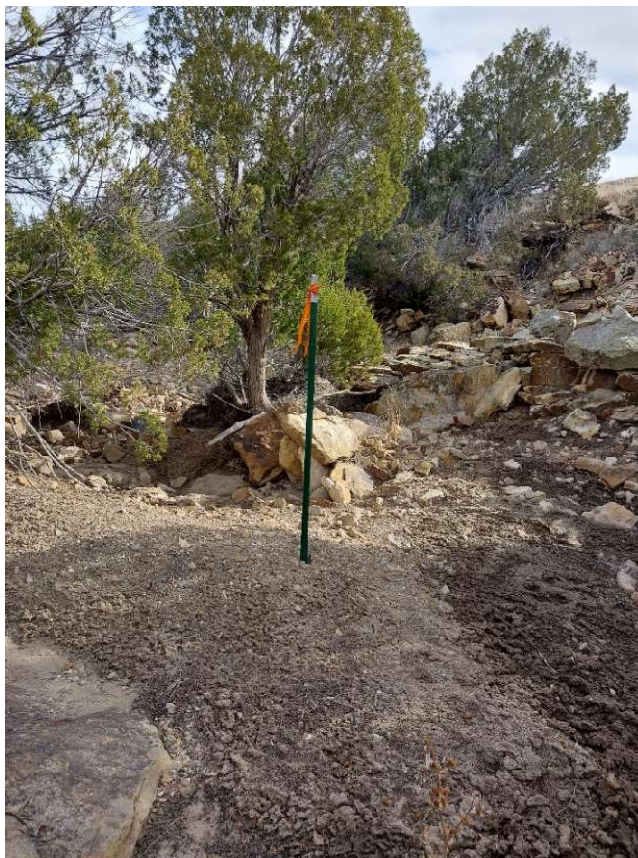
Photo #8: Permit boundary marker along the western boundary offset marker along the western boundary.

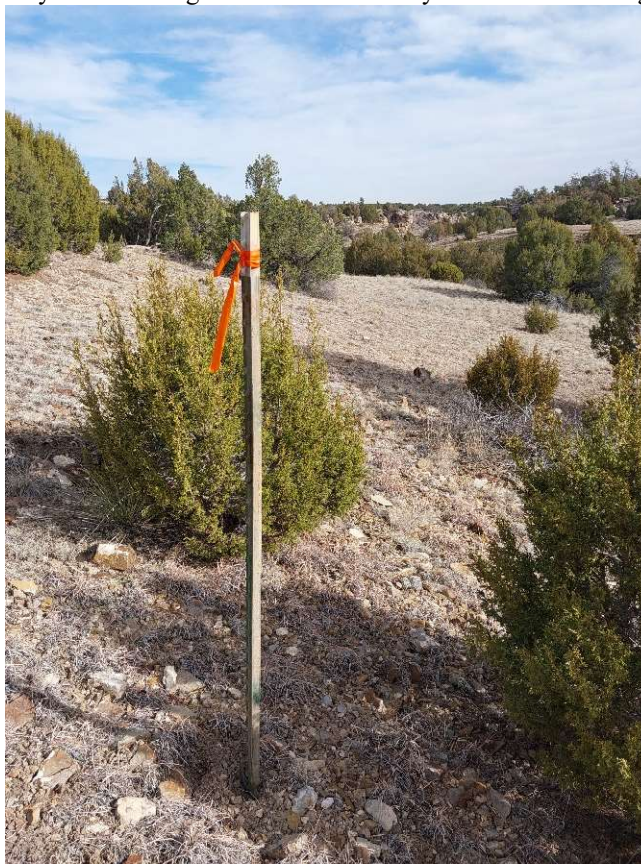
Photo #9: Permit boundary markers, northwestern corner.

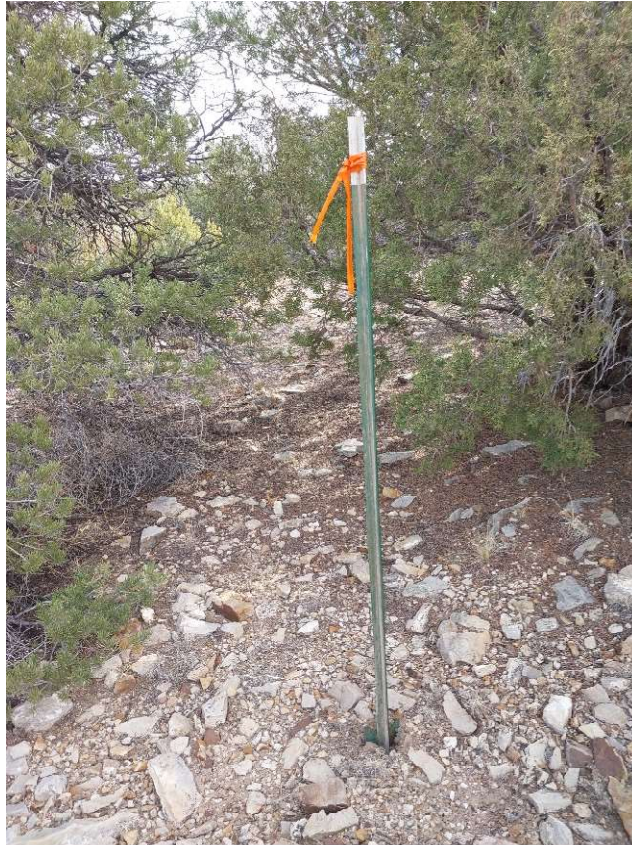
Photo #10: Permit boundary marker, northeastern corner.

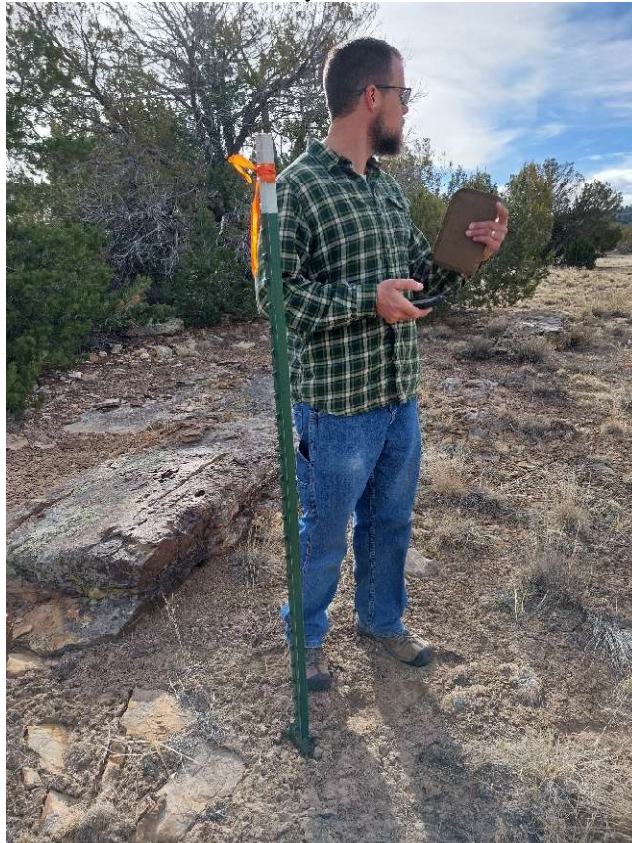
Photo #11: Permit boundary marker, east corner of the offset along east boundary. Jared Ebert is standing next to the marker, verifying the coordinates.

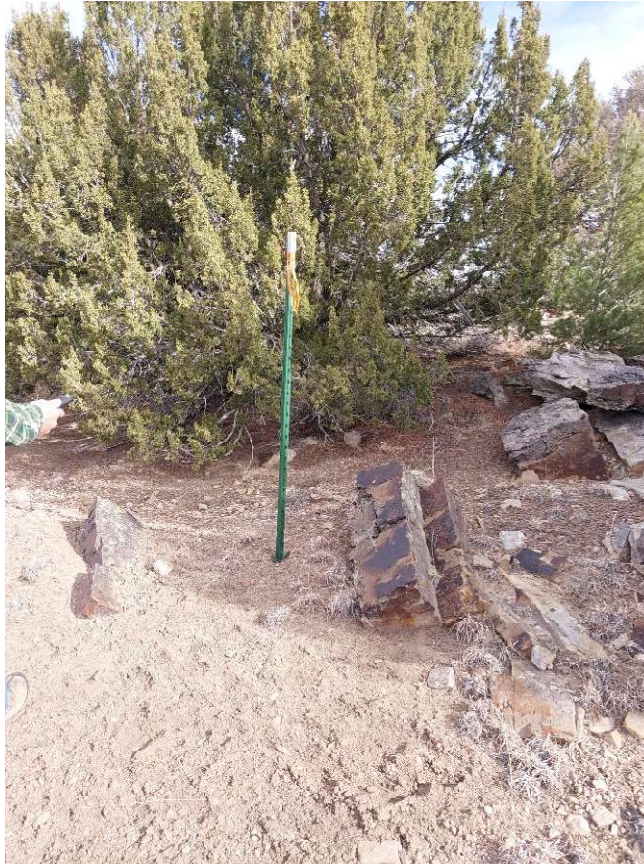
Photo #12: Permit boundary marker, west corner of the offset along the eastern boundary.

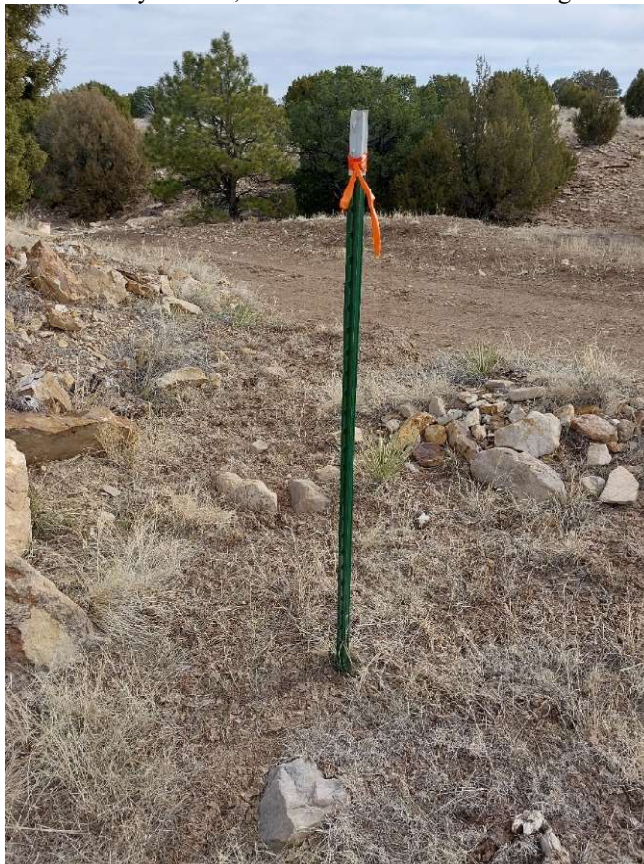
Photo #13: Permit boundary marker, southeast corner of permit.

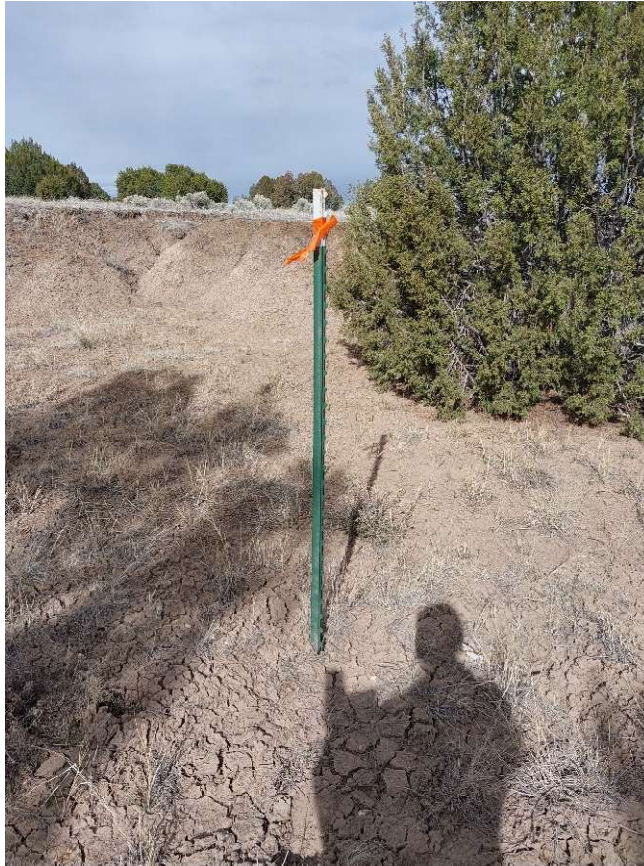
Photo #14: Permit boundary marker, southwest corner of permit.
