**MINERALS PROGRAM INSPECTION REPORT**  
**PHONE: (303) 866-3567**

<b>MINE NAME:</b> Thorson Mine	<b>MINE/PROSPECTING ID#:</b> M-1981-020	<b>MINERAL:</b> Anhydrite, gypsum	<b>COUNTY:</b> Fremont
<b>INSPECTION TYPE:</b> Surety-Related Inspection	<b>WEATHER:</b> Clear	<b>INSP. DATE:</b> March 21, 2024	<b>INSP. TIME:</b> 10:00
<b>OPERATOR:</b> Indian Springs Ranch, LLP	<b>OPERATOR REPRESENTATIVE:</b> Ina Finch	<b>TYPE OF OPERATION:</b> 110c - Construction Limited Impact	
<b>REASON FOR INSPECTION:</b> Surety Related	<b>BOND CALCULATION TYPE:</b> Complete Bond	<b>BOND AMOUNT:</b> \$2,500.00	
<b>DATE OF COMPLAINT:</b> NA	<b>POST INSP. CONTACTS:</b> None	<b>JOINT INSP. AGENCY:</b> None	
<b>INSPECTOR(S):</b> Hunter Ridley	<b>INSPECTOR'S SIGNATURE:</b>

# Thorson Mine M-1981-020

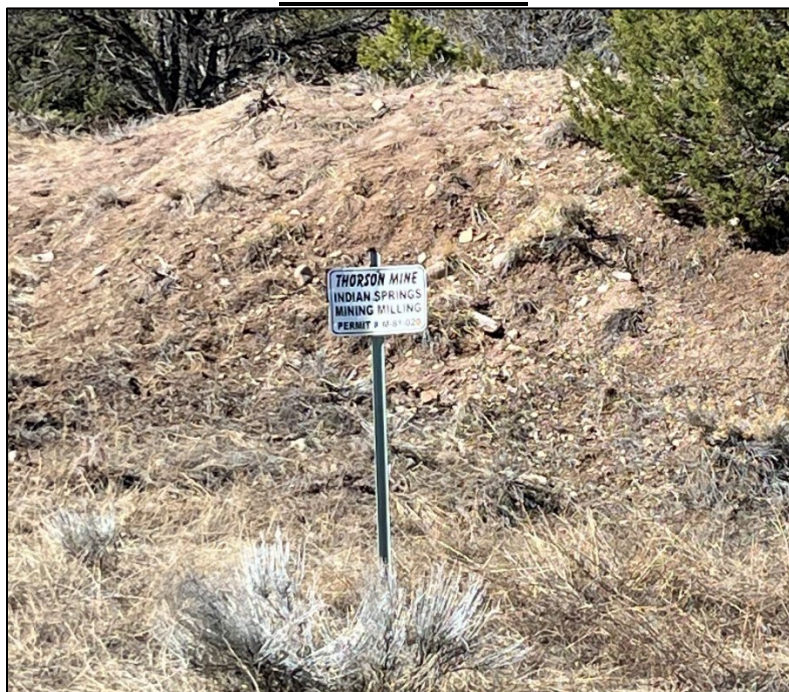
**Signs and Markers:** The permit sign was properly posted (Photo 1) and boundary markers were observed to be in place along the permit boundary, far from the current disturbance.

**Figure 1: Mine sign posted in accordance with Rule 3.1.12.**

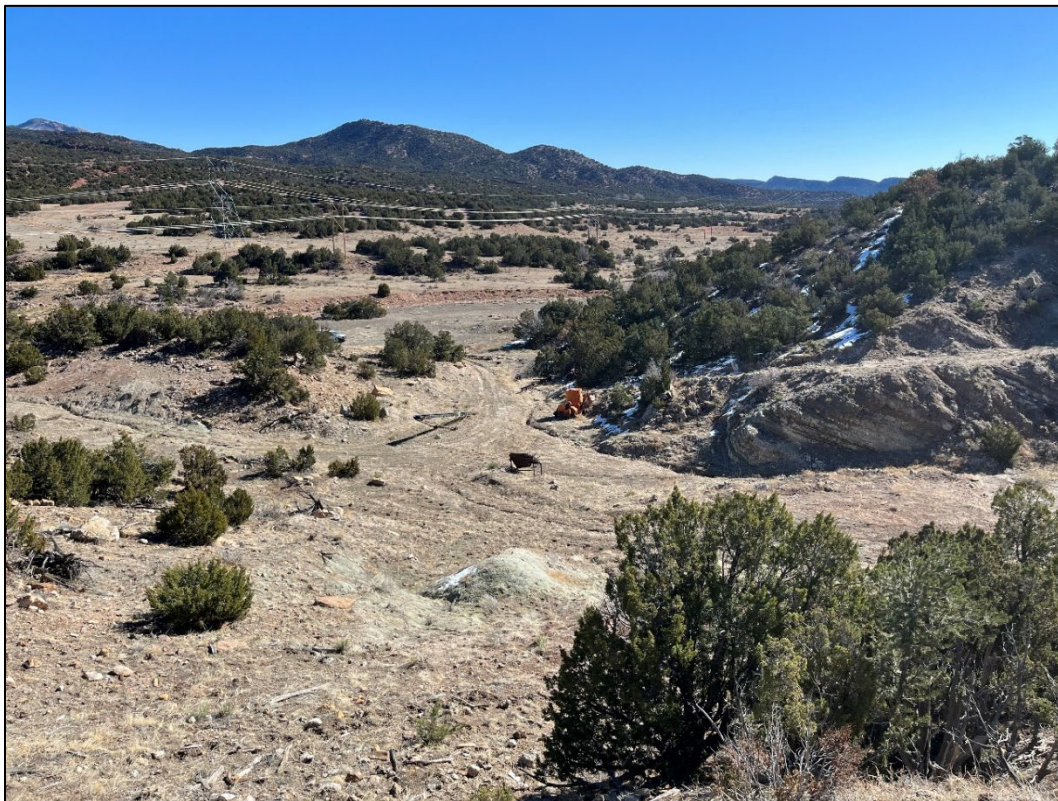
**Support Facilities On-site:** A screen and conveyor (Photo 2) were observed on site.

**Figure 2: View east of disturbed area from above slope, a screen and conveyor are visible below.**

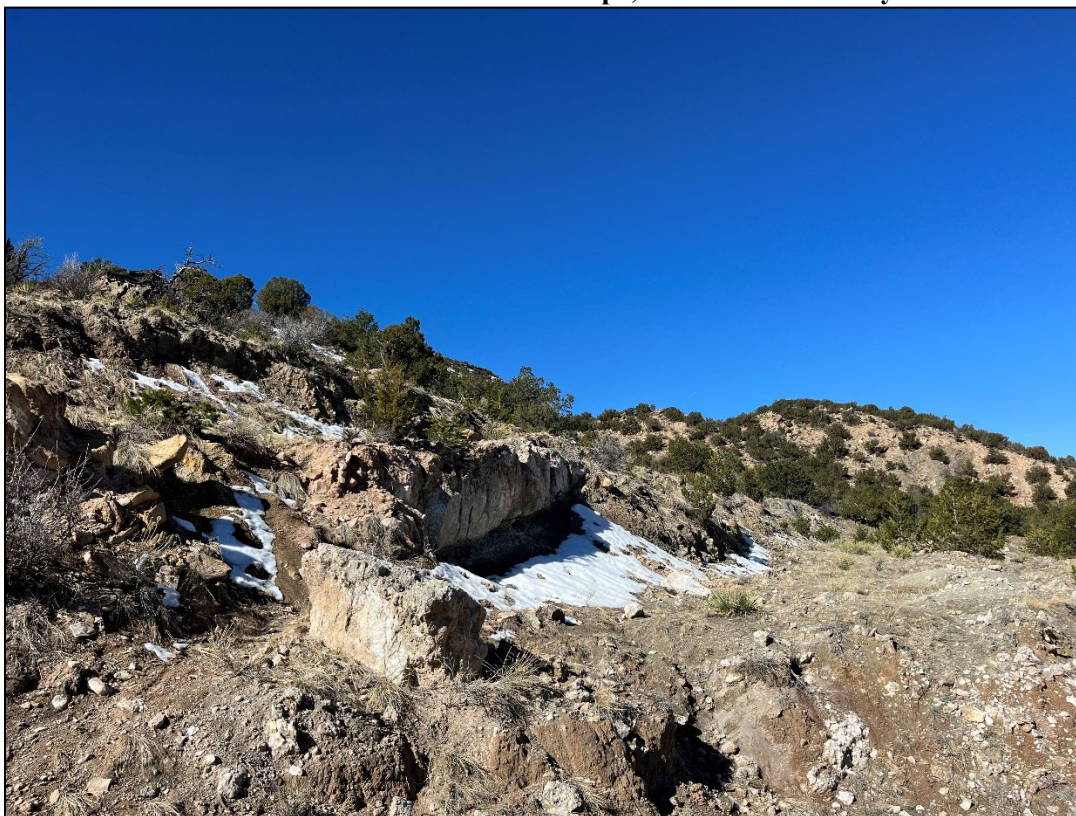
**Gen. Compliance with Mine Plan:** The operation appeared to be in compliance with the approved mine plan. Observed benches are estimated between 8 and 10 feet high (Photos 3 and 4). The approved mine plan states benches can be no higher than 20 ft. In final reclamation, slopes will vary from 2H:1V to 4H:1V, with multi-bench safety berms that allow for a final 1H:1V to 2H:1 slope, which blends into the hillside above the quarry. The maximum allowed disturbed area is 9.8 acres. Google Earth was used to measure the disturbed area, which was estimated to be ~ 0.5 acres, based on 2019 imagery.

**Figure 3: View west of mined slope and existing benches.**

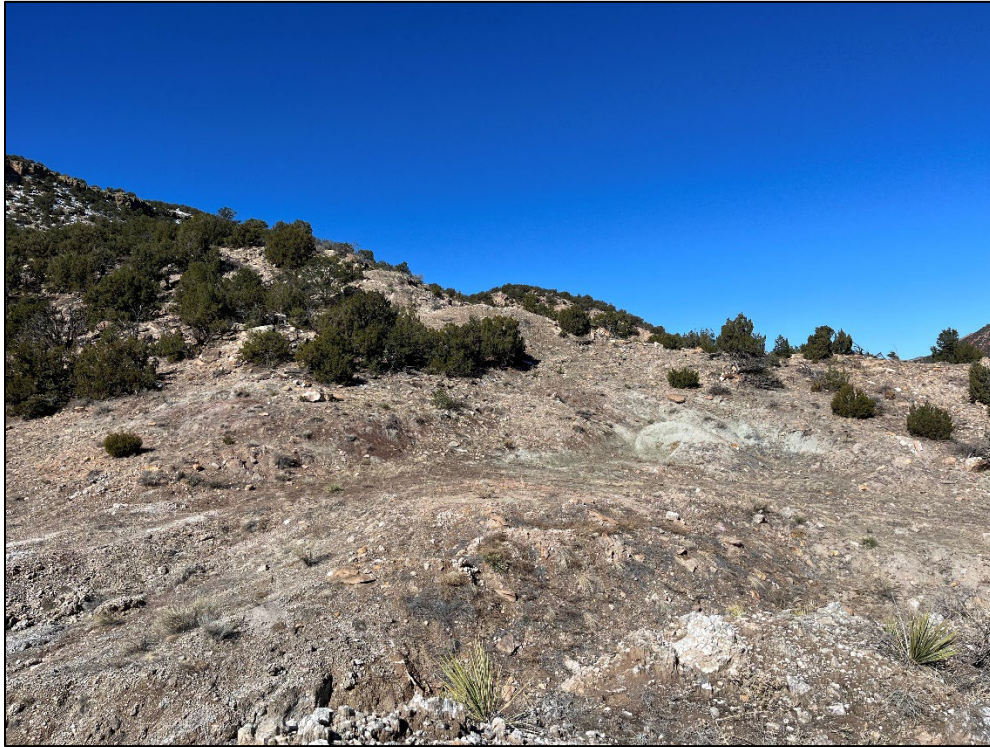
**Backfilling and Grading:** Sufficient backfill material appeared to be available as there is ample room to push material down to fill the few benches. The Operator stated a small pile of bentonite could also be used to fill in slopes (Photo 4).

**Figure 4: View of existing benches and a small pile of bentonite, considered overburden in this landscape.**

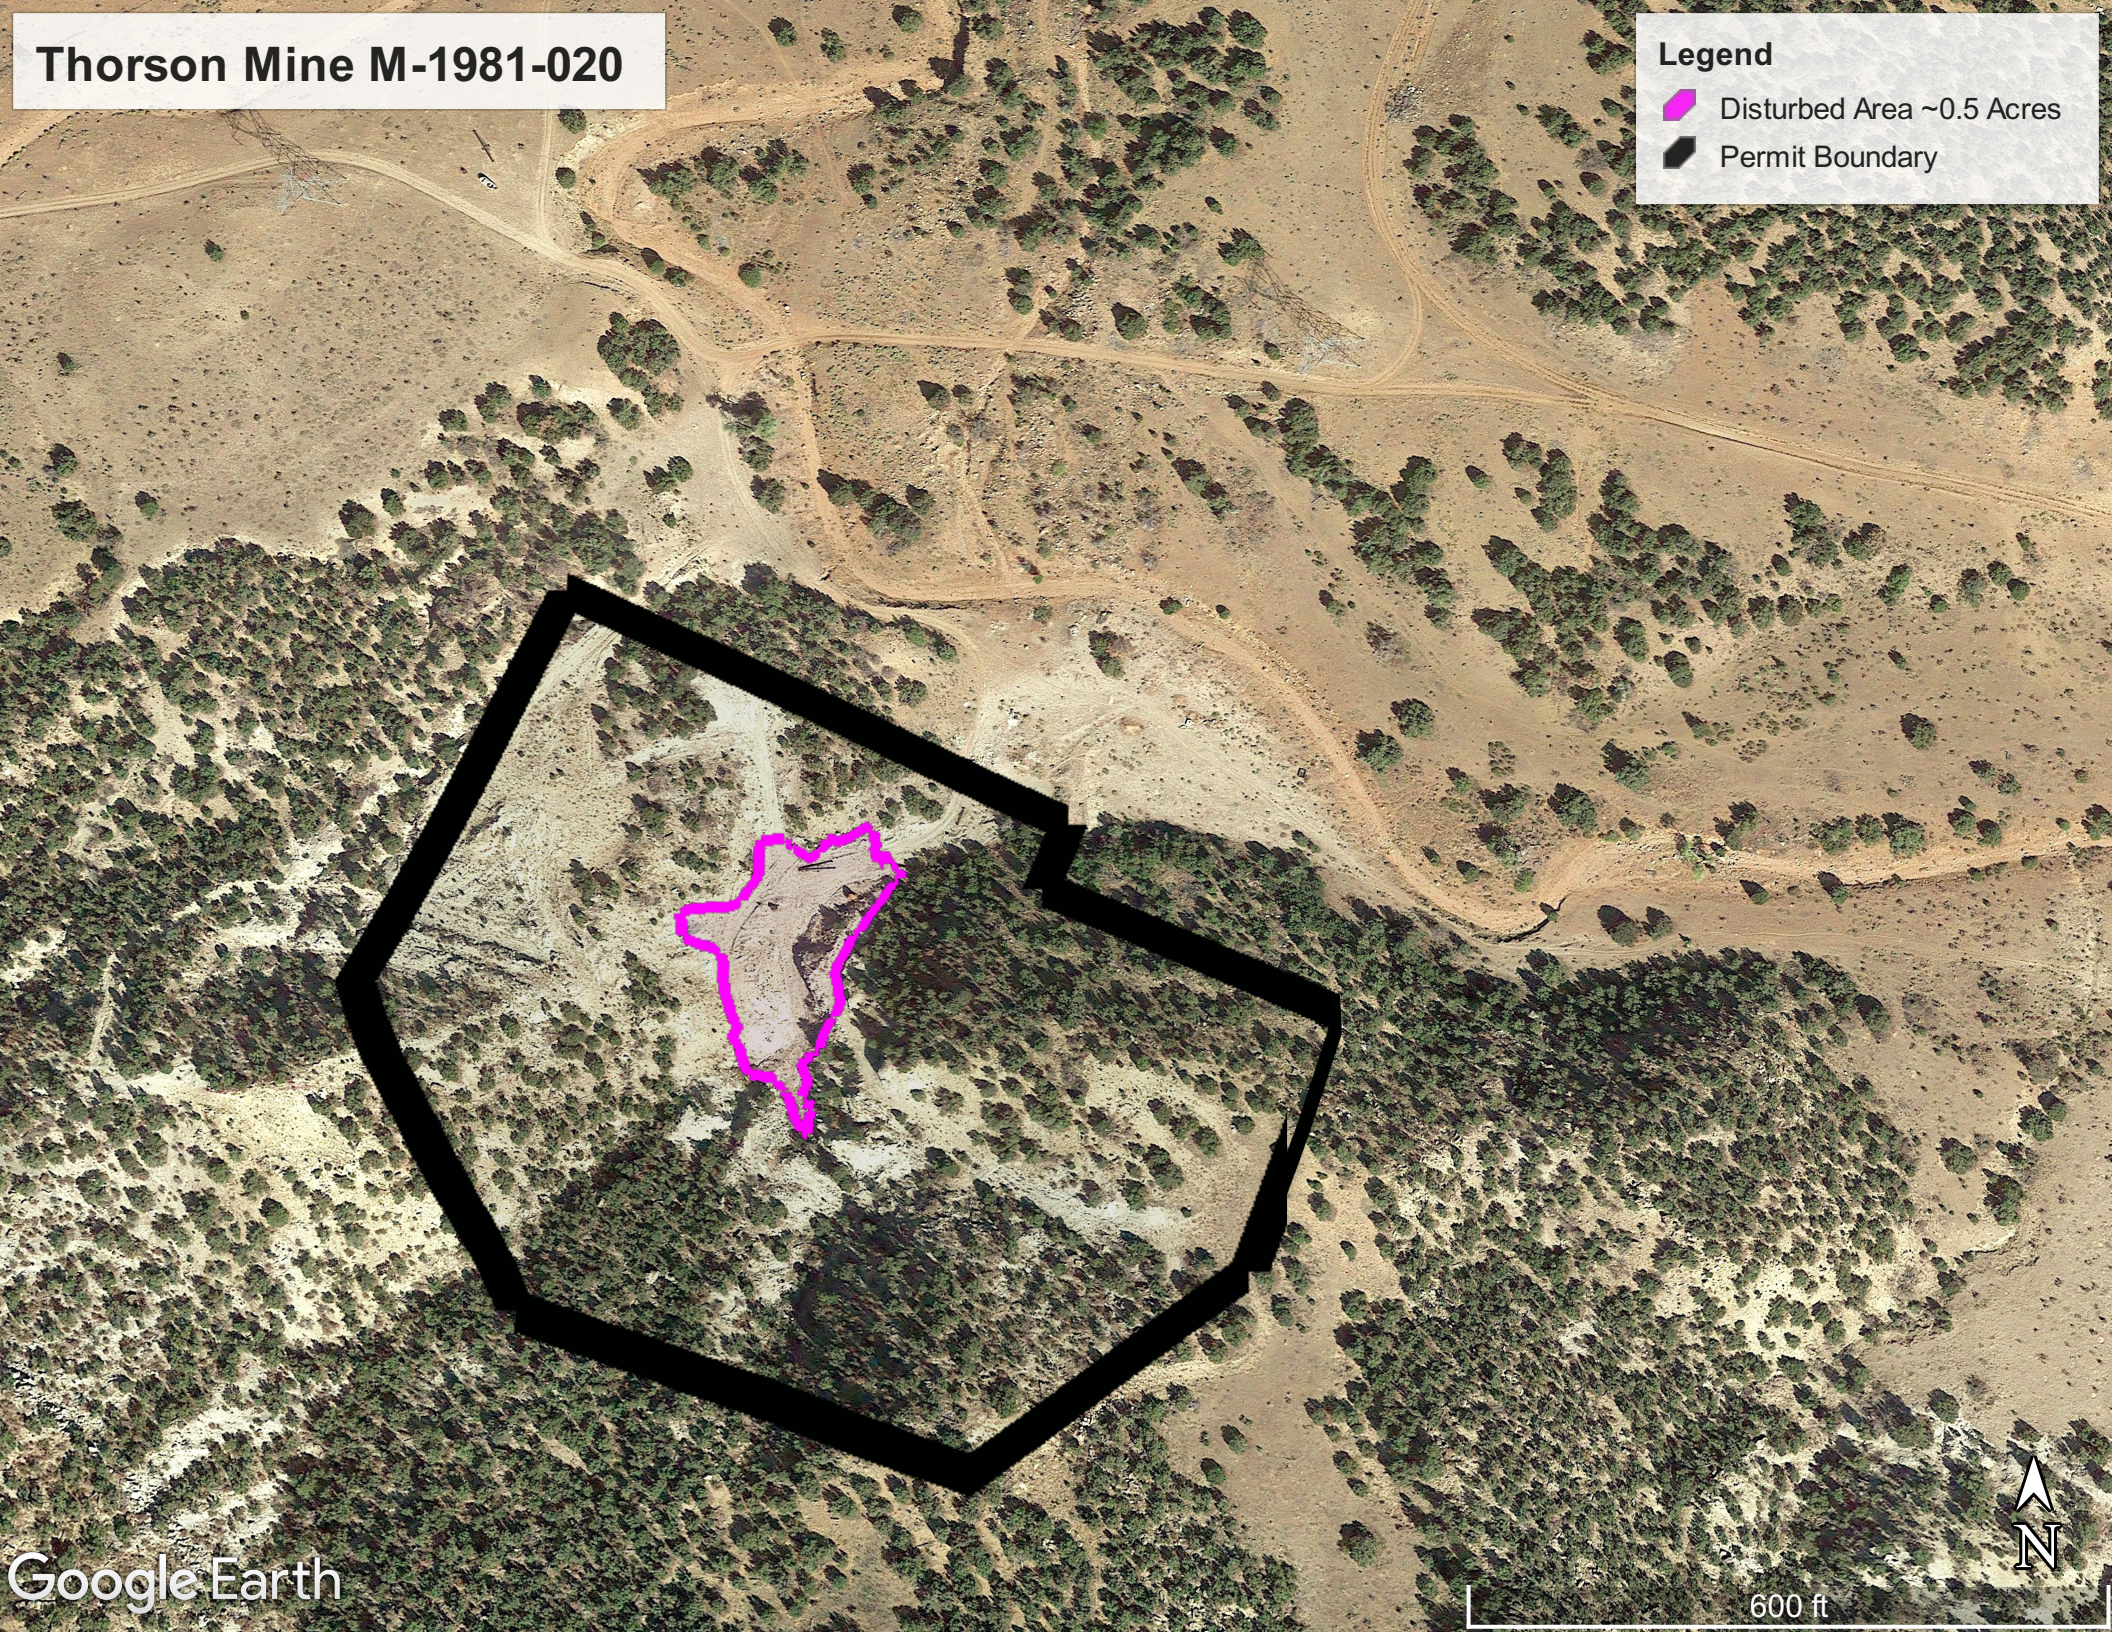
Disturbed Area ~0.5 Acres
