Newmont Mining Corporation
 Cripple Creek & Victor Gold Mine
 Liner Repair CQA
 NewFields Job No. 475.0106.068
 Week Ending Friday, March 22, 2024

FIELD WEEKLY PROGRESS REPORT

PROJECT: VLF2 PHASE 3 STAGE A.1 LINER REPAIR
SITE: CRIPPLE CREEK & VICTOR GOLD MINE (COLORADO)
CONTRACTOR: NEWMONT CC&V MINING OPERATIONS
 JHL CONSTRUCTORS
WEEK ENDING: FRIDAY, MARCH 22, 2024

REPORTING PERIOD: 03.16.2024 THROUGH 03.22.2024

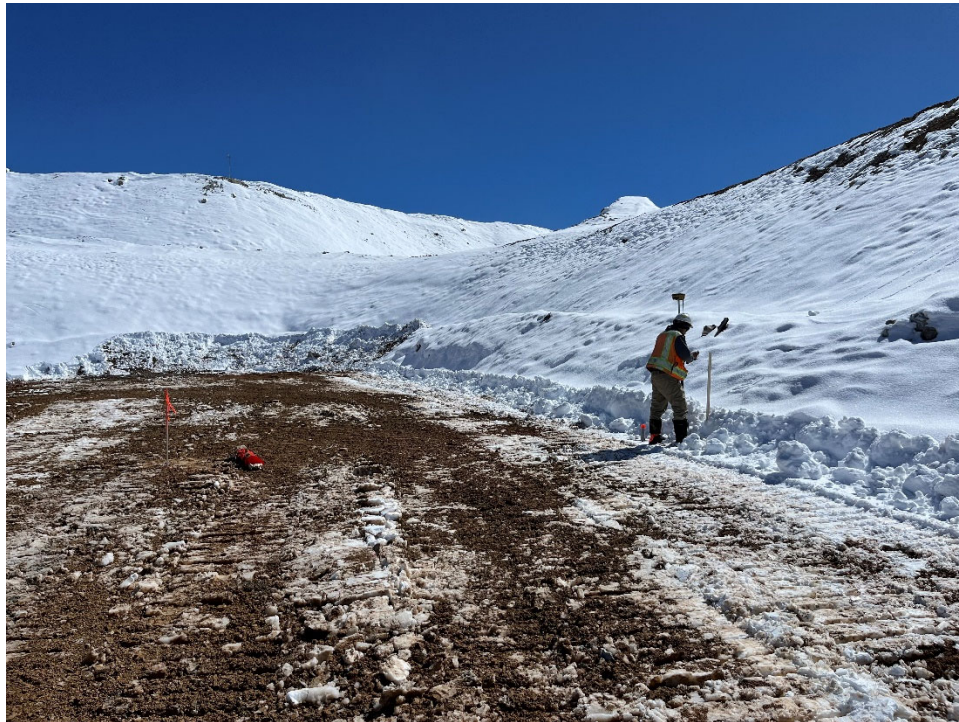
March 18, 2024 – Foresight West Survey Support.

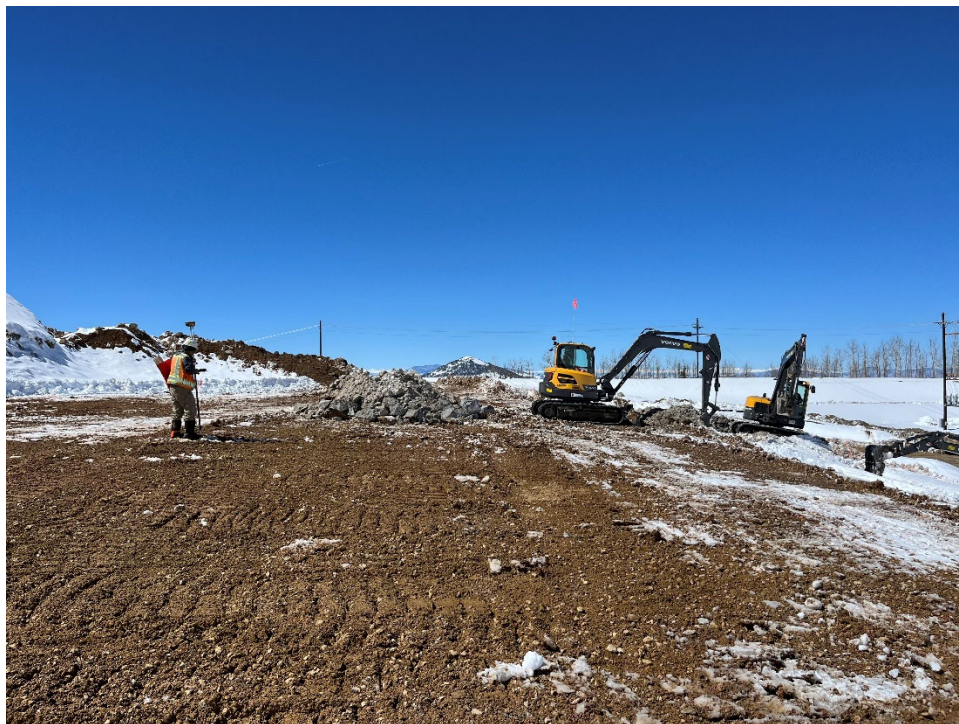
March 19, 2024 – Removal of ROM material up 2:1 slope..

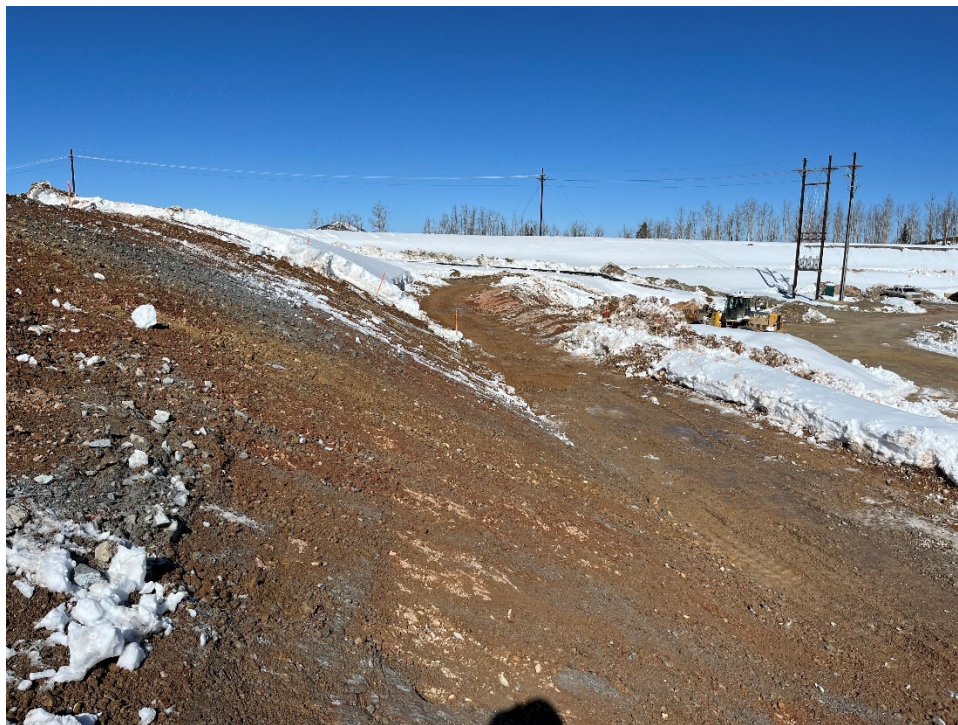
March 19, 2024 – Completion of Removal of ROM material on 2:1 slope.

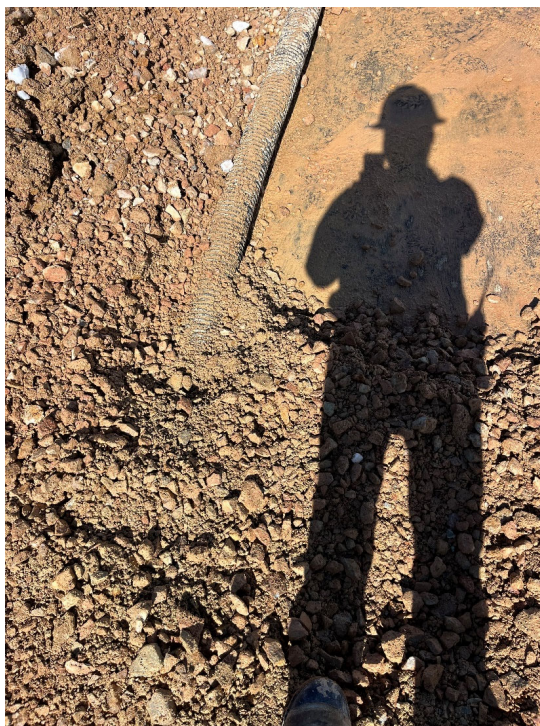
- No displacement of DCF material from previous stacking of ROM was noted during the excavation process.
- The High-Volume Solution Collection piping system was determined to be in-tact and had not crushed or shifted during ROM placement. Damage occurred during the excavation of the DCF.

March 20, 2024 – HVSC 4 inch CPeP Perforated Pipe After Excavation.

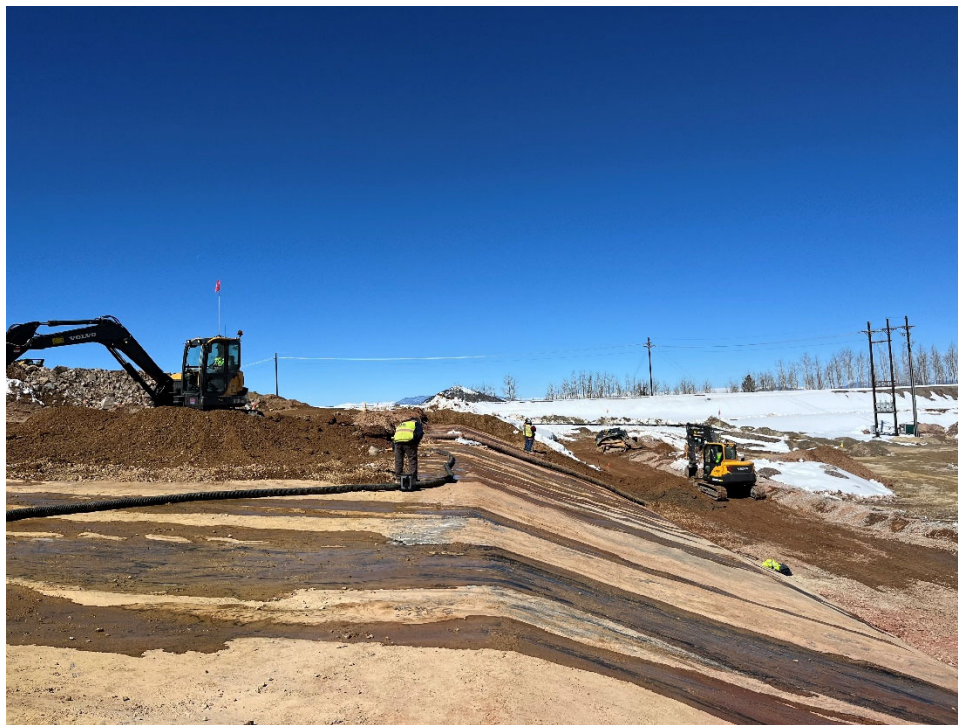
- The geomembrane surface showed no significant signs of movement or strain from the ROM placement once exposed.
- Any geomembrane damage created by the excavation of the DCF layer was marked and covered by sand bags to prevent meteoric water from contacting and damaging the Soil Liner Fill (SLF) surface.

March 21, 2024 – Exposed Geomembrane Surface on 2:1 Slope.

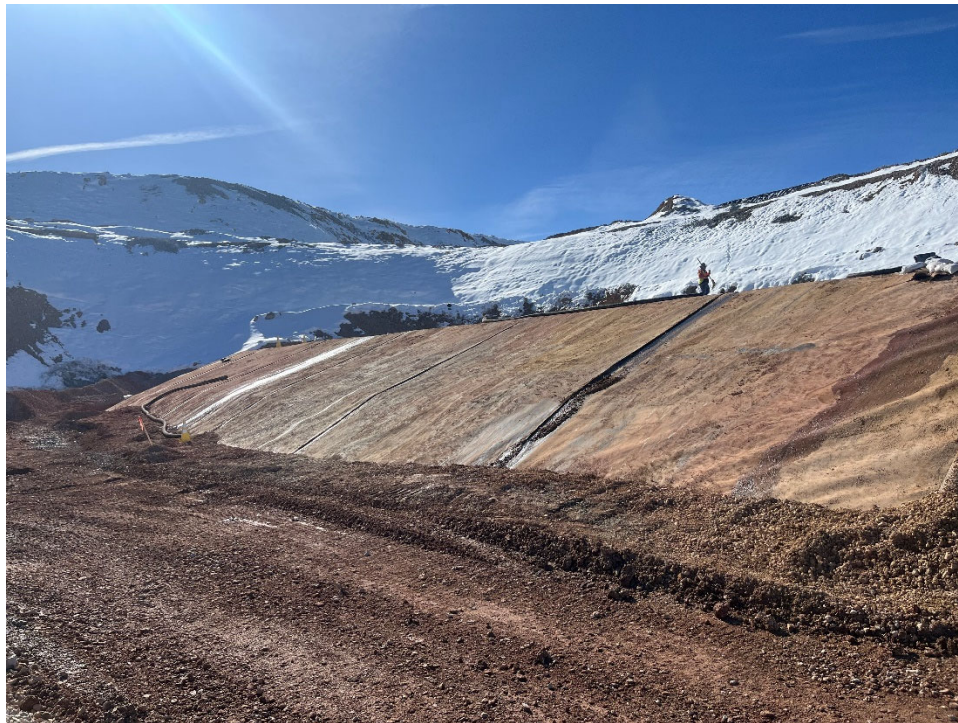
March 22, 2024 – Exposed Geomembrane Surface on 2:1 Slope.
