LOGAN WASH MINE ANNUAL REPORT

Mine Permit No. M-1977-424
Anniversary Date: March 28, 2024

Glenn Springs Holdings, Inc.
5 Greenway Plaza, Suite 110
Houston, TX 77046

Western Water & Land, Inc.
743 Horizon Court, Suite 330
Grand Junction, CO 81506

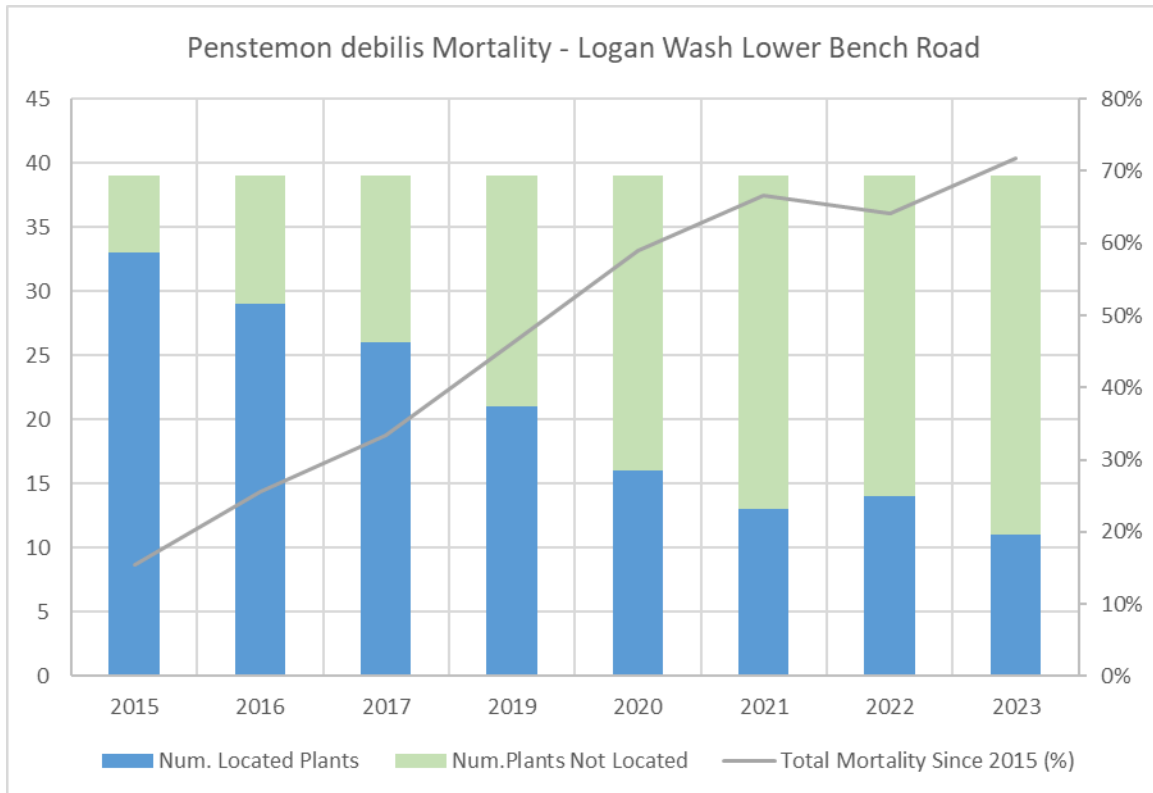
transplanted *P. debilis* indicate a current mortality rate of approximately 72 percent. The chart below shows the mortality rate for each year since transplanting in 2015. No mortality rate was measured in 2018, but casual observations indicate that overall plant numbers have decreased, both in the transplanted plants and new volunteer plants in the area on and immediately adjacent to the Lower Bench Access Road.
