### REQUEST FOR TECHNICAL REVISION (TR) COVER SHEET

File No.: M- 1980-110 Site Name: Henderson Development

Technical Revision  
M-1980-110  
Henderson Development (Sandy Acres)  
March 2024

To: Derek Slack  
From: Tim Crawford and Austin Malotte  
Subject: E-470 – Sandy Acres Pit – Gravel Pit History, Shallow Alluvial Ground Water and Standing Water Condition Summary  
Job: 9607.00  
Date: March 28, 2024

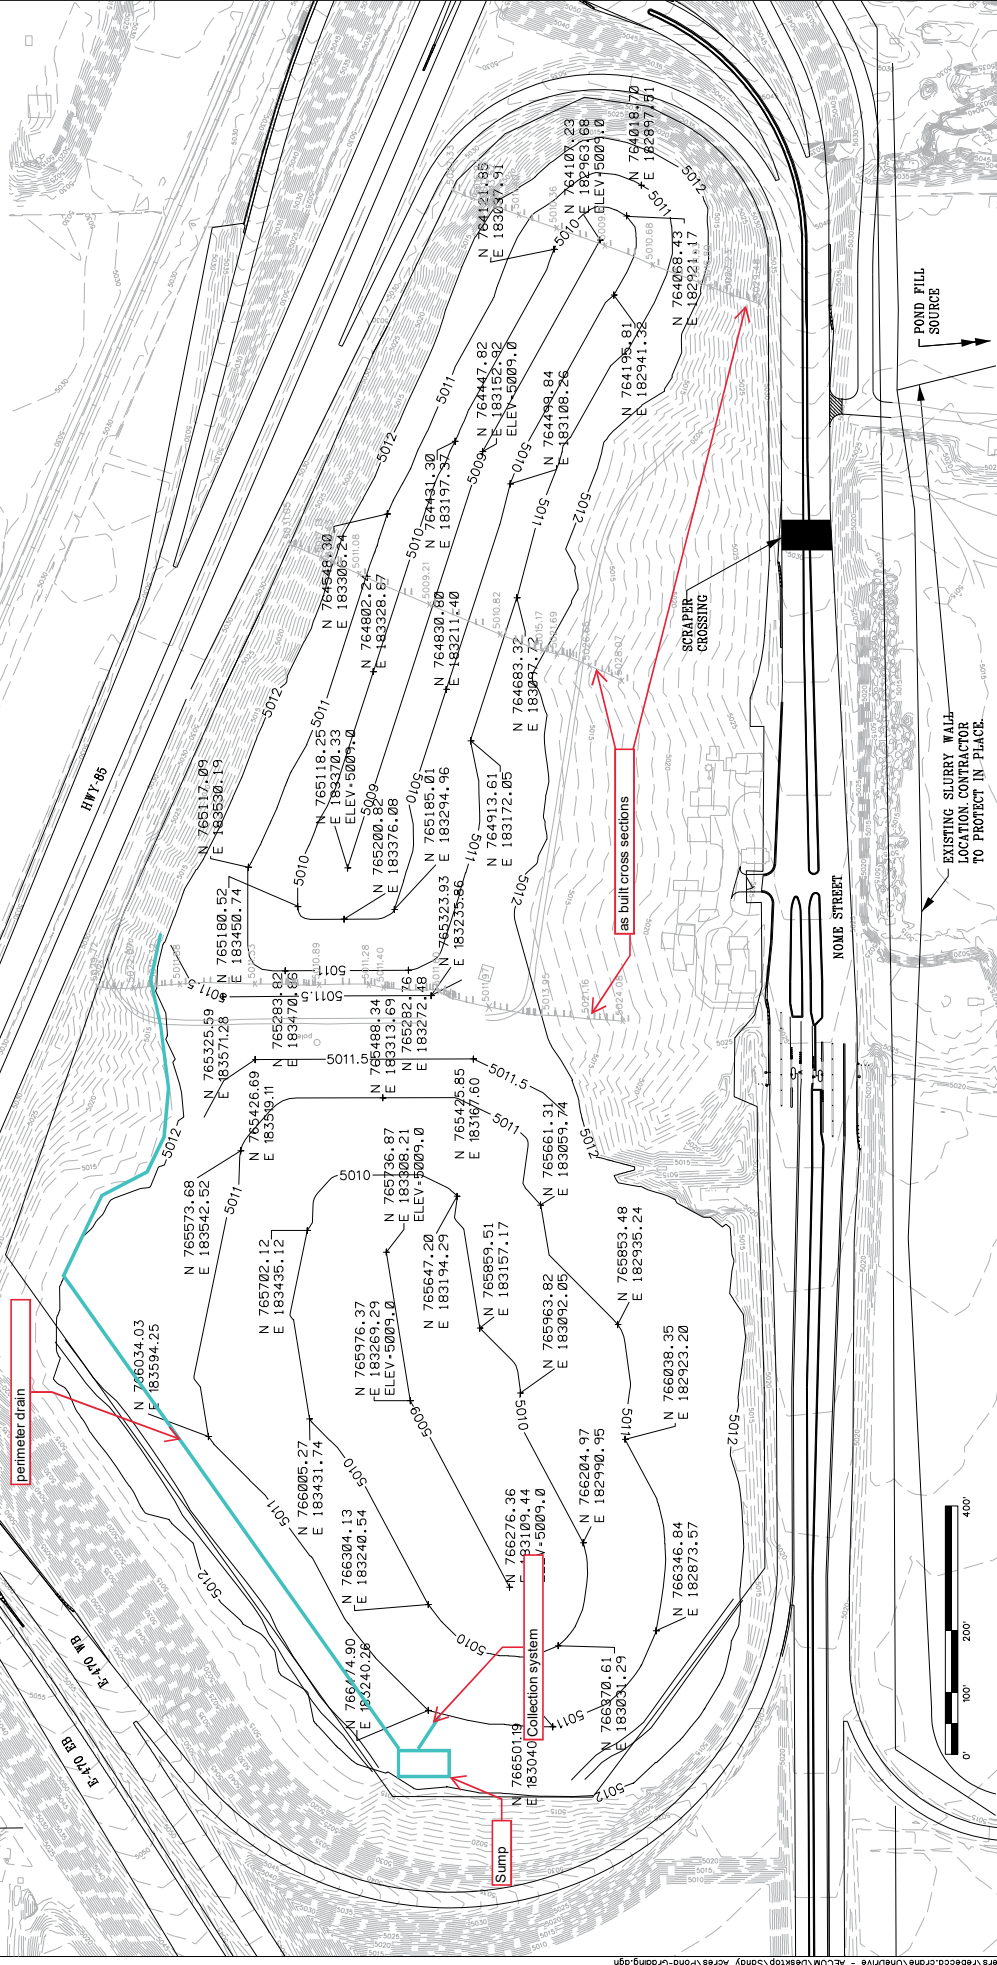
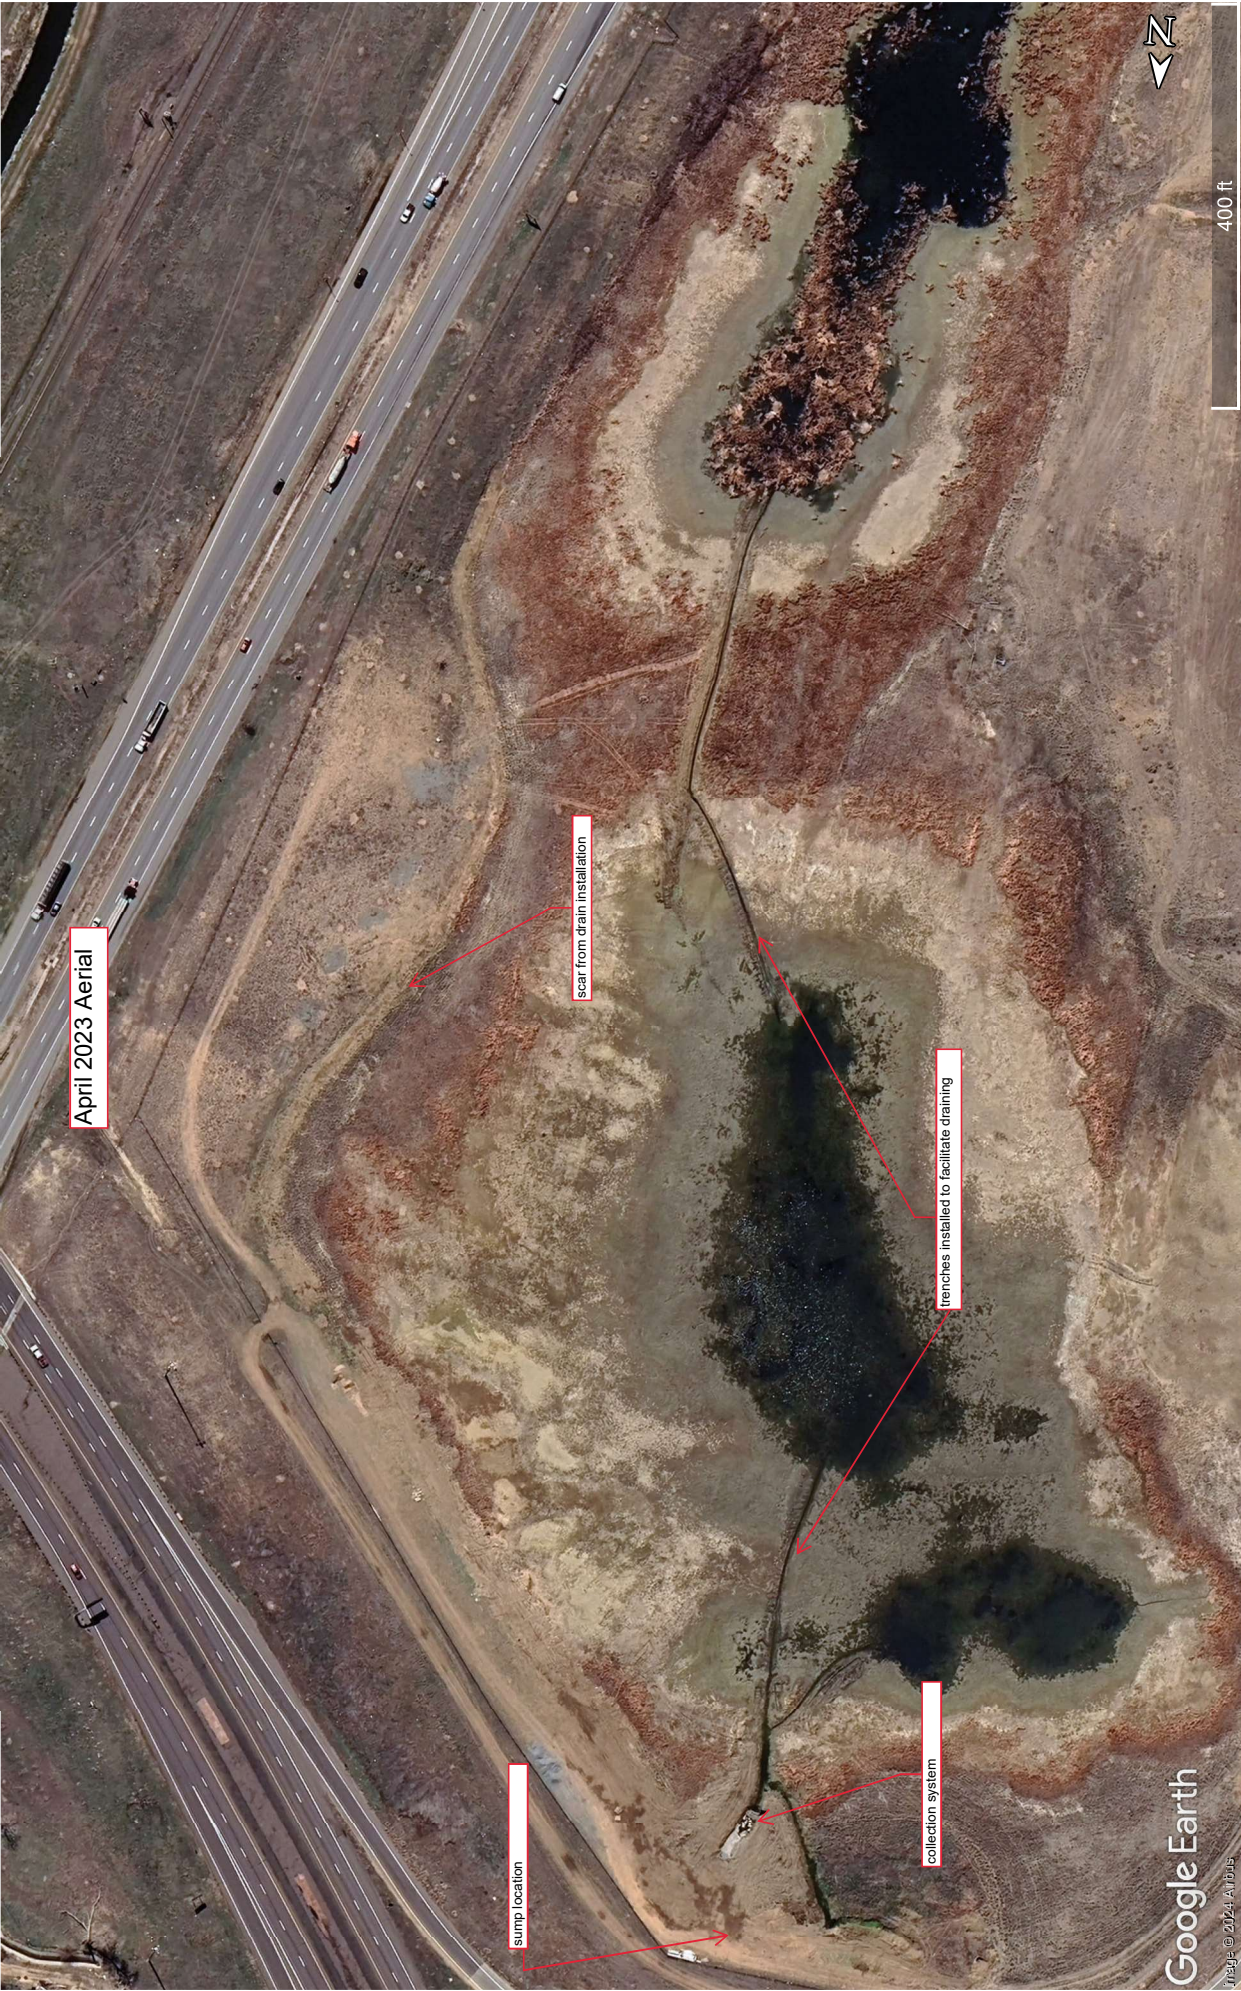
POND GRADING

2. Survey data/elevations for the pit backfill.
  - a. Please see two drawings in the pdf. One shows cross section elevations taken which are overlaid onto the design plan sheet. The second sheet is for reference which shows that the water elevation was at 5006.8 prior to backfilling the pond.

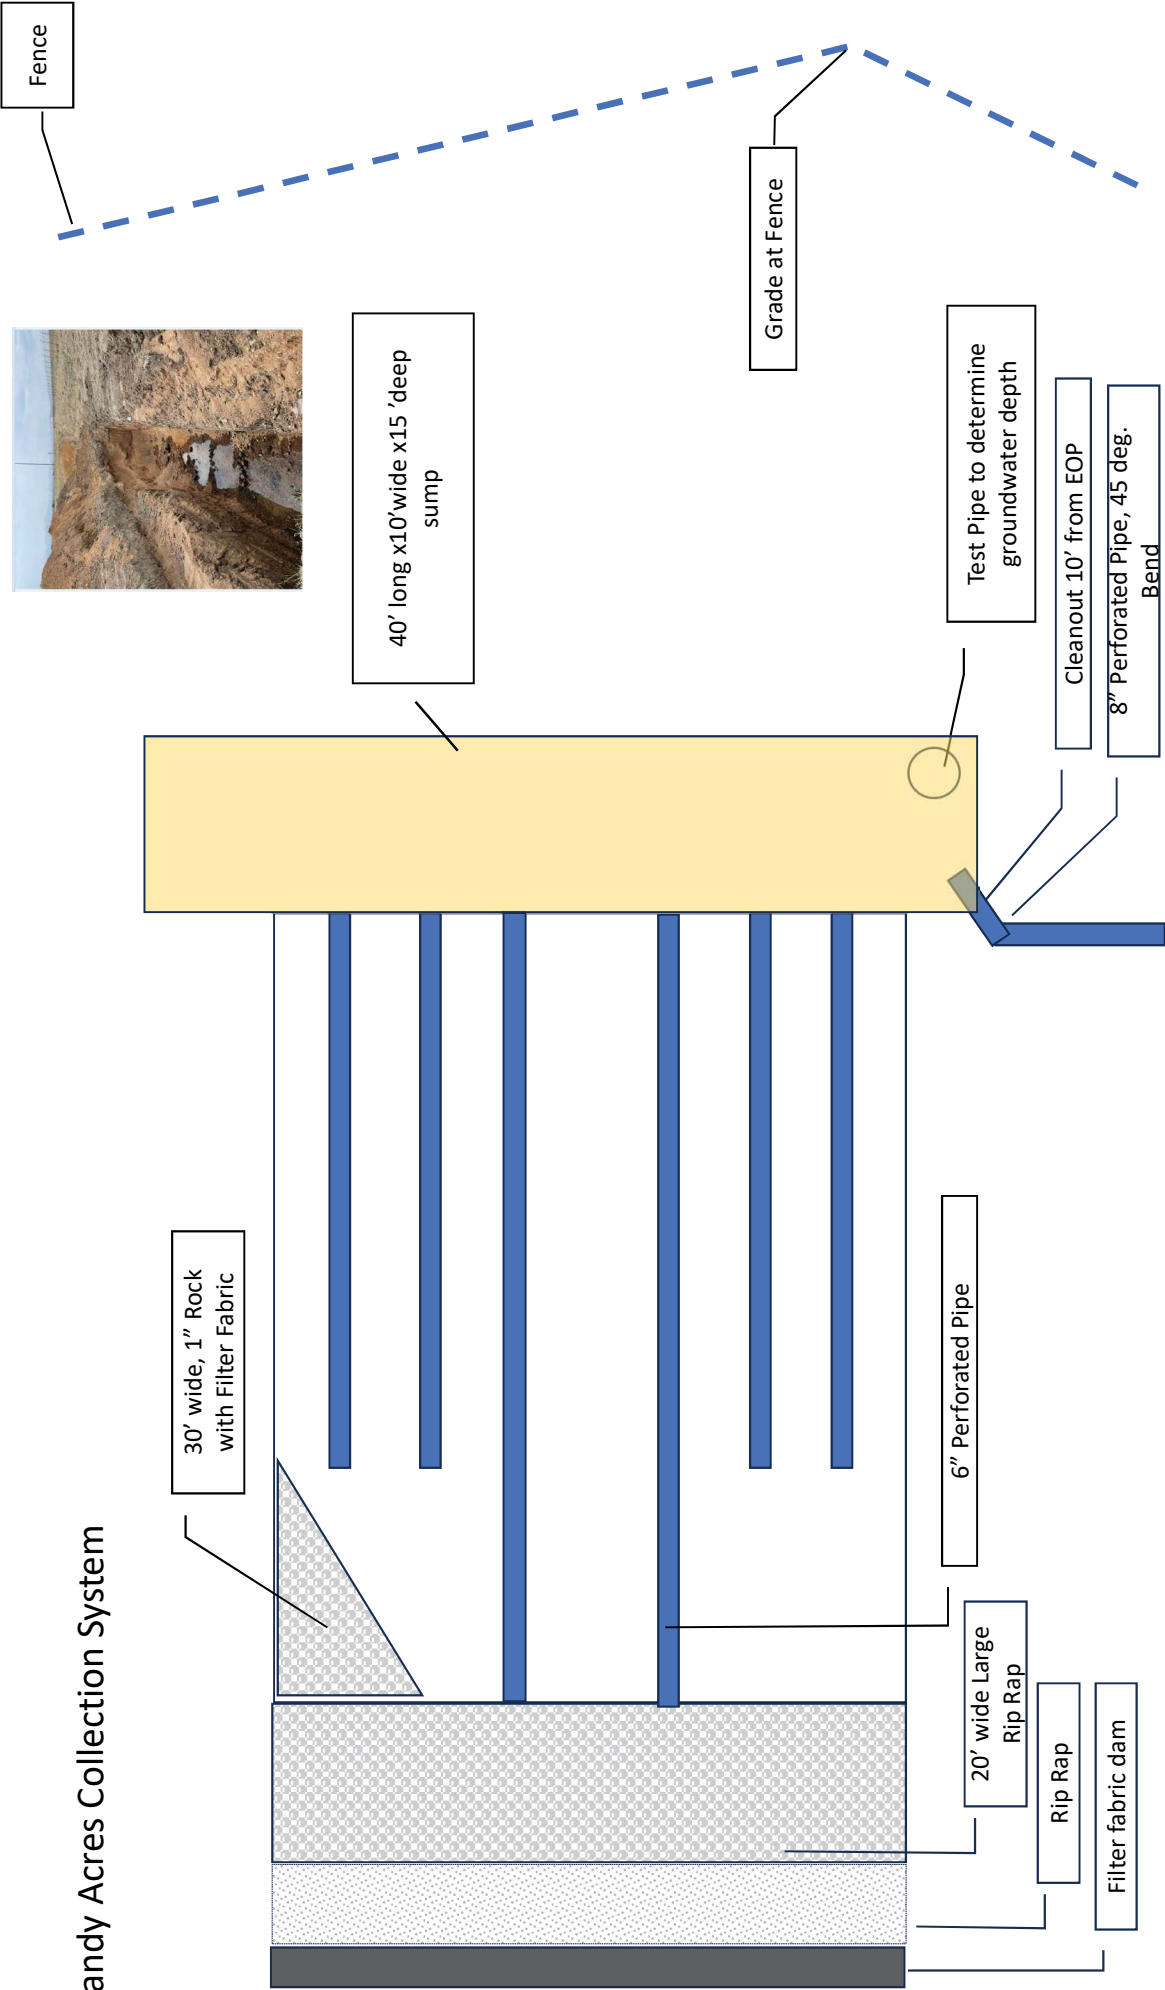
Sandy Acres Collection System

April 2023 Aerial

scar from drain installation

trenches installed to facilitate draining

collection system

sump location

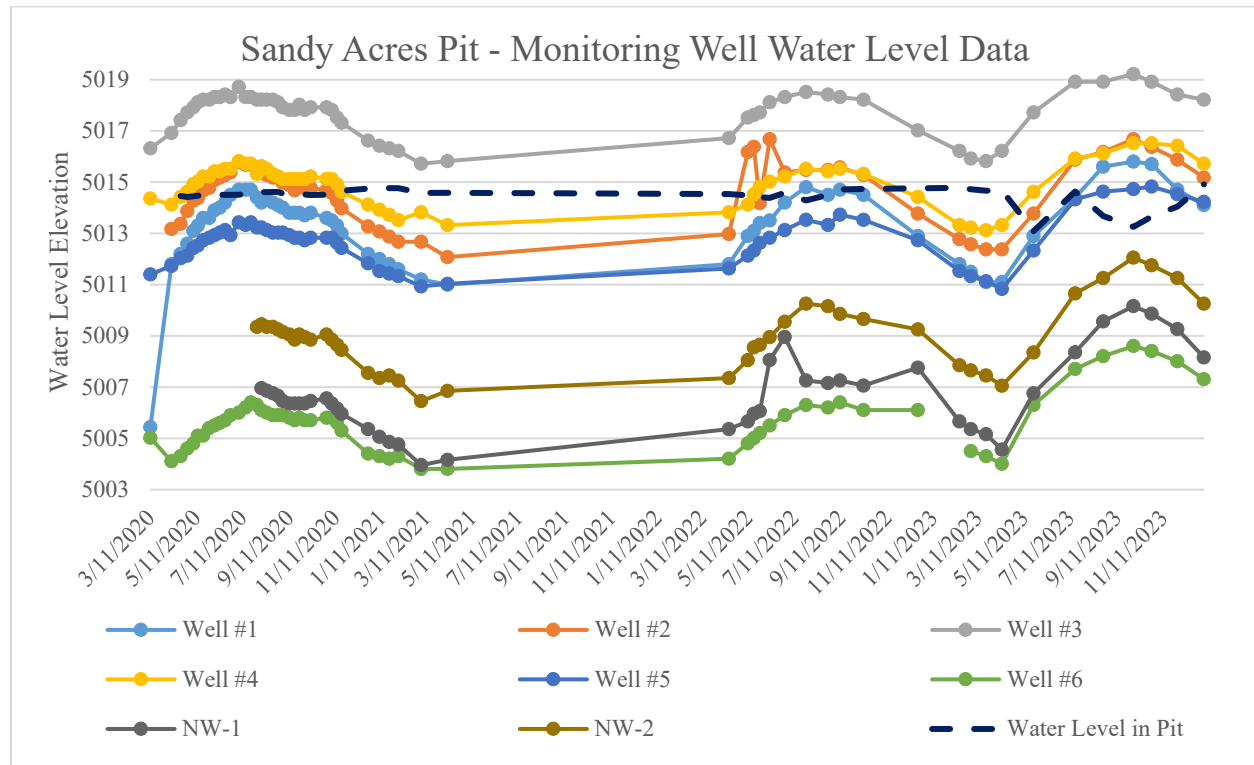
The water level data collected from the monitoring wells have been used to prepare hydrographs of water level elevations surrounding the pit along with the elevation of the water standing in the pit, as presented in the hydrograph below.

The water level data indicate ground water elevations surrounding the pit that range from 5003.8 to 5019.2 feet, a water table that fluctuates annually by up to approximately 5 feet annually and a general ground water gradient from the south/southeast (MW-3) to the north/northwest (MW-6).<sup>1</sup>

The hydrograph indicates that the water table elevations in the areas around MW-1, MW-2, MW-3, MW-4 and MW-5 are higher than the elevation of the water level in the pit during some portions (MW-1, MW-2, MW-4 and MW-5) or all (MW-3) of the year. This indicates that the water table surrounding the pit is higher than the pit in these areas and that South Platte River alluvial aquifer ground water is discharging to the pit in these areas at least at some portions of the year.

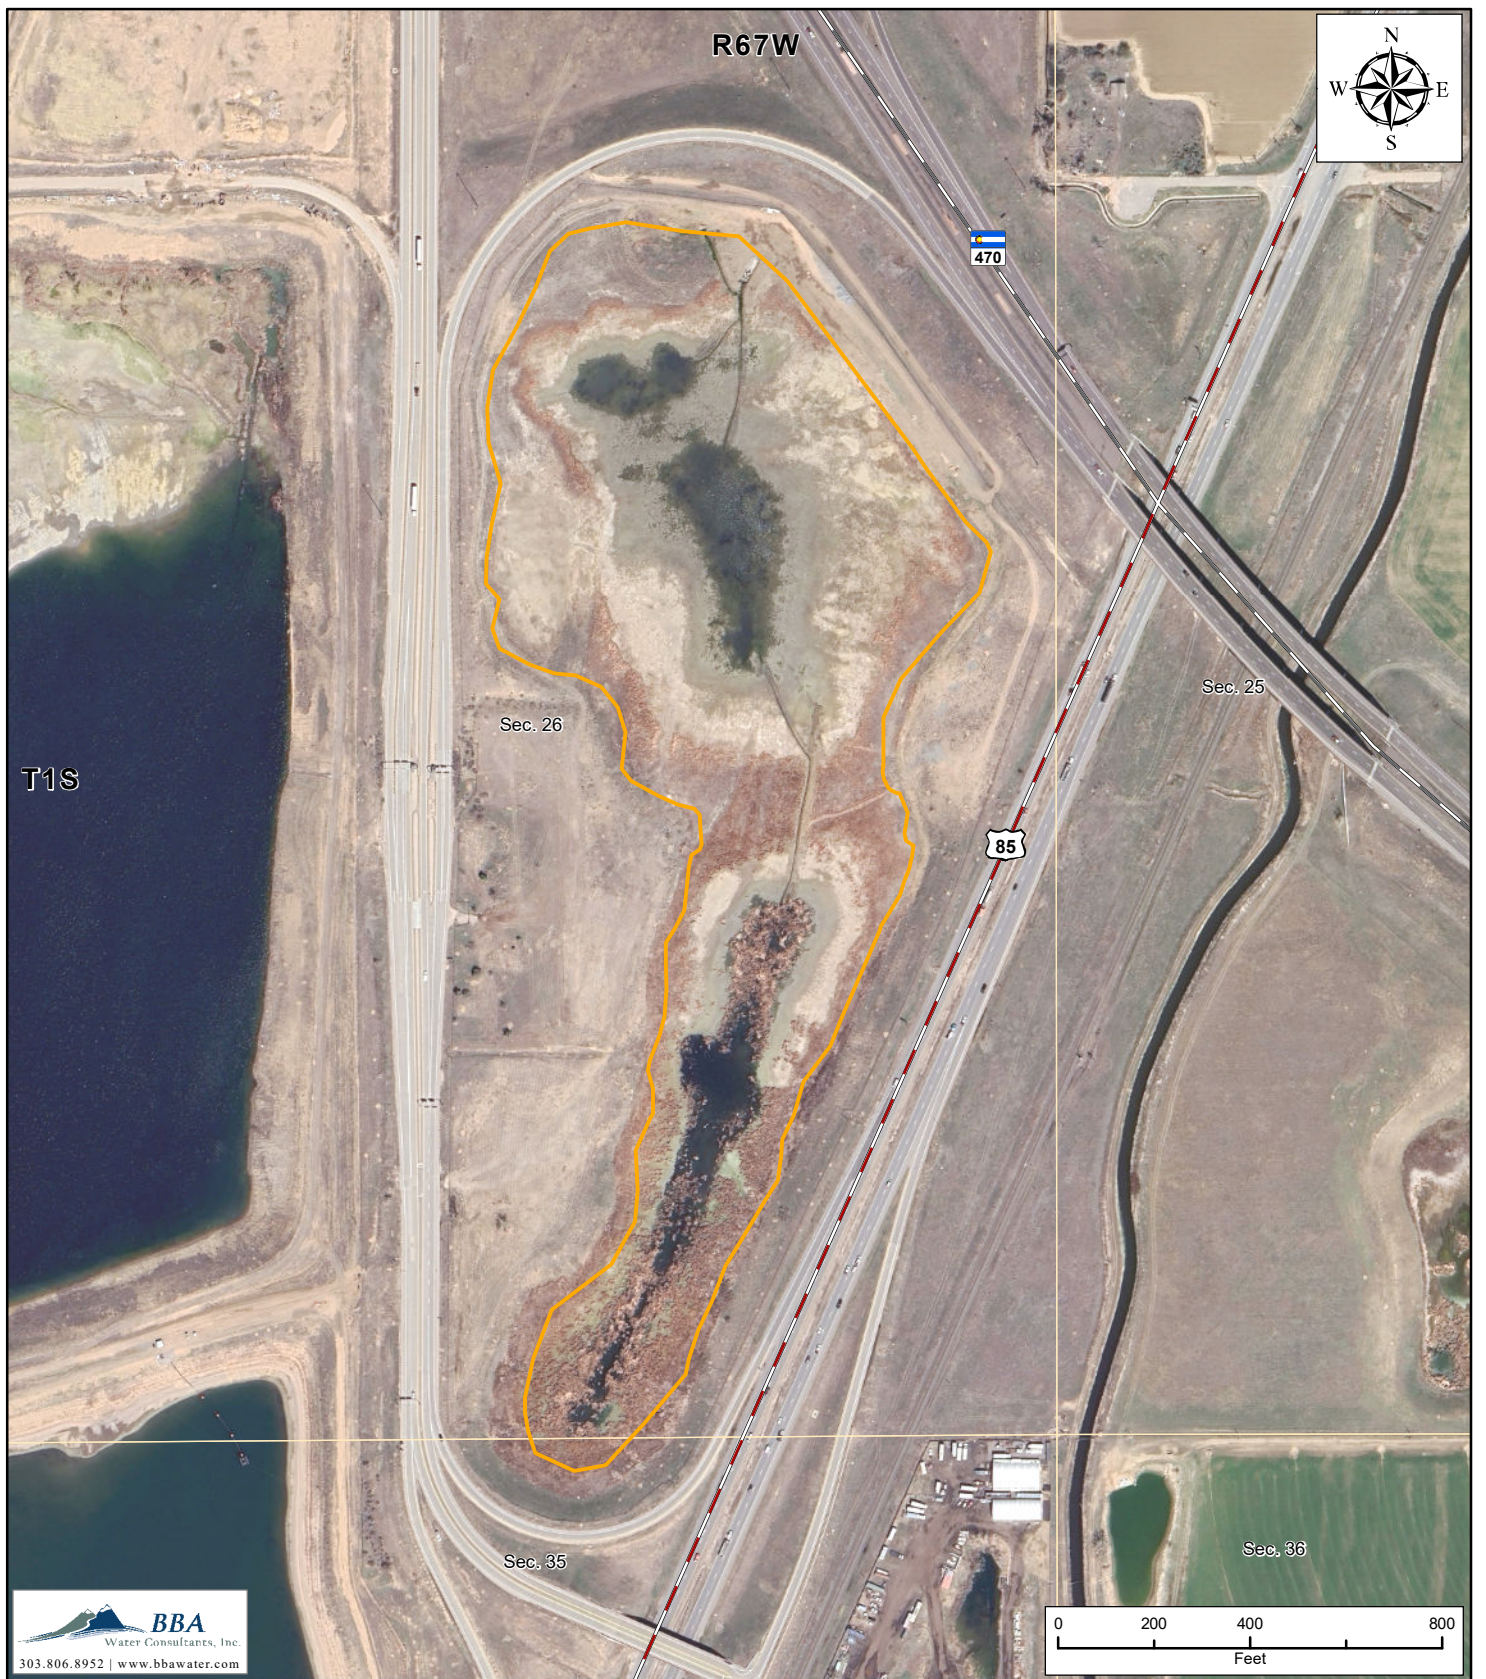
**Figure 7**  
**E-470 Sandy Acres Pit**  
**Aerial Photography 2023**

Aerial photography of the Sandy Acres Pit site generally confirms the history of the pit presented in the permit file. The photography confirms that by 1993, a southern gravel pit cell had been constructed and the mining of a second northern gravel pit cell had begun (Figure 2). Aerial photography confirms that the mining of the Sandy Acres Pit was completed by approximately 2001 (Figure 3). Standing water was observed in the pit in the available photography through this time and continued consistently until 2015 when E-470 began the backfilling project, discussed above (Figure 4). The aerial photography depicts the backfilling of the pond and confirms that no standing water was observed on top of the backfilled material in the pit during 2018 (Figure 5). By the end of the summer of 2019, however, aerial photography indicates standing water was again present in the bottom of the Sandy Acres Pit on top of the backfill material (Figure 6). Aerial photography from April of 2023, after the installation of the trenching and sump collection system, indicates a decrease in the amount of standing water in the pond (Figure 7).
