## QUARTERLY SEDIMENTATION POND INSPECTION REPORT

Mine: Lorencito

Inspection Period: First Quarter 2024

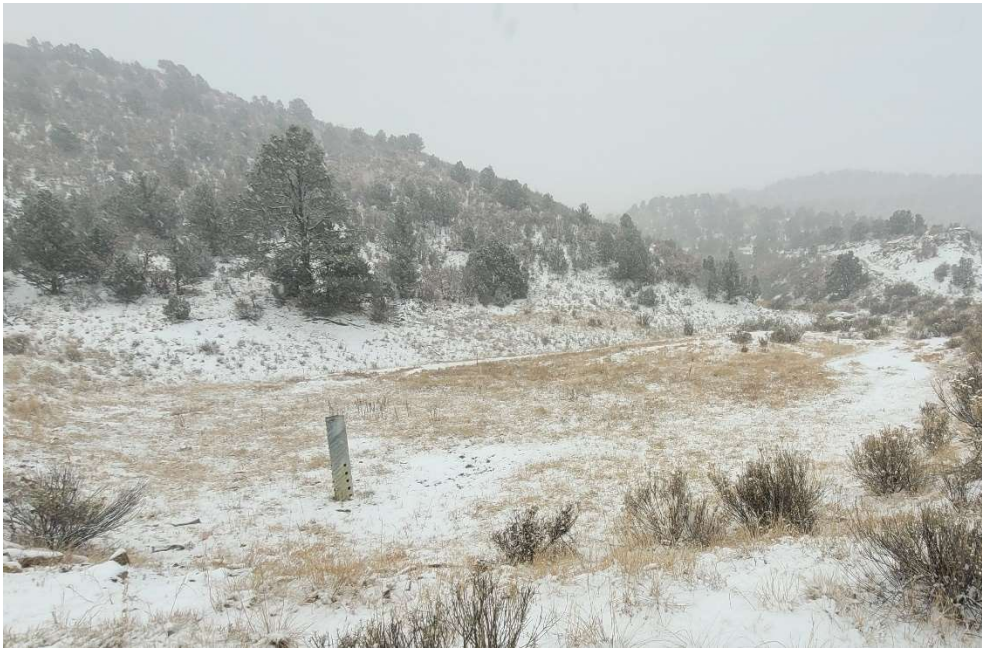
NPDES ID. No.: Pond #5

Explain: Sediment in pond does not appear to be over capacity by visual inspection.

Pond was empty at time of inspection. Ground Covered in Snow during inspection.

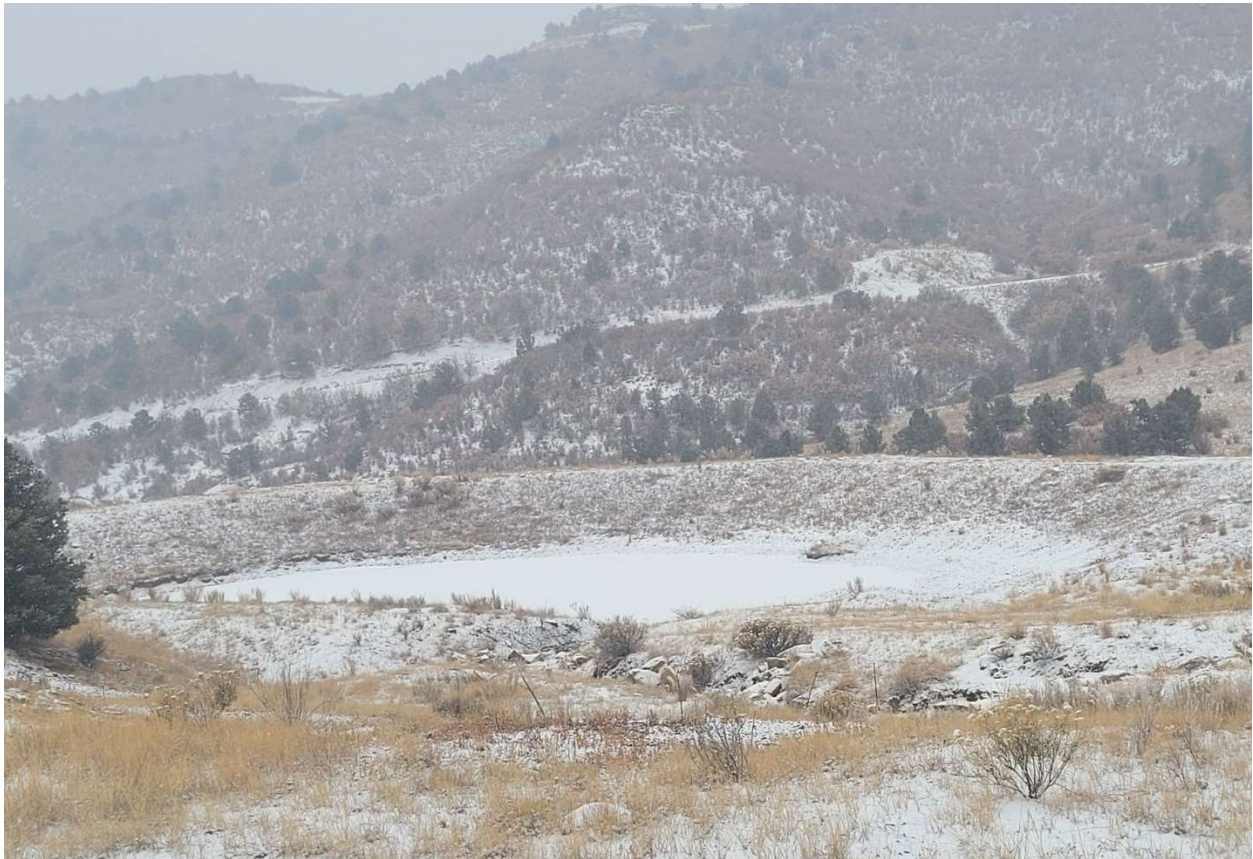
NPDES ID. No.: Pond #6

Pond was holding water and was frozen at time of inspection, not near the bottom of the decant. Ground Covered in Snow during inspection.

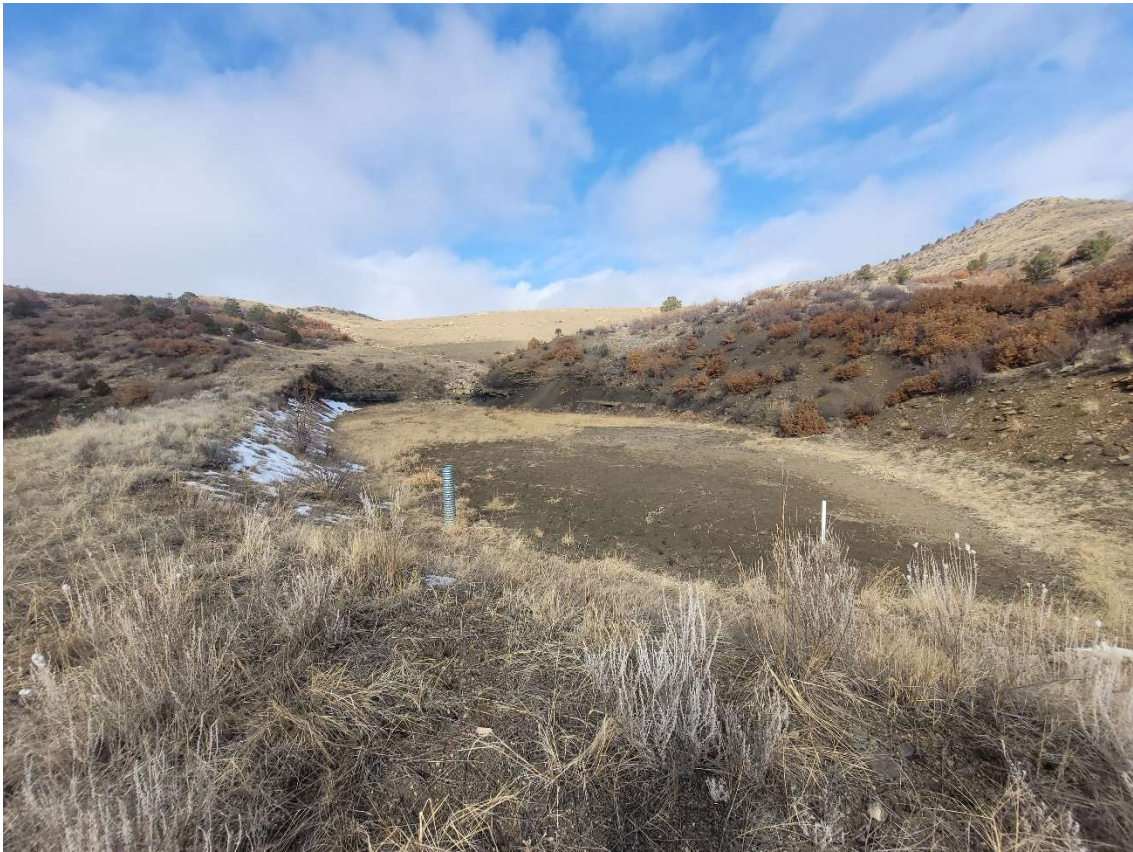
NPDES ID. No.: Pond #7

Pond was not holding any amount of water at time of inspection. Not discharging.

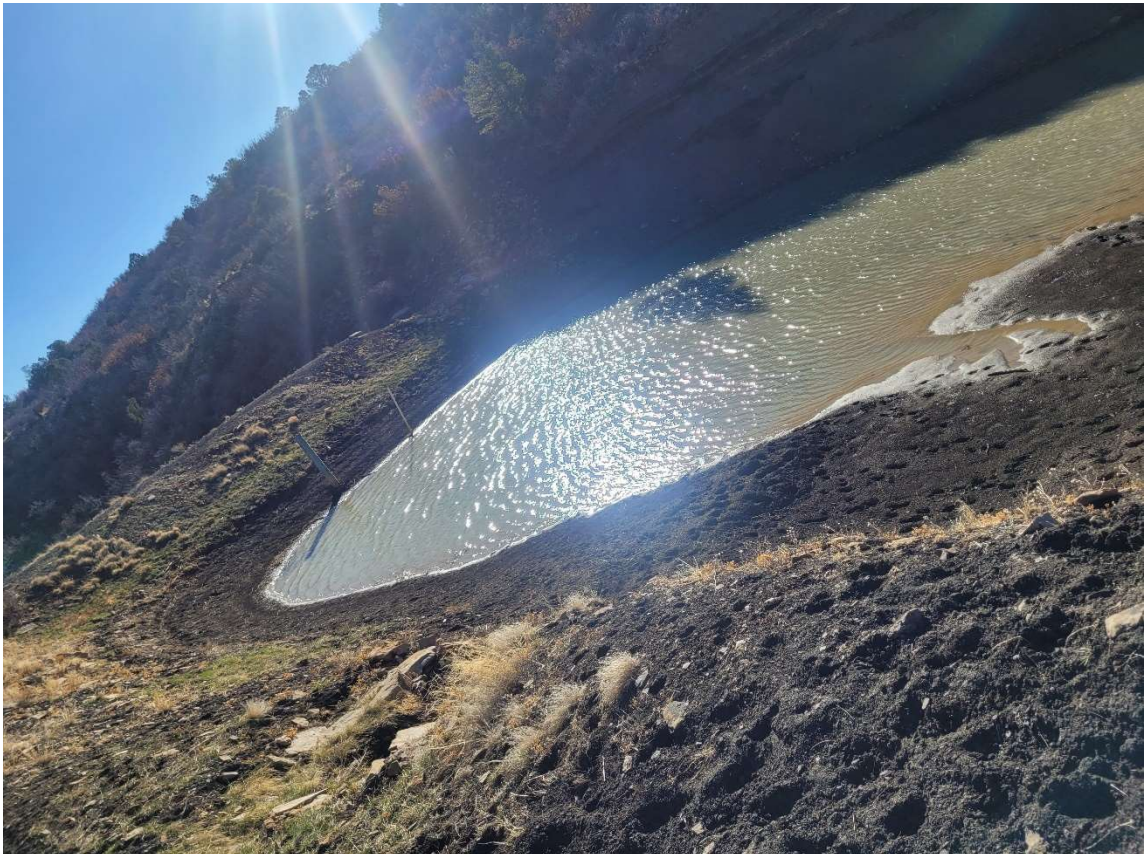
NPDES ID. No.: Pond #8

Pond was holding water at the time of inspection. Appears to have not discharged recently.

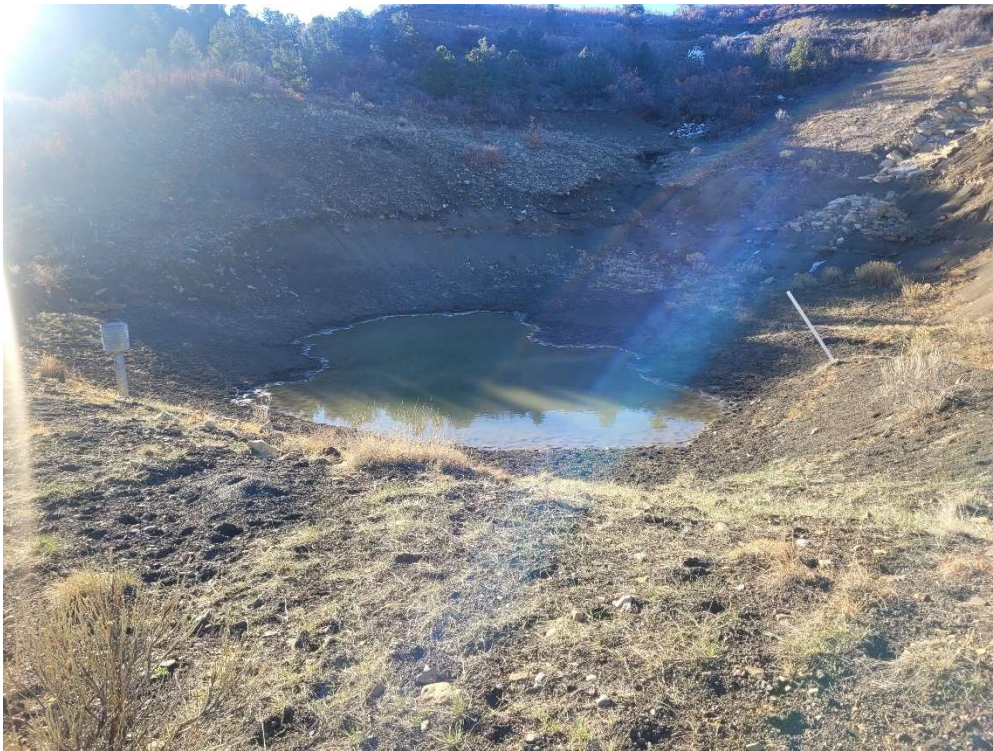
NPDES ID. No.: Pond #9 (North)

Pond was holding some water at time of inspection. Not near the level of the decant.

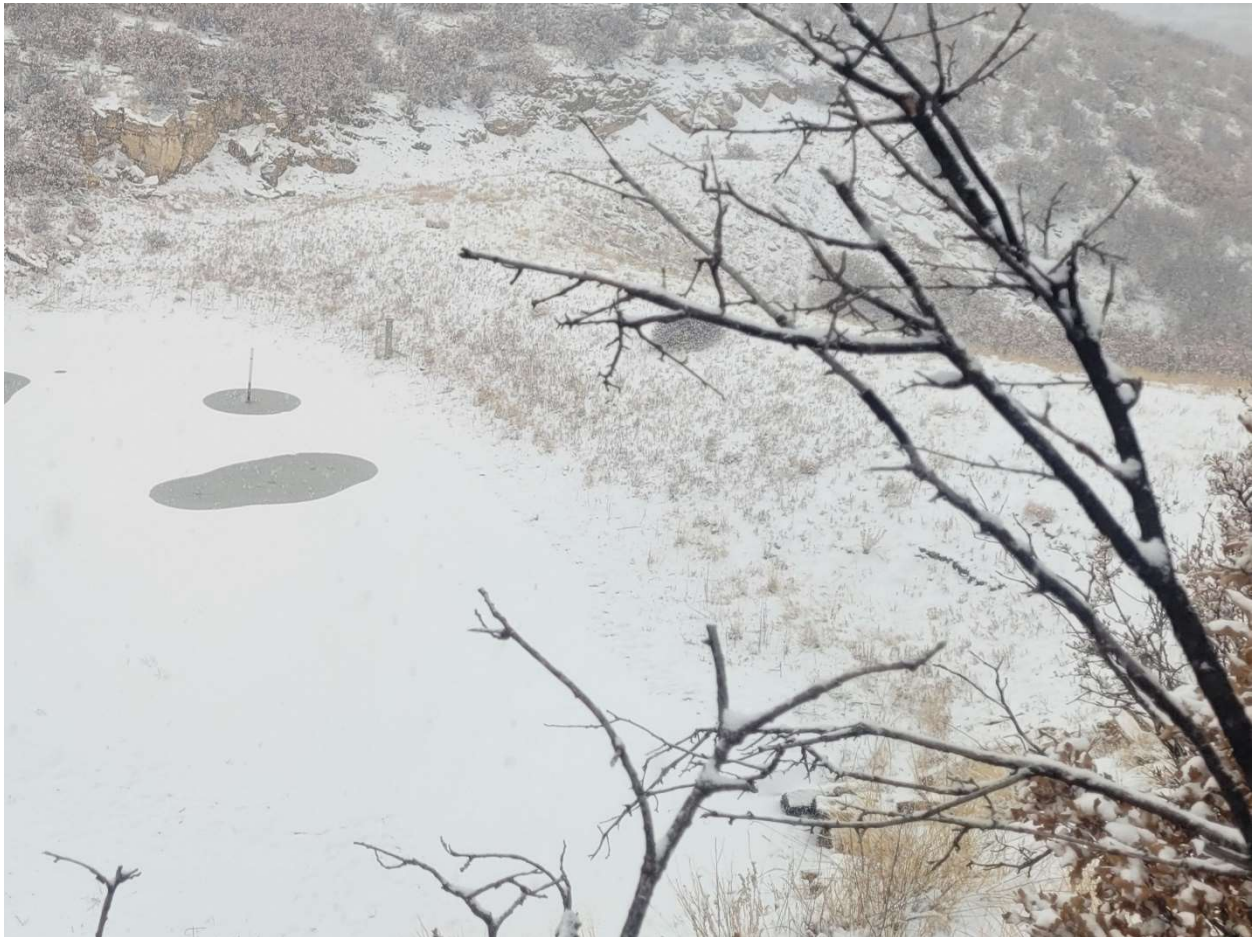
NPDES ID. No.: Pond #9A (South)

Pond was holding water and was frozen at time of inspection. Does not appear to have recently discharged. Ground Covered in Snow during inspection.
