**Inspection Report, Foidel Creek Mine, C-1982-056**

### PERMIT INFORMATION

### INSPECTION INFORMATION

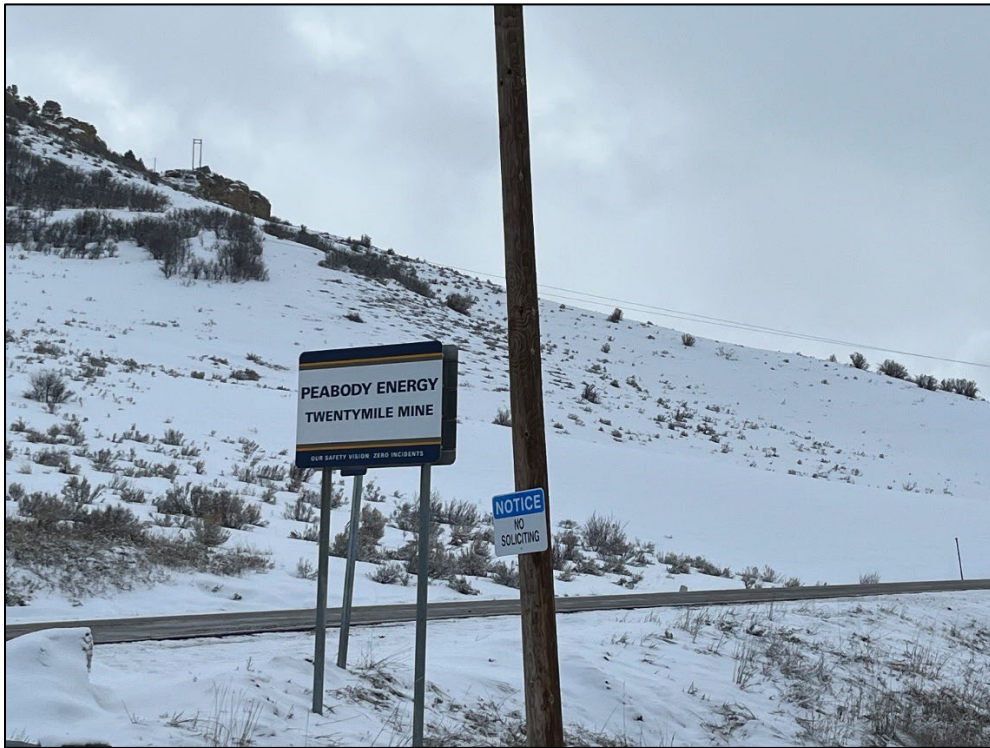
Mine identification markers were observed throughout the site (Photo 1). All information for compliance was present across all signs.

*Photo 1: Signs across the site, including here at the entrance road, were found to be in compliance.*

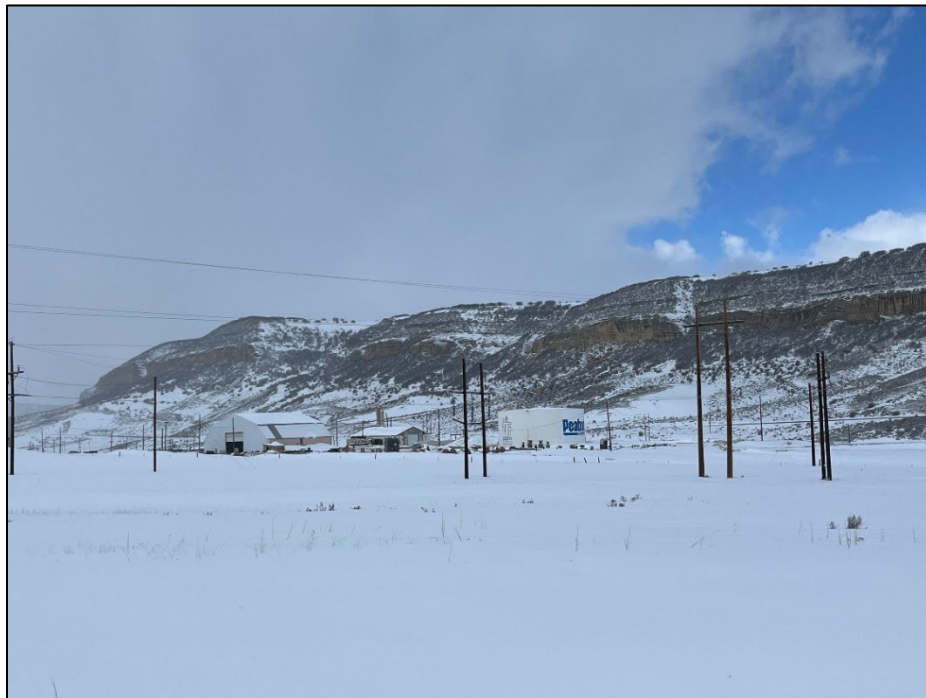
Storage areas and excess equipment have remained organized through the winter season (Photo 2). A water leak was recently fixed behind the warehouse building. Final backfill and grading of this area is still needed, and will be completed once weather conditions allow (Photo 6). The Stoker Coal Loadout building which was sealed in late 2023 to correct a water leakage issue is still sealed well and functioning properly. BMPs installed as part of this corrective action will likely be in need of maintenance as the spring season approaches and runoff increases around this area. Please ensure these BMPs remain functional throughout the winter season and especially into the spring. No coal spills were observed in front of the loadout building.

*Photo 2: View west of the million gallon tank, PM Bay, and material storage area. Pond G is located to the north.*

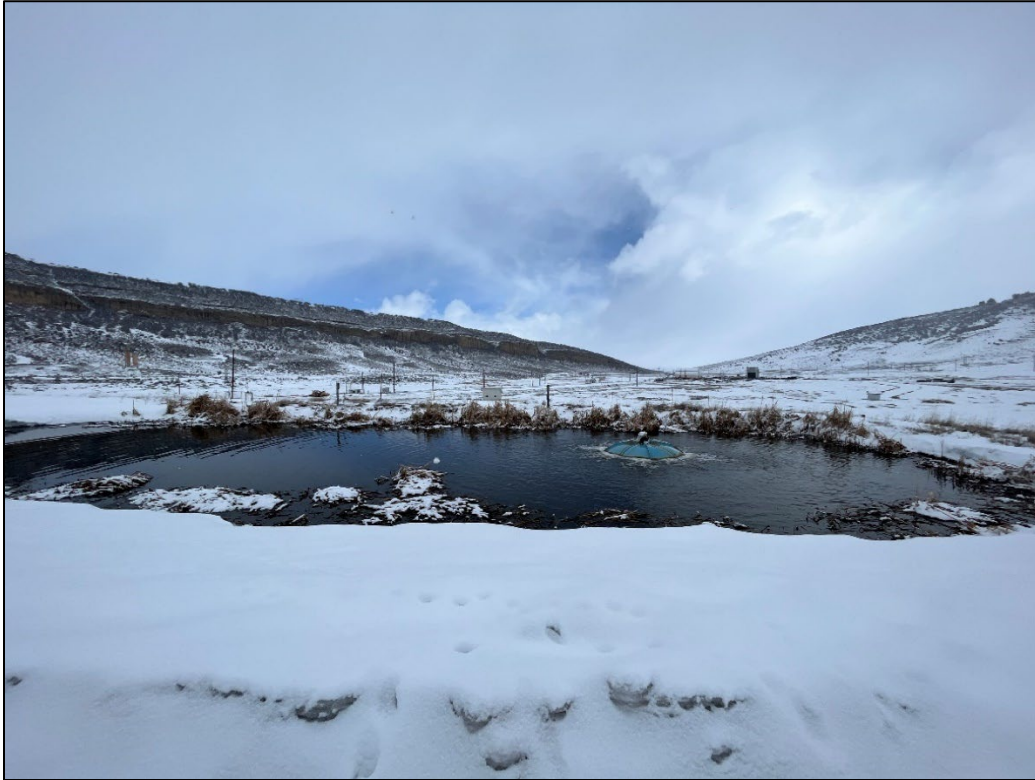
*Photo 3: View north of one of three facility ponds, currently discharging.*

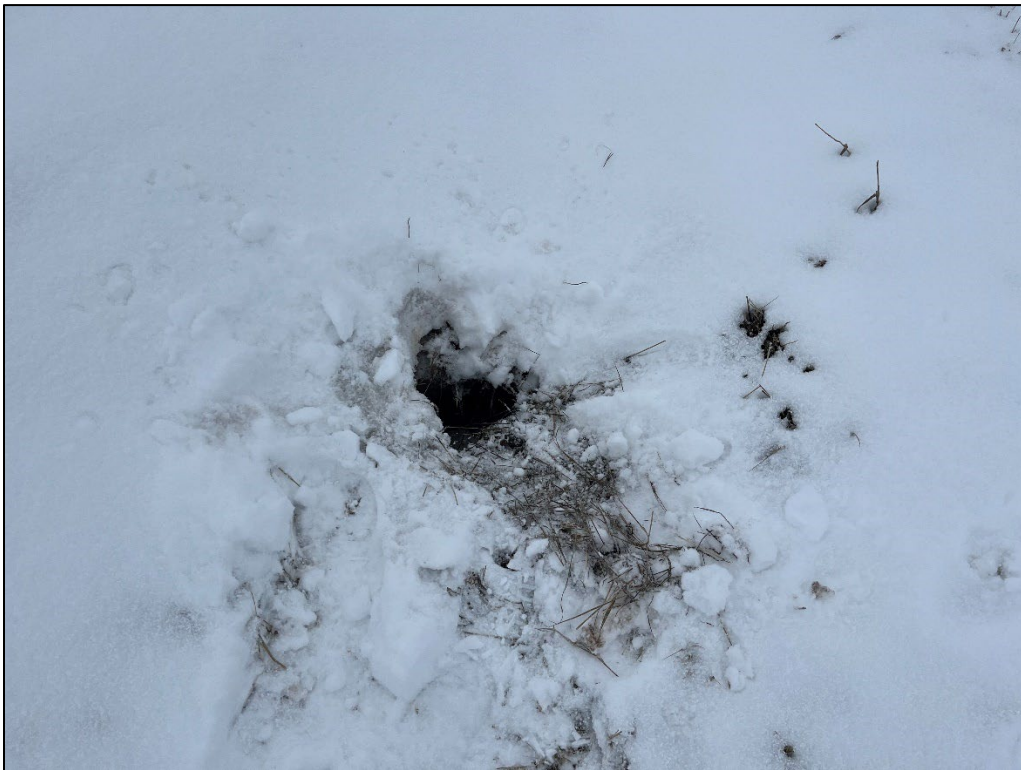
*Photo 4: The culvert nearest the southernmost facility pond.*

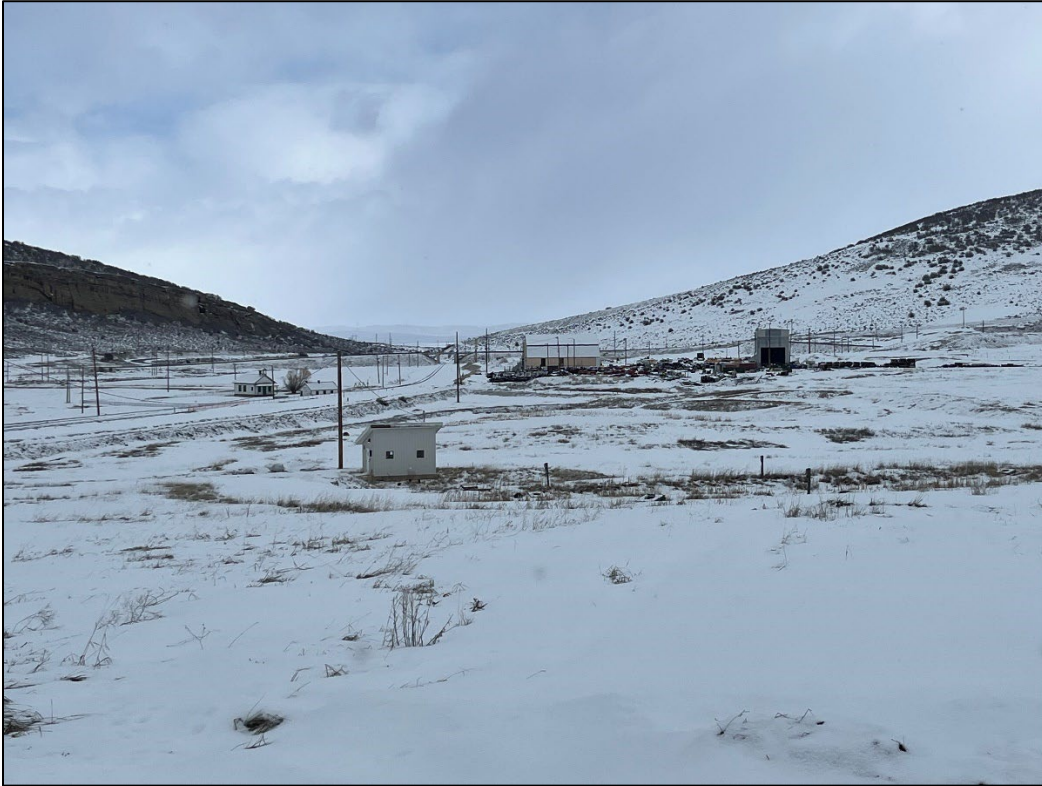
*Photo 5: View north of Pond F, not discharging.*

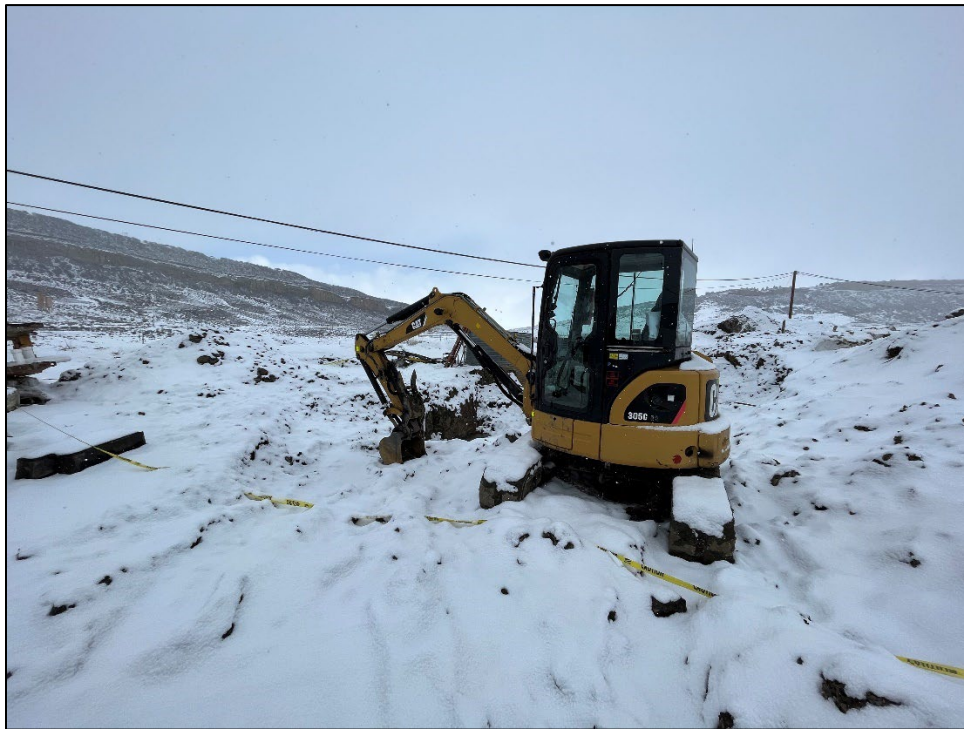
*Photo 6: A water line was recently replaced behind the warehouse, the leak has been fixed, but the new line still needs to be buried.*

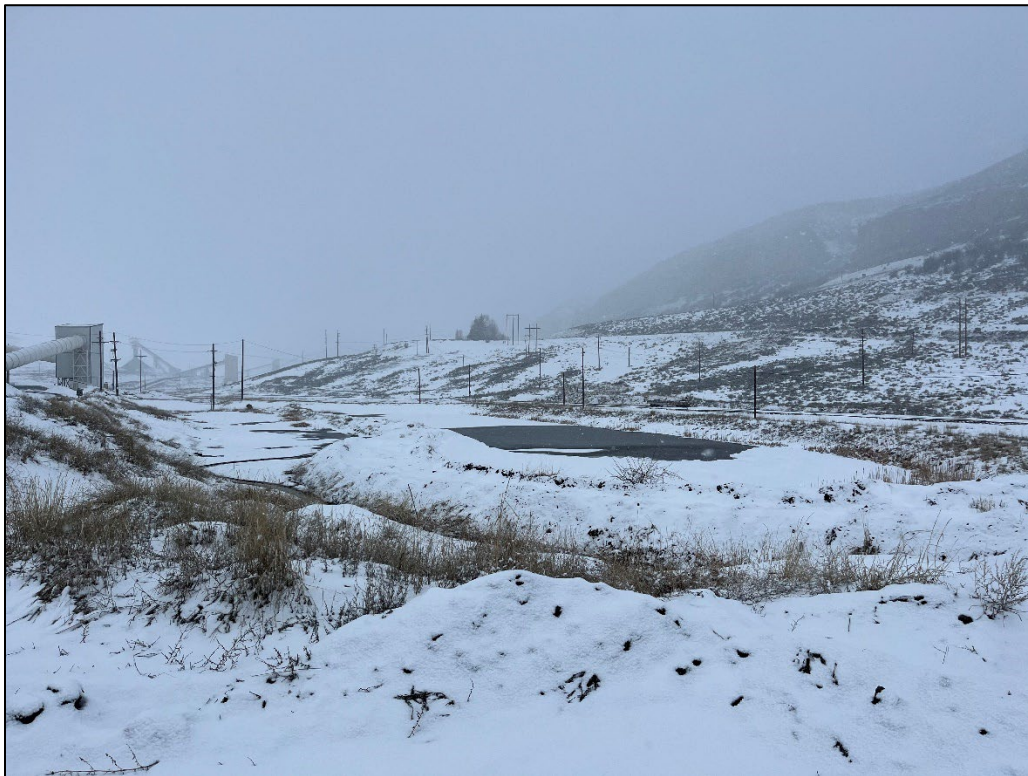
*Photo 7: View southwest of Pond E, currently discharging.*

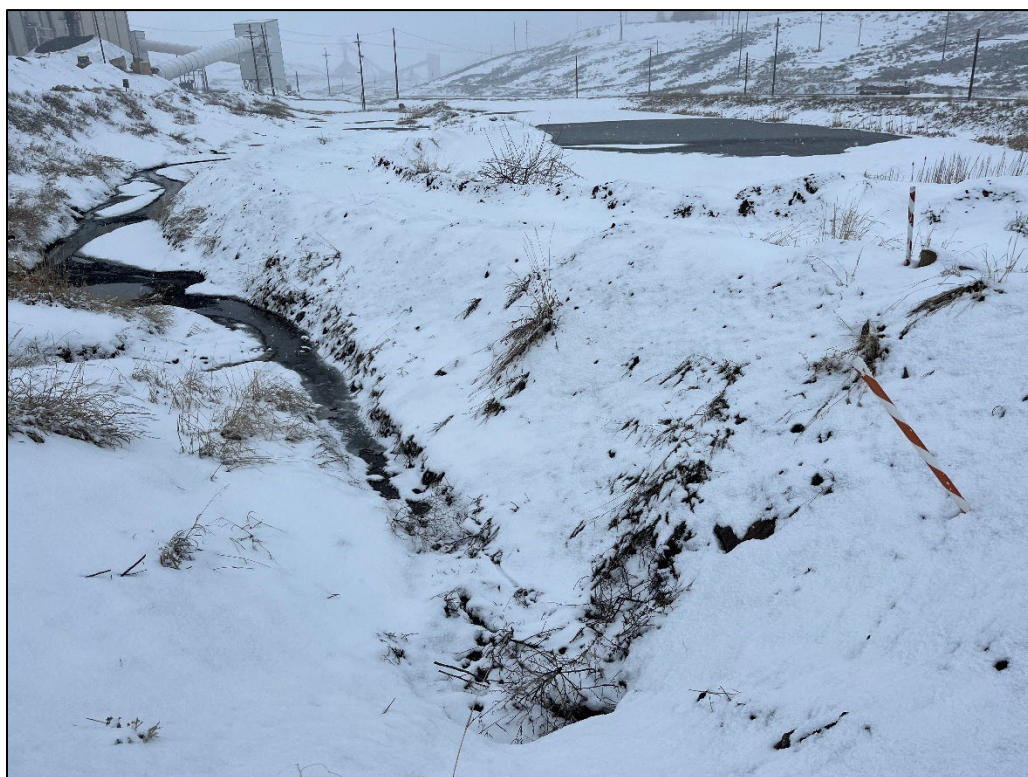
Ponds were checked for discharge and culverts were inspected for function where conditions allowed. Notable observations include a partially blocked culvert at Pond E (Photo 8) and a blow down of cattails at the Pond D discharge culvert, which was very full at the time of inspection (Photo 9). TC should continue to clean out culverts when vegetation and sediment hinders function. A sample of ponds and discharge points are represented in Photos 3, 4, 5, 7, 9, 11, 12, 14, 15, 17, 21, 22. No erosional or structural issues were noted at any of the ponds.

*Photo 8: View of the northernmost culvert of Pond E.*

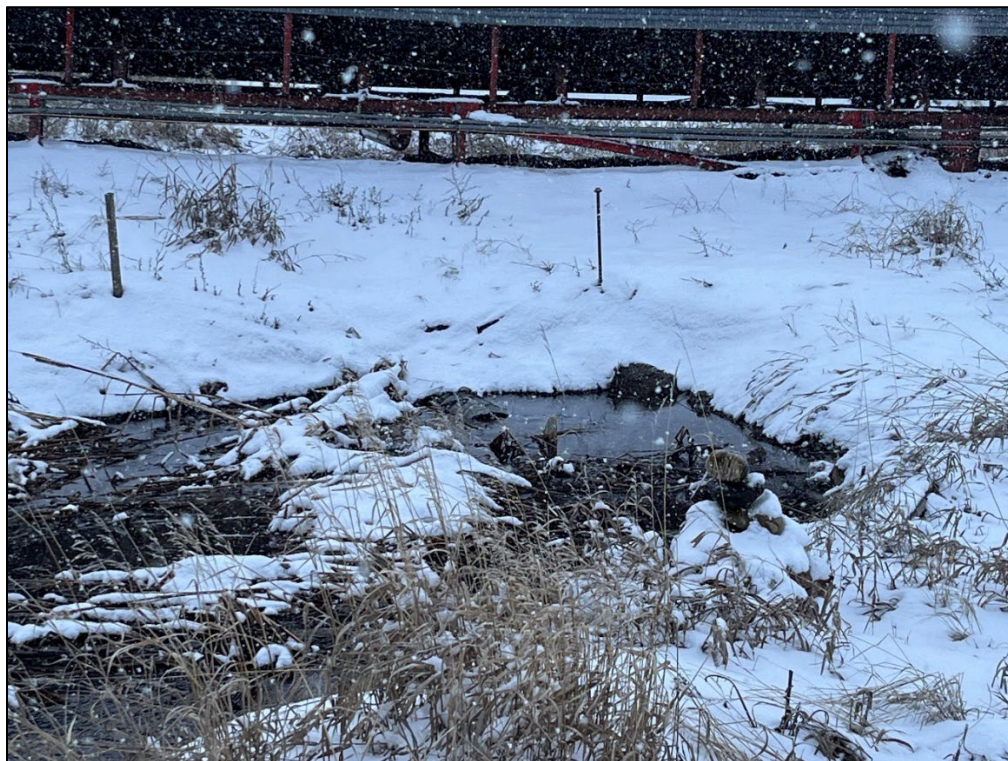
*Photo 9: Discharge culvert for Pond D, cattails were recently blown down by winds.*

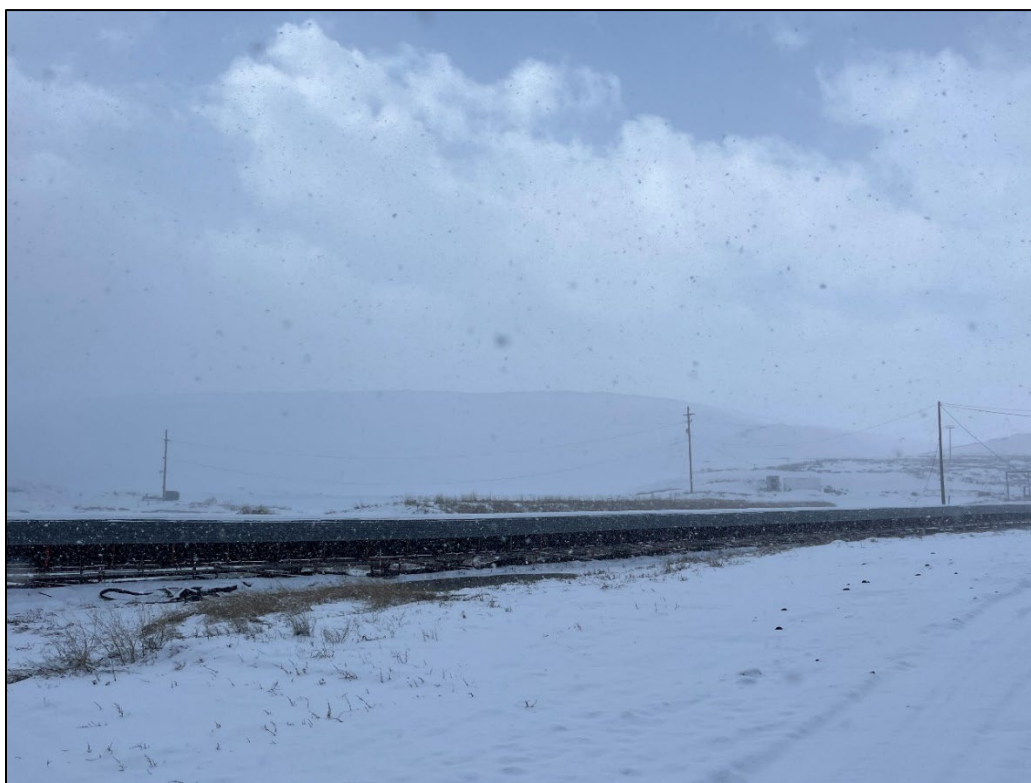
Due to wet and muddy conditions, the top of the refuse pile was not accessible during this inspection. However, trucks were noted to be hauling at the time of inspection (Photos 10 and 19).

*Photo 10: View southeast of the refuse pile, partially covered by snow and fog.*

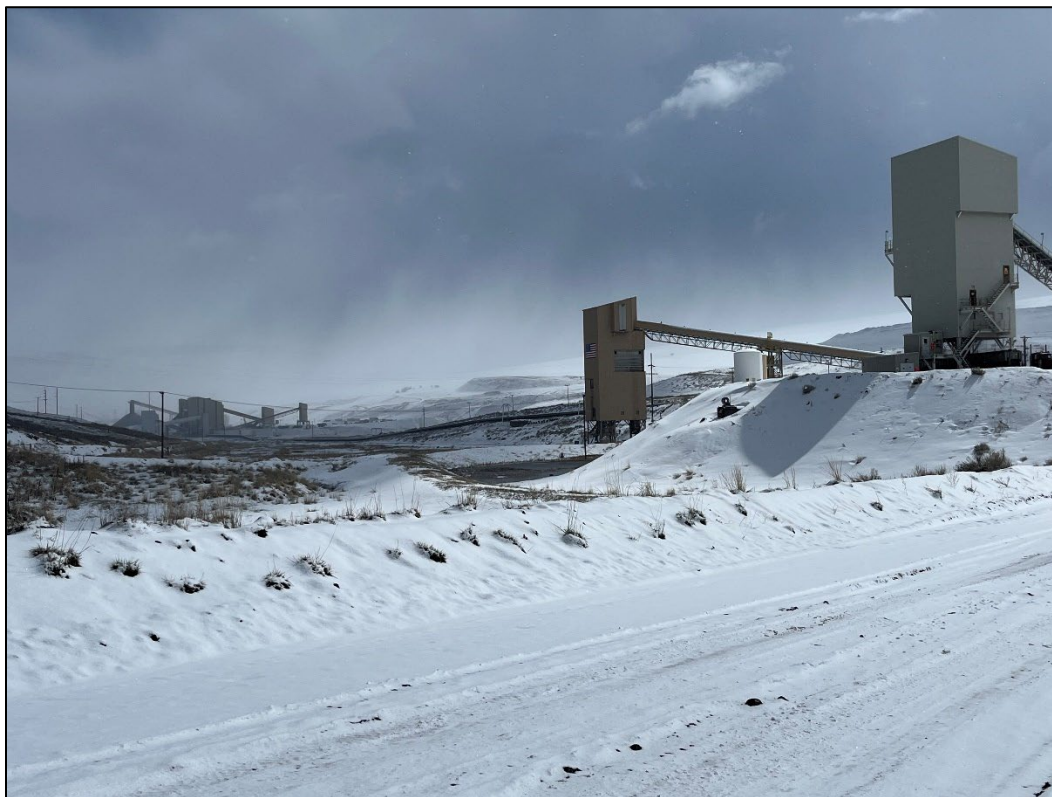
*Photo 11: View northeast of Pond C, holding water.*

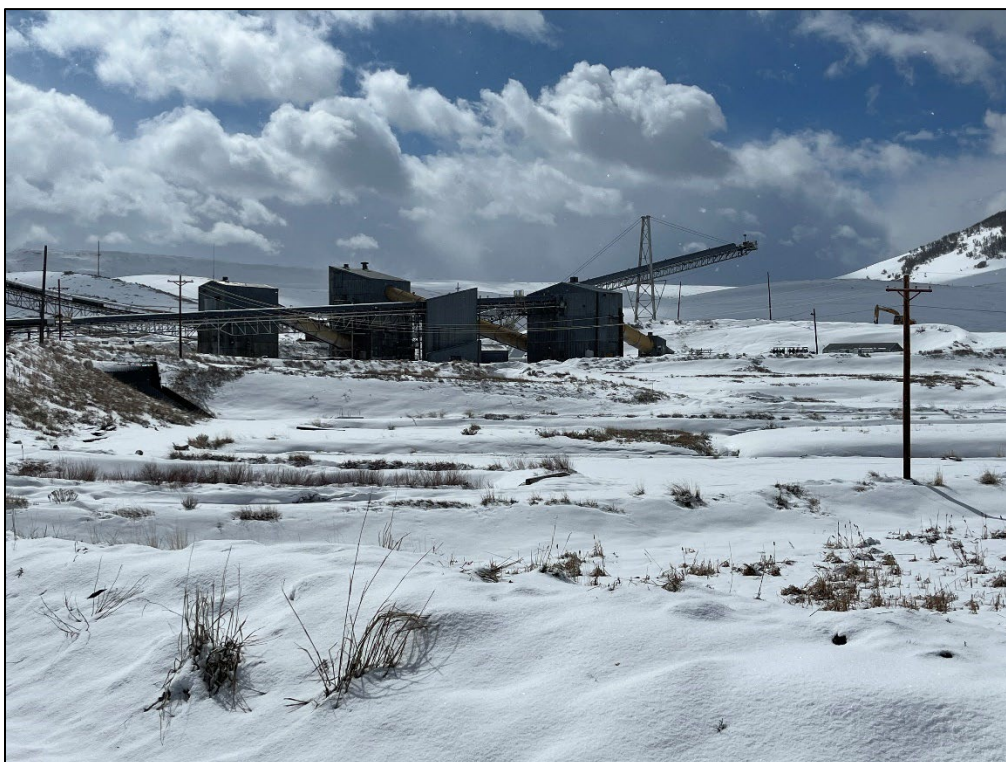
*Photo 12: View southwest of Ponds B, currently discharging.*

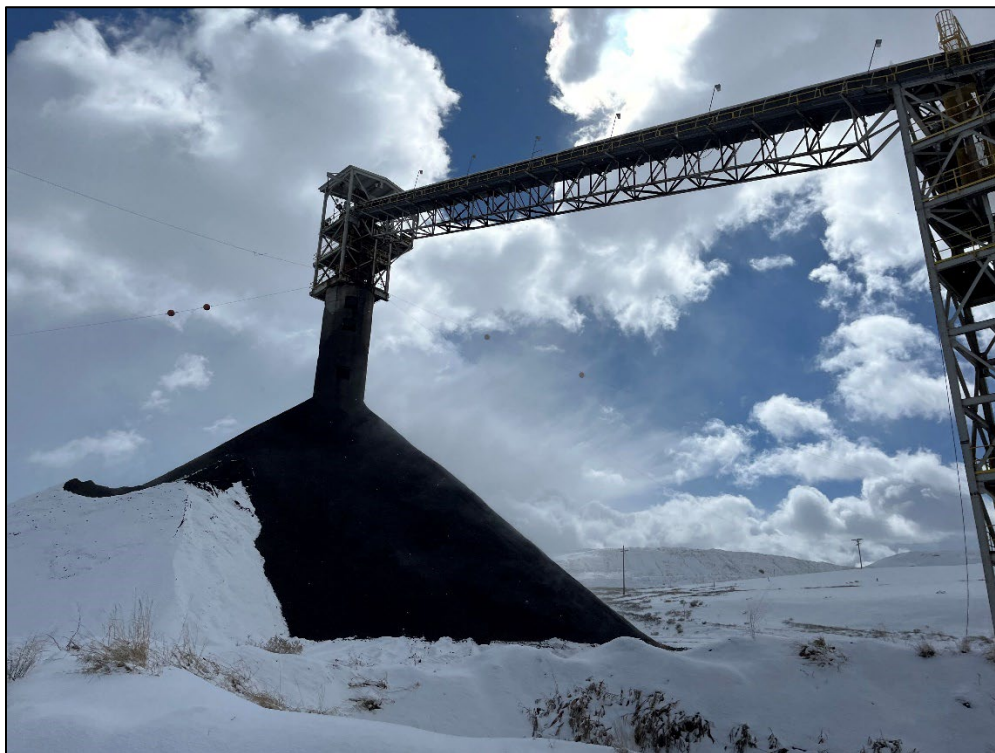
*Photo 13: View east of the coal stockpile loadout.*

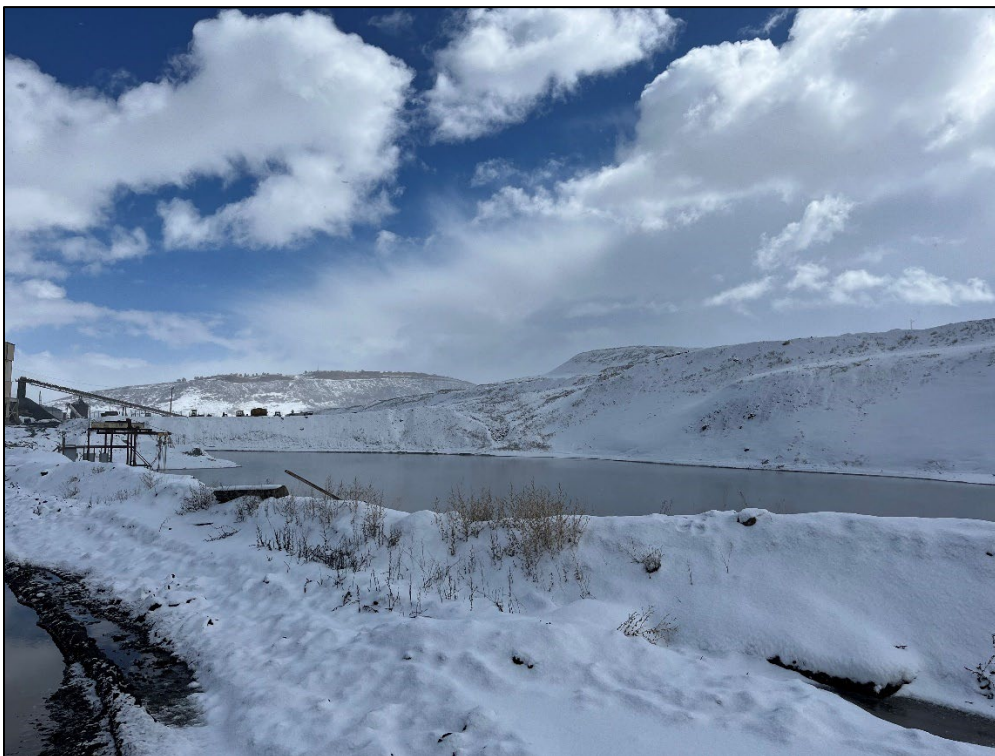
*Photo 14: View northeast of the Pit Pond.*

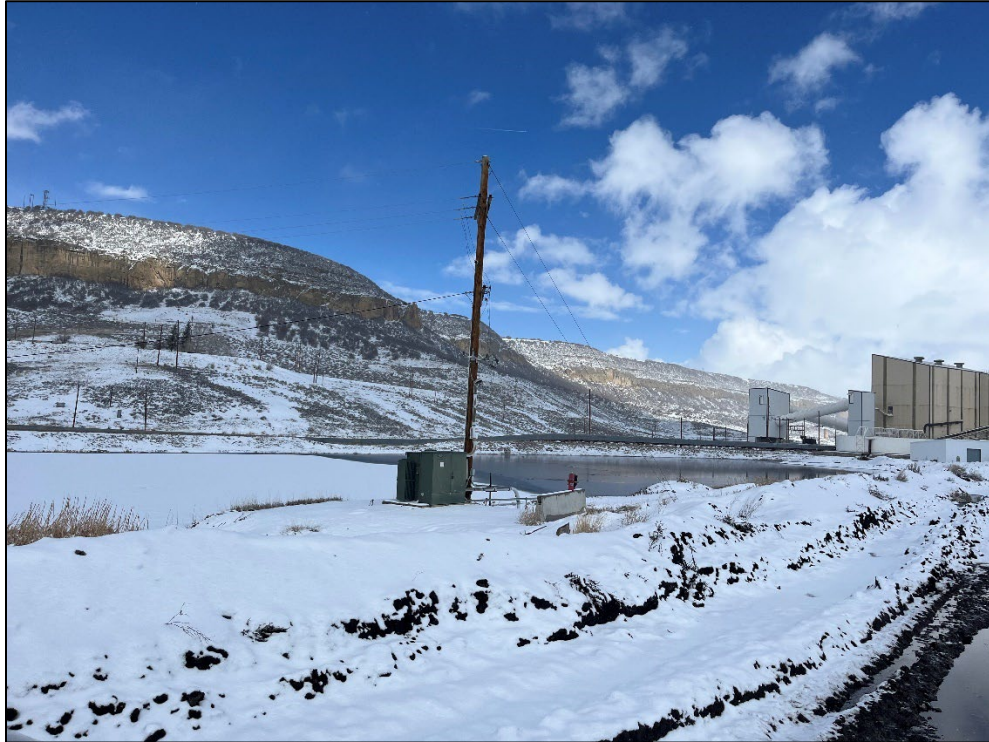
*Photo 15: View northwest of Pond D.*

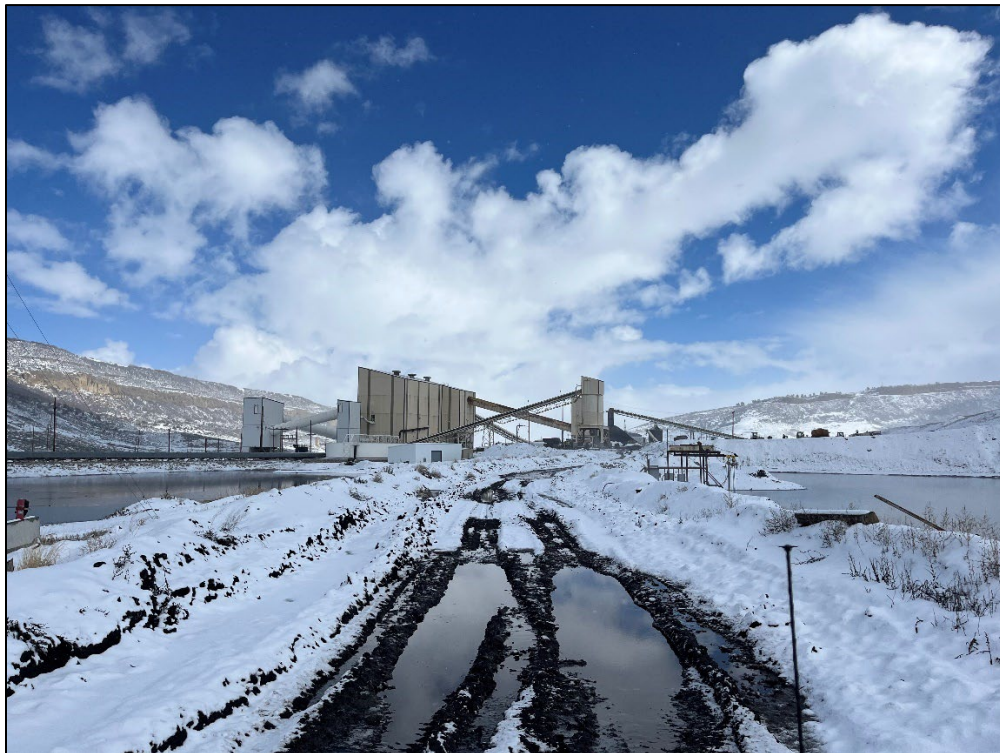
Haul roads throughout the site were plowed, but only navigable with a 4WD vehicle. Recent heavy snowfall and subsequent snowmelt has caused the entirety of the site to be muddy and difficult to navigate. Roads will be in need of regarding efforts when conditions allow to remedy large ruts caused by truck travel (Photo 16).

*Photo 16: View north of the main facilities area from the Refuse Haul Road, Pond D and the Pit Pond are adjacent to this road.*

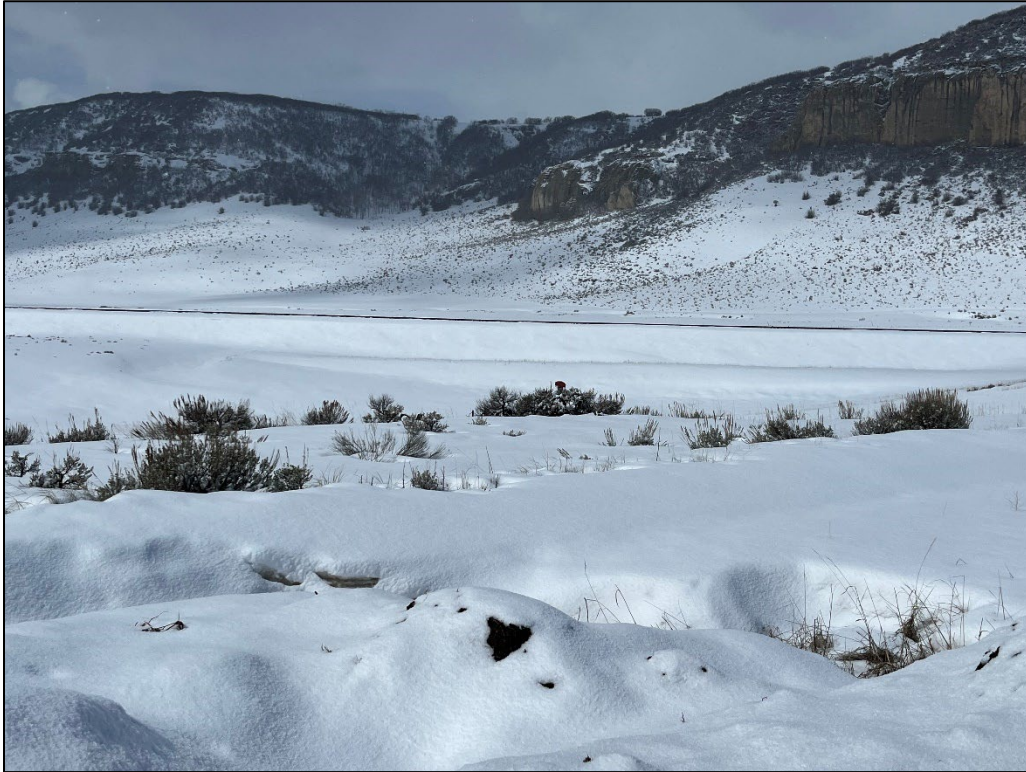
*Photo 17: View west of pond T, not currently discharging.*

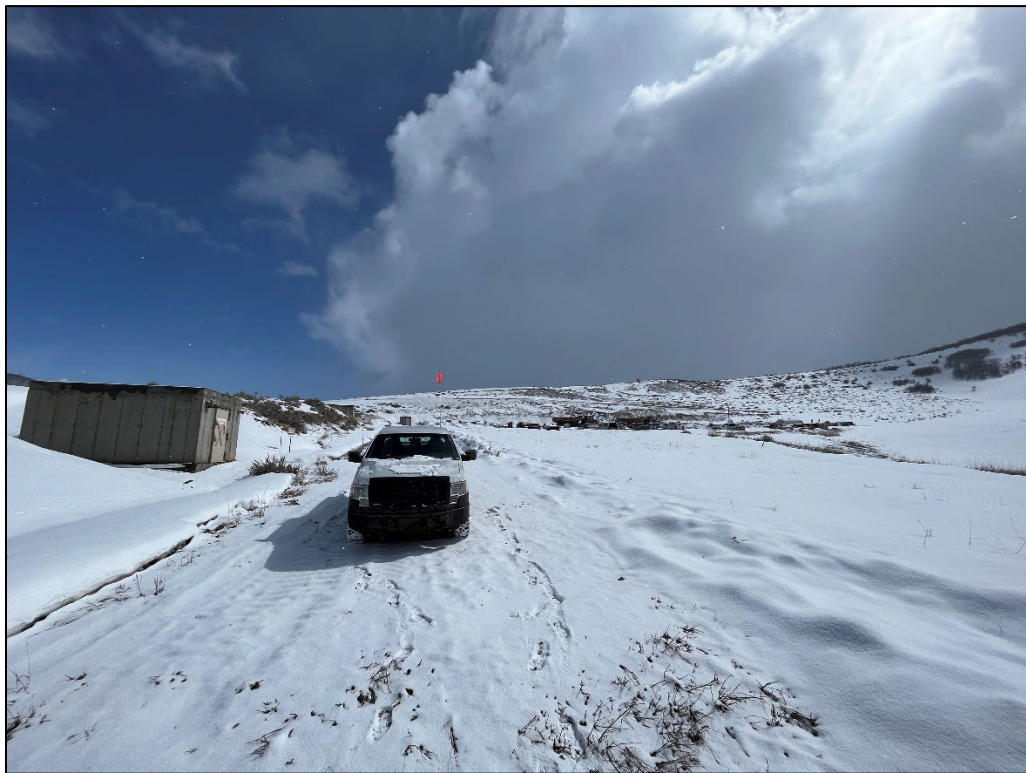
The Operator stated that inventory of the site's explosives bunkers have continued monthly as required (Photo 18).

*Photo 18: View north of the explosives bunkers and excess equipment storage.*

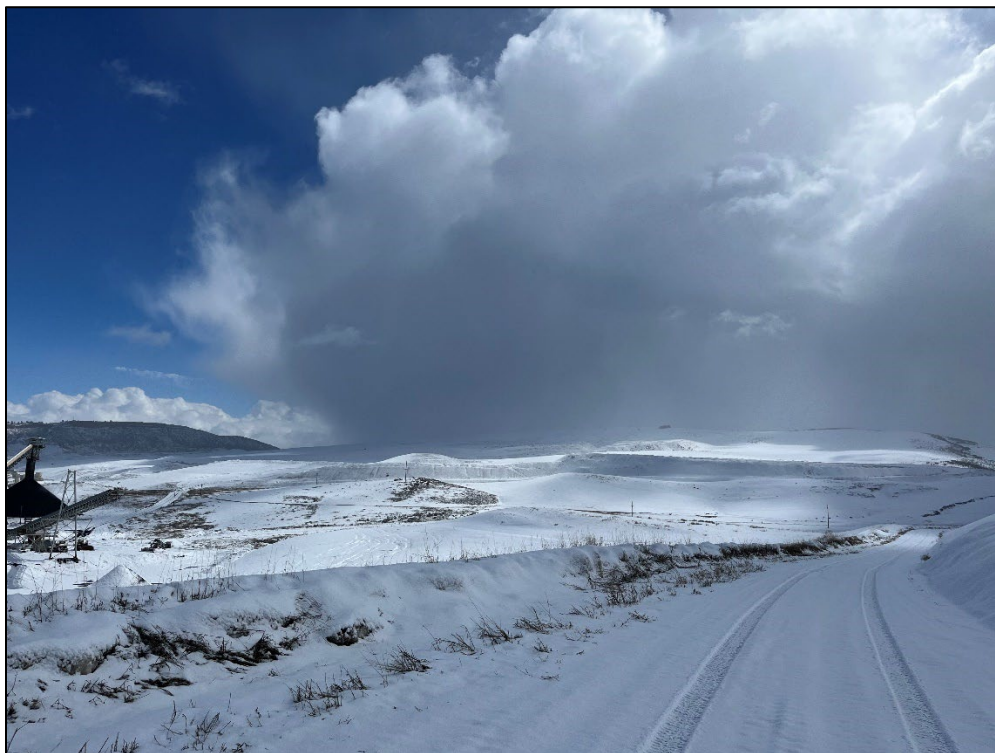
*Photo 19: View east of the refuse pile from atop the road adjacent to the ROM storage area.*

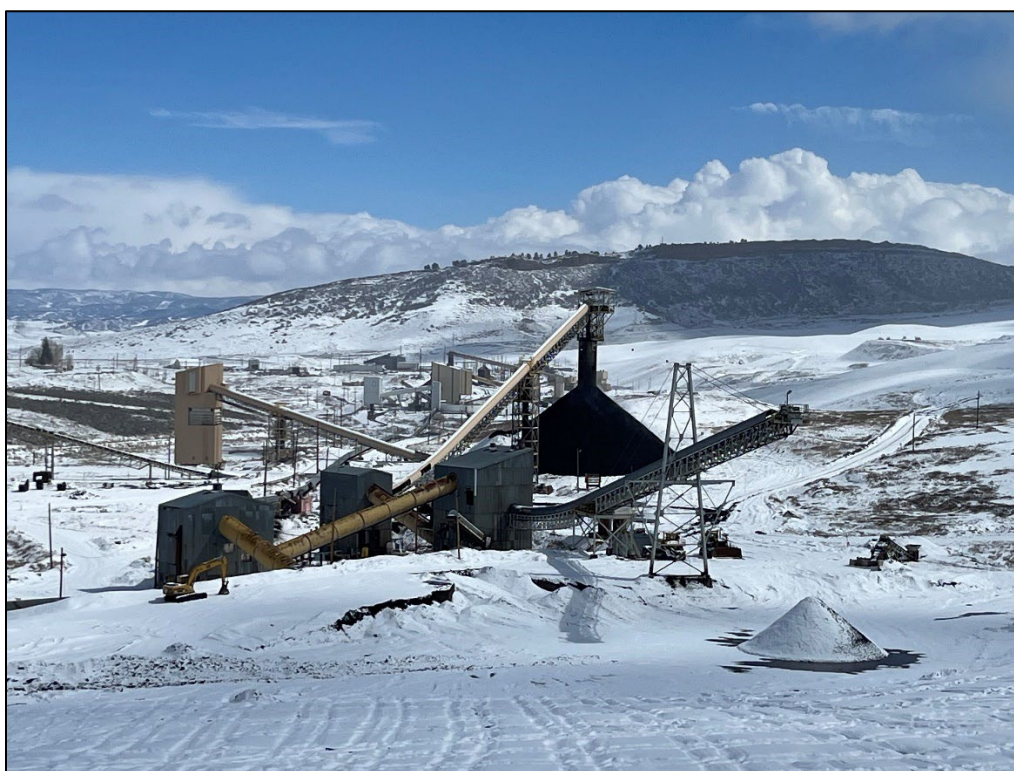
The Division was informed during the last site inspection that a large, old conveyor tube located on the eastern side of the wash plant facility had been damaged. At the time, no new coal was being washed and processed. However, TC has salvaged surplus conveyor equipment from the nearby Peabody Sage Creek Mine to build a temporary replacement conveyor while a new conveyor tube is being fabricated. Coal is now being processed as usual (Photo 13 and 20). The Operator stated that a fully replaced conveyor would likely not be on site until fall of 2024.

*Photo 20: View north of the ROM coal storage area and other main facilities.*

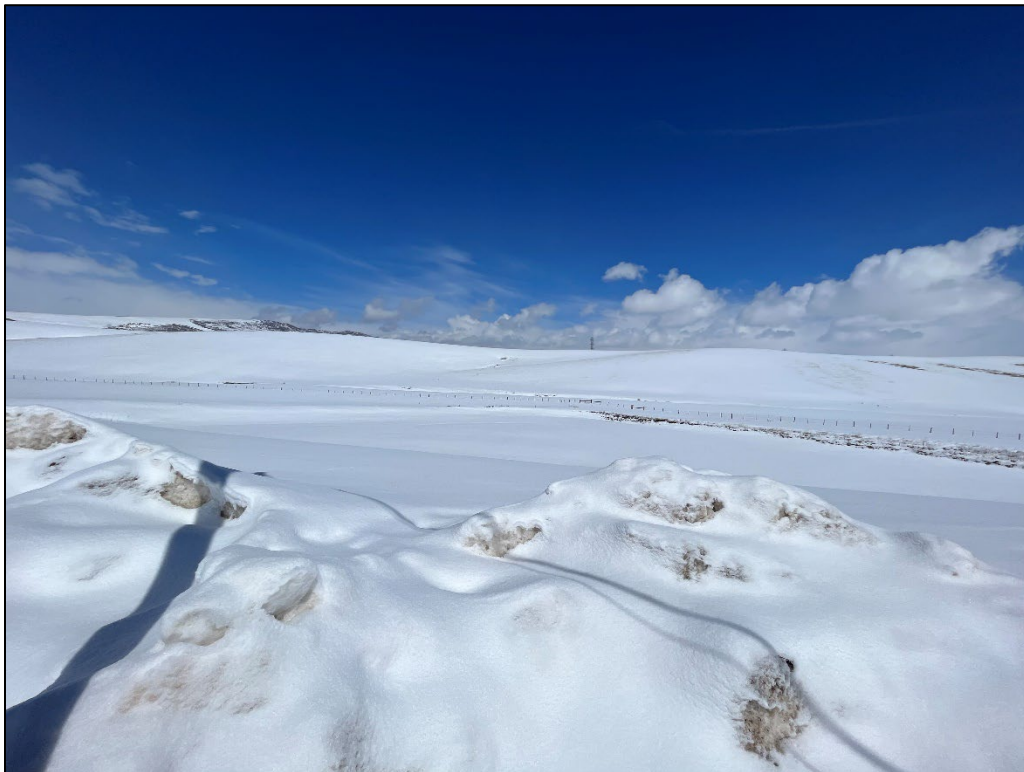
The Passive Water Treatment Plant has been turned off for the winter months. All facilities in the 6MN area are functioning as usual (Photos 21 and 22). Fuel in this area is still begin stored in secondary containment. The blower fans in this area which bring heat down to the mine workings remain turned on for the winter season.

*Photo 21: View N of the 6MN sediment pond.*

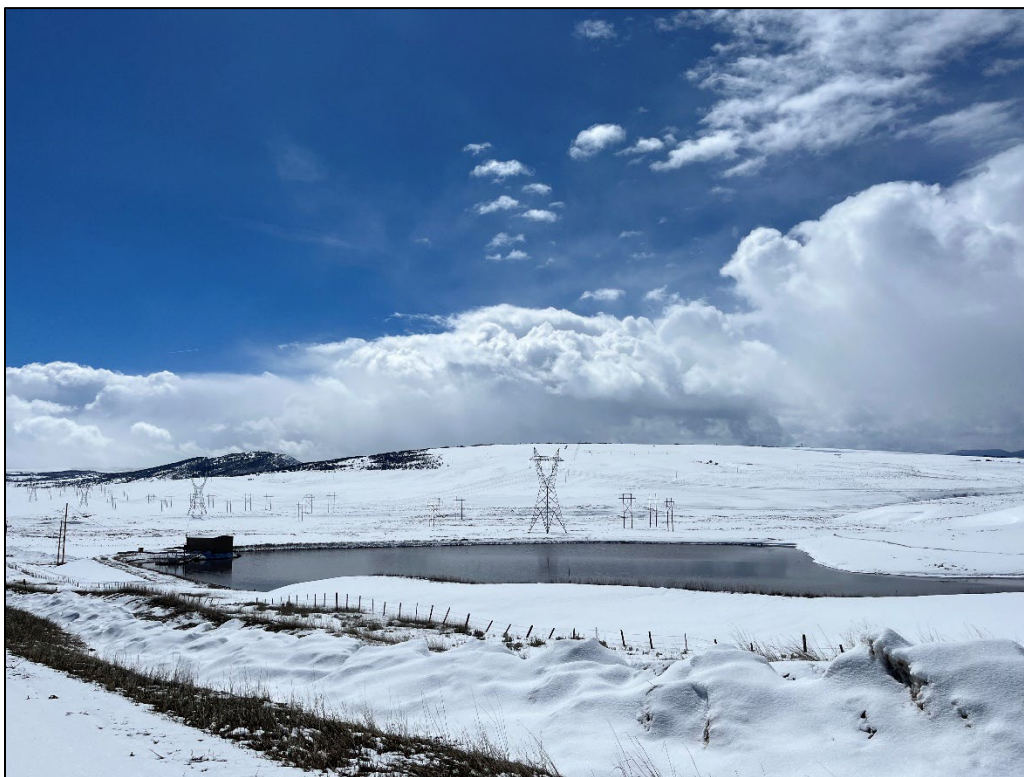
*Photo 22: View SE of the 6MN Reservoir.*
