Inspection Report, Hayden Gulch Loadout, C-1992-081

PERMIT INFORMATION

Permit Number: C-1992-081 Mine Name: Hayden Gulch Loadout Operator: Hayden Gulch Terminal, LLC Operator Address: Ms Miranda Kawcak 29515 Routt County Road 27 Oak Creek, CO 80467	County: Routt Operation Type: Loadout Permit Status: Active Ownership: Private
	Operator Representative Present:
Operator Representative Signature: (Field Issuance Only)

Inspection Start Date: March 27, 2024 Inspection Start Time: 09:00 Inspection End Date: March 27, 2024 Inspection End Time: 09:45	Inspection Type: Coal Partial Inspection Inspection Reason: Normal I&E Program Weather: Cloudy / Snowing
Joint Inspection Agency: None	Joint Inspection Contacts:
Post Inspection Agency: None	Post Inspection Contacts:
Inspector(s): Hunter Ridley	Inspector's Signature: <i>Hunter Ridley</i> Signature Date: April 1, 2024

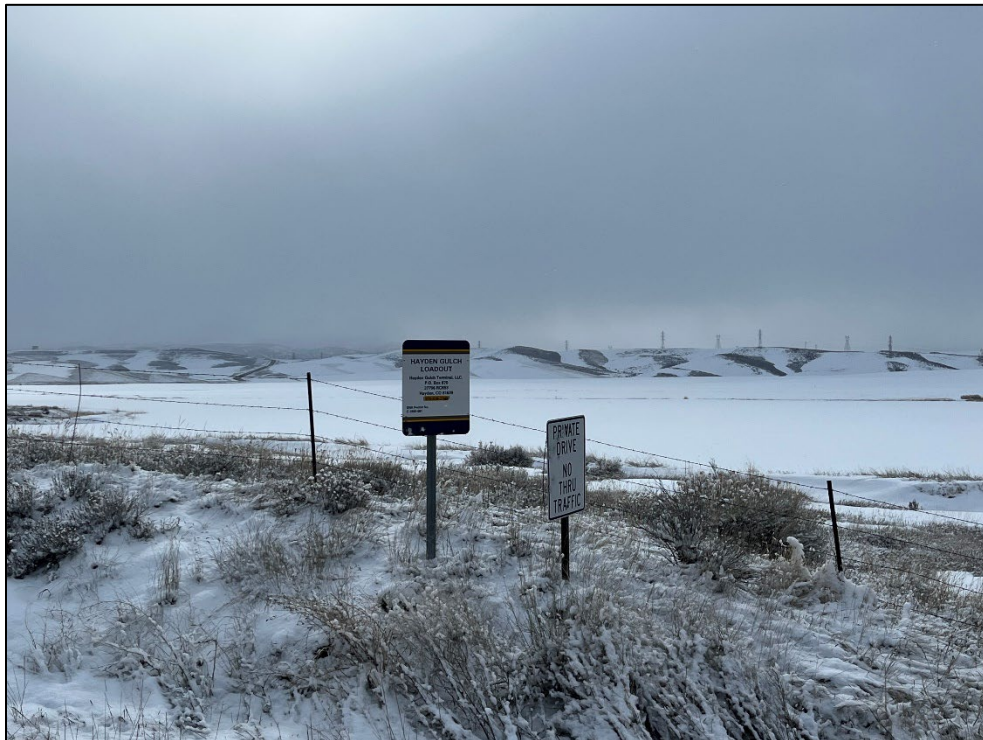
Mine identification signs were observed at the western end of the TAHR (Photo 1) and adjacent to the unreleased agricultural section north and south of Hwy 40 (Photo 2). All required information was present on the signage.

Photo 1: Mine sign posted at the western end of the TAHR.

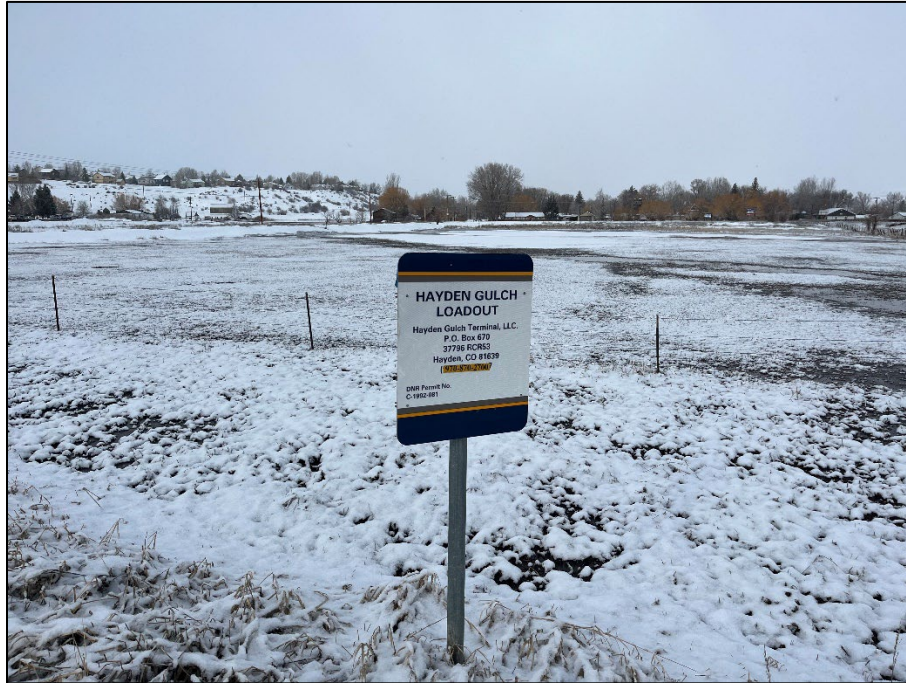
Areas not Phase III bond released and not included in the current SL-3 release area includes the fields directly north and south of Hwy 40, to be reclaimed to agricultural use as hay fields. This area includes 6.8 acres of which 2.3 are disturbed (Photo 2).

Photo 2: Mine sign posted at the intersection of Hwy 40 and Hawthorne St.

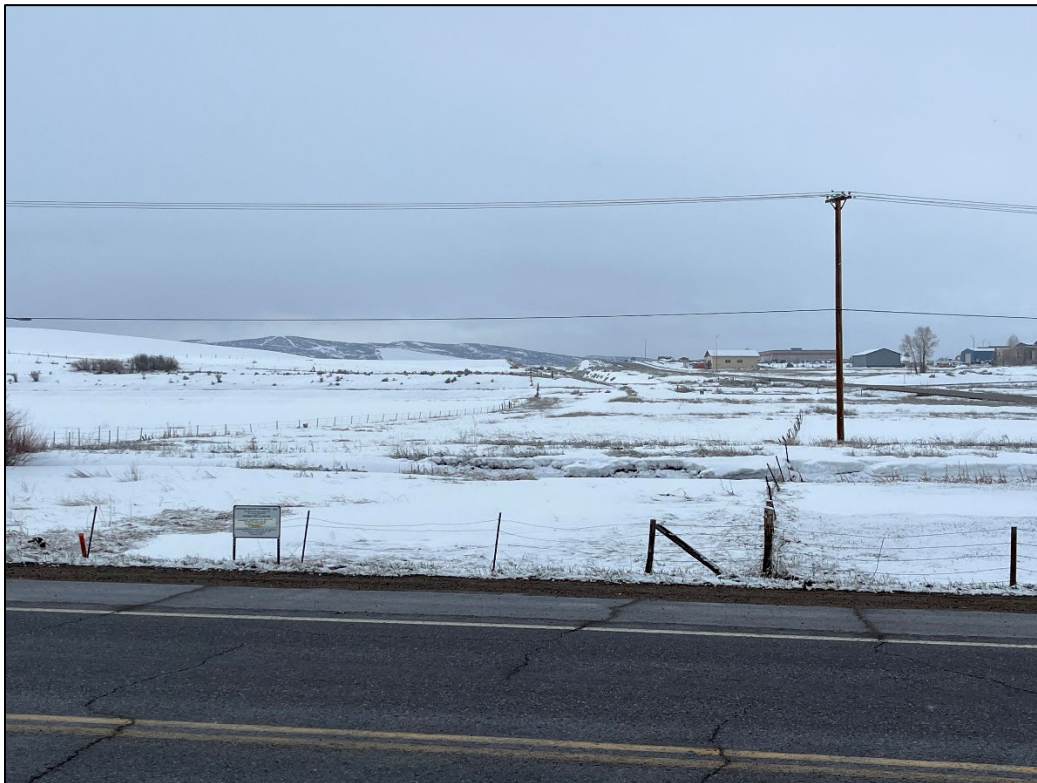
The remaining permit area near Hwy 40 appeared vegetated under the snow (Photos 3, 4, and 5). This area of disturbance will be fully incorporated into adjacent hay fields at the conclusion of the 10-year liability period.

Photo 3: View south of snow-covered hayfields, adjacent to Hawthorne St., currently unreleased.

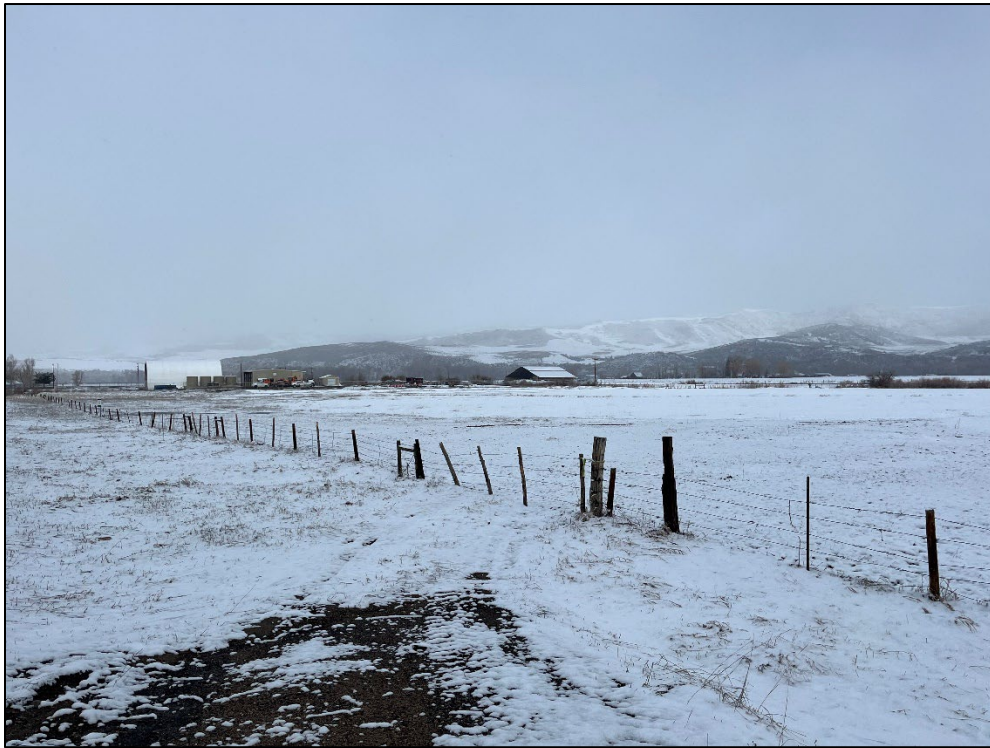
Photo 4: View north of unreleased, snow-covered hay fields adjacent to Hwy 40.

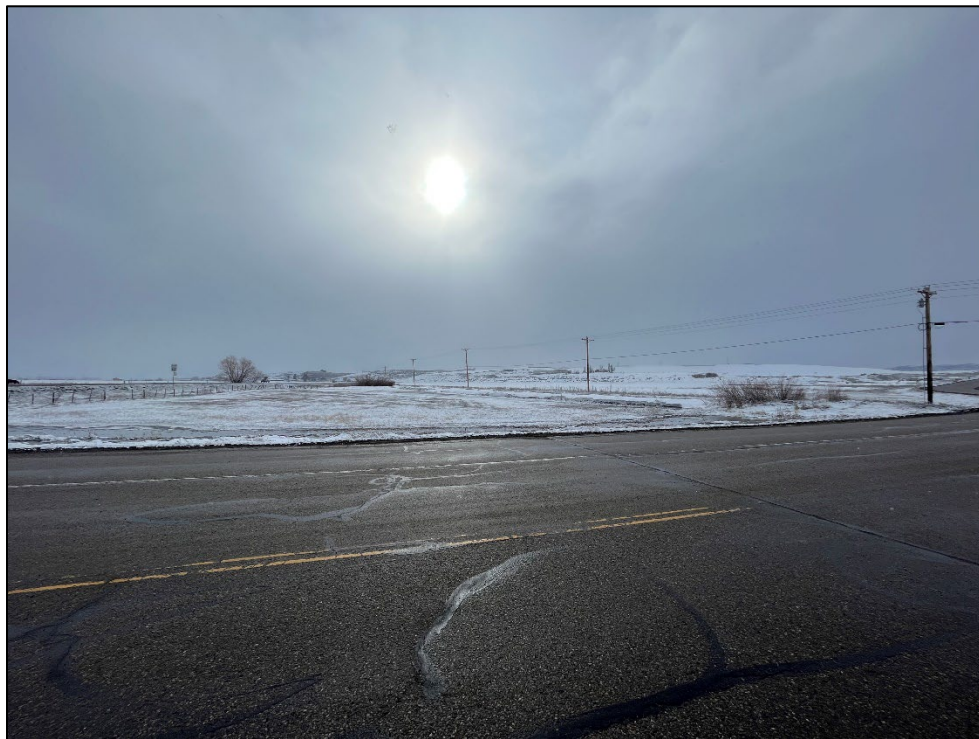
Photo 5: View east of the unreleased, snow-covered agricultural hay fields. Taken from Hawthorne St.

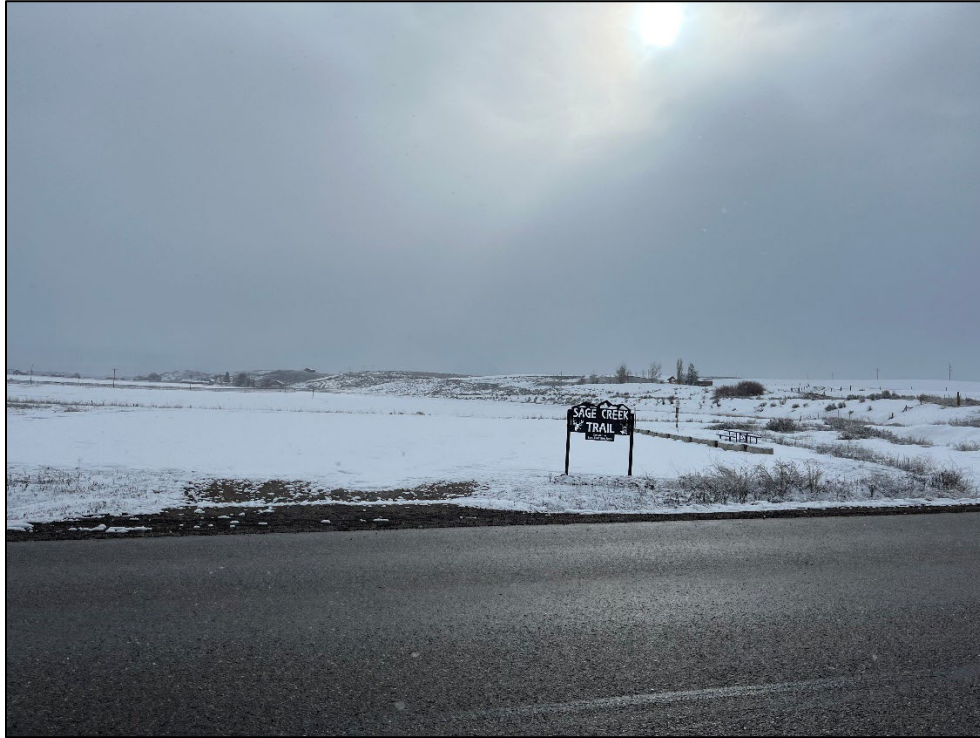
Photo 6: View east of the parking lot entrance to the Sage Creek Trail which is part of the Tracks to Trails Program.

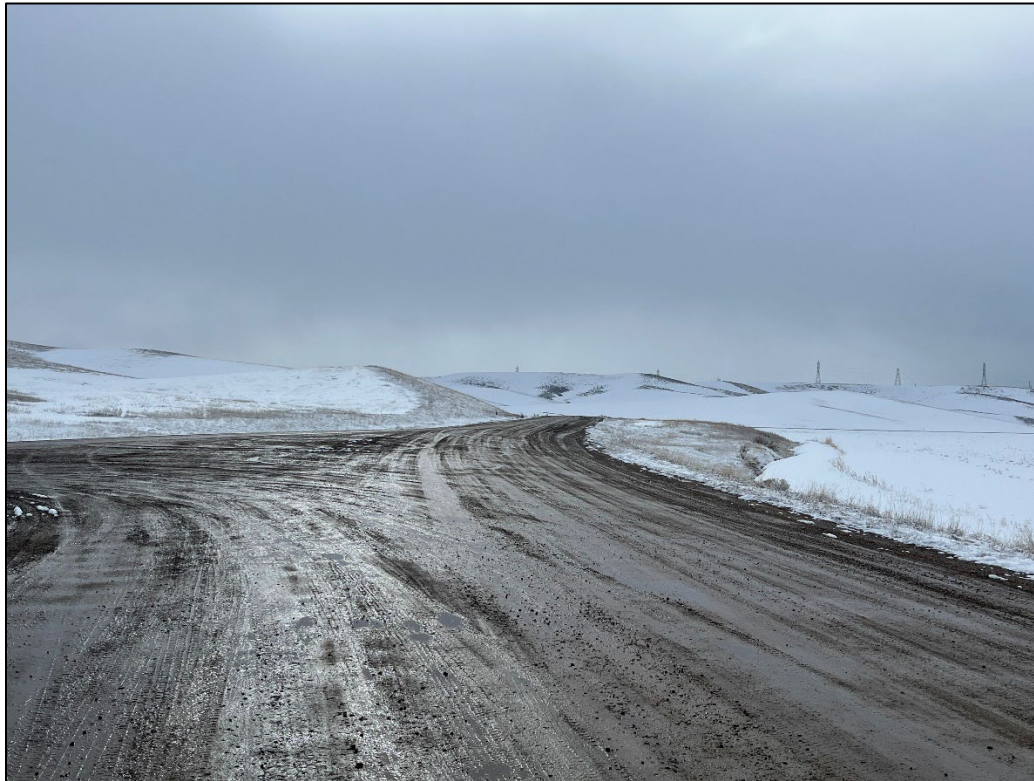
Maintenance of the recently released Tie Across Haul Road (TAHR) is the responsibility of the City of Hayden. The TAHR was plowed and navigable (Photos 7 and 8). Recent heavy snowmelt made conditions slightly muddy and slick. No erosion features of concern were noted.

Photo 7: View east of the entrance to the TAHR.

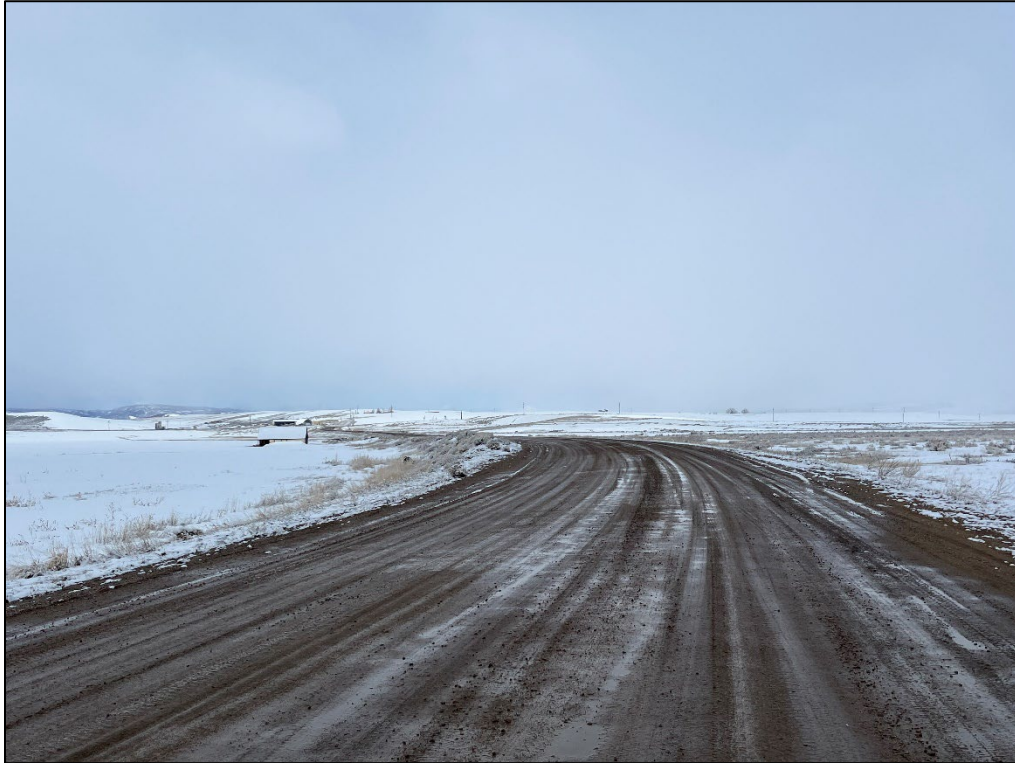
Photo 8: View west of the TAHR.

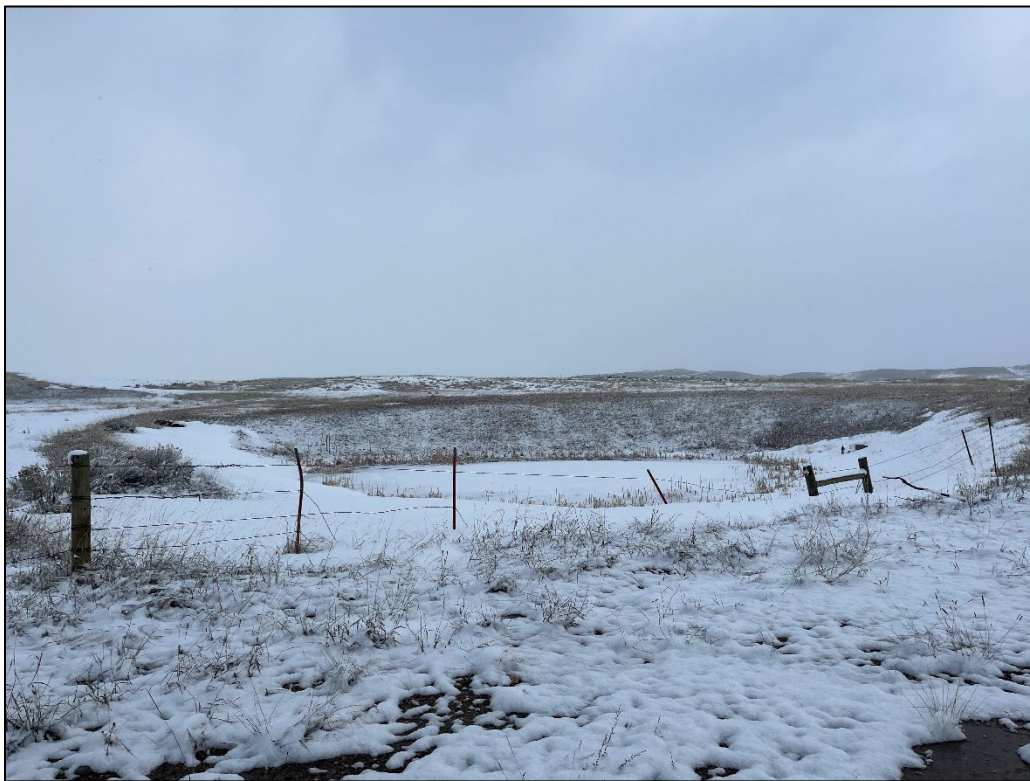
Truck Loop Pond 001 was functioning properly (Photo 9). Rail Loop Pond 002 was inaccessible due to the culvert construction happening along the Sage Creek Trail. Culverts within the previously released Tracks to Trails area are still under construction by the City of Hayden. This area was turned over to the City of Hayden for recreational

Photo 9: View north of Truck Loop Pond 001.
