McClane Canyon Mine, C-1980-004, March 2024 Complete Inspection Report

PERMIT INFORMATION

INSPECTION INFORMATION

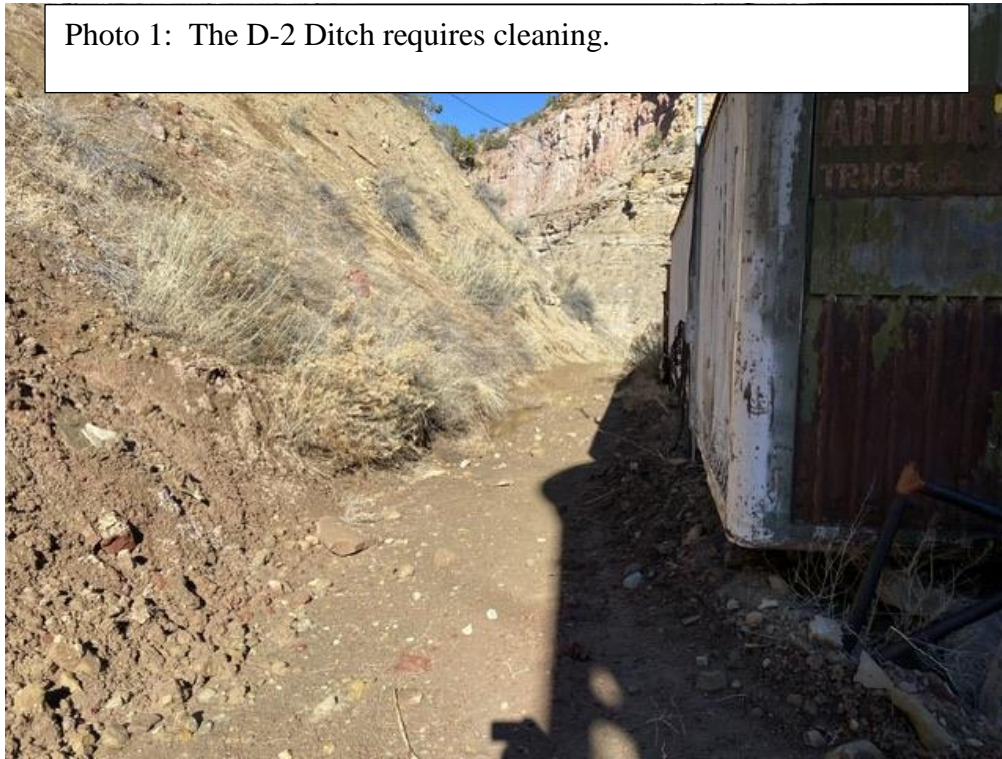
The D-2 Ditch is located on the south side of the portals shop. The ditch had sediment deposited in it from spring snowmelt. No water was in the D-2 Ditch during the inspection. **The D-2 Ditch needs to be cleaned as soon as possible to restore the full functionality of the water conveyance system. Please complete this maintenance item by April 18, 2024.**

Photo 1: The D-2 Ditch requires cleaning.

1. The D-2 Ditch on the south side of the portals shop has partly filled with sediment (Photo 1). The ditch needs to be cleaned to restore the ditch's full functionality to transport runoff as designed. Please clean the ditch by **April 18, 2024**.

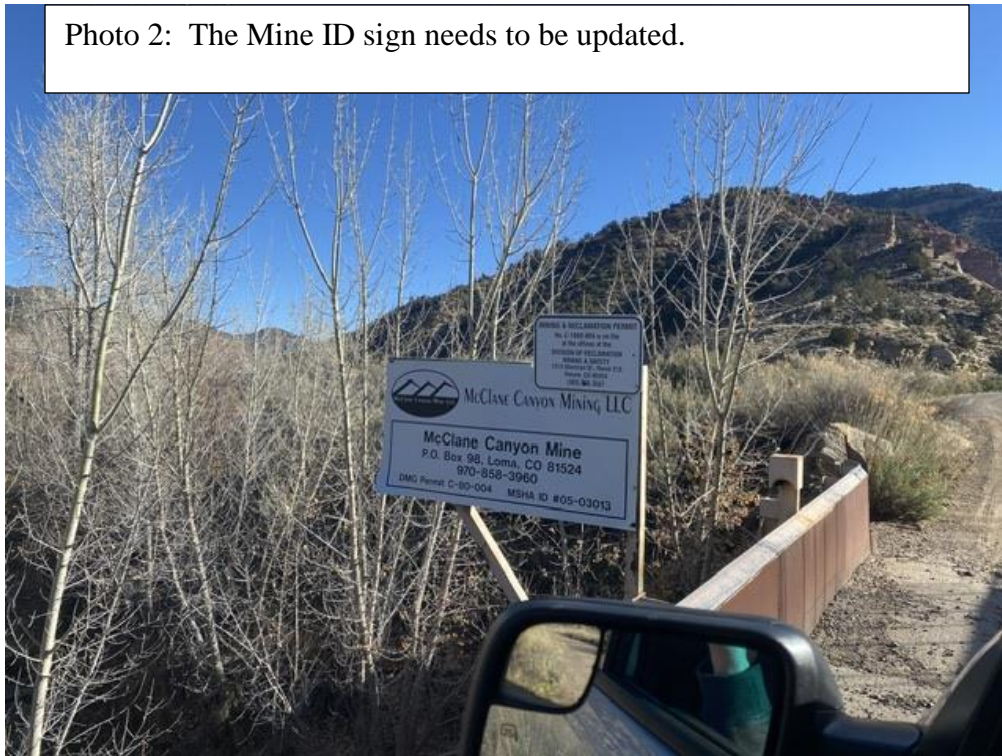
Photo 2: The Mine ID sign needs to be updated.

3. The Mine Identification sign posted to the left of the gated entrance over East Salt Creek needs to be updated with the current operator's name and address (Photo 2). Please update the mine identification sign no later than **May 24, 2024**.

The Mine Identification sign posted to the left of the gated entrance over East Salt Creek needs to be updated with the current operator's name and address. Please update the mine identification sign no later than **May 24 2024**.

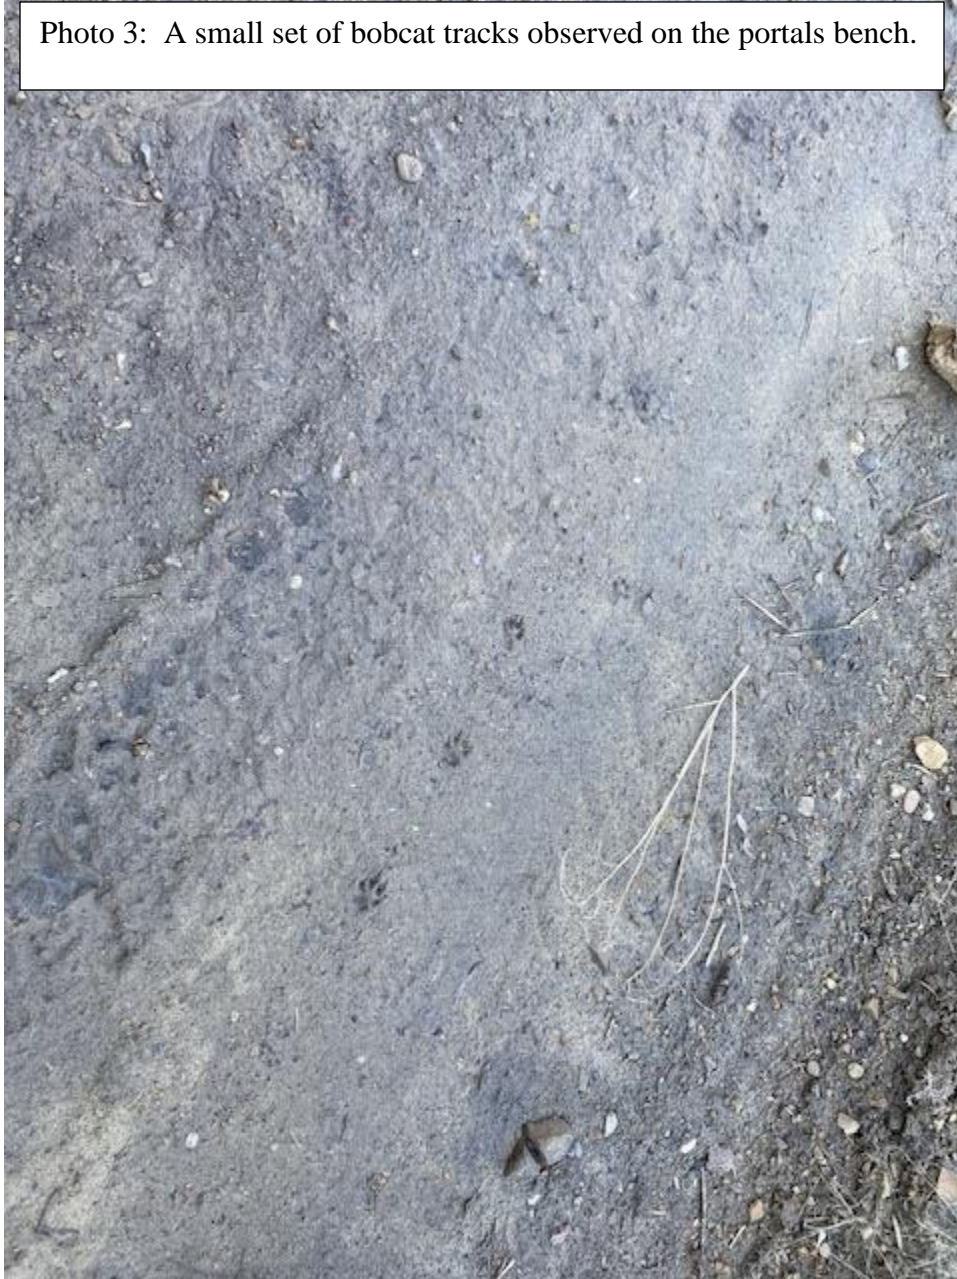
throughout the inspection of the mine site, several sets of track from deer, elk and bobcats (Photo 3) were observed.

Photo 3: A small set of bobcat tracks observed on the portals bench.

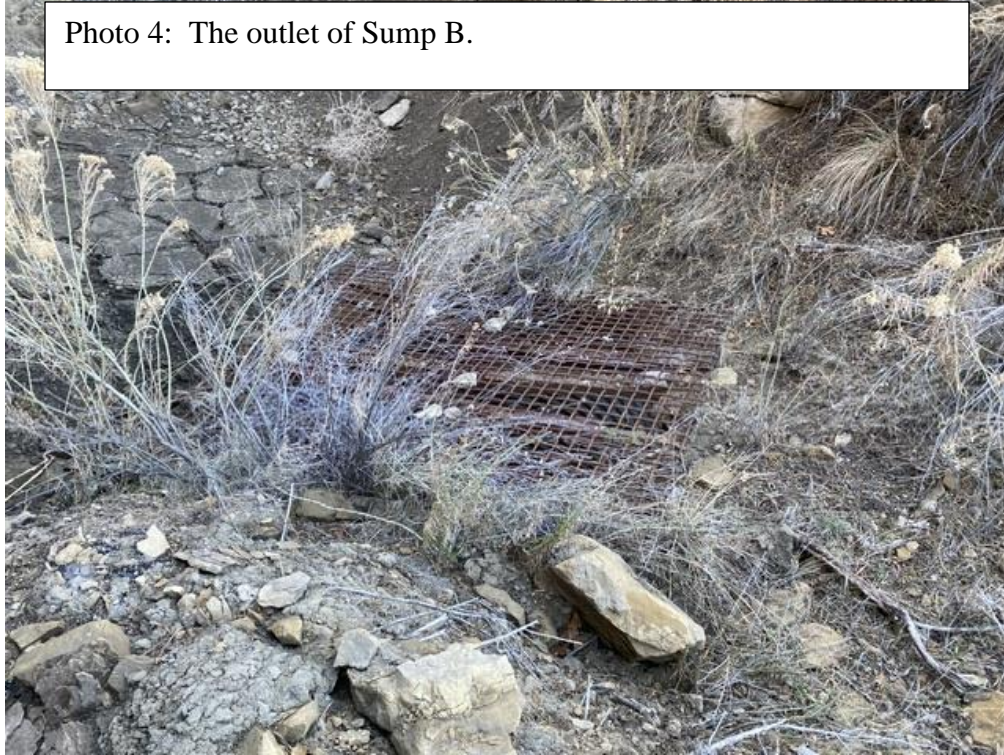
Sump A is located at the northeast corner of the portals area. Sump A also diverts clear water from upstream to a diversion underneath the portals pad. Sump A was not holding any water. The trash rack over the outlet was clear of debris (Photo 4). There were no indications of instability or erosion.

Photo 4: The outlet of Sump B.

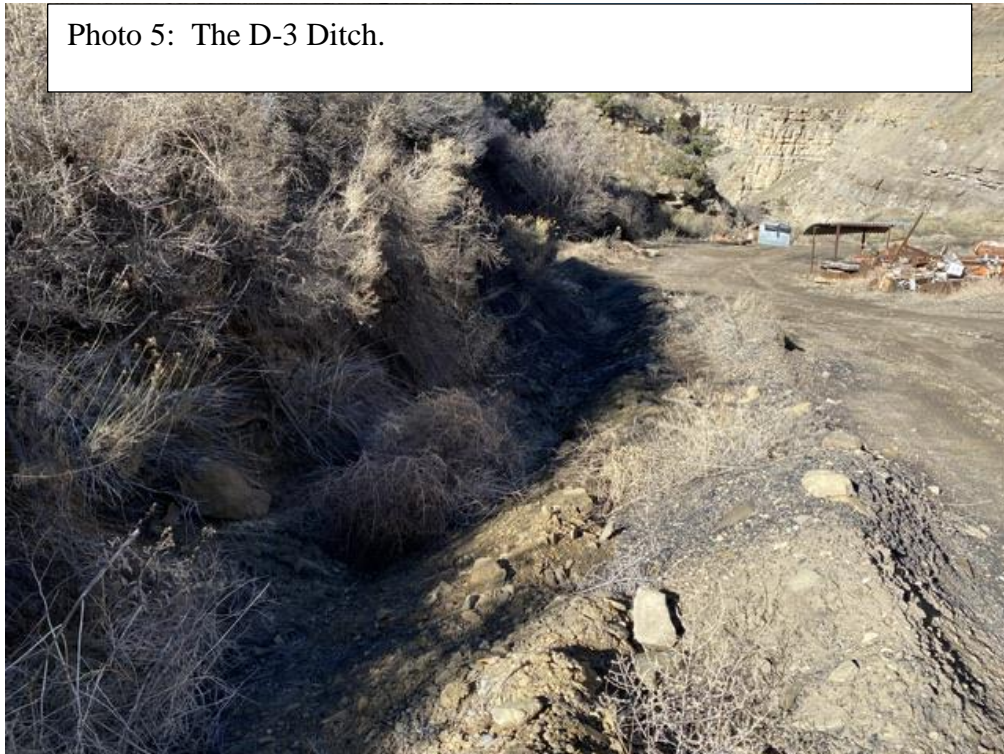
The D-3 Ditch is located west and below the portals shop. The ditch was observed to be stable and clear of blockages (Photo 5). There was no water in the ditch at the time of the inspection.

Photo 5: The D-3 Ditch.

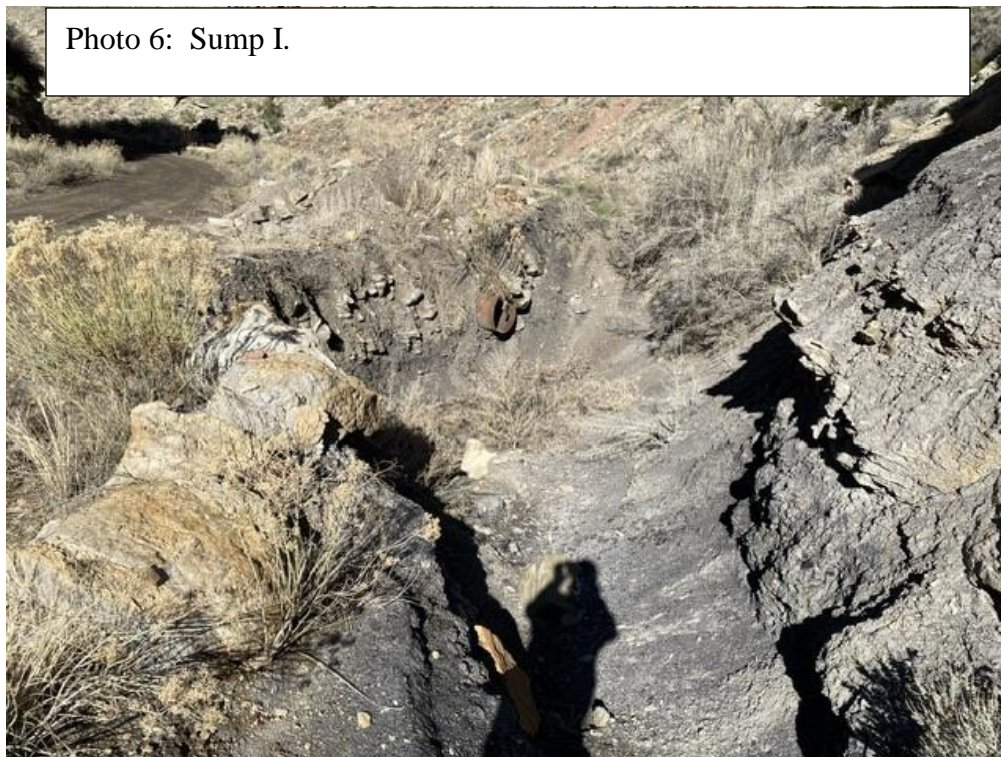
Sump I is located in the western end of the portals area. Sump I was dry at the time of the inspection (Photo 6). The sump was stable with no erosional features. The outlet for the sump was clear of debris.

Photo 6: Sump I.

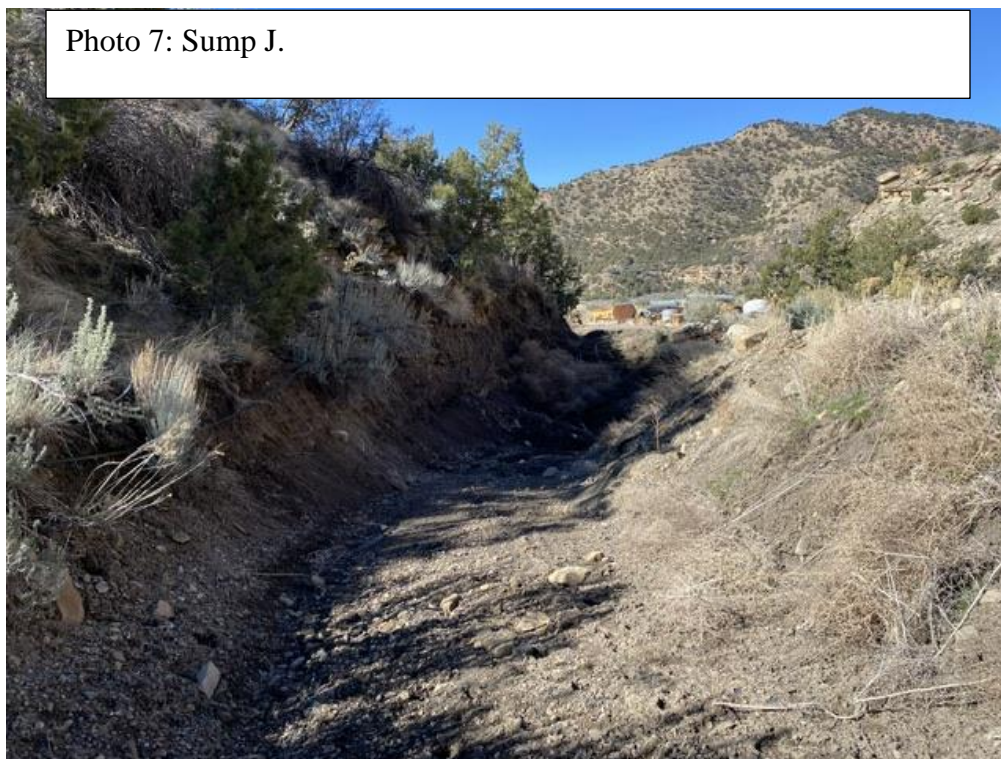
Sump J was muddy but not holding water during the inspection (Photo 7). The sump was stable with no erosion. The outlet from the sump into the D-6 ditch was observed to be clear of debris.

Photo 7: Sump J.

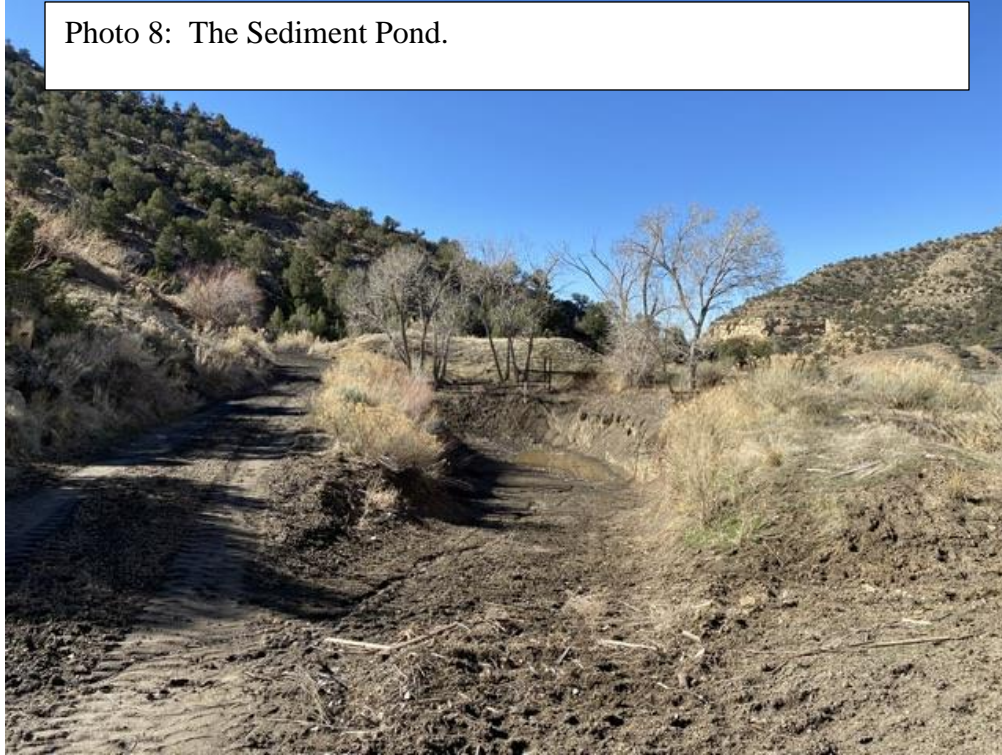
The sediment pond was holding a small puddle of water (Photo 8). The level of water in the pond was below the primary discharger outlet. The outlet was clear of debris. The pond's embankment was stable with vegetative cover. There were no erosional features observed. The Inlet from the D-6 ditch into the sediment pond was stable. There were no erosional issues.

Photo 8: The Sediment Pond.

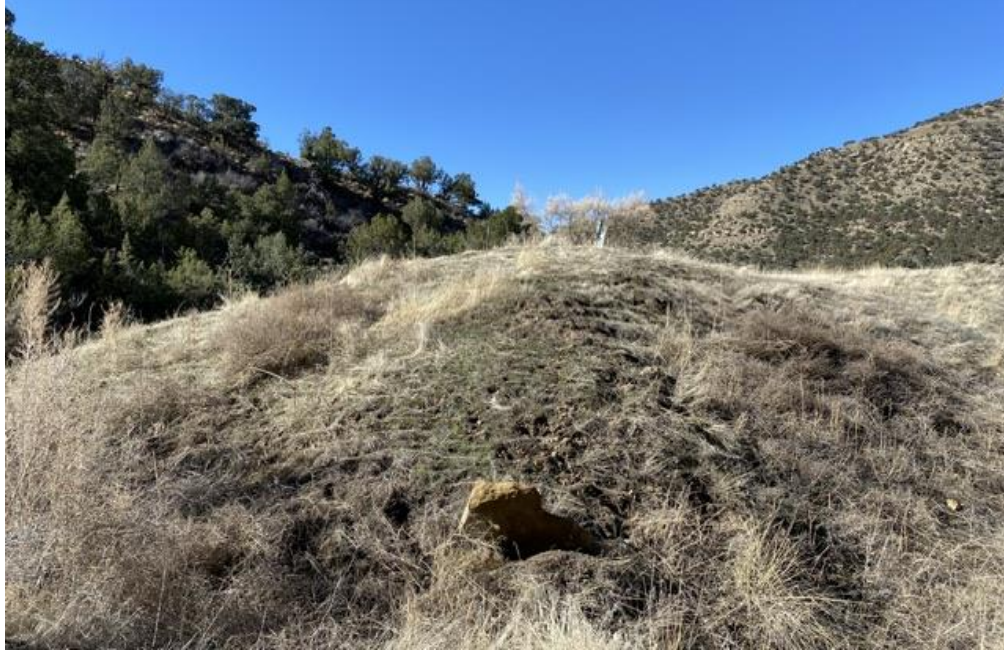
The topsoil pile is located just west of the sediment pond. The pile was stable with no erosional features (Photo 10). The perimeter berm was intact with no erosional issues. The topsoil pile marker was observed posted on top of the topsoil pile.

Photo 10: The Topsoil Pile.
