TRAPPER MINING INC.  
CRAIG, COLORADO

HORSE GULCH FILL  
QUARTERLY FILL CERTIFICATION

# **Horse Gulch Fill Quarterly Inspection Report**

**First Quarter 2024**

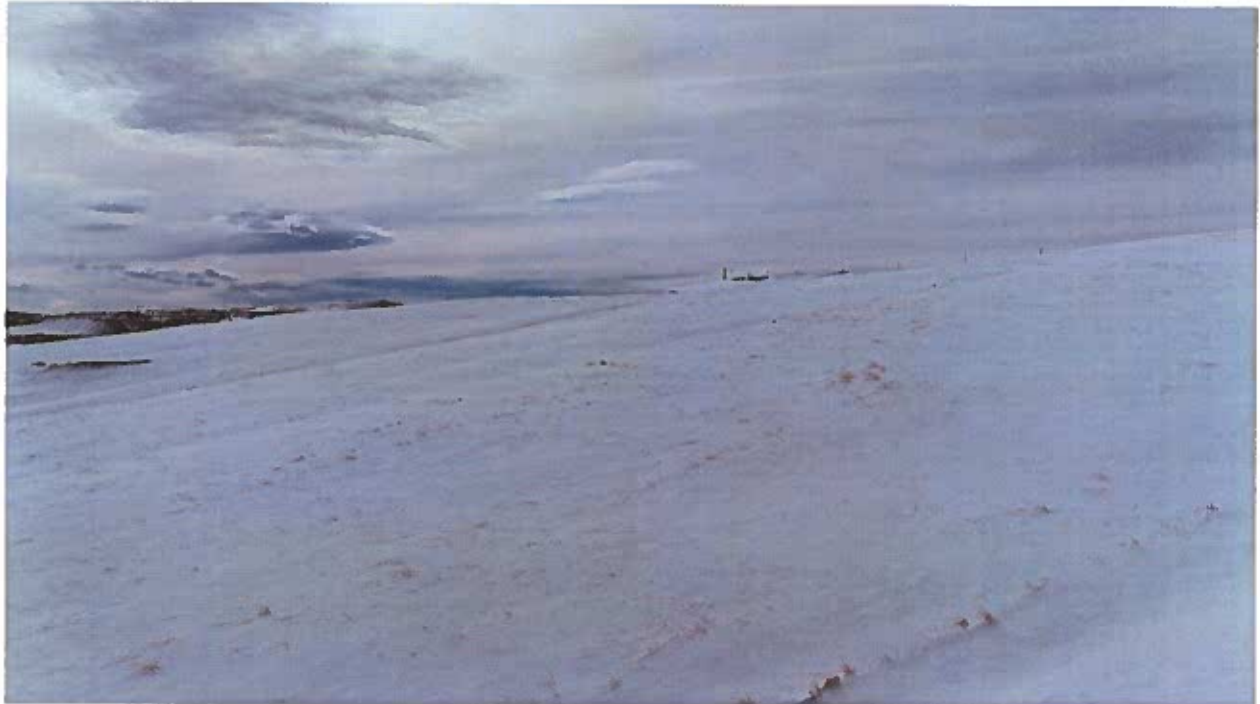
At the time of the inspection the area was covered with snow. No appearances of instability, structural weakness, or other hazardous conditions were observed. Both the southeast side of the fill and the northeast side of the fill were inspected this quarter (Photographs 1 and 2). The area where cracks were detected on the top south portion of the dump during the first quarter of 2013 inspection was checked. There was no additional cracking found.

*Photograph 1: North-east Side Looking South (3/28/2024)*

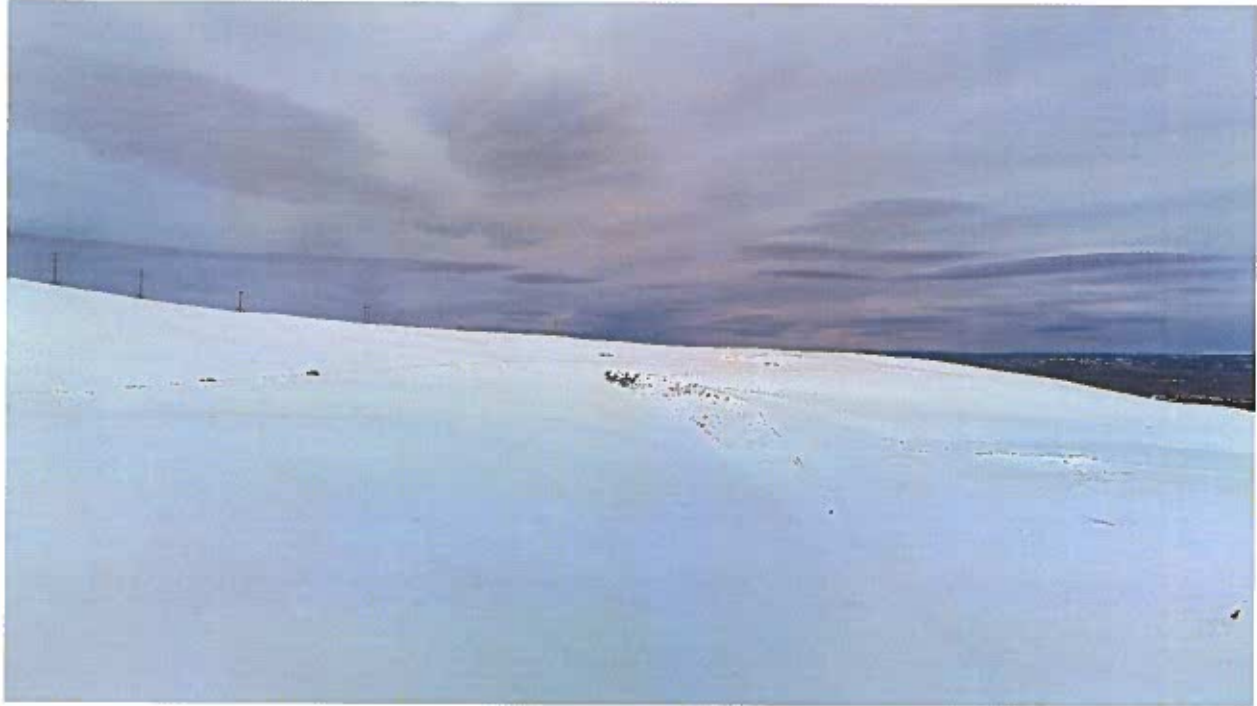
*Photograph 2: South Side Looking North (3/28/2024)*

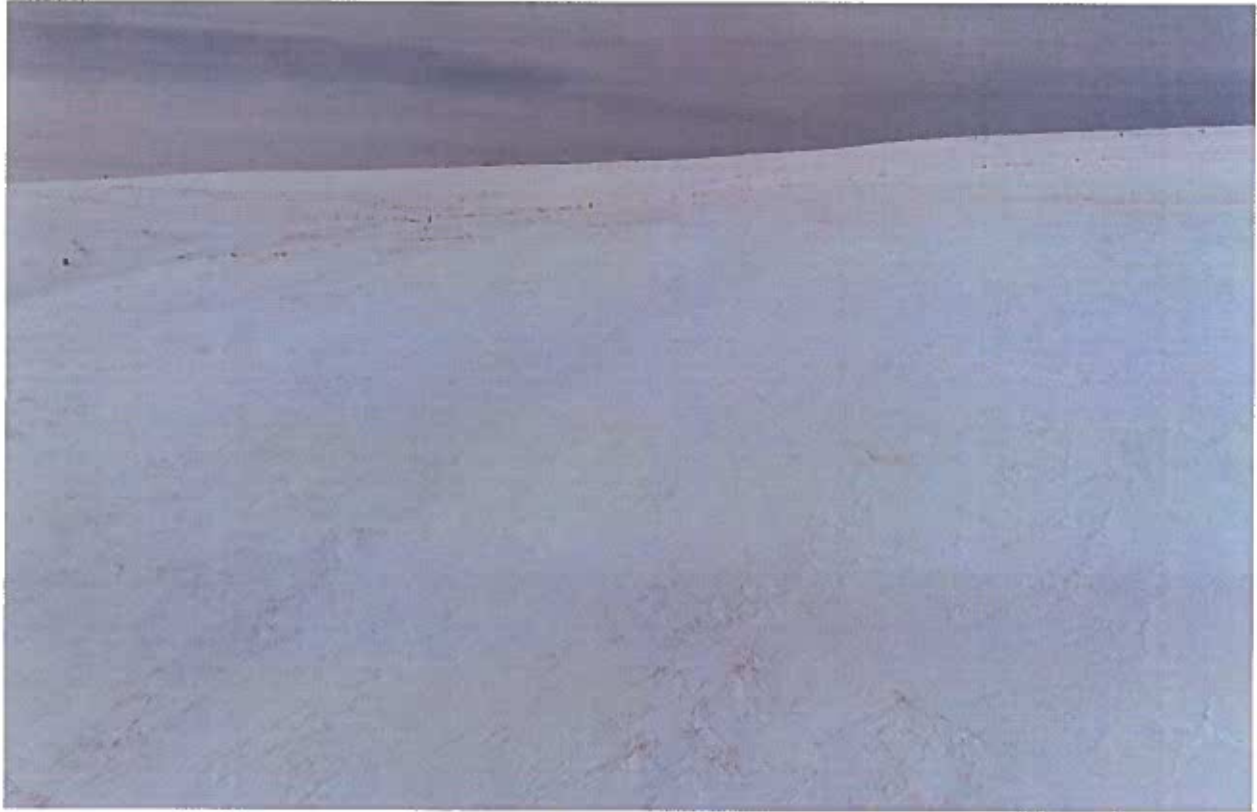
There was no placement of material or contour work done on the fill this quarter. All the required material for the fill has been placed and compacted. It is anticipated there will be no more additional fill material placed on the fill.

Photograph 3 depicts the east facing slope of the fill.

*Photograph 3: East Side of the Fill Looking South-west (3/28/2024)*
