## Additional Surface Water Monitoring Locations Required Letter, Grassy Valley, M1980-244

**Photographic Log - GV06 032824\_V2.pdf**  
1696K

## PHOTOGRAPHIC LOG

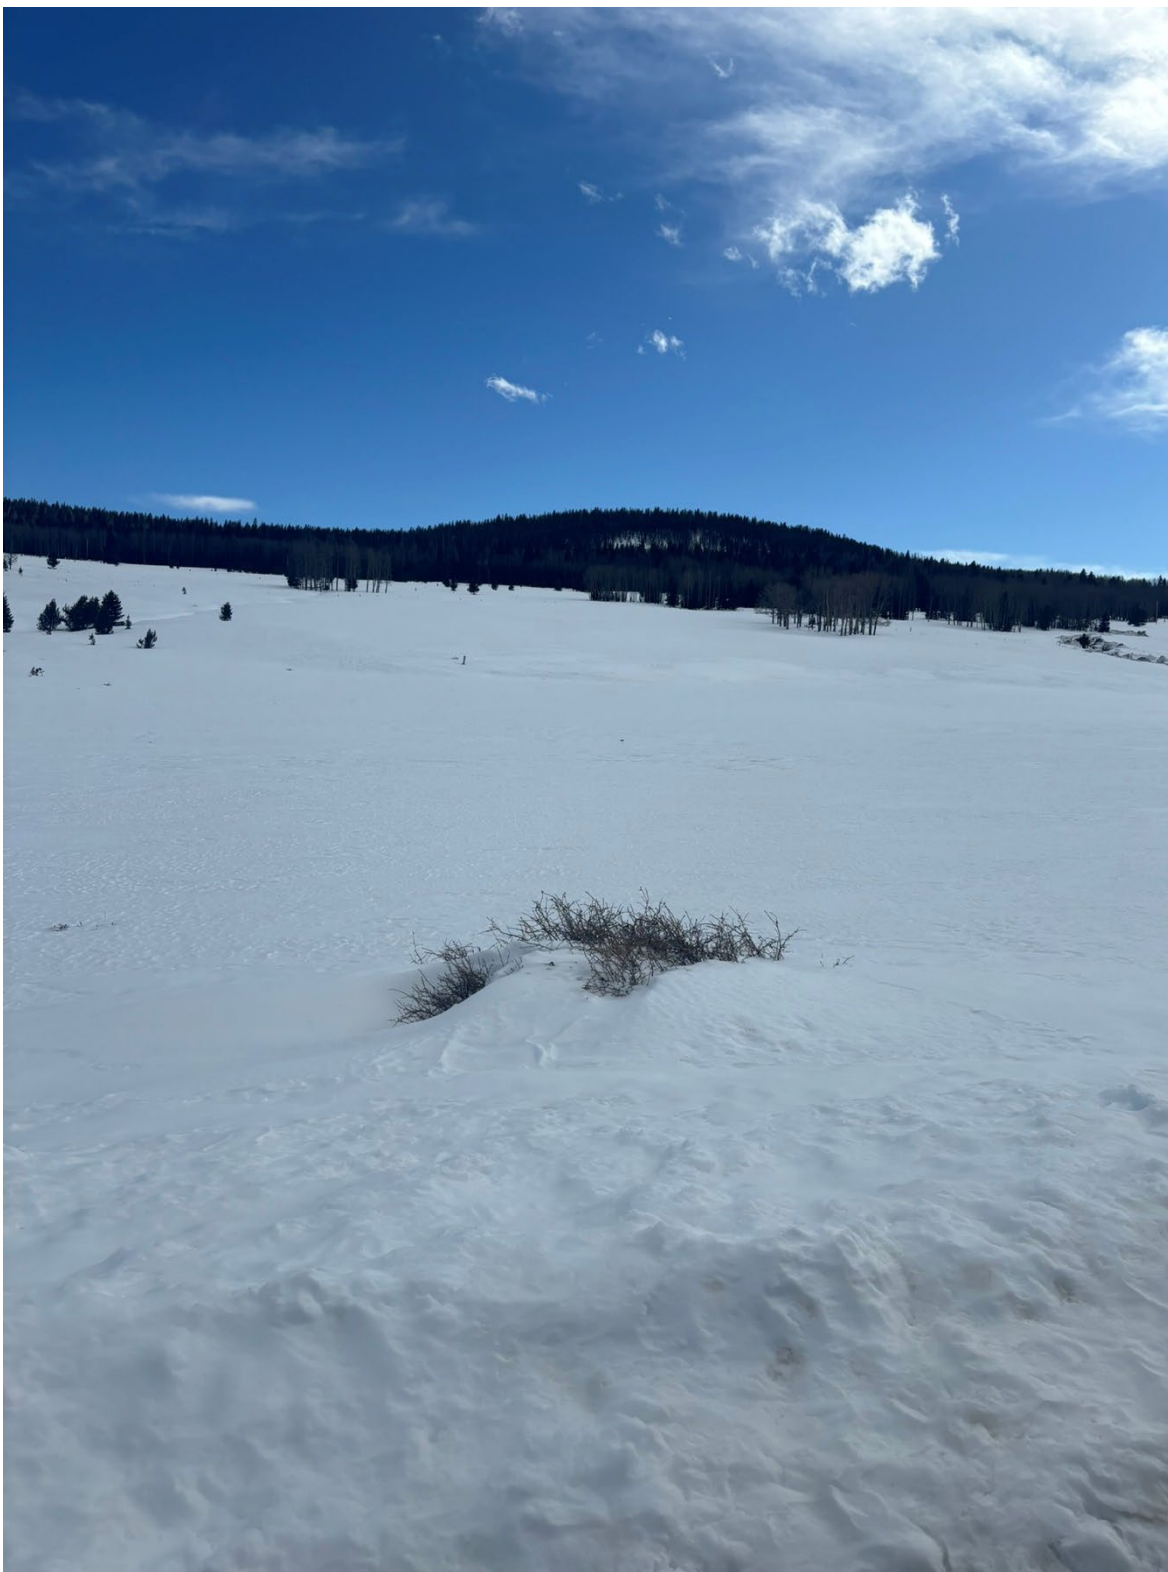
Photograph 1: View of the GV-06 surface water monitoring location, looking south. Photo taken 3/28/2024 at approximately 15:45 MDT.

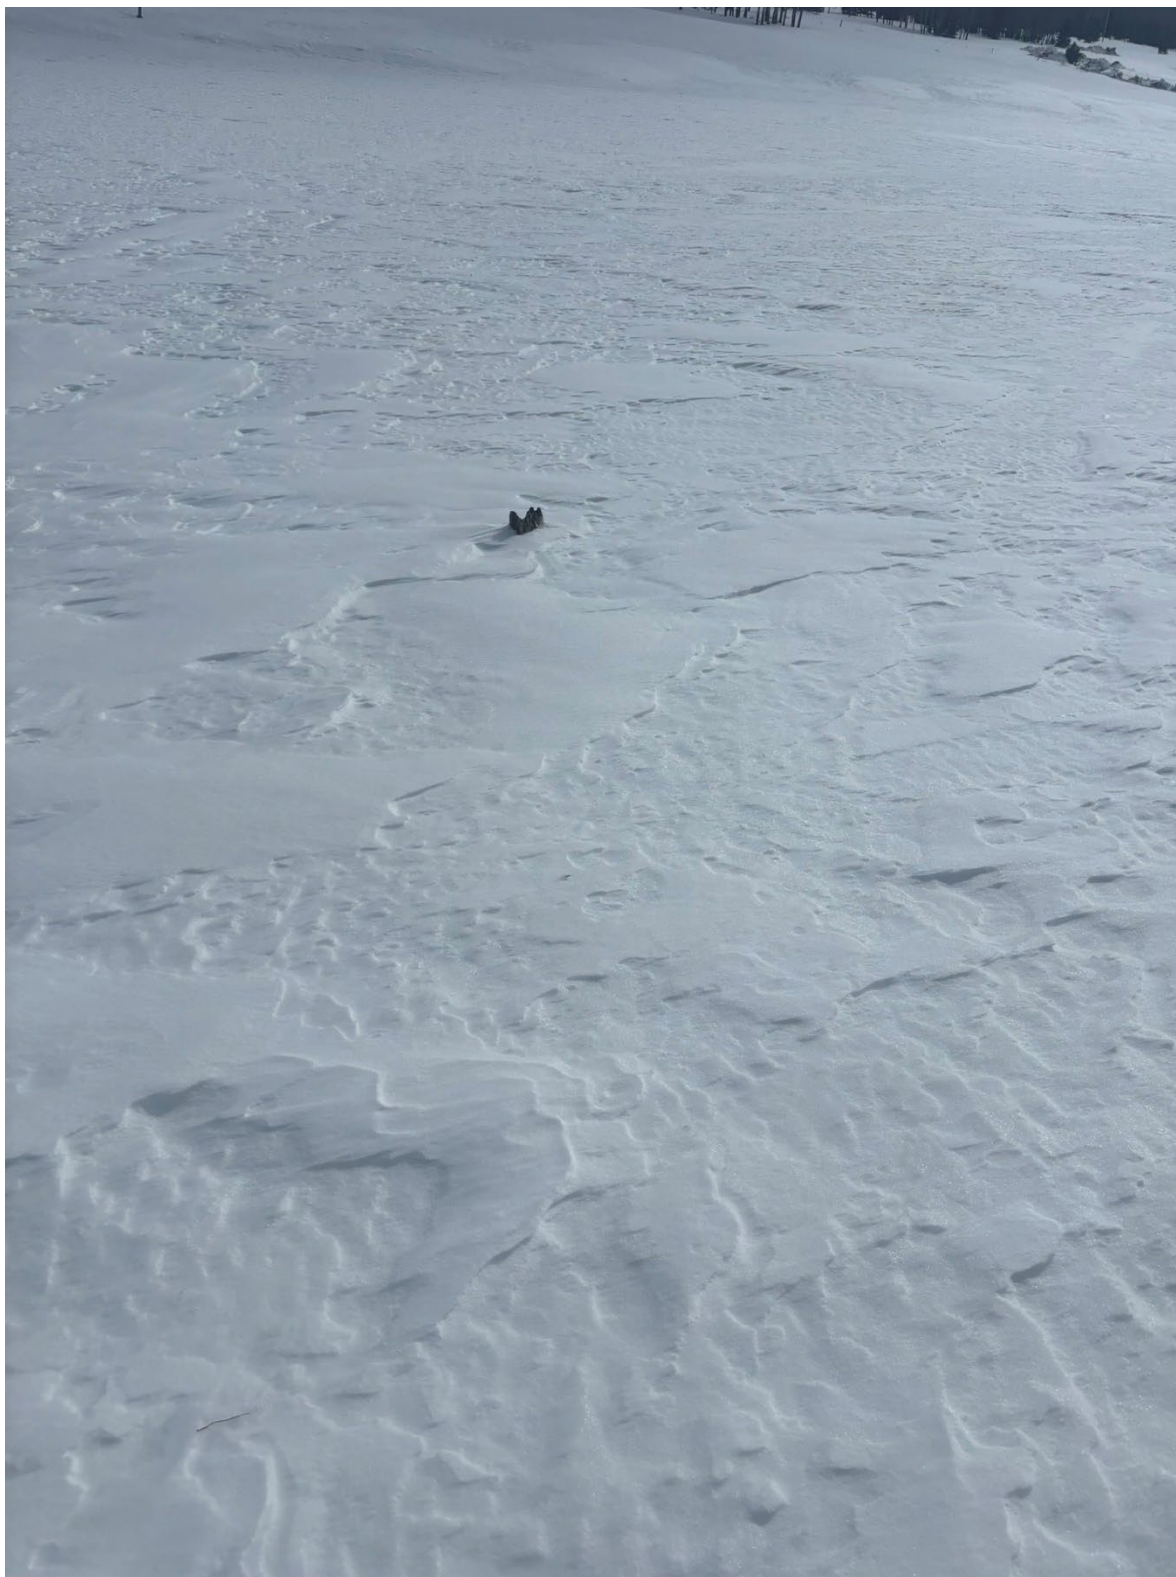
Photograph 2: View of the GV-06 surface water monitoring location, looking southwest. Photo taken 3/28/2024 at approximately 15:45 MDT.

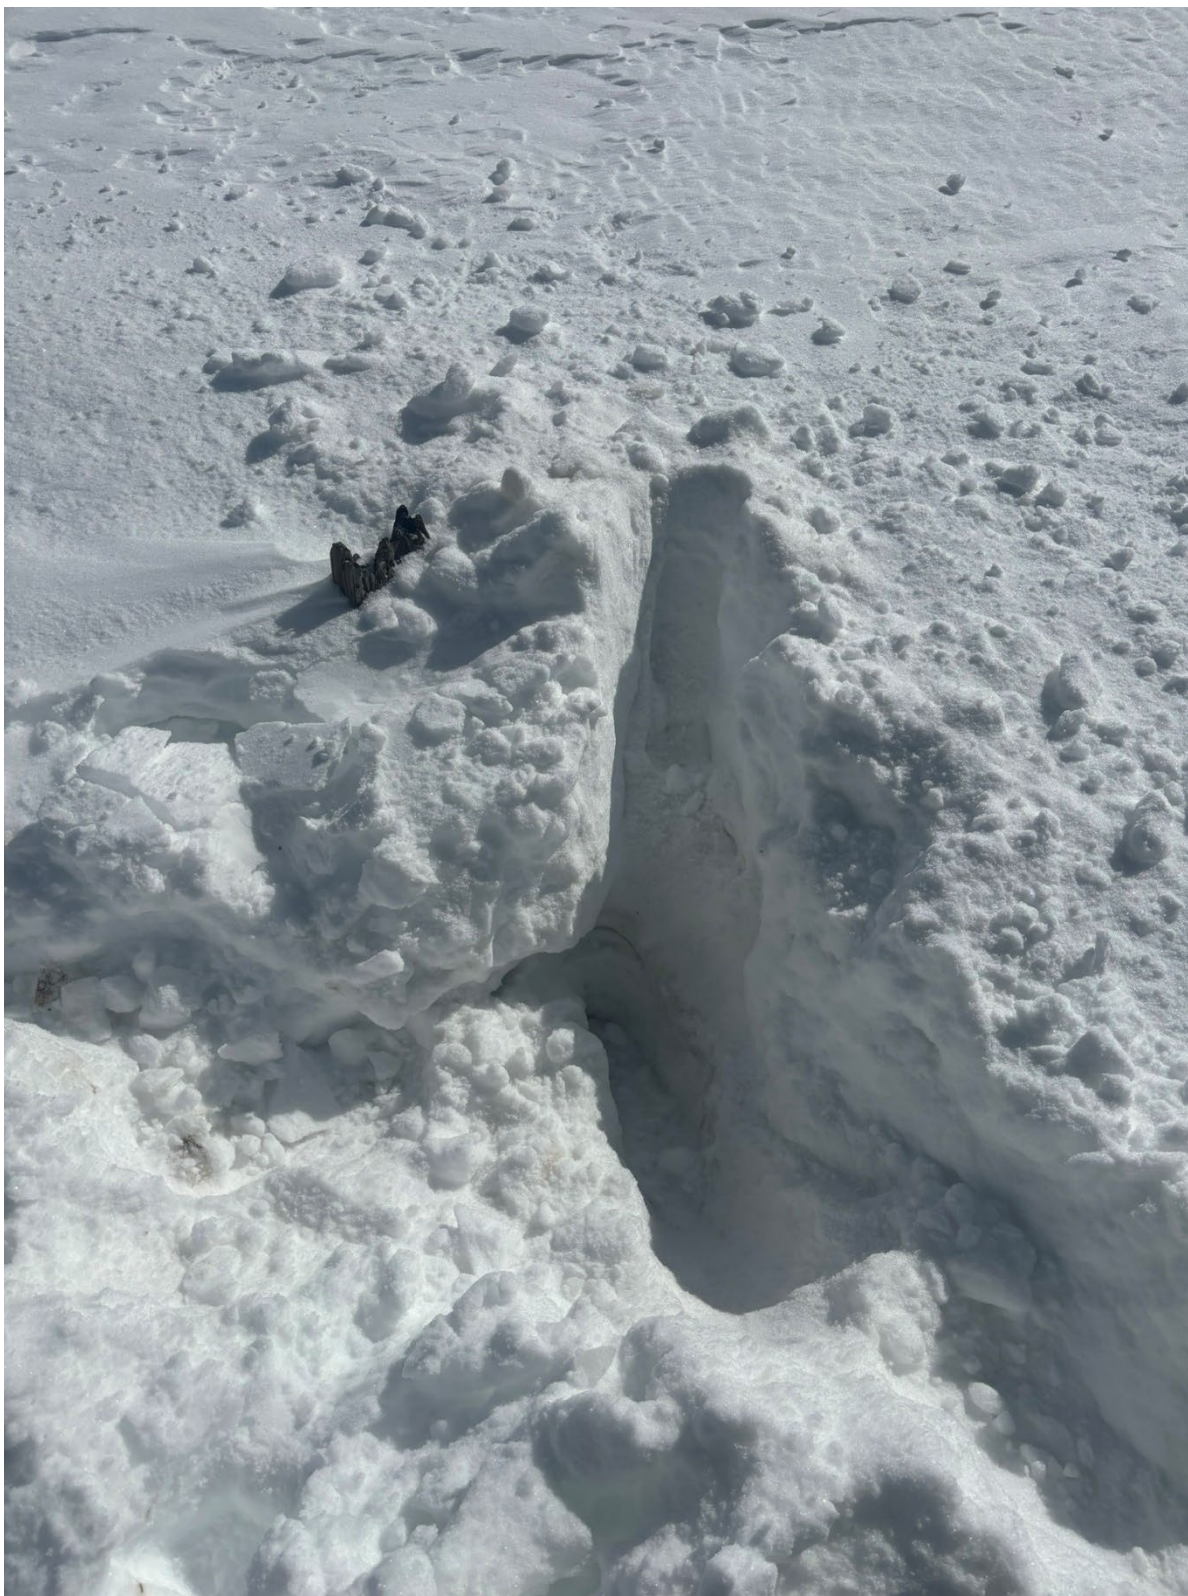
Based on historic coordinates of the GV-04 location, it appears that the GV-06 and GV-04 locations have been combined. There was minimal lateral distance between the GV-06 location and the coordinates for the GV-04 location, so they were assumed to be the same.

Photograph 3: View of the GV-06 surface water monitoring location after snow and ice was removed. No flowing water was observed at the location. Photo taken 3/28/2024 at approximately 15:45 MDT.

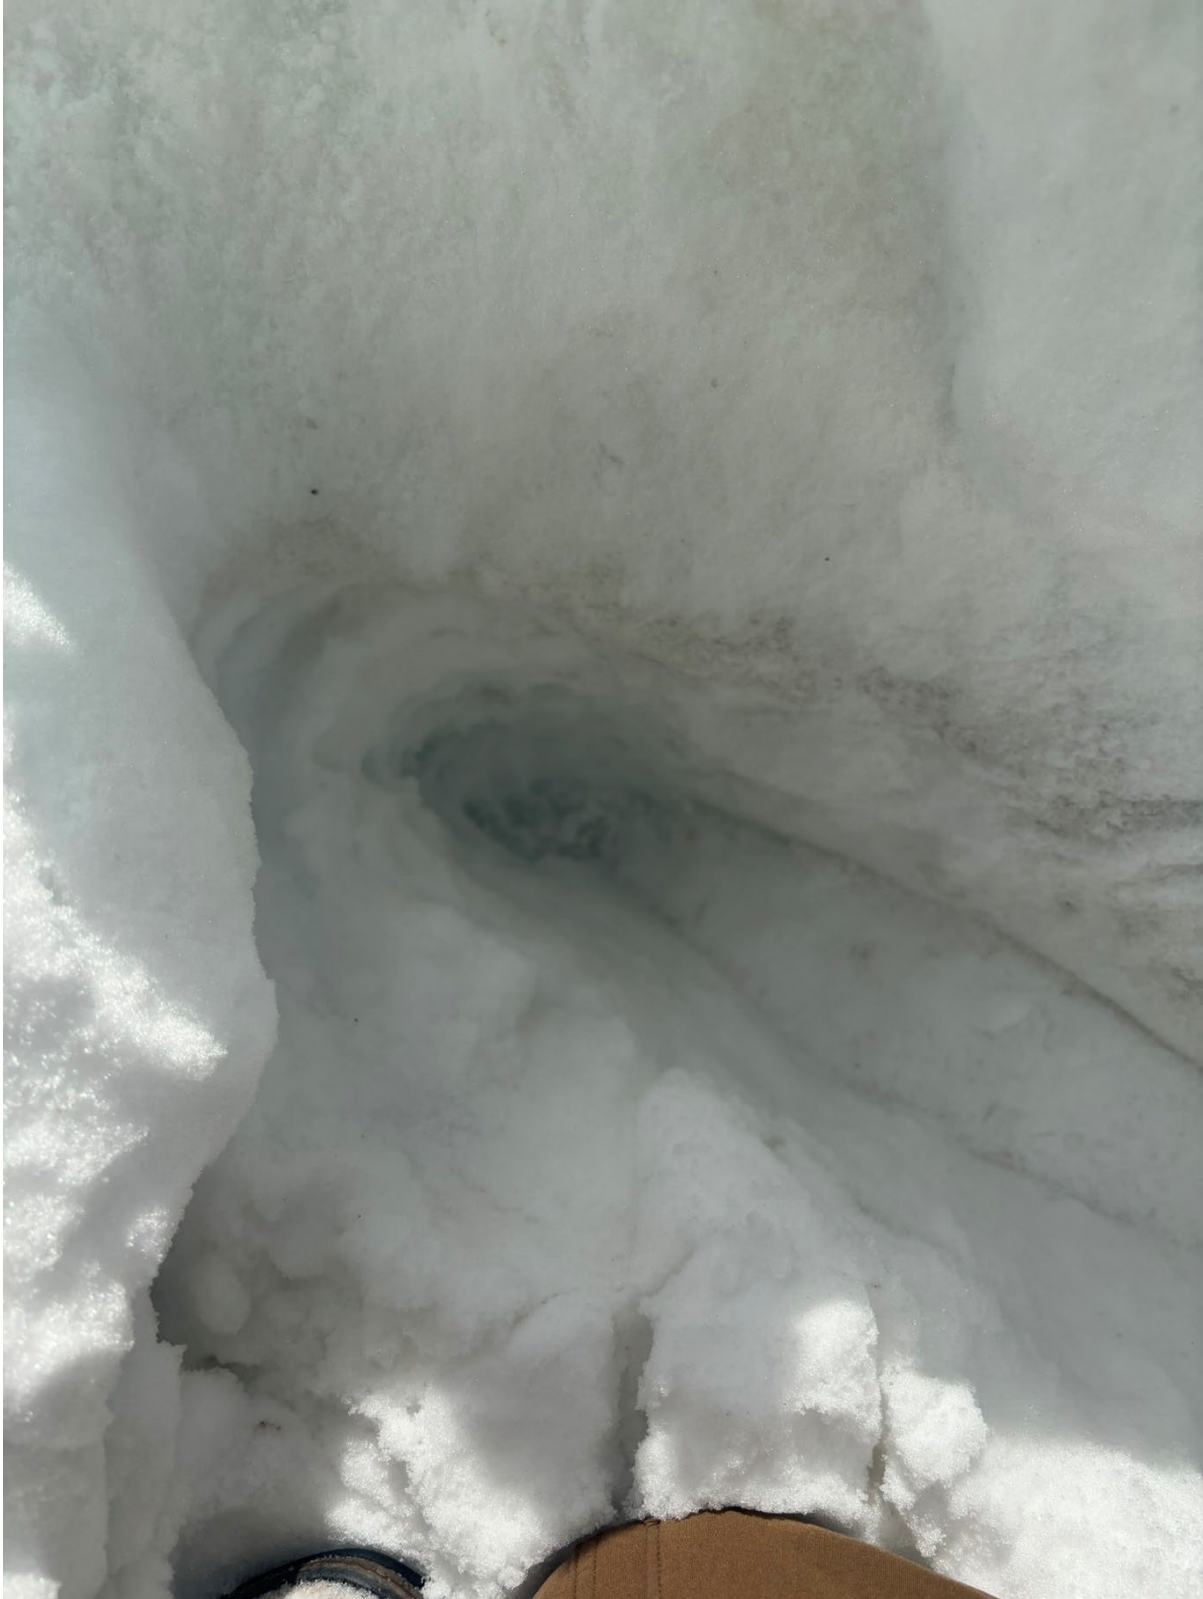
Photograph 4: View of the GV-06 surface water monitoring location after snow and ice was removed. No flowing water was observed at the location. Photo taken 3/28/2024 at approximately 15:45 MDT.

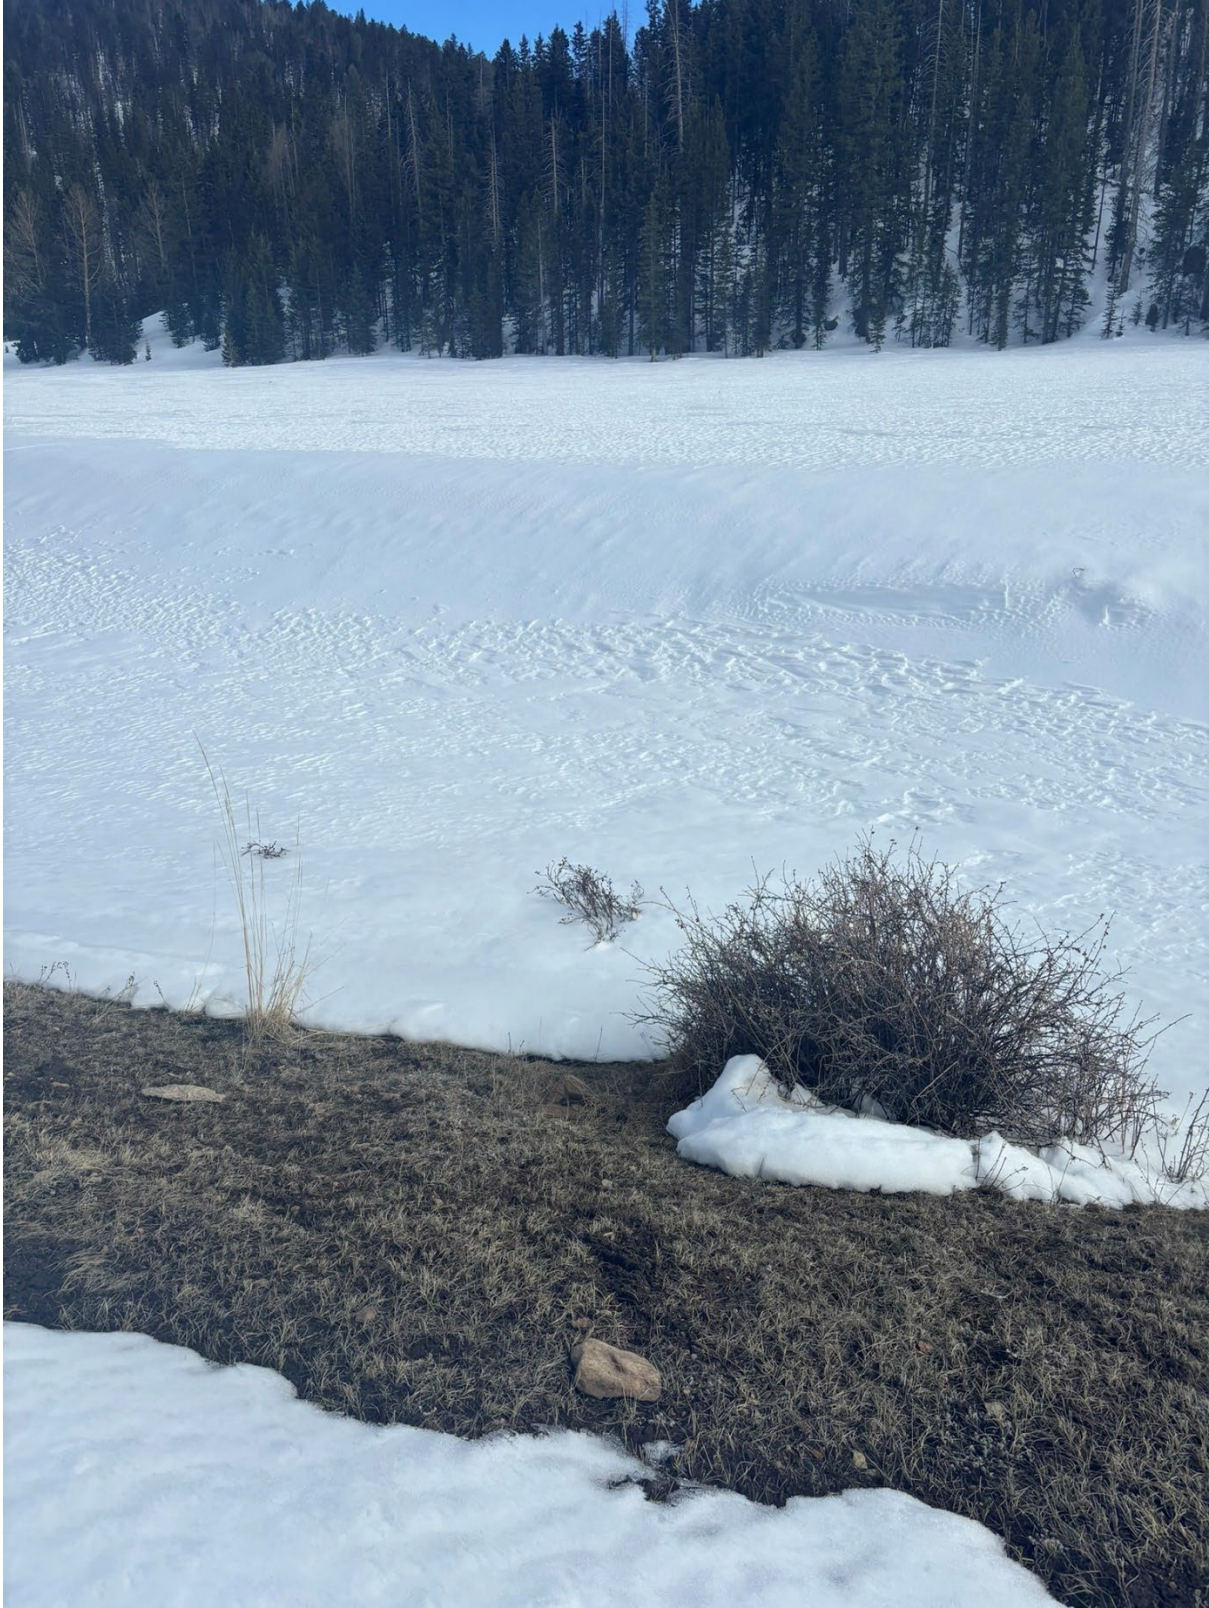
GV-4.5 Spring and GV-05 are located on private property so only a visual observation from the county road could be conducted. Based on field observations, it's anticipated that water was not flowing at these locations at the time of inspection. CC&V is currently reviewing historical records to identify if an easement is in place that would allow access to these locations.

Photograph 5: View of the suspected location of the GV-4.5 Spring looking south. Photo taken 3/28/2024 at approximately 15:55 MDT.

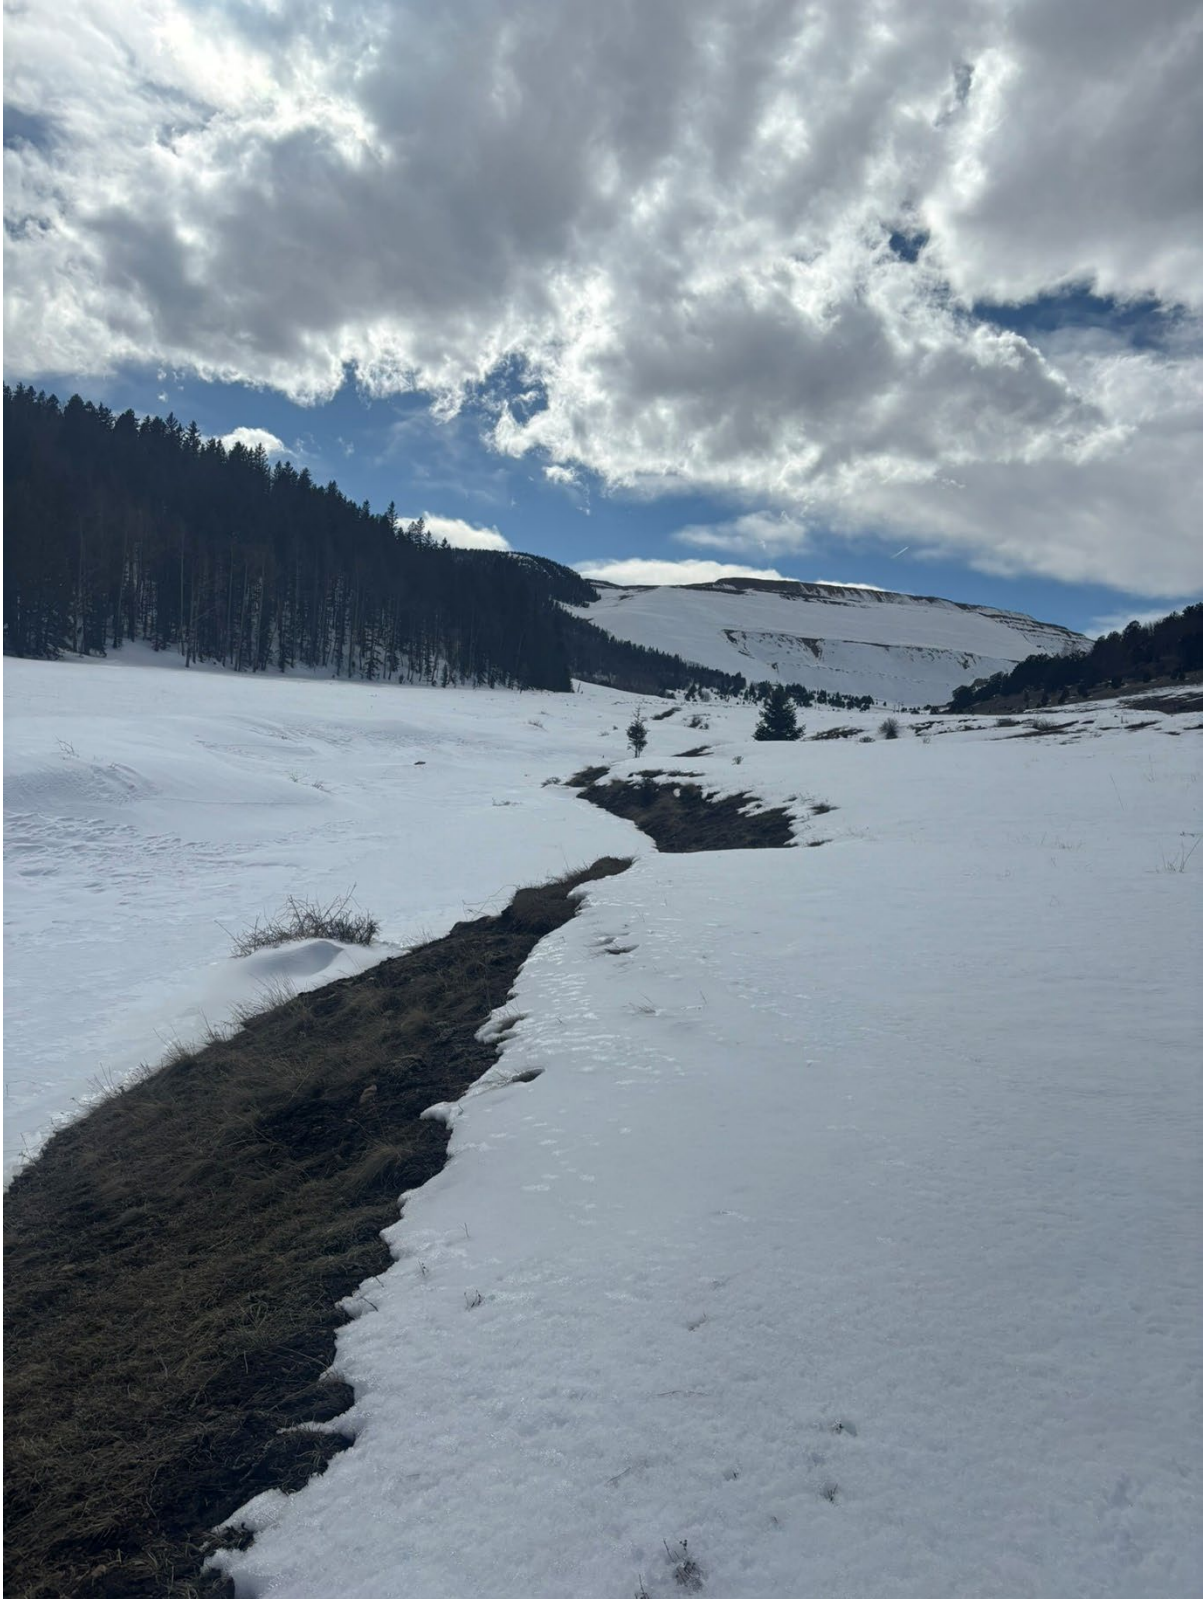
Photograph 6: View of the suspected location of the GV-4.5 Spring looking southwest showing snow accumulation. Photo taken 3/28/2024 at approximately 15:55 MDT.

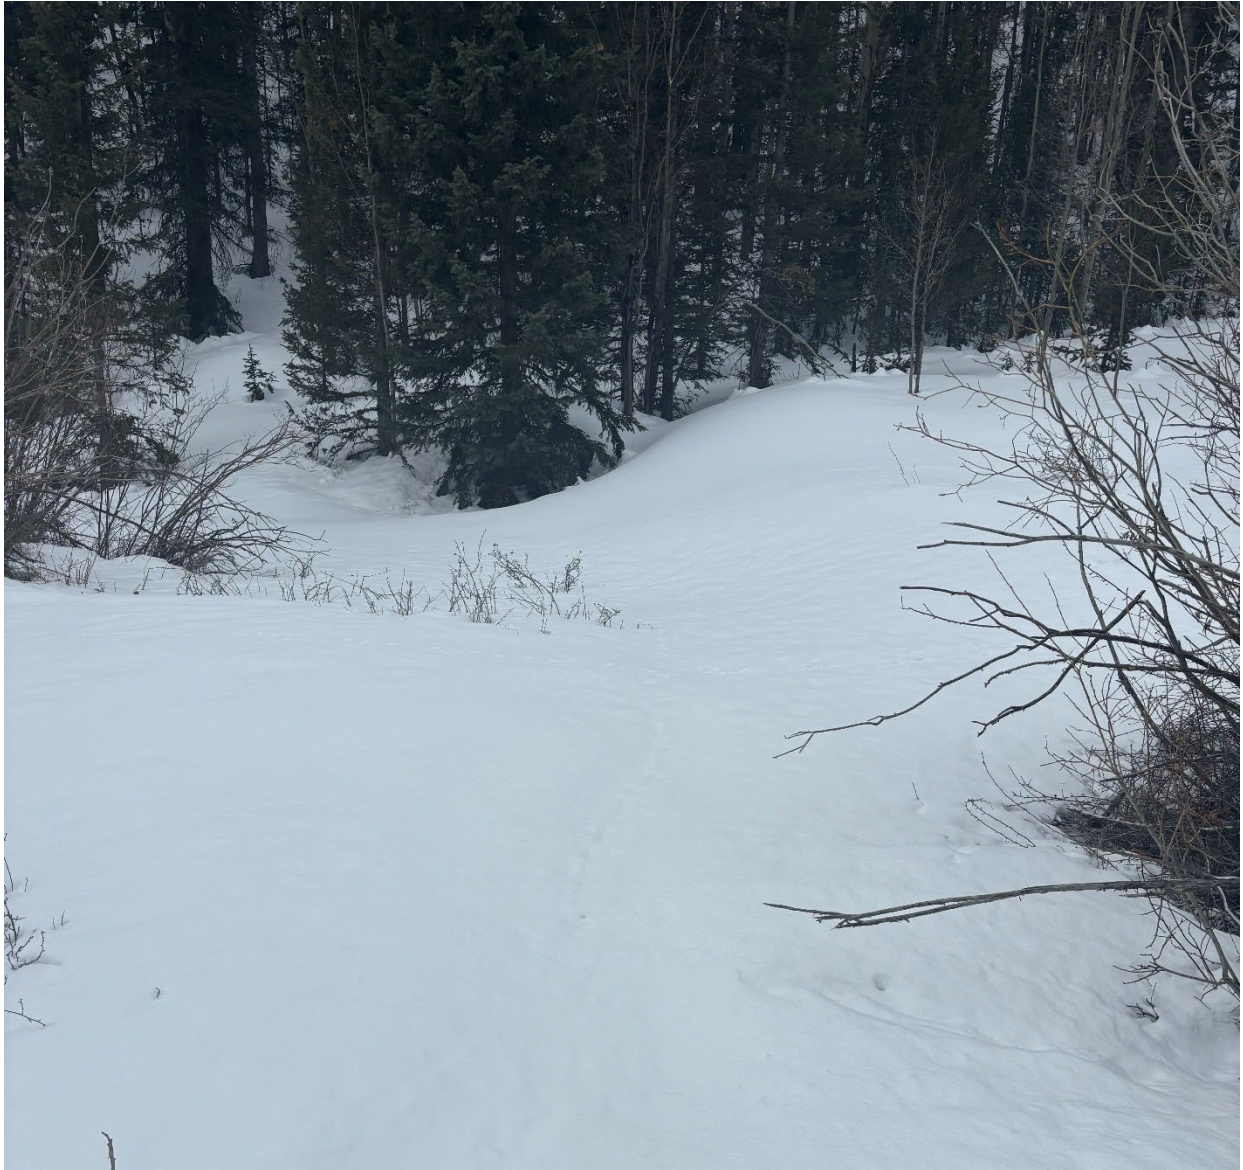
Photograph 7: View of the suspected location of the GV-05 looking south showing snow accumulation.  
Photo taken 3/28/2024 at approximately 15:55 MDT.
