PERMIT INFORMATION

Permit Number: C-1981-015 Mine Name: Fruita No 1 & 2 Operator: Dorchester Coal Company Operator Address: Greg Lewicki 9054 South Forrest Drive Highlands Ranch, CO 80126	County: Mesa Operation Type: Underground Permit Status: Revoked Ownership: Private
	Operator Representative Present: NA
Operator Representative Signature: (Field Issuance Only)

Inspection Start Date: March 21, 2024 Inspection Start Time: 11:05 Inspection End Date: March 21, 2024 Inspection End Time: 11:45		Inspection Type: Coal Complete Inspection Inspection Reason: Normal I&E Program Weather: Clear	
Joint Inspection Agency: None		Joint Inspection Contacts: None	
Post Inspection Agency: None		Post Inspection Contacts: None	
Inspector(s): Clayton Wein	Inspector's Signature: <i>Clayton Wein</i>		
			Signature Date: 4/2/2024

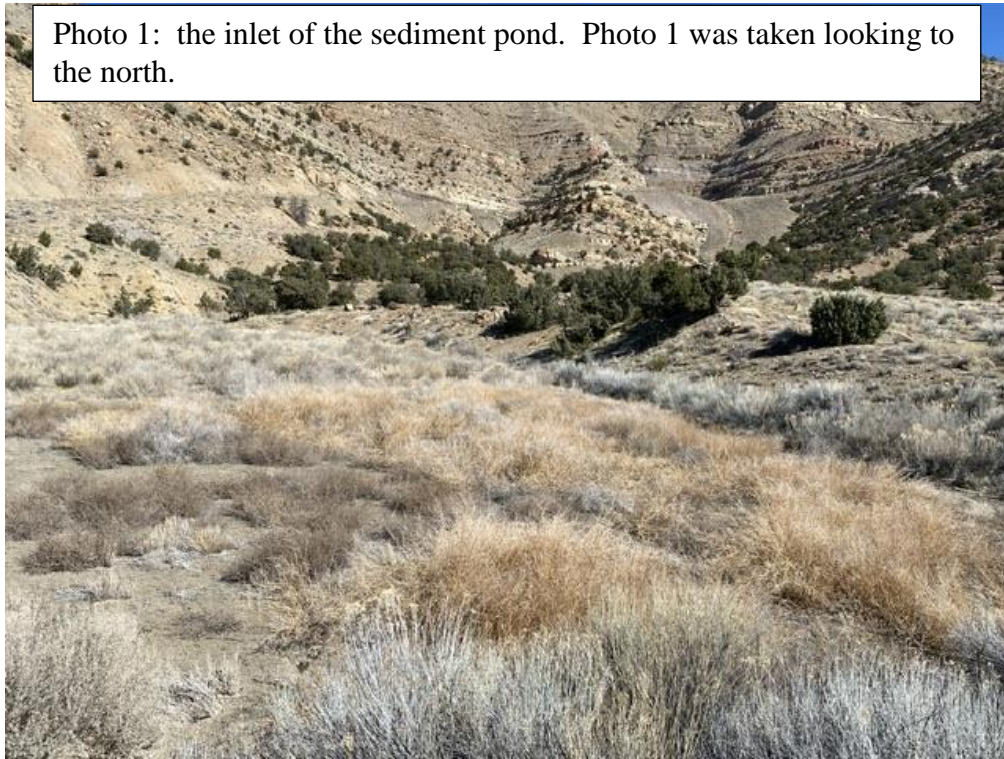
The sediment pond is located within the southern portion of the permit boundary. The pond will remain as a permanent feature. The pond was dry during the inspection (Photo 1). The embankment was stable with vegetative cover (Photo 2). There were no indications of erosion. The riprap lined outlet was clear of obstructions and able to function as designed.

Photo 1: the inlet of the sediment pond. Photo 1 was taken looking to the north.

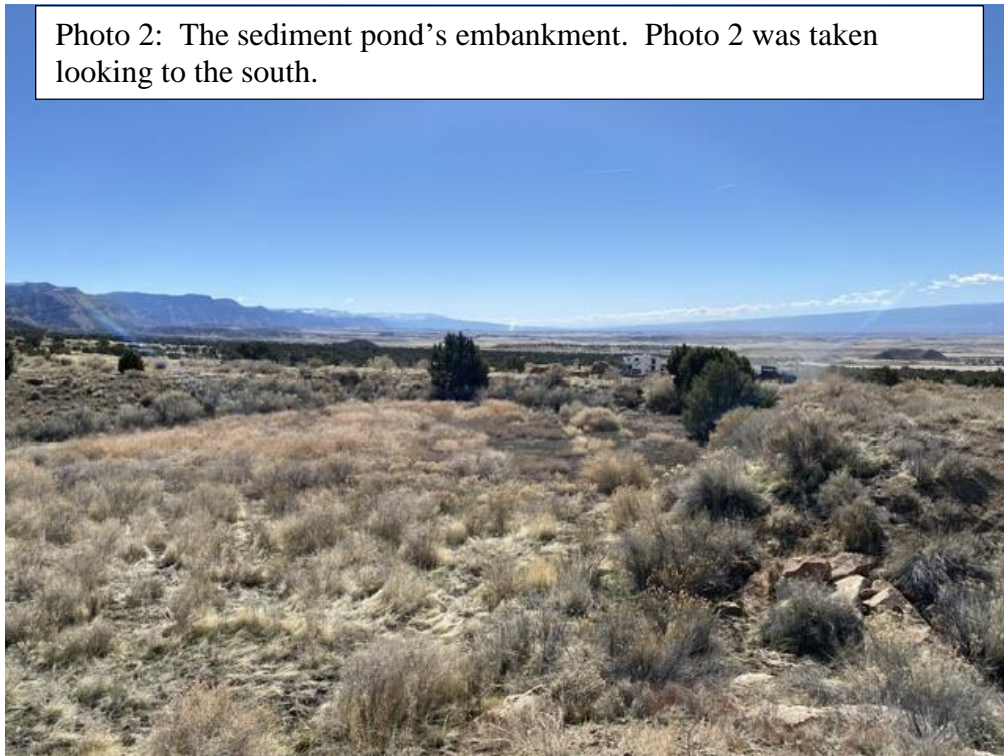
Photo 2: The sediment pond's embankment. Photo 2 was taken looking to the south.

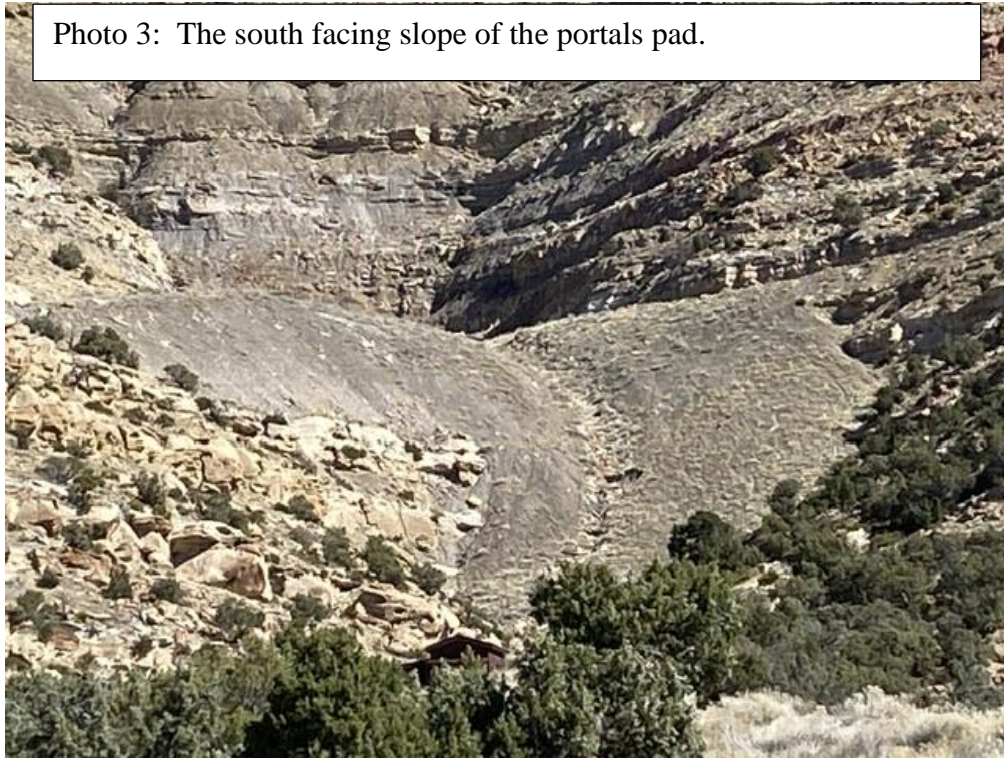
There is an armored channel extending from the top of the portals pad, down the steep slope to the drainage below, and then into the sediment pond (Photo 3). The channel was dry. The riprap liner appeared to be in good condition. There were no new erosional features identified.

The portals pad reclamation included sealing and backfilling the portals, roughening the pad surface and reseeding the pad. The reclaimed portals were stable with no erosional concerns. The pad was stable with vegetative cover. There were no new erosional features identified. The south slope of the portals pad was stable with sparse vegetative cover. Due to the steep slope and southern exposure, vegetation has had a difficult time growing in. The sparse vegetative growth has been documented in previous Division inspection reports. There were no indications of instability or new erosion on the slope.

Photo 3: The south facing slope of the portals pad.

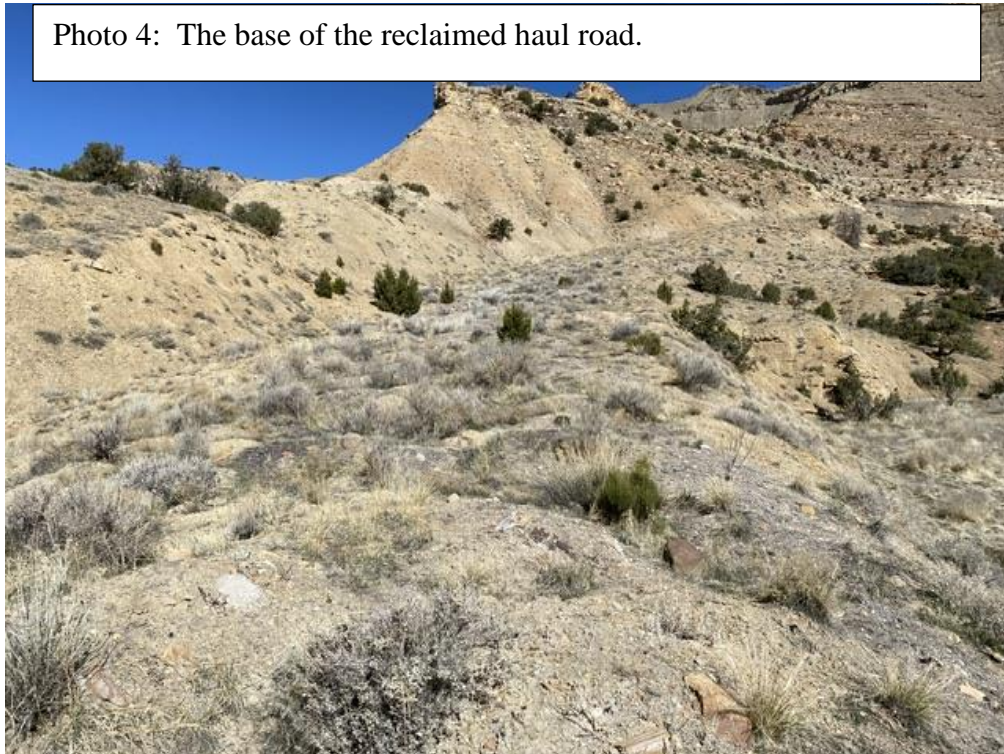
The haul road extended from the west side of the sediment pond up the steep slope to the portals bench (Photos 4 and 5). The haul road was reclaimed by roughening the surface and seeding. The roughened surface was utilized to help create micro climates for the vegetation. The reclaimed haul road was stable with vegetative cover. There were no indications of new erosion. An old erosional rill on the middle portion of the reclaimed haul

Photo 4: The base of the reclaimed haul road.

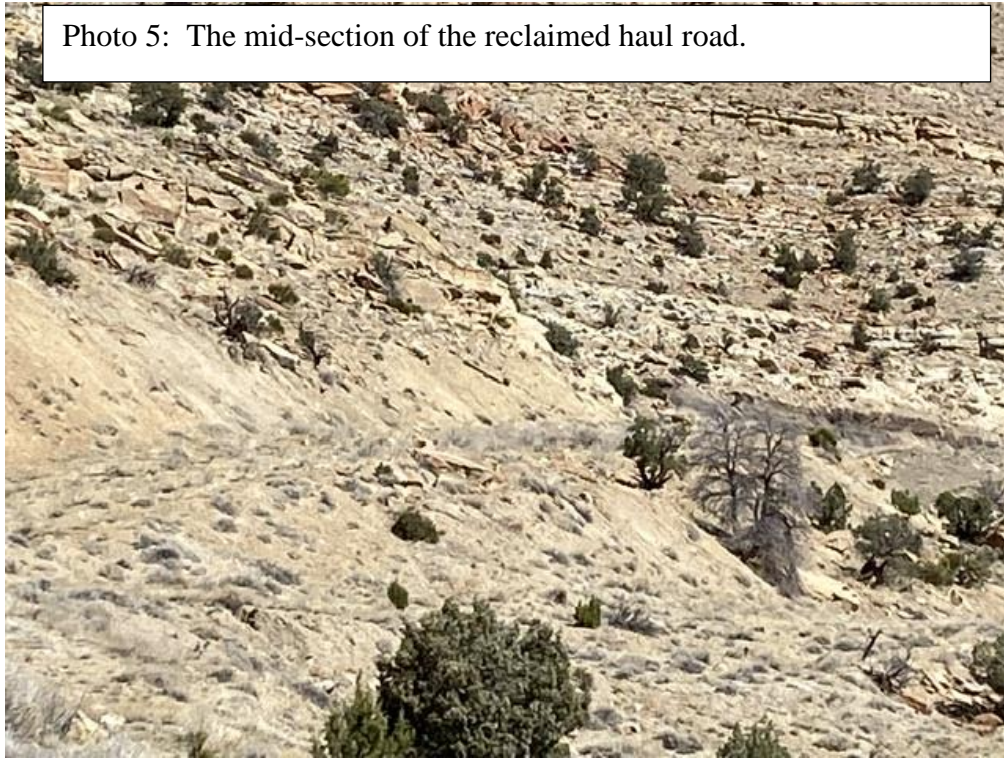
road has been documented in previous Division inspection reports. The rill had not enlarged in size. The rill appears to remain self-stabilized and transports runoff across the reclaimed haul road, down the drainage and into the sediment pond. There were no indications of offsite impacts and the rill was dry.

Photo 5: The mid-section of the reclaimed haul road.
