MINERALS PROGRAM INSPECTION REPORT

MINE NAME: Cortner Pit		MINE/PROSPECTING ID#: M-1986-159	MINERAL: Sand and gravel	COUNTY: Pueblo
INSPECTION TYPE: Surety Release Inspection		WEATHER: Clear	INSP. DATE: March 19, 2024	INSP. TIME: 09:50
OPERATOR: Martin Marietta Materials, Inc.		OPERATOR REPRESENTATIVE: Julie Mikulas	TYPE OF OPERATION: 112c - Construction Regular Operation	
REASON FOR INSPECTION: Surety Release Requested		BOND CALCULATION TYPE: Complete Bond	BOND AMOUNT: \$204,831.00	
DATE OF COMPLAINT: NA		POST INSP. CONTACTS: None	JOINT INSP. AGENCY: None	
INSPECTOR(S): Jocelyn Carter Jared Ebert		INSPECTOR'S SIGNATURE:

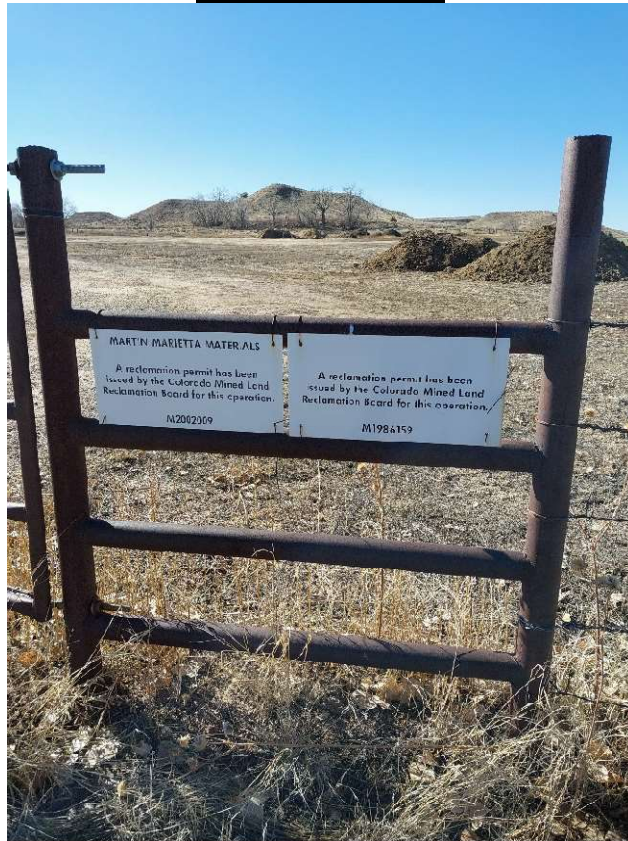
The mine sign is posted in accordance with Rule 3.1.12(1). There was no issue with the boundary markers that were viewed at the time of inspection; not all the boundary markers were verified during the inspection. The boundary marker located in the southwest corner of the permit area was viewed knocked over and should be replaced, see Photo #5 below.

Photo #1: The mine sign posted at the entrance gate on the south side of Cortner Rd.

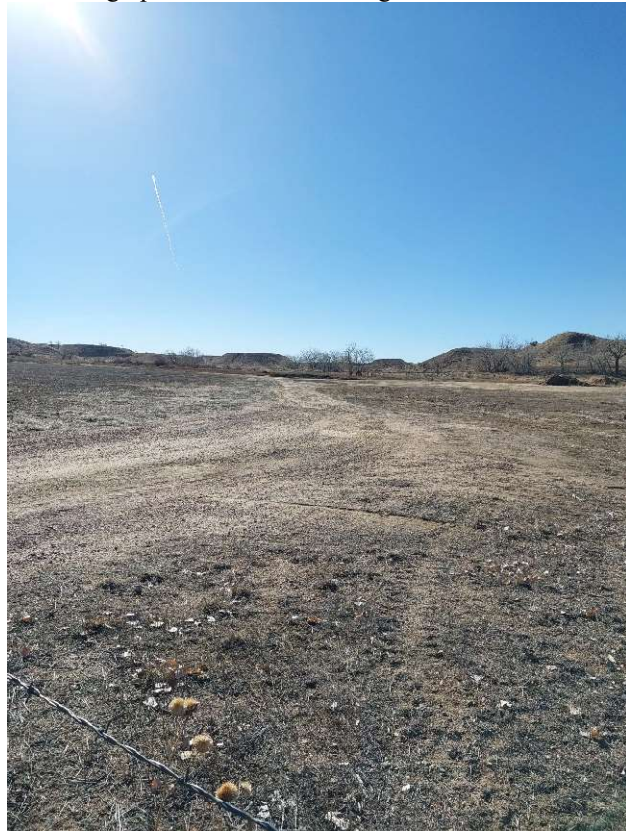
The access road used to access the site appeared to be stable, no pooling was observed on the road or in the roadside ditches. The access road will remain after reclamation operations at the request of the landowner, Joe Scalese. The stockpile of asphalt used for ice control of the access road was observed in the northeastern portion of the permit boundary. This material will need to be removed prior to release of the permit.

Photo #2: View of the access road from the entrance gate.

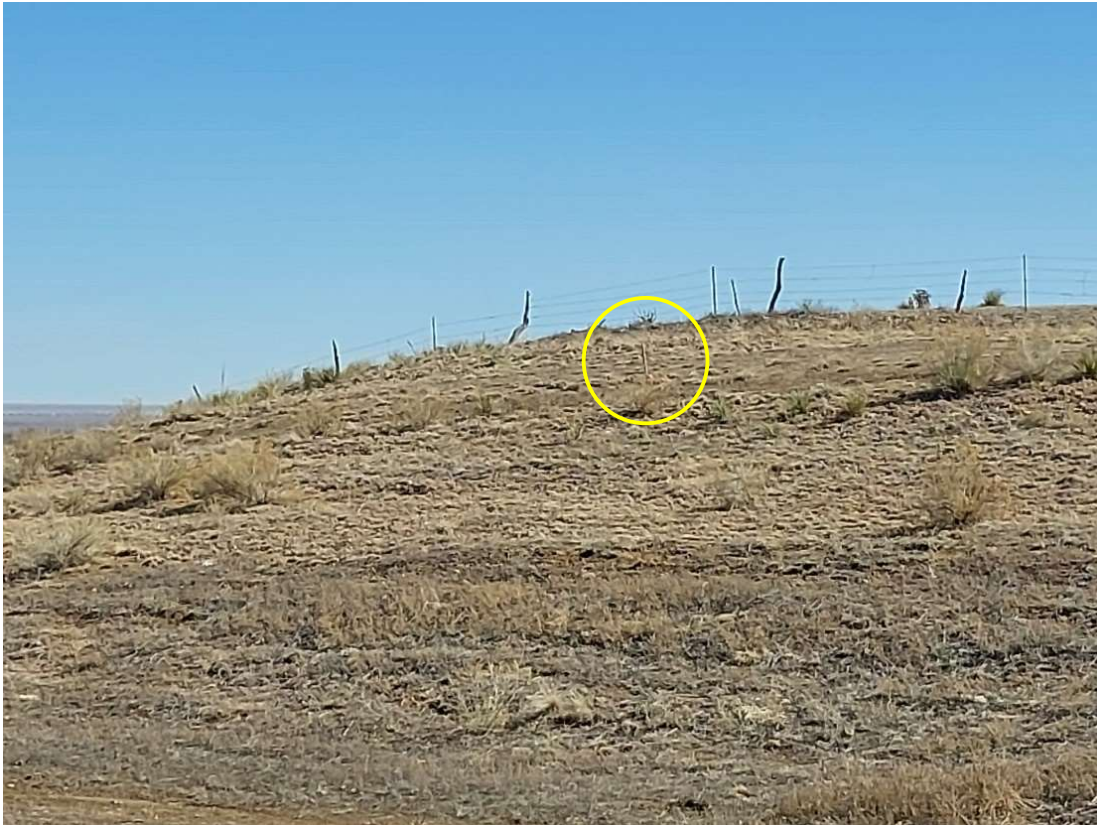
Photo #3: Northeast boundary marker, taken from within the permit area, looking north northeast.

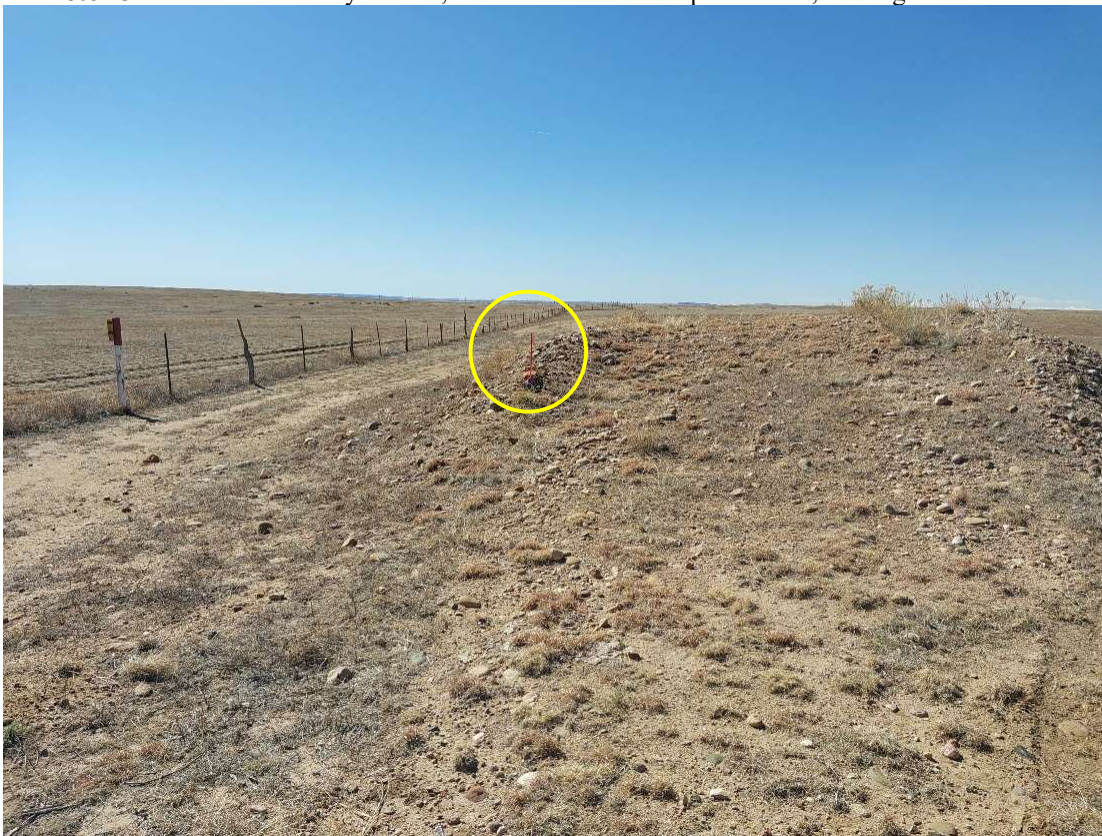
Photo #4: Southeast boundary marker, taken from within the permit area, looking south.

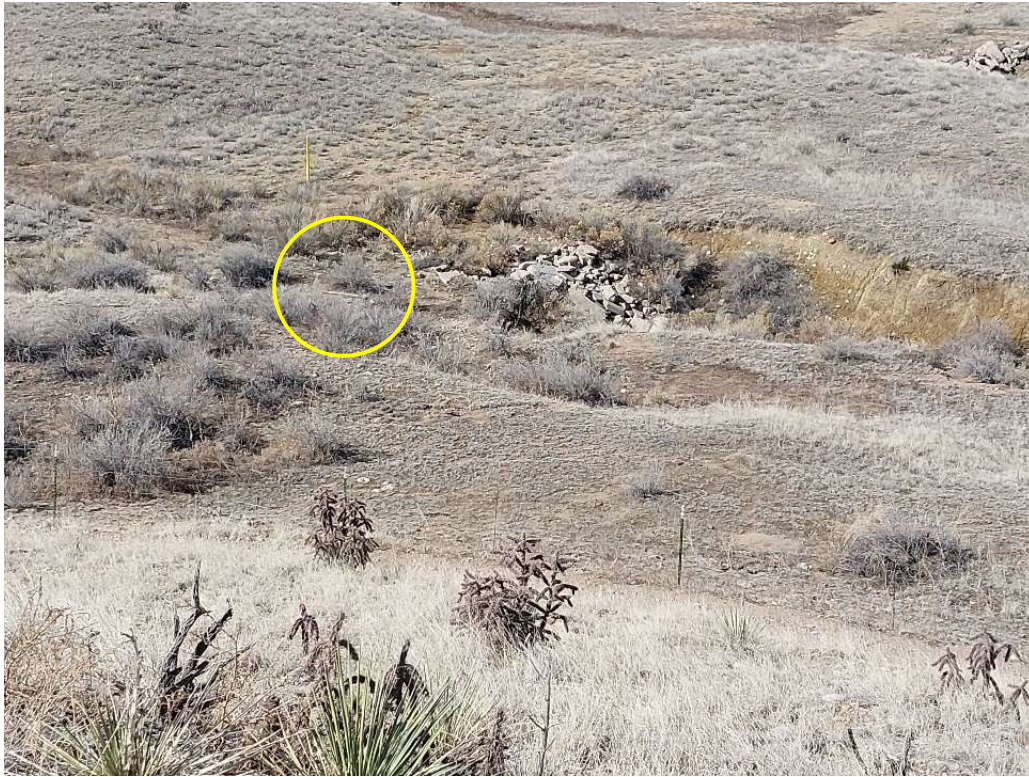
Photo #5: Southwest boundary marker, knocked down, viewed from within the permit area, looking southeast.

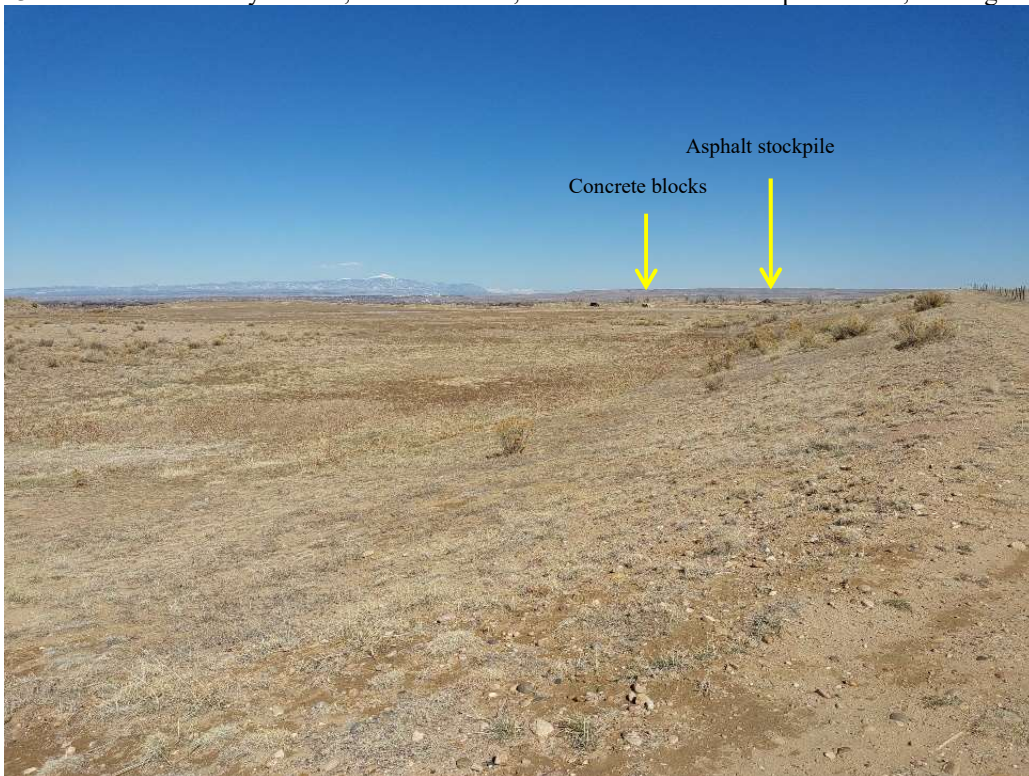
There was an asphalt stockpile area and some concrete blocks seen in the northeast portion of the permit area. Julie stated that the neighboring landowner, Joe Scalese, has requested these materials and MMMI has agreed to him taking the materials.

Photo #6: View of permit area, taken from the southeast corner of permit area, looking north. The asphalt stockpile and concrete blocks can be seen in the upper right of the photo.

The permittee is in compliance with the approved reclamation plan. At this time, the only item of note is the presence of the asphalt stockpile, used for ice control of the access road, and the concrete blocks. MMMI has granted the neighboring landowner, Joe Scalese, permission to collect both items; both items will need to be removed prior to release of the permit.

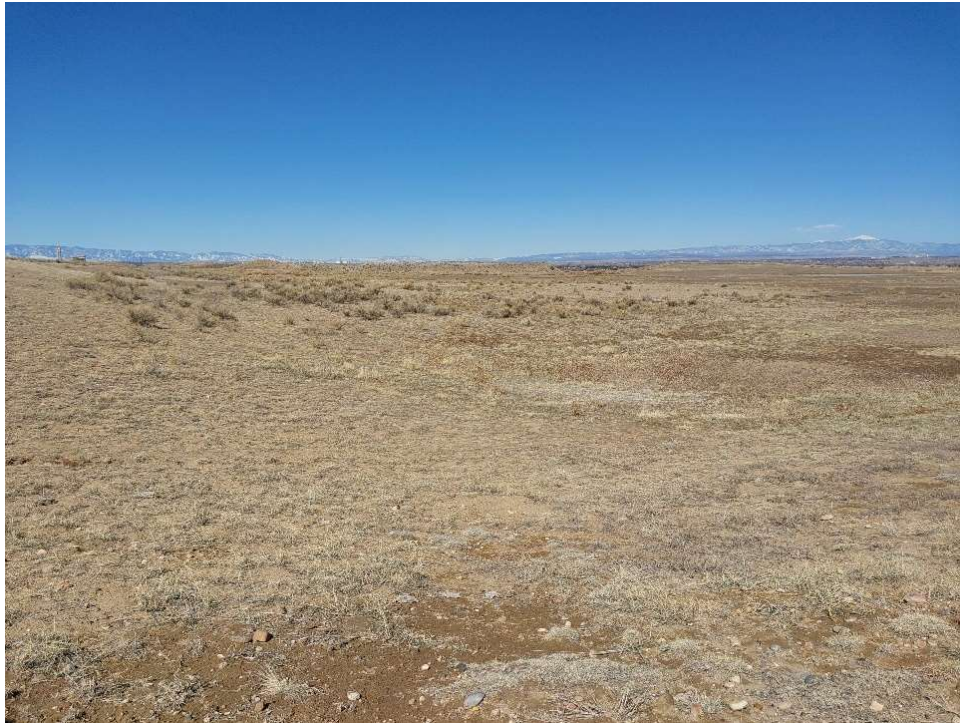
Photo #7: View of permit area, taken from the southeast corner of permit area, looking west.

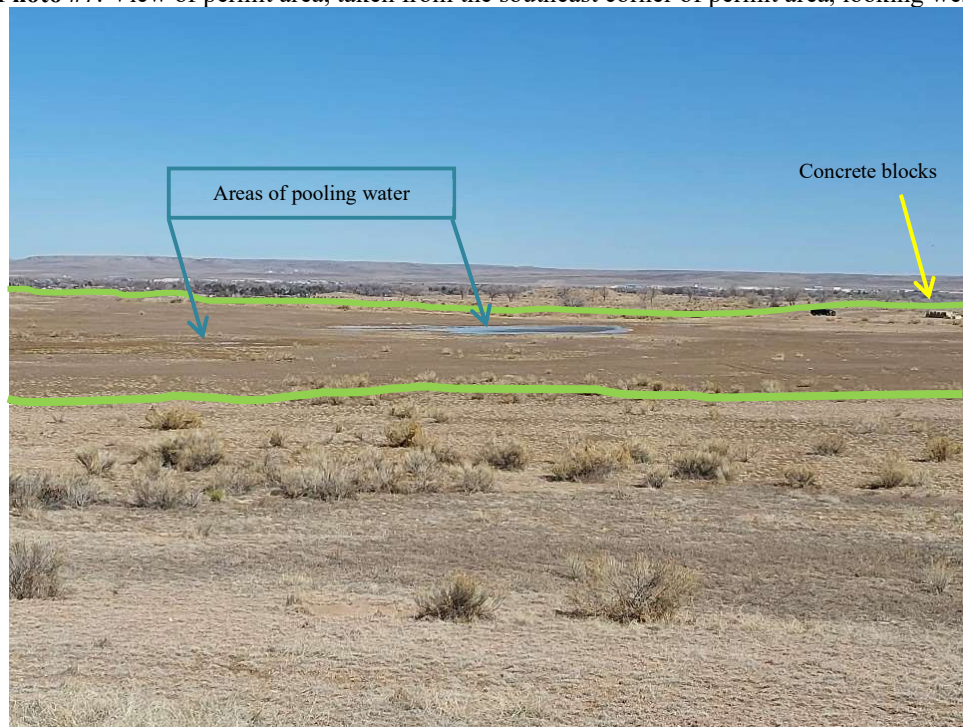
There were a few low-lying areas that were holding water at the time of the inspection, with a few intermittent smaller areas as well. The pools of water observed were very shallow. Given the relatively higher elevation of the site compared to the surrounding areas and the recent storm events, the Division does not consider the presence of the water to be a problem with the hydrologic balance to this area.

Photo #8: Looking north from the south of the permit boundary. A portion of the 20 acres needing vegetation re-established (outlined in green) and the areas that were holding water from snowmelt and rain from recent storm can be seen. The concrete blocks are seen on the right side of the photo. This photo provides a good idea of the target vegetation density in the foreground.

According to inspection reports, the noxious weed Tamarisk was observed on the site and the permittee had taken appropriate measures to abate the issue by having it removed (November 13, 2023). The area of sparse vegetation will need to be reseeded with the approved seed mixture and the noxious weed plan will need to be followed.

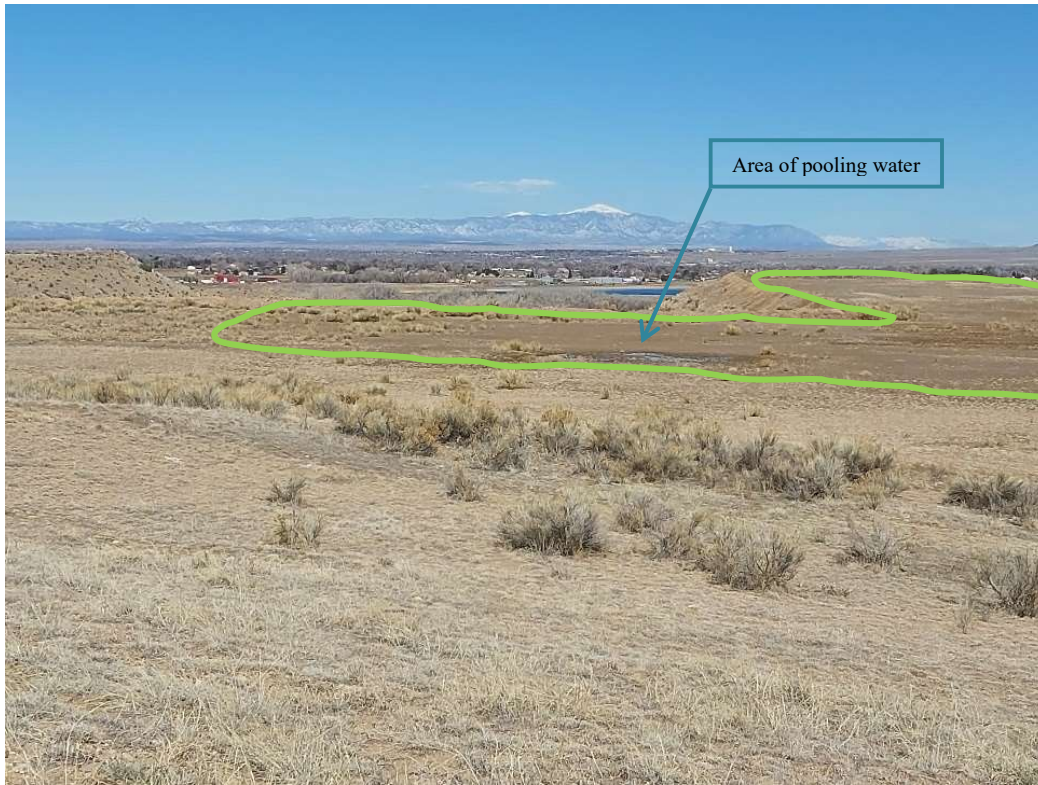
Photo #9: Looking northwest from the south of the permit boundary. A portion of the 20 acres needing vegetation re-established (outlined in green) and the areas that were holding water from snowmelt and rain from recent storm can be seen. This photo provides a good idea of the target vegetation density in the foreground.

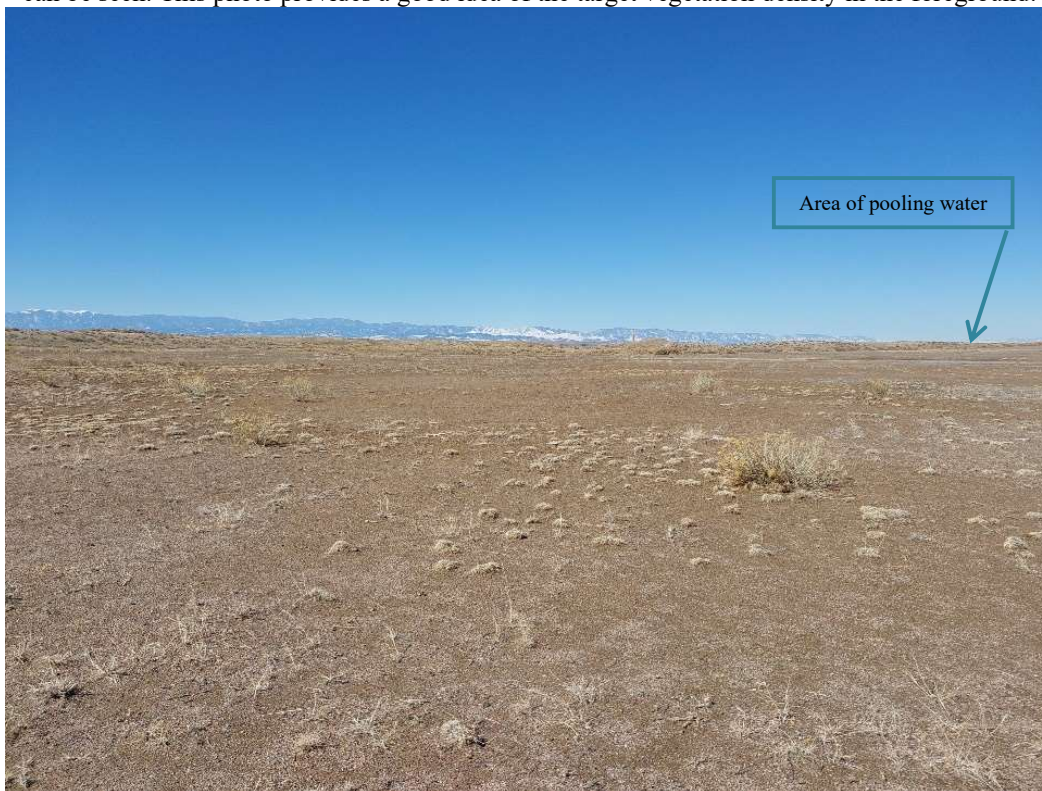
Photo #10: Looking south from northeast portion of permit area. The area of sparse vegetation can be seen as well as an are of pooling water from recent snowmelt and storm event.

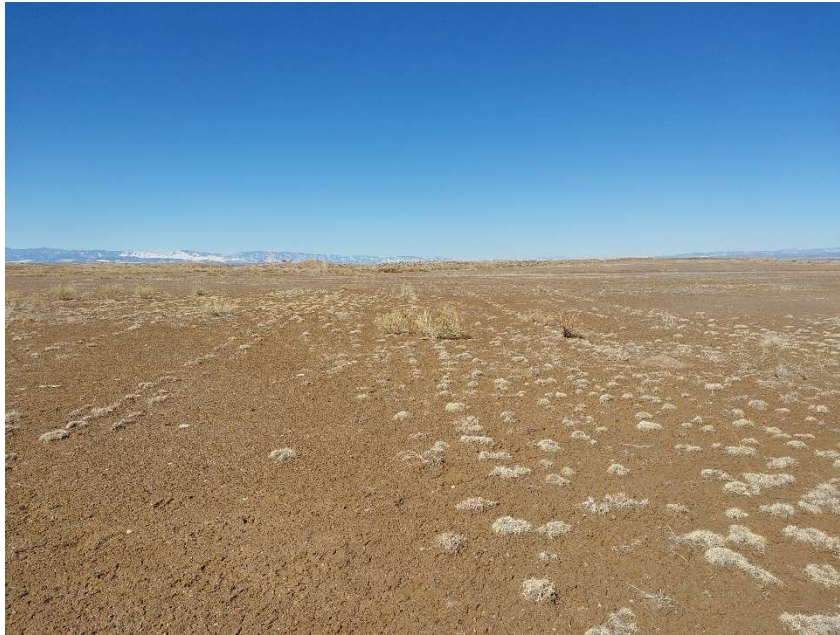
Photo #11: Looking to the west from within the area of sparse vegetation. Seed rows can be seen from this perspective, showing that seeding is being done, but the establishment has not been successful.

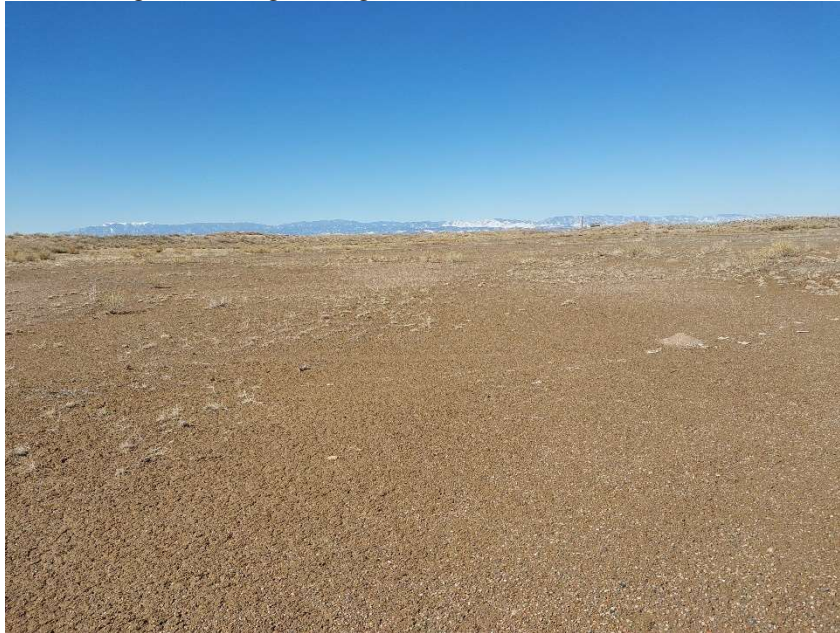
Photo #12: Looking southwest from within the area of sparse vegetation.

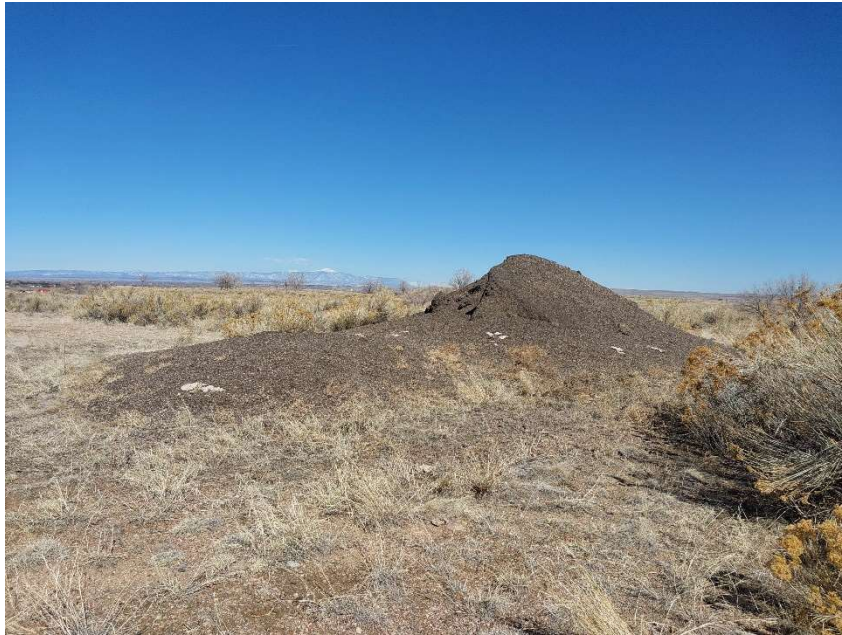
Photo #13: The asphalt stockpile used for ice control of the access road, located in the northeast corner of the permit boundary. Taken looking north.

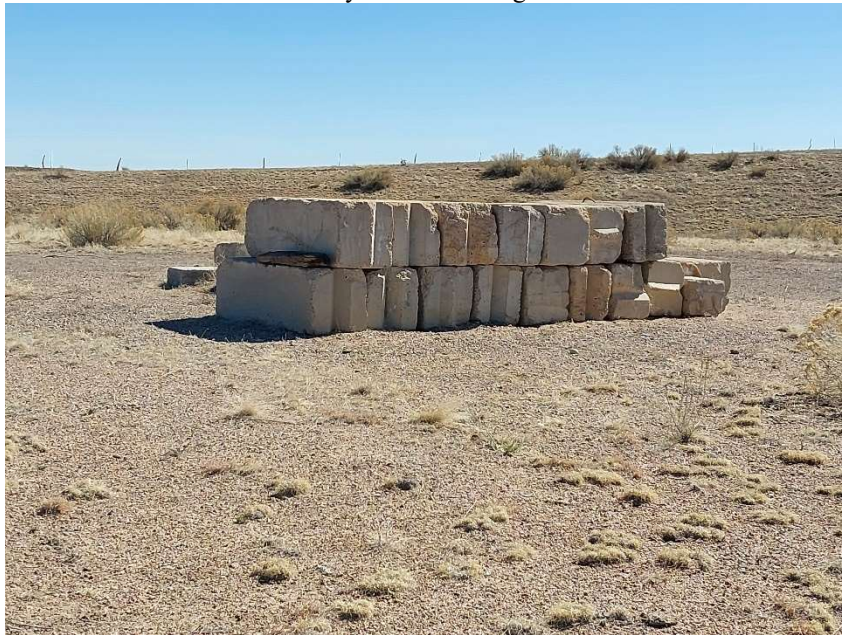
Photo #14: Concrete blocks located in the northeast portion of the permit area, south of the asphalt stockpile. Taken looking east northeast.
