C-1981-035 King Partial Inspection Report March 2024

Permit Number: C-1981-035 Mine Name: King Coal Mine Operator: GCC Energy, LLC Operator Address: Mr Jordan McCourt 6473 County Road 120 Hesperus, CO 81326	County: La Plata Operation Type: Underground Permit Status: Active Ownership: Private
	Operator Representative Present: Micheal Dickson
Operator Representative Signature: (Field Issuance Only)

Inspection Start Date: March 27, 2024 Inspection Start Time: 15:40 Inspection End Date: March 27, 2024 Inspection End Time: 16:35	Inspection Type: Coal Partial Inspection Inspection Reason: Normal I&E Program Weather: Clear
Joint Inspection Agency: None	Joint Inspection Contacts:
Post Inspection Agency: None	Post Inspection Contacts:
Inspector(s): Lucas West	Inspector's Signature:

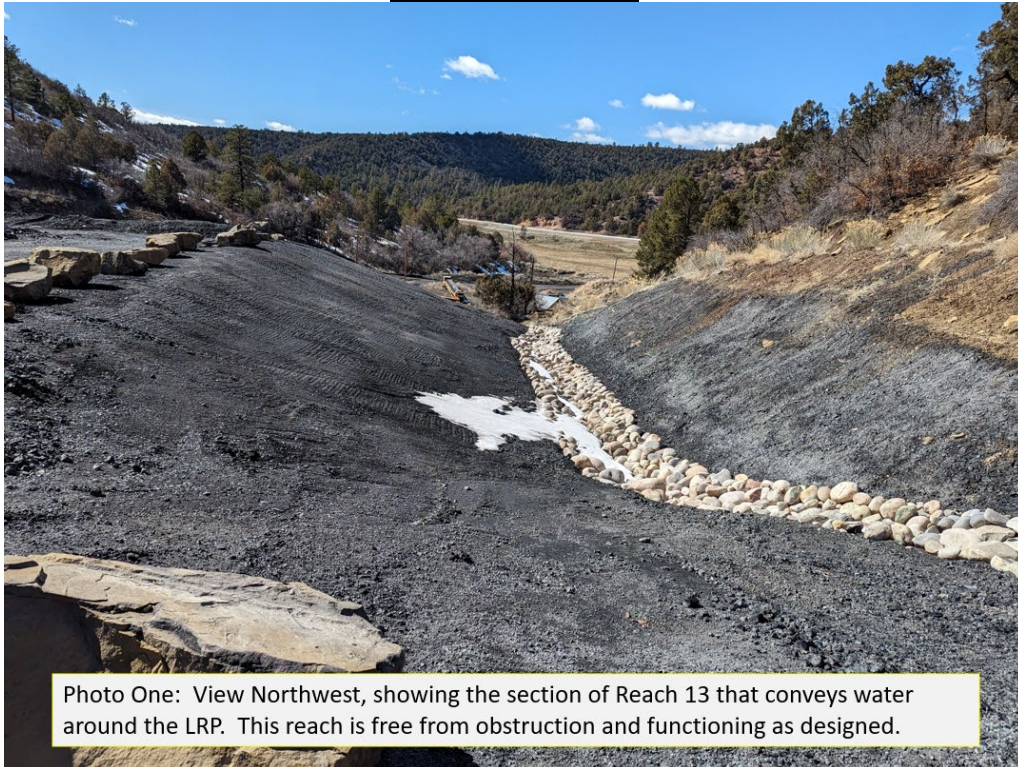
At the King I facility the internal drainage structures in and around the Lower Refuse Pile were observed. All drainage structures were free from obstruction and able to function as designed. Reach 13 has been well maintained and can be seen in Photos One and Two. The culvert along the access road to the Upper Refuse Pile that continues the flow of reach 10 was clear and unobstructed. Reach 10 leading around the South side of the of the LRP was clear and a temporary conveyance has been constructed to direct flows around the Southwest side and down Reach 10 as it parallels the Access Road. The section of this reach that runs along the access road can be seen in Photo Three. It is functioning as designed and shows no significant signs of down cutting or erosion. All observed conveyances in the lower area of the King I facility were clear and functioning as designed. The East and West Sediment Ponds, shown in Photos Four and Five both contained water but showed no signs of discharge during the inspection. The banks remain well vegetated and appeared stable at the time of the inspection.

Photo One: View Northwest, showing the section of Reach 13 that conveys water around the LRP. This reach is free from obstruction and functioning as designed.

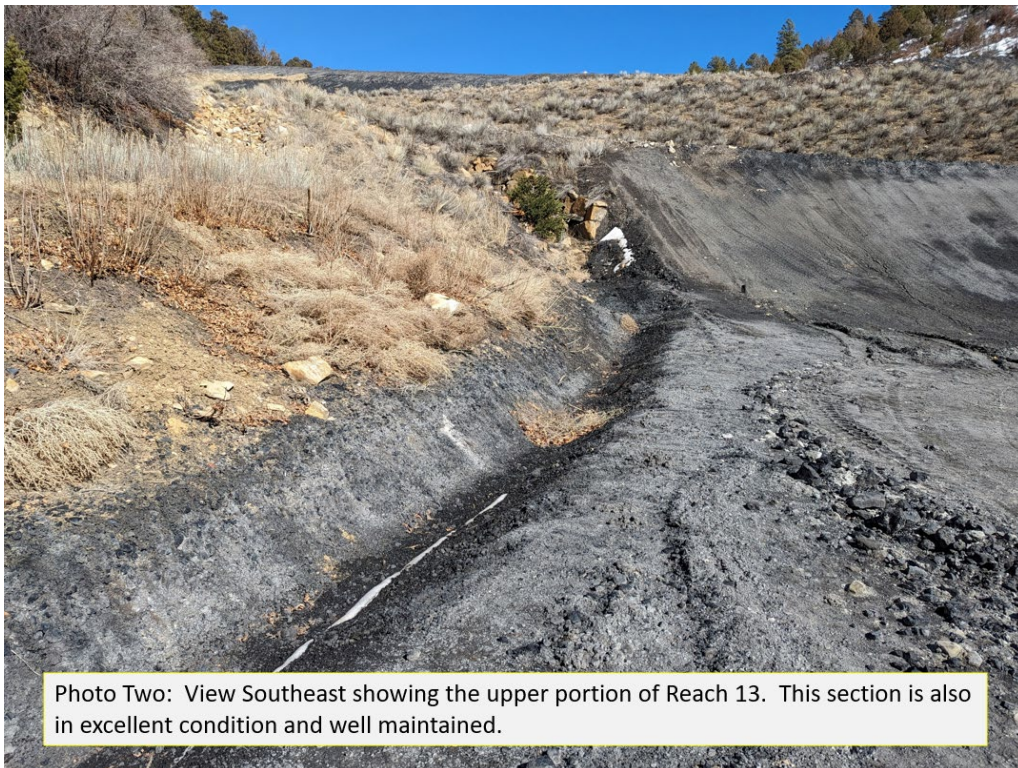
Photo Two: View Southeast showing the upper portion of Reach 13. This section is also in excellent condition and well maintained.

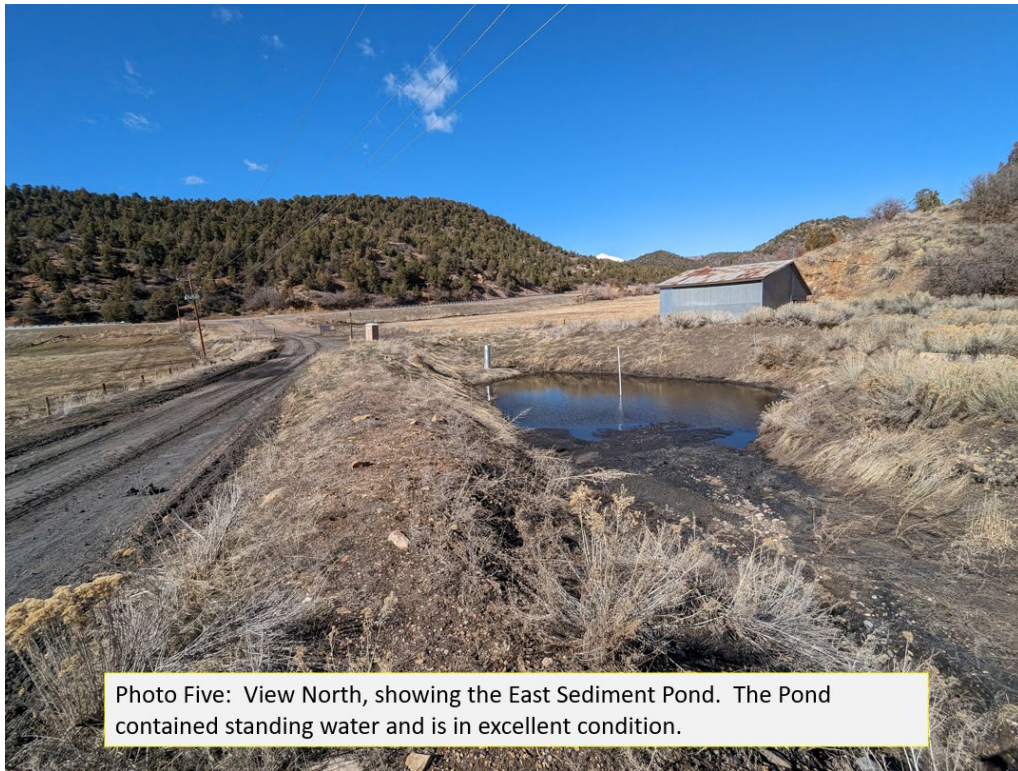
Photo Five: View North, showing the East Sediment Pond. The Pond contained standing water and is in excellent condition.

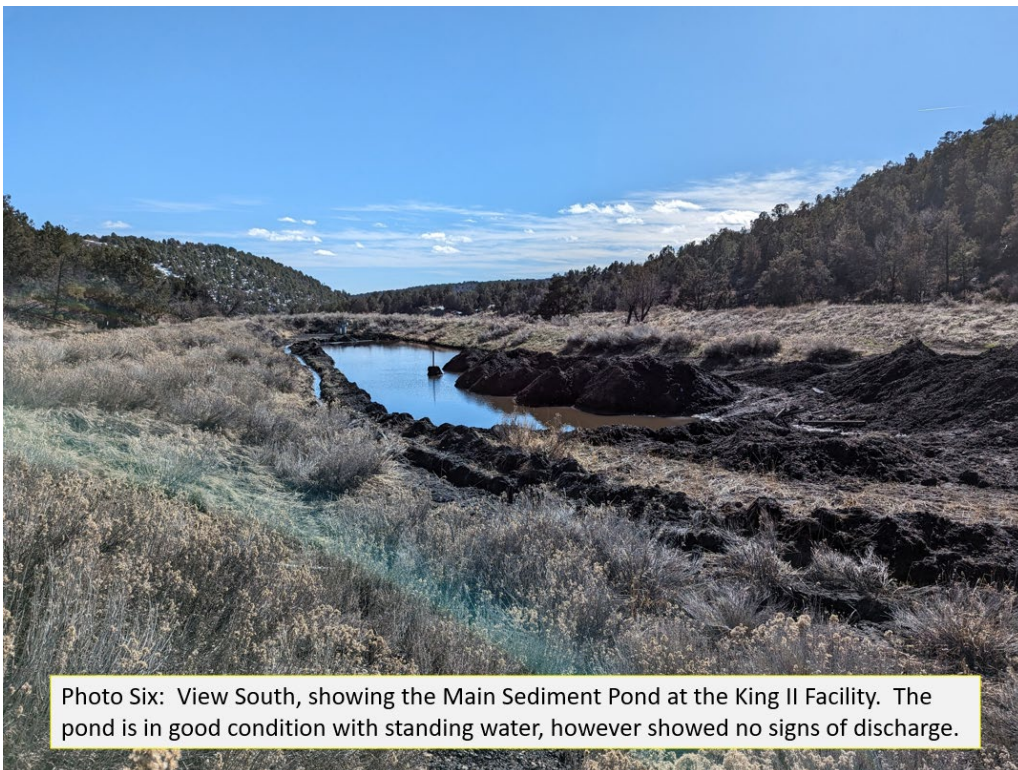
At the King II Facility the main sediment pond is in good condition and contains standing water as seen in Photo Six. The banks of the pond appear stable and no evidence of discharge, or recent discharge was noted. The main culvert leading into the pond was free from obstruction and flowing freely, delivering active snowmelt to the pond. Various other points in the extensive network of internal drainage structures were observed, all to be unobstructed and free flowing. Examples of the other internal structures can be seen in Photos Seven and Eight. All structures, and the pond appear to be functioning as designed and handling the snowmelt well. Both the East and West Clear Water Ditches were observed to be in good condition and functioning as designed.

Photo Six: View South, showing the Main Sediment Pond at the King II Facility. The pond is in good condition with standing water, however showed no signs of discharge.

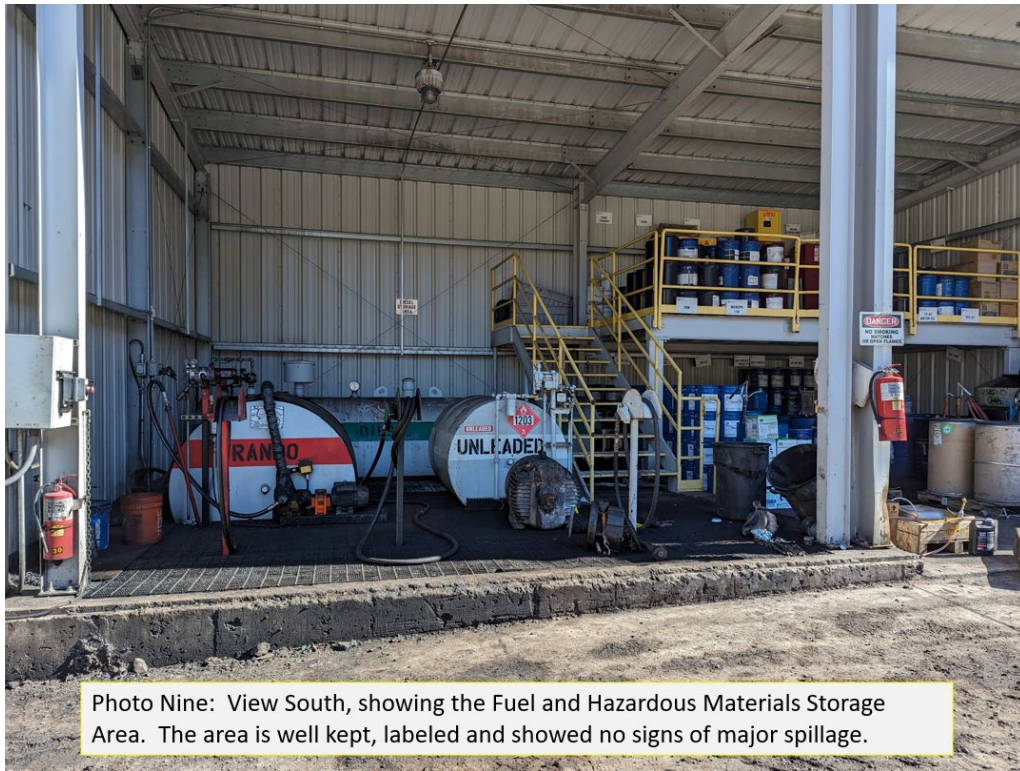
The Fuel and Hazardous Materials Storage Area was observed at King II. All fuels and oils stored in the area neat, well-kept and stored with proper secondary containment as seen in Photo Nine. No evidence of spills or leaks were noted during this inspection.

Photo Nine: View South, showing the Fuel and Hazardous Materials Storage Area. The area is well kept, labeled and showed no signs of major spillage.
