**MINERALS PROGRAM INSPECTION REPORT**  
**PHONE: (303) 866-3567**

<b>MINE NAME:</b> Lopez Quarry No. 2	<b>MINE/PROSPECTING ID#:</b> M-2007-034	<b>MINERAL:</b> Sand and gravel	<b>COUNTY:</b> Las Animas
<b>INSPECTION TYPE:</b> Surety-Related Inspection	<b>WEATHER:</b> Clear	<b>INSP. DATE:</b> March 26, 2024	<b>INSP. TIME:</b> 11:00
<b>OPERATOR:</b> S & S Services	<b>OPERATOR REPRESENTATIVE:</b> Lonny Lopez	<b>TYPE OF OPERATION:</b> 110c - Construction Limited Impact	
<b>REASON FOR INSPECTION:</b> Surety Related	<b>BOND CALCULATION TYPE:</b> Complete Bond	<b>BOND AMOUNT:</b> \$24,832.00	
<b>DATE OF COMPLAINT:</b> NA	<b>POST INSP. CONTACTS:</b> None	<b>JOINT INSP. AGENCY:</b> None	
<b>INSPECTOR(S):</b> Amber M. Gibson	<b>INSPECTOR'S SIGNATURE:</b>

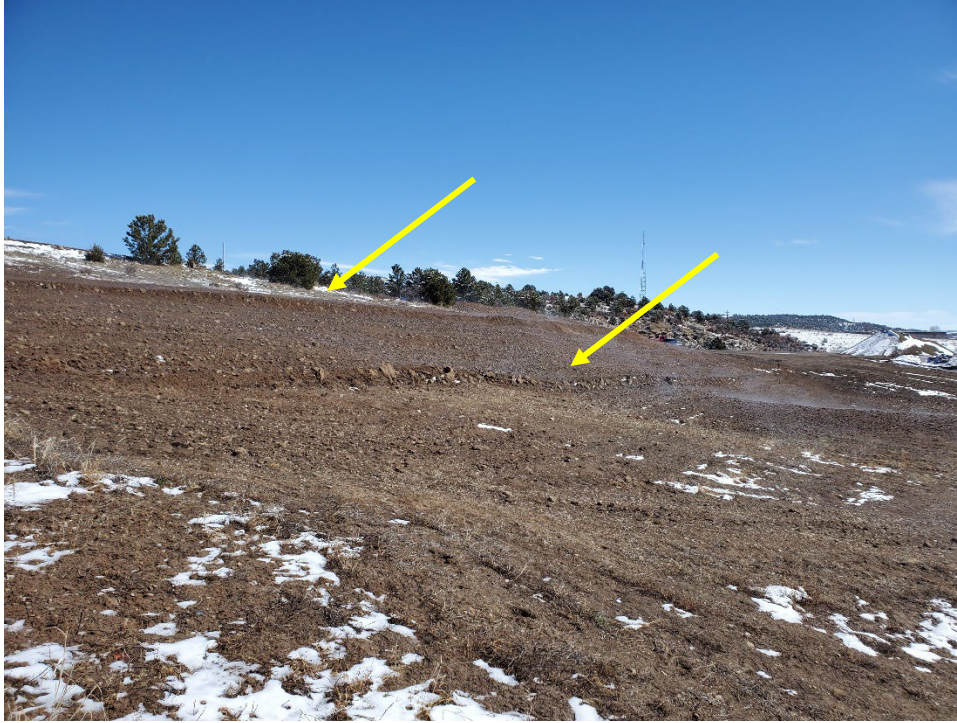
The Operator has re-stabilized the slopes throughout the disturbed area to repair erosion that occurred as a result of surface water run-off throughout the pit. To prevent run-off from leaving the site, earthen berms are located along the southern perimeter of the disturbance (Photo 9). The Operator has also installed water bars along the re-stabilized slopes in the north-west portion of the permit to help direct and slow surface water flow over the slopes (Photo 1).

**Photo 1:** Looking north-east across recently reclaimed slopes that had erosion gullies present during the Division's 2023 inspection. The arrows point to the water bars installed to help slow and direct surface water flow on the slopes.

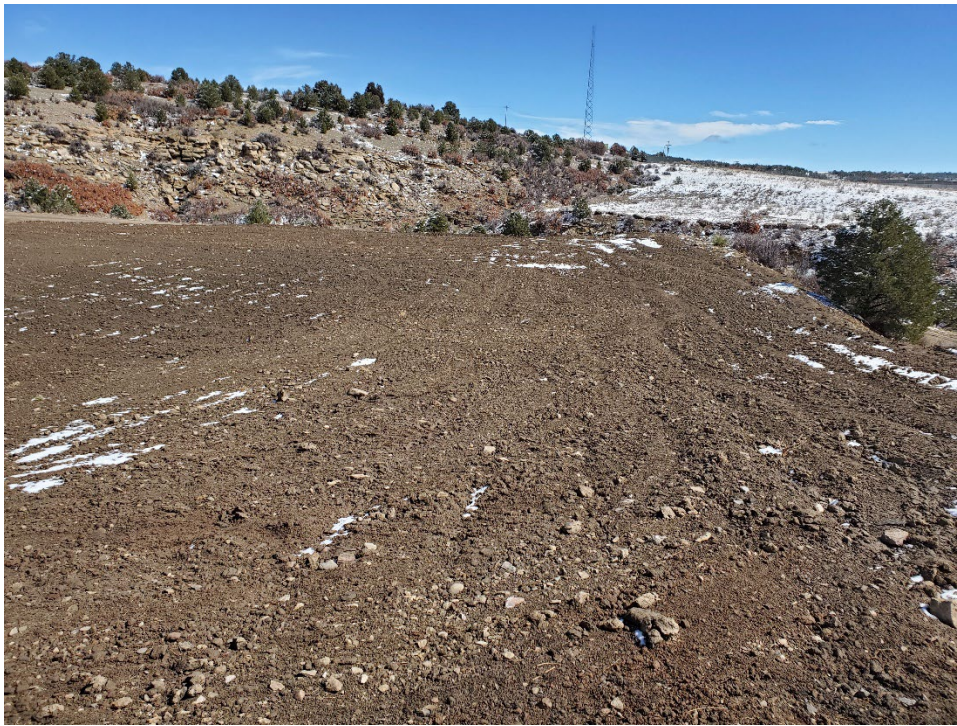
**Photo 2:** Looking at the north-east corner of the disturbed area that has been recently reclaimed.

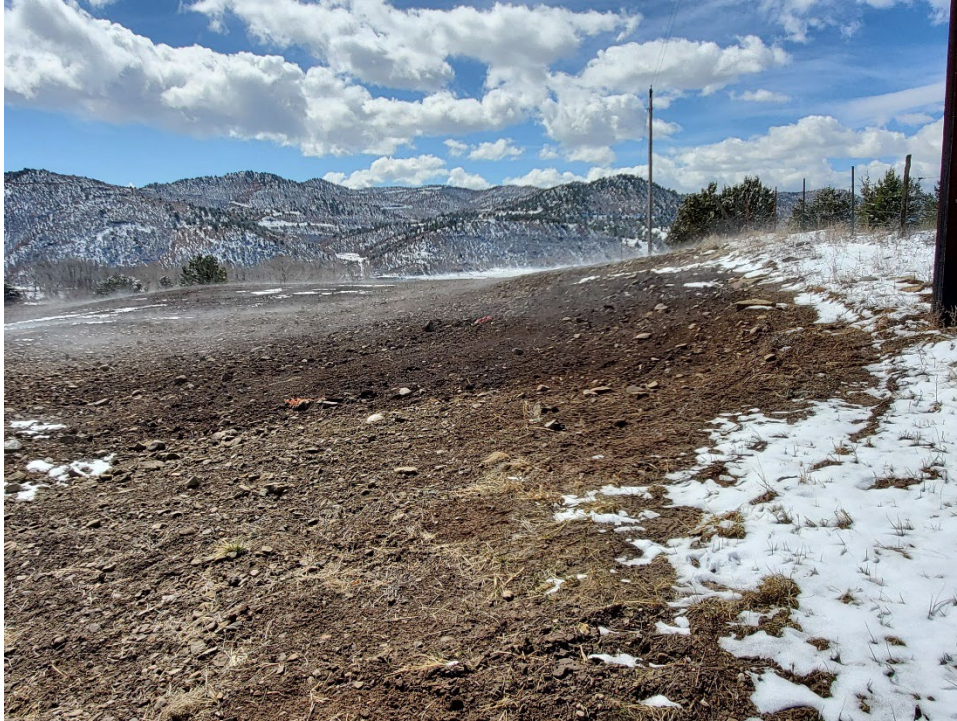
**Photo 3:** Looking south along the western fence at recent reclamation.

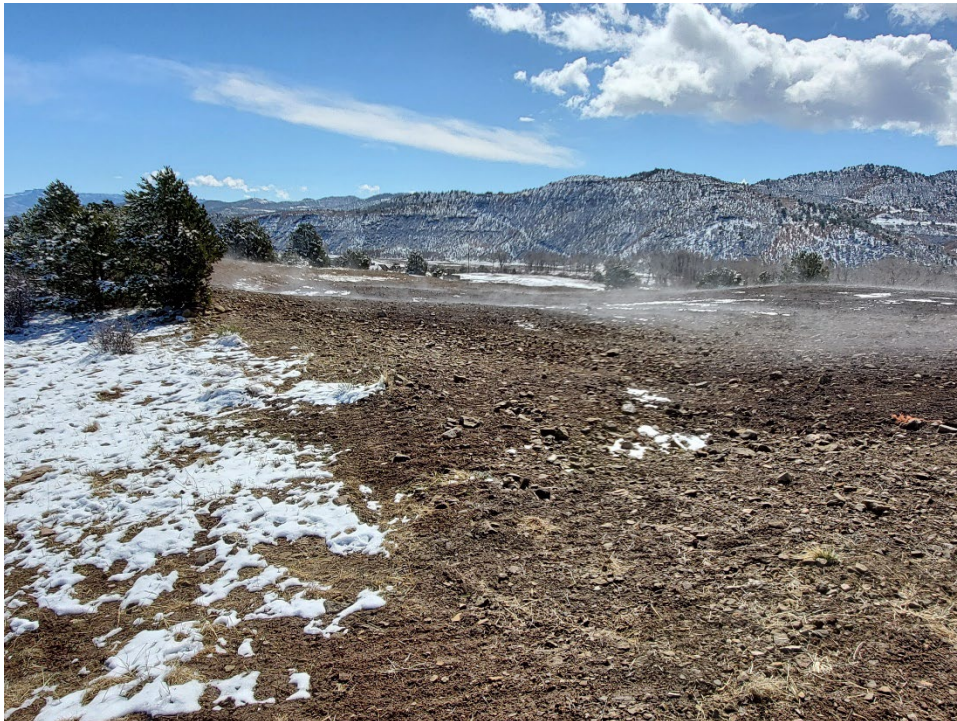
**Photo 4:** Looking east from the western and north-western most extent of the disturbance onsite at the recent reclamation.

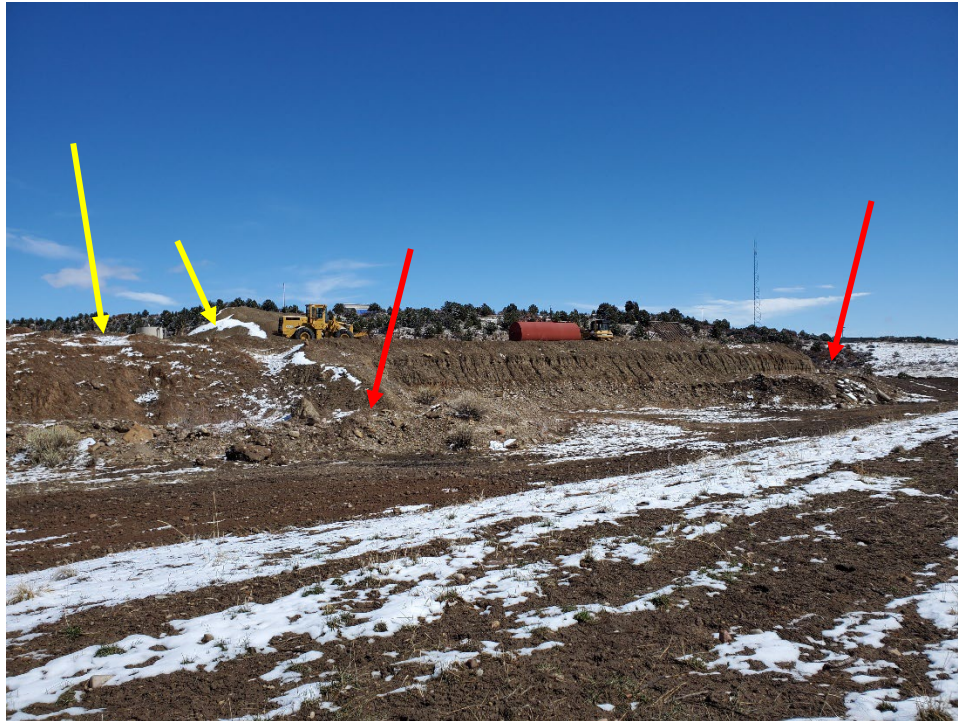
Additional overburden material is available on-site to be used as backfill in the future (Photos 5, 7, & 8). During the inspection, broken concrete slabs were noted within the piles containing material to be crushed (Photo 5). The Operator stated that they will crush that material when they crush again, or use it for backfill. The Division reminds the Operator that per their currently approved plan, they are not approved to import inert fill. If any imported materials are to be used as fill, they must be approved as inert fill via a Technical Revision. If the Operator crushes the concrete material and incorporates it within the product, a revision will not be required.

**Photo 5:** Looking north-east at the remaining section of highwall. The red arrow points to a pile of material that may still be crushed. The yellow arrows points to overburden that can be used for backfilling and grading.

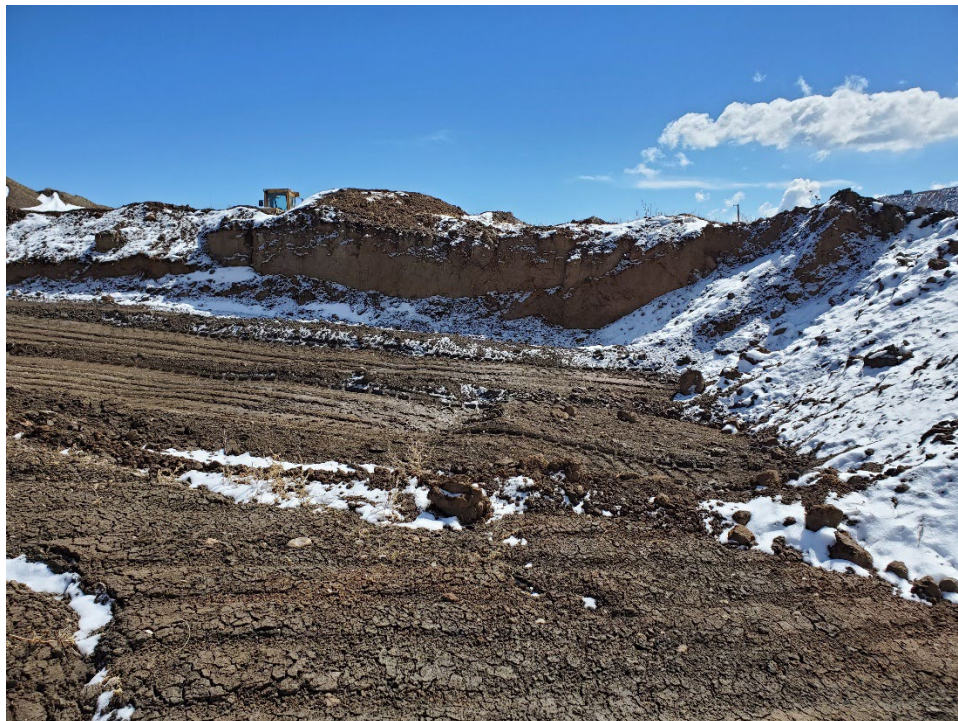
**Photo 6:** Looking east at the western portion of the highwall that runs north to south.

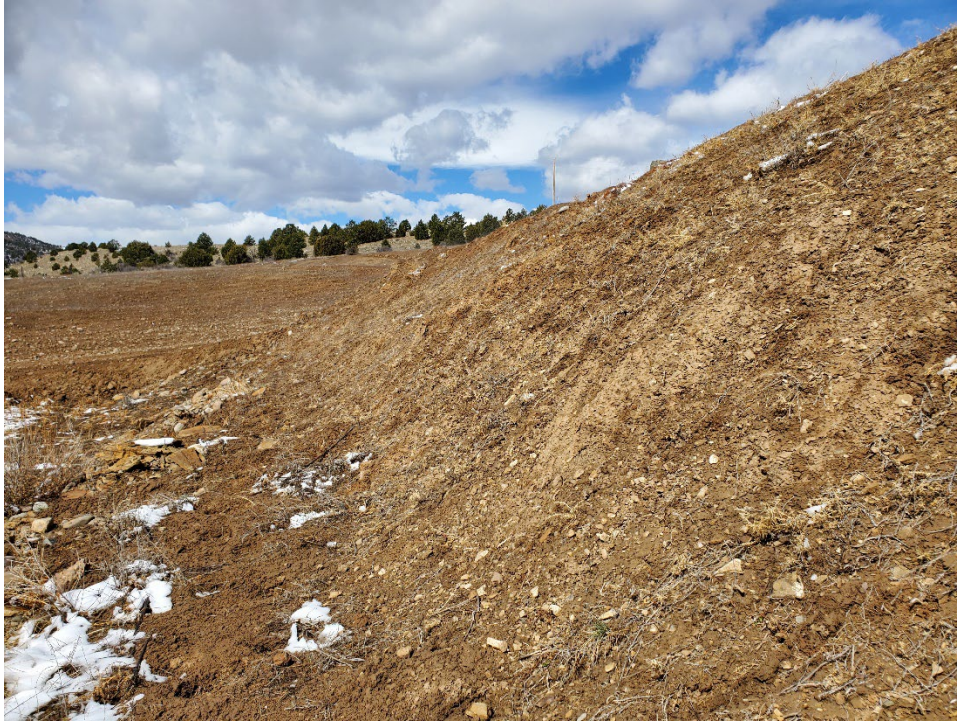
**Photo 7:** Looking west across excess fill material.

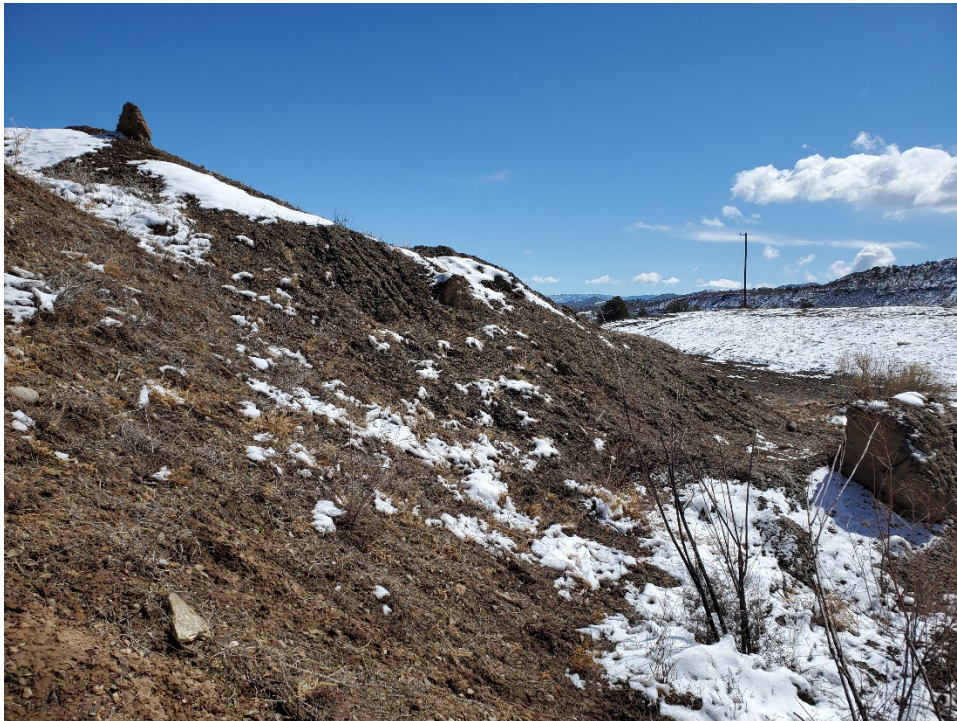
**Photo 8:** Looking east across excess fill material.

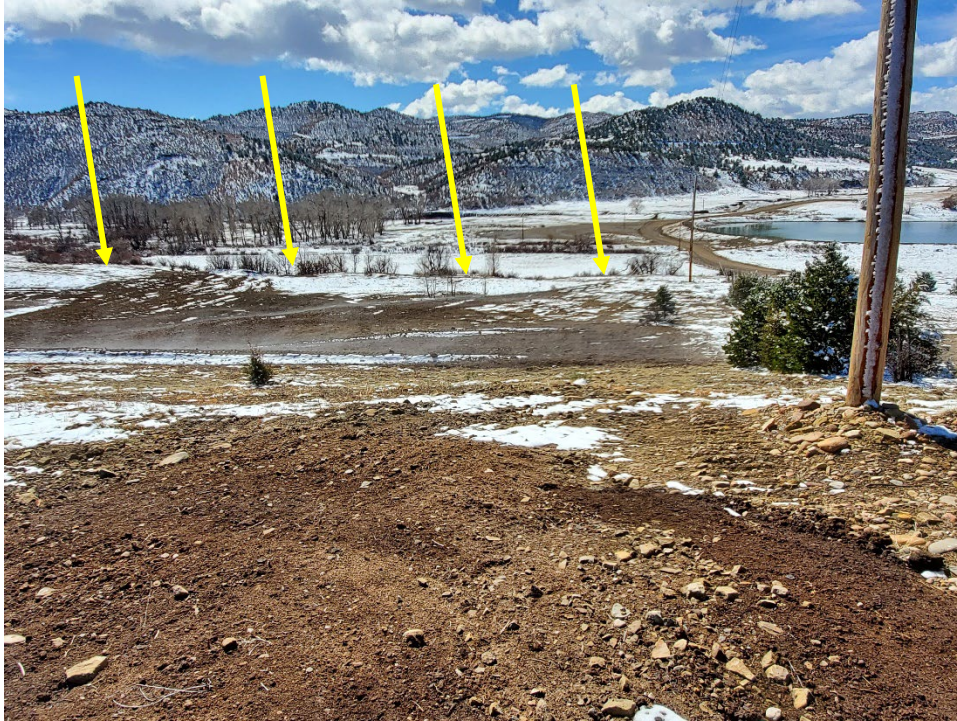
**Photo 9:** Looking south at the recent reclamation along the south border. The arrows point to earthen berms used to keep run-off from leaving the site.

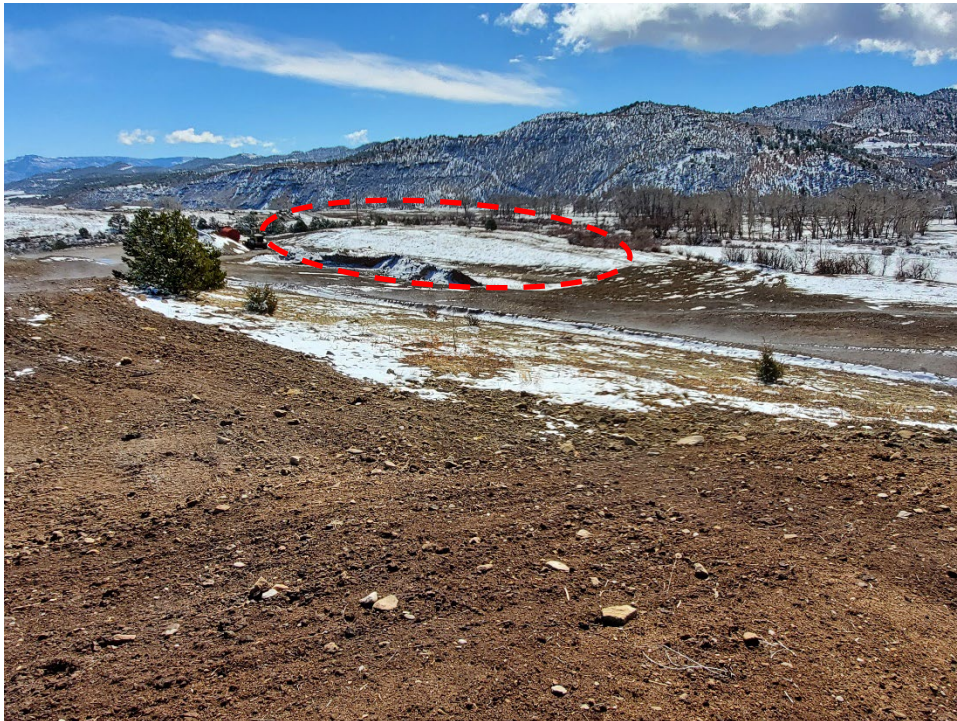
**Photo 10:** Looking south-east across the pit. Circled is the sloped topsoil pile.

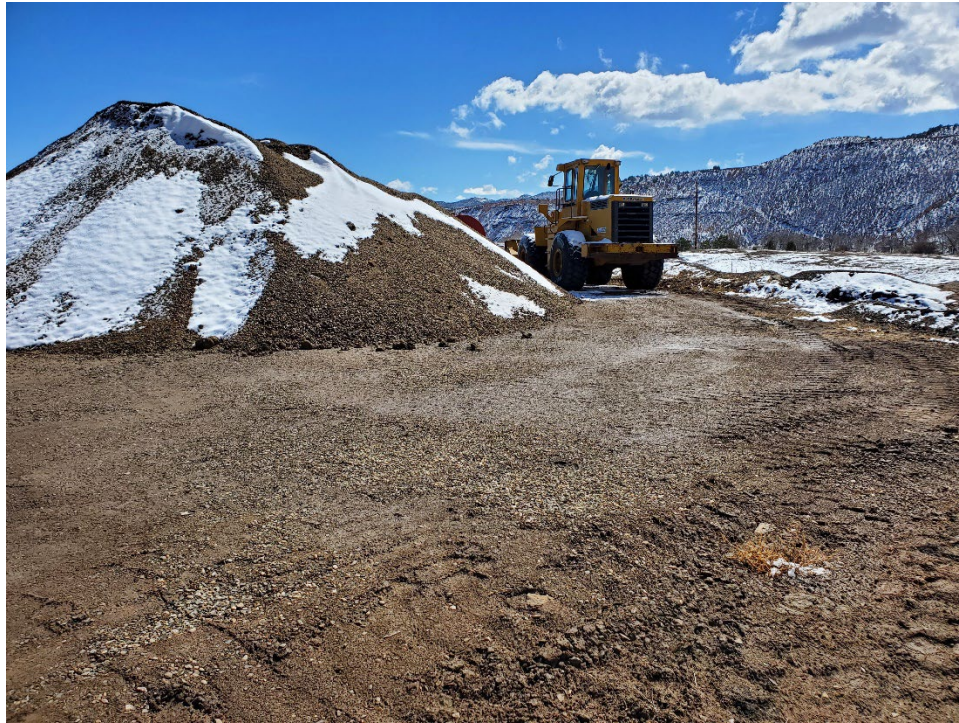
**Photo 11:** Looking east at a product stockpile and equipment in the laydown area.

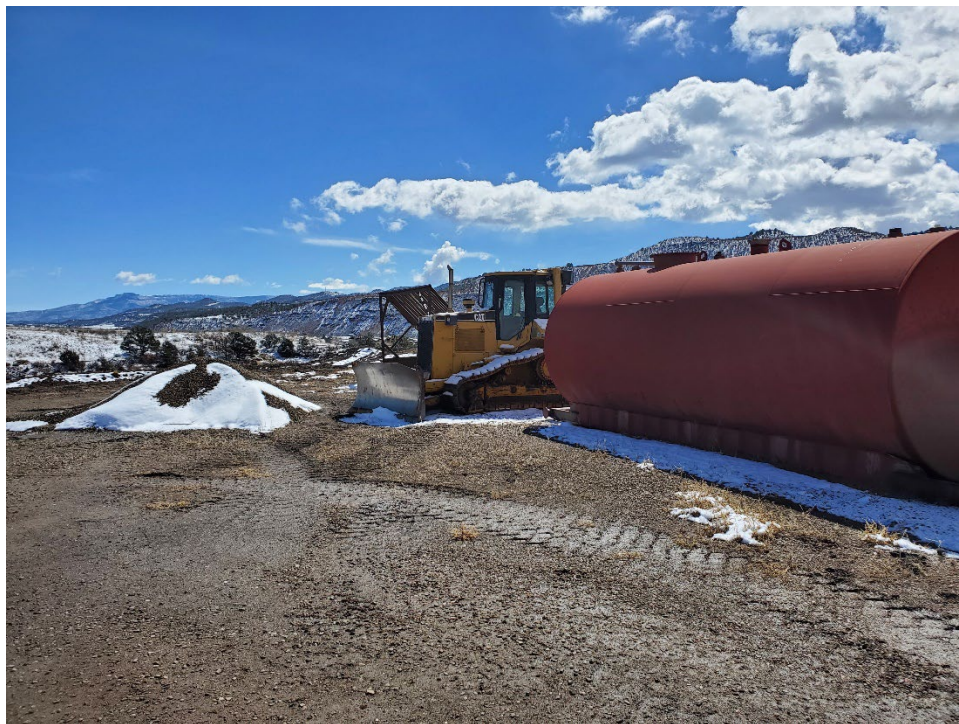
**Photo 12:** Looking east at another smaller product pile, grizzly screener, red water tank, and loader.

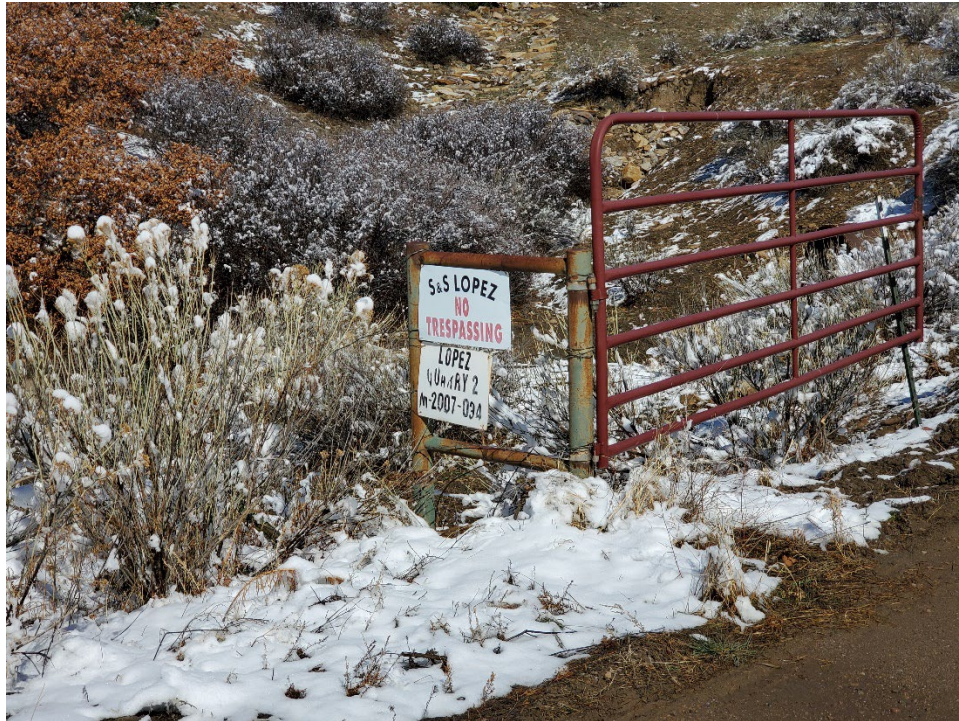
A permit sign, posted in compliance with Rule 3.1.12(1) was observed at the entrance to the site (Photo 13).

**Photo 13:** Looking north-west at the mine sign posted at the entrance to the site.

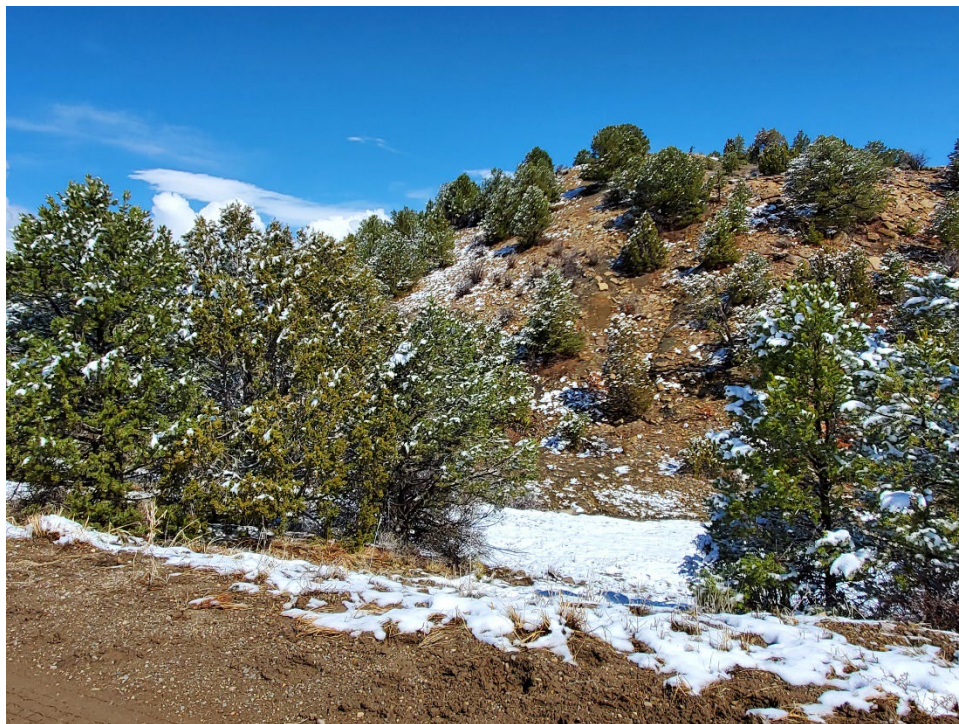
The Operator and the Division agree that there are many discrepancies in the spatial orientation of features on the approved map in comparison with what is on the ground. Most specifically, the area that was to be designated as a stockpile area in the northern most portion of the permit was to be located to the east of the bend in the access road (see Figure 1 and Figure 2). However, to maintain a similar shape and orientation of the approved map, and in agreement with the approved 9.8 acres, this area actually would have to be located on top of a hill to the north of the main mining area, beyond the creek bed (see Photo 14 and Figure 1).

**Photo 14:** Looking north-west at the hill beyond the creek bed (see Figure 1).

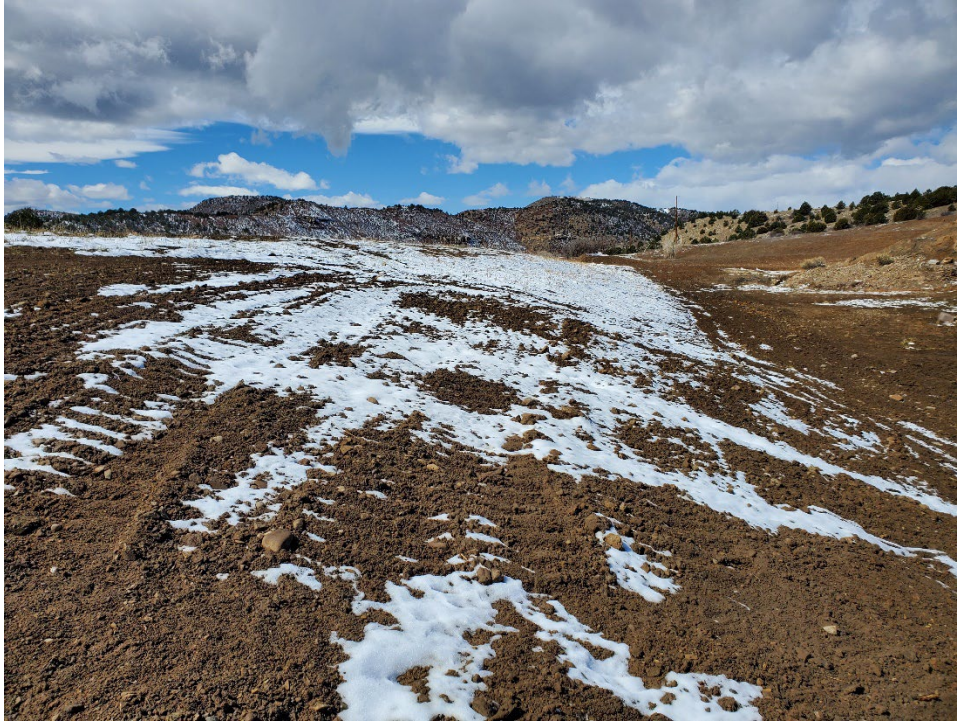
On February 22, 2024, the Operator sent the Division photos indicating that this issue had been resolved. During the recent March 26, 2024 inspection, the topsoil pile was again observed. The area that had had erosion features forming has since been stabilized and seeded (Photo 15), as implicated in the Operator's submission.

**Photo 15:** Looking west across the topsoil stockpile. The area that had been cited for erosion and that required seeding has been graded and seeded (in the foreground).

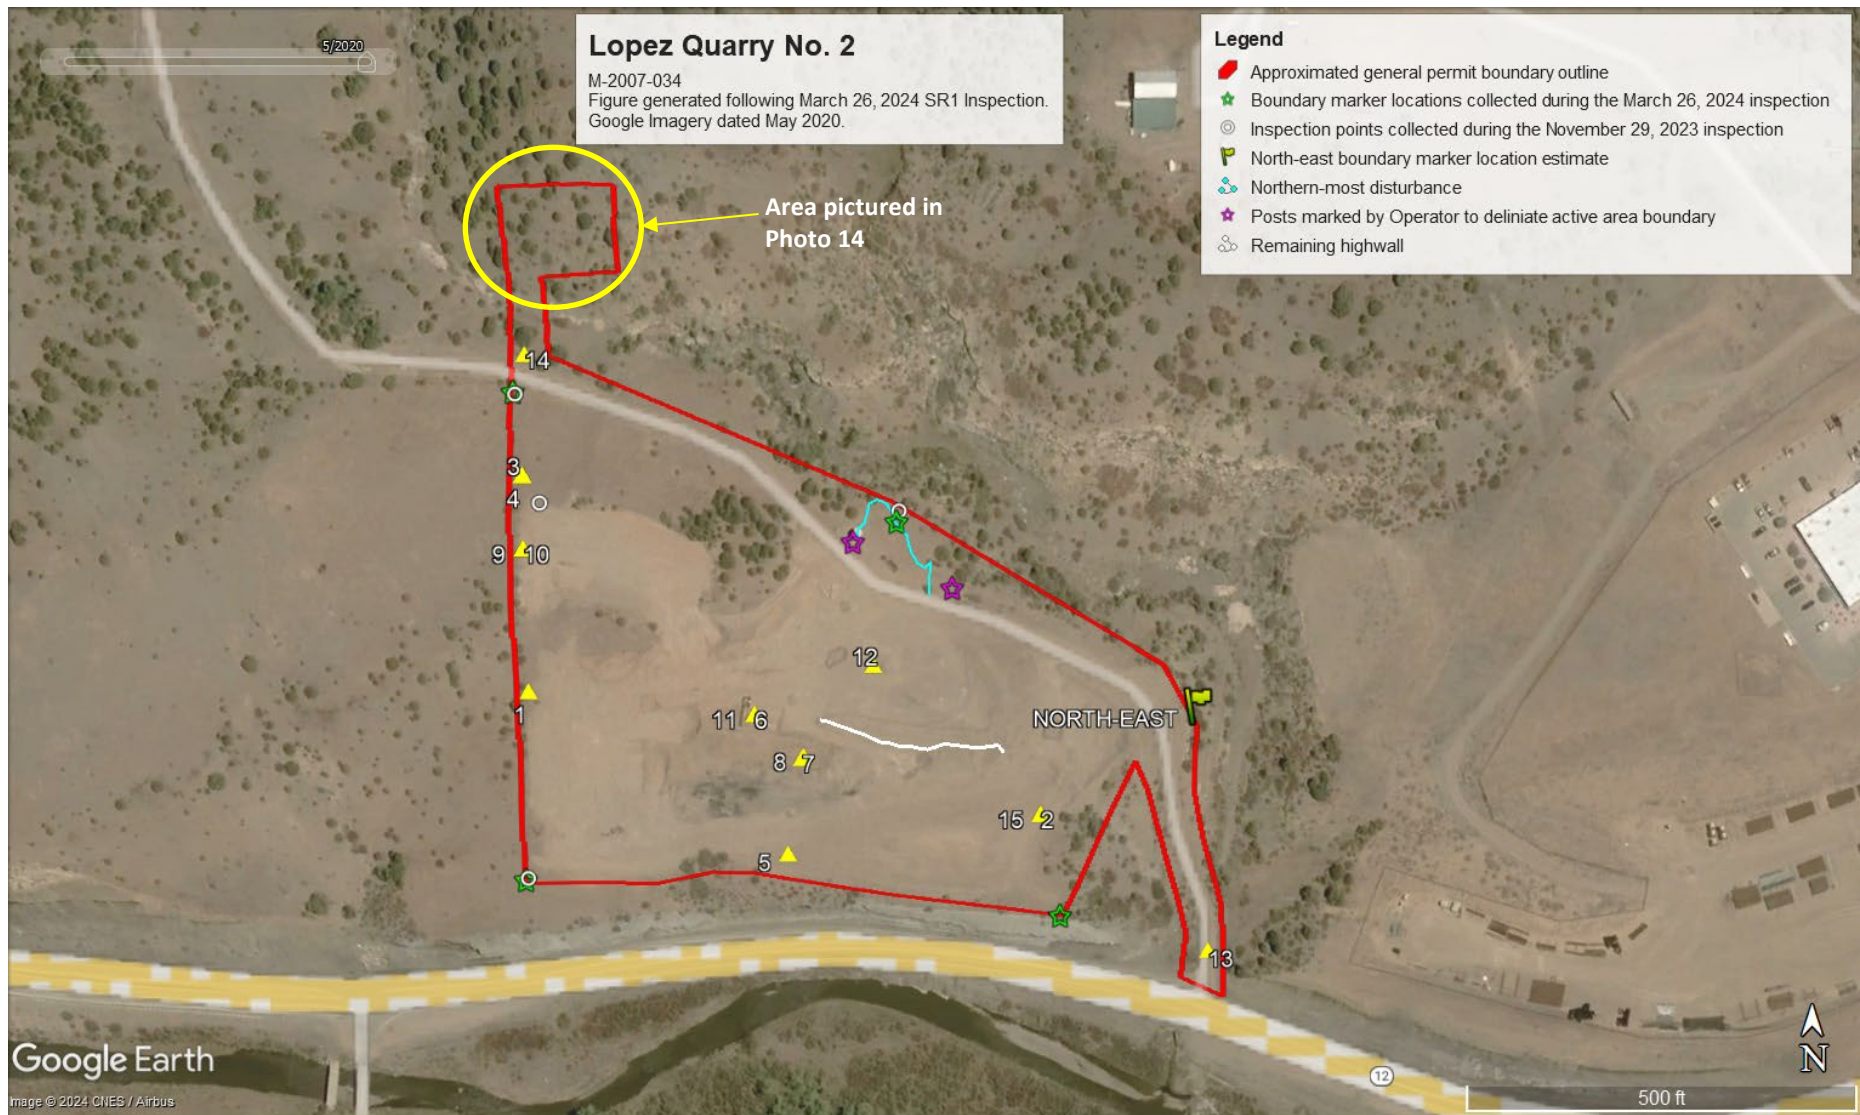
The Operator stated that they intend to keep operating out of the pit for at least the next few years. The active mining area has been greatly reduced, and now is contained within approximately 2 acres near the east-central portion of the permitted area. As stated during the previous inspection, the Operator does not intend to mine any further north, with no intentions to mine within the northern-most area originally described as a stockpile area (see Figure 1).

**Figure 1:** Figure generated in Google Earth Pro following the Division's November 29, 2023 and March 26, 2024 inspections. The Division collected coordinates and paths using Esri Field Maps during the inspection. The white circle icons indicate specific inspection points collected during the November 2023 inspection. The blue line indicates the northern-most disturbance boundary, walked by the Division and Operator during the 2024 inspection. The boundary marker collected in this area during the 2023 inspection (see photo 12.4 in the 2023 report) appears to more accurately represent the northern permit boundary, compared with the temporary flag observed during the 2024 inspection (green star in the north central portion of the permit in the figure). The north-east marker was not observed during the inspection, but the Division proposes that one be placed in the approximate location shown above (yellow flag).

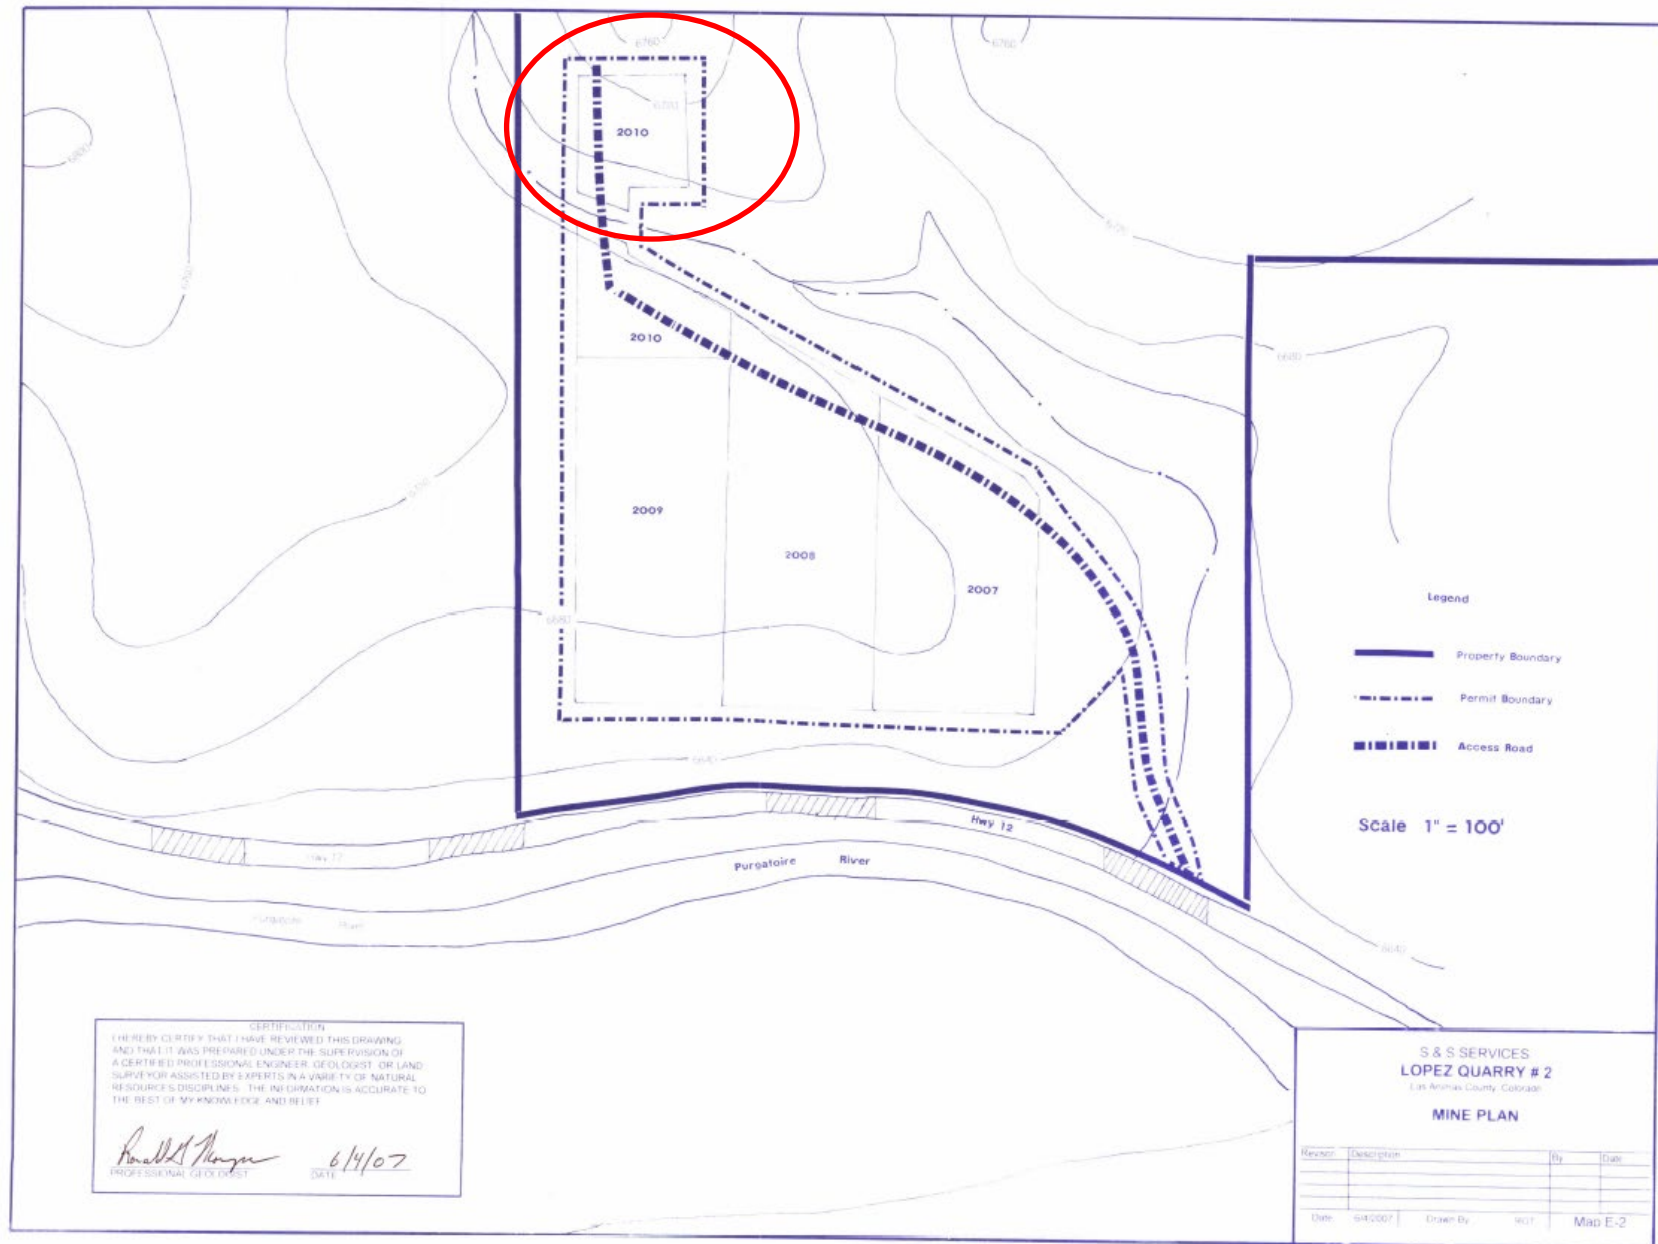
**Figure 2:** Approved mining plan map with a red circle added to indicate the northern portion mentioned in the mining plan that was proposed to possible serve as a topsoil stockpile location. Notice how the map appears to suggest that this area is directly north of the bend in the access road, in an area with a gradual slope.
