DRMS Inspection Report, March 29, 2024 Inspection, Lorencito Canyon, C-1996-084

COLORADO
Division of Reclamation,
Mining and Safety
Department of Natural Resources

Permit Number: C-1996-084 Mine Name: Lorencito Canyon Mine Operator: New Elk Coal Company, LLC Operator Address: Mr. John Terry 12250 Highway 12 Weston, CO 81091	County: Las Animas Operation Type: Surface Permit Status: Permanent Cessation Ownership: Private
	Operator Representative Present: John Terry
Operator Representative Signature: (Field Issuance Only)

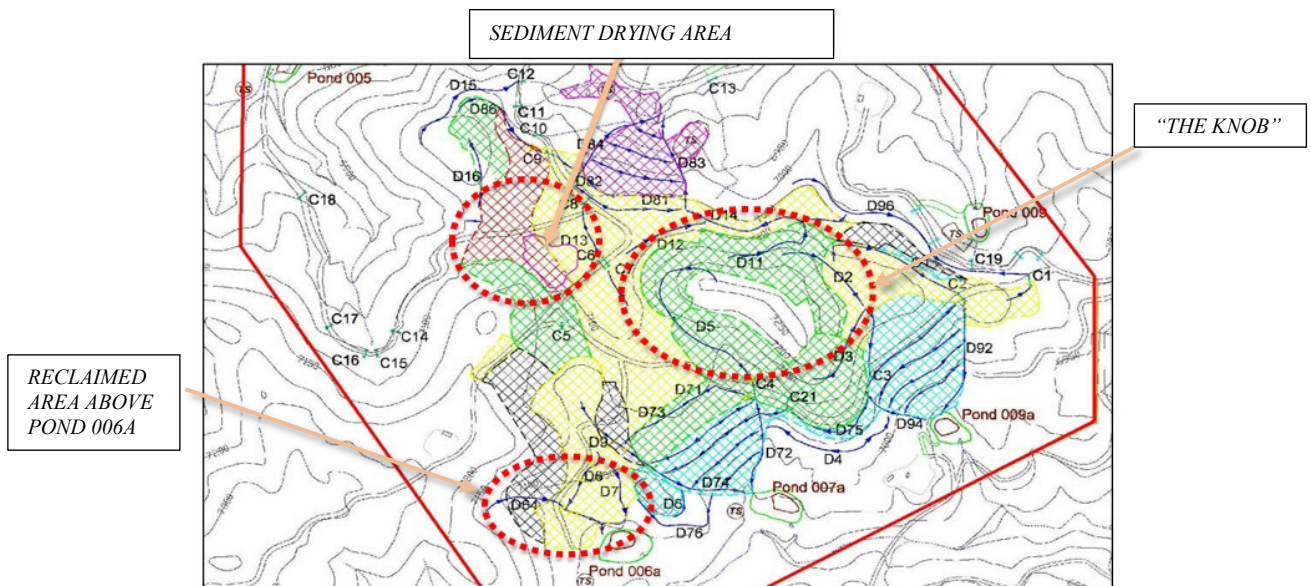
4. The following items pertain to ongoing erosional issues in the areas shown in Figure 1, that pursuant to Rule 4.14.6 need to be addressed. A Technical Revision will be required to expand on the current Rill and Gully plan in the PAP. **The Operator shall submit the technical revision, obtain approval, repair the erosion, and stabilize the slopes pursuant to the approved plan by December 31, 2024.**

FIGURE 1. AREAS WHERE RILLS, GULLIES AND SPARSE VEGETATION HAS BEEN FOUND TO BE A PERSISTENT PROBLEM AT THE SITE ARE WITHIN THE DOTTED CIRCLE AREAS. BACKGROUND IMAGE IS THE 2020 ANNUAL REPORT MAP.

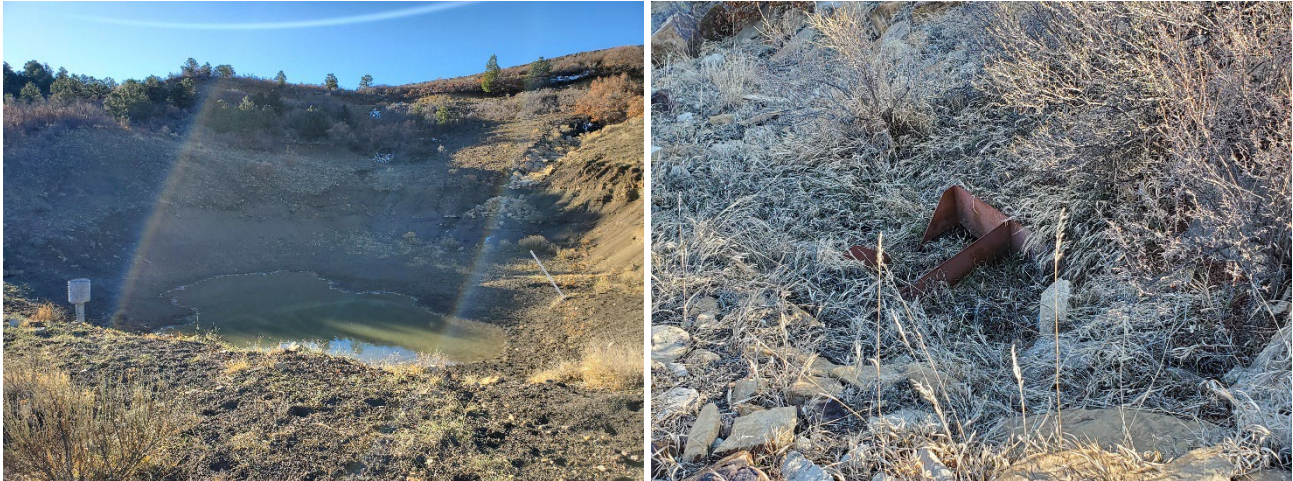
- Pond 009 was holding some water and was not discharging (Photo 1). The pond embankment was stable and vegetated, and the primary and emergency spillways appeared clear and functional.

Photo 1: Pond 009 and Pond 009's flume.

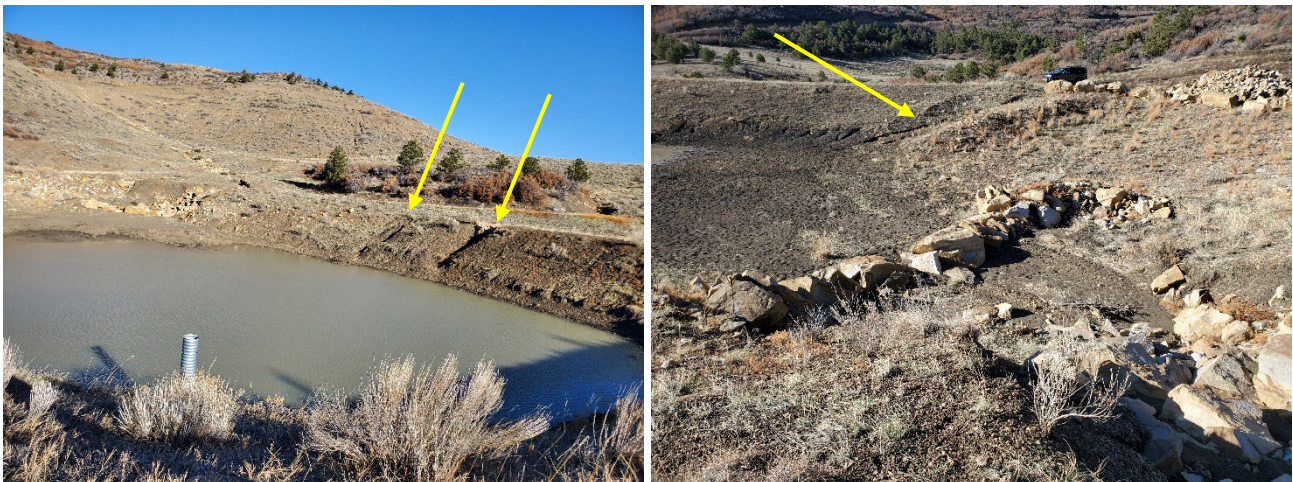
1. Erosion rills are forming on the north and west banks of Pond 006a. The erosion on the north bank appears to have been addressed at some point, because rebar is placed above the rills. However, it appears that the prior BMPs are no longer functioning adequately. **Pursuant to Rule 4.05.5(1)(c), the Operator shall address the erosion and repair the north bank.** The erosion on the west bank appears to have been caused by runoff from the road located east of Pond 006a. **Pursuant to Rule 4.05.5(1)(c), the Operator shall address the erosion and repair the west bank.**

Photo 2: Pond 006a. Arrows indicate the erosion on the north (left photo) and west (right photo) banks.

- Pond 006a was holding some water (Photo 2) and was not discharging. The primary and emergency spillways appeared clear and functional.
- **Photo 2 below corresponds with the maintenance item #1 on the first page of this report which states:**
 - *“Erosion rills are forming on the north and west banks of Pond 006a. The erosion on the north bank appears to have been addressed at some point, because rebar is placed above the rills. However, it appears that the prior BMPs are no longer functioning adequately. **Pursuant to Rule 4.05.5(1)(c), the Operator shall address the erosion and repair the north bank.** The erosion on the west bank appears to have been caused by runoff from the road located east of Pond 006a. **Pursuant to Rule 4.05.5(1)(c), the Operator shall address the erosion and repair the west bank.**”*

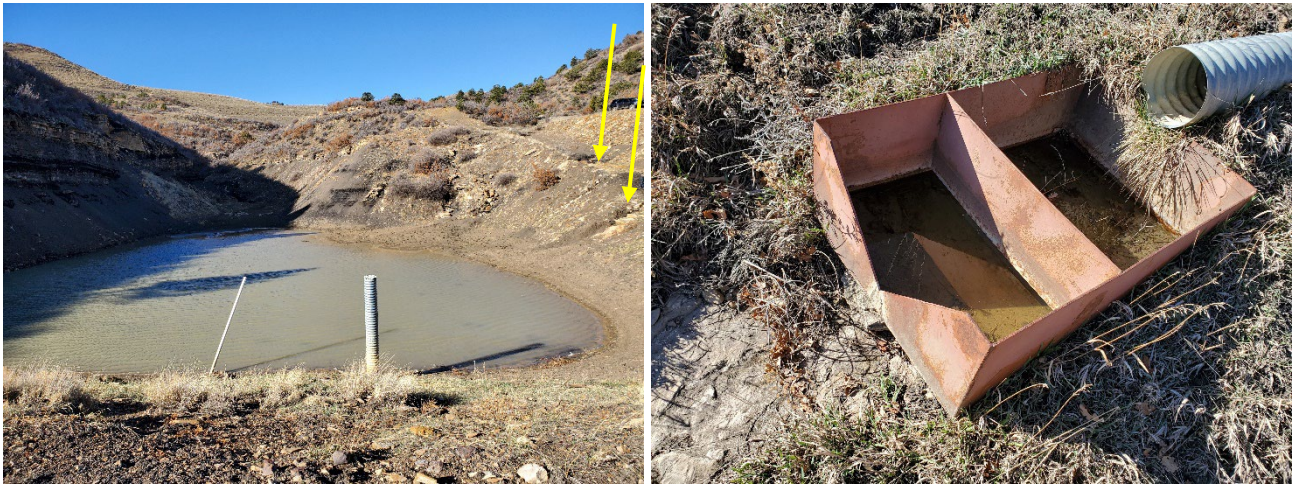
2. The majority of Pond 008's embankment was stable and vegetated, however, the west bank contains some erosion rills and gullies. The erosion appears to have been caused by run-off from the roads above and down to the pond. **Pursuant to Rule 4.05.5(1)(c), the Operator shall repair the erosion and stabilize the west bank of Pond 008.** The Operator stated that they will likely install additional rock berms along the western-most road to help prevent run-off from running down the slopes and into the pond. The Operator also stated that they plan to remove the sediment (deposited as a result of the bank erosion) along the west bank of Pond 008.

- Pond 008 was holding some water and was not discharging (Photo 3). The primary and emergency spillways appeared clear and functional. The flume was nearly full, but was not discharging.

Photo 3: (Left) Pond 008. Arrows point to erosion on the pond's west bank, coming down from the path to the pond below the road. (Right) nearly full flume at Pond 008 outlet.

- **Photo 3 (above) corresponds with the maintenance item #2 on the first page of this report which states:**
 - *"The majority of Pond 008's embankment was stable and vegetated, however, the west bank contains some erosion rills and gullies. The erosion appears to have been caused by run-off from the roads above and down to the pond. **Pursuant to Rule 4.05.5(1)(c), the Operator shall repair the erosion and stabilize the west bank of Pond 008.** The Operator stated that they will likely install additional rock berms along the western-most road to help prevent run-off from running down the slopes and into the pond. The Operator also stated that they plan to remove the sediment (deposited as a result of the bank erosion) along the west bank of Pond 008."*

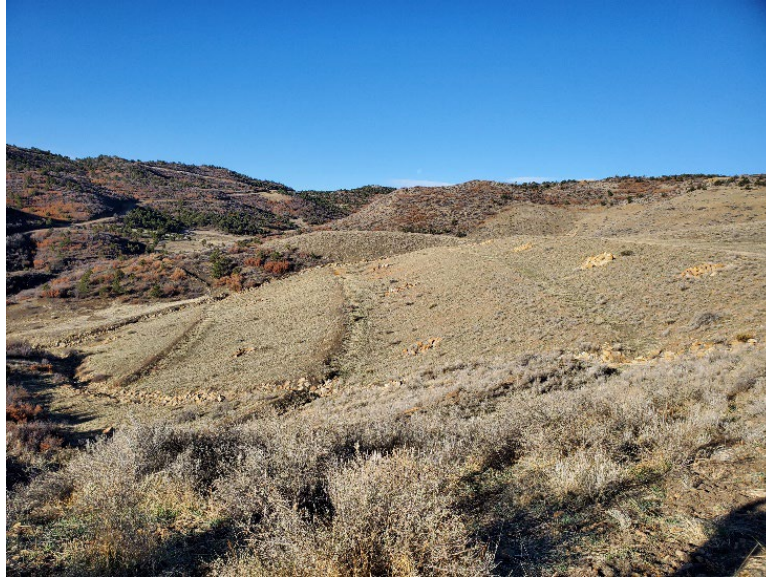
- Fill 007 was observed. Fill 007 was well vegetated and appeared stable (Photo 4).

Photo 4: Looking west across Fill 007.

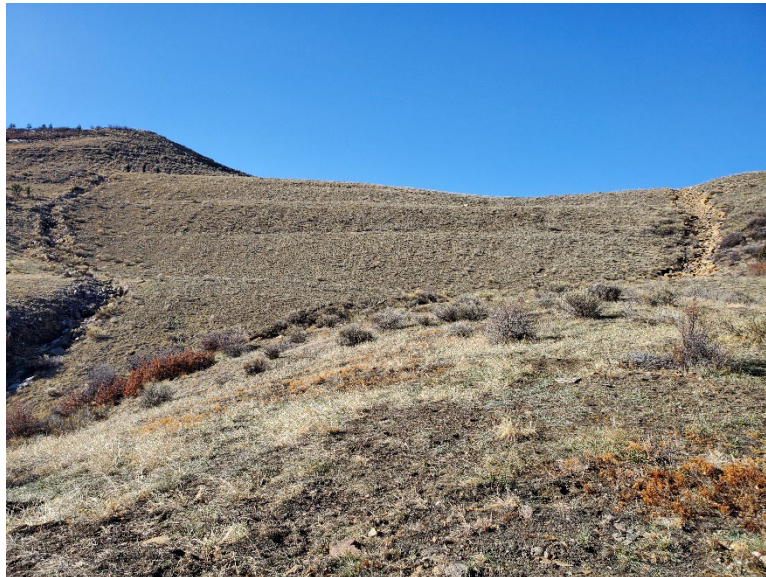
- Fill 008 was observed. Fill 008 was well vegetated and appeared stable (Photo 5).

Photo 5: Looking north at Fill 008.

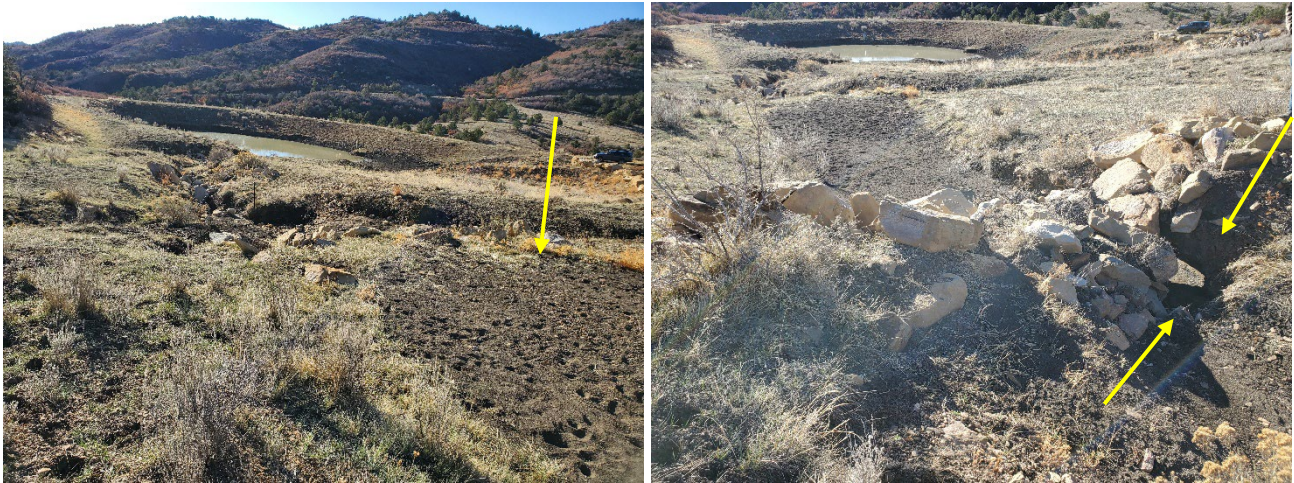
- b. The check dams leading to Pond 006a, within ditches D8 and D64, are nearly full of sediment. **Pursuant to Rules 4.05.3(1)(c)-(e) and 4.05.5, the Operator shall clean out the sediment from the check dams to prevent excess sediment from entering the pond.**

Photo 6: (Left) Arrow points to a check dam that is nearly full of sediment (see Maintenance Item #3a). (Right) Arrows point to an area where water has undercut a check dam along its southern bank (see Maintenance Item #3a).

Pursuant to Rules 4.05.3(1)(c)-(e) and 4.05.5, the Operator shall clean out the sediment from the check dams to prevent excess sediment from entering the pond.”

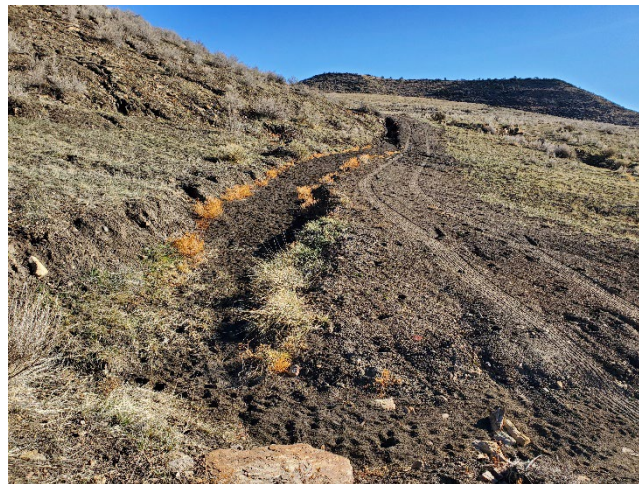
3. The following items pertain to ongoing maintenance issues, cited in previous reports for the area in and around the reclaimed area above Pond 006a:
 - a. The ditch along the road leading to Pond 006a is eroding and nearly full of sediment. The overloaded ditch is contributing to the build-up of sediment in the check dams of ditches D8 and D64. **Pursuant to Rule 4.03.2(4), the ditch along the west side of the road leading to Pond 006a needs to be cleaned out and repaired.**

Photo 7: Ditch along the west side of the access road to Pond 006a that is full of sediment (see Maintenance Item #3b).

- **Photos 6-7 below correspond with maintenance item #3 on Page 2 of this report, which states:**
 - *“The following items pertain to ongoing maintenance issues, cited in previous reports for the area in and around the reclaimed area above Pond 006a:*
 - a. *The ditch along the road leading to Pond 006a is eroding and nearly full of sediment. The overloaded ditch is contributing to the build-up of sediment in the check dams of ditches D8 and D64. Pursuant to Rule 4.03.2(4), the ditch along the west side of the road leading to Pond 006a needs to be cleaned out and repaired.*
 - b. *The check dams leading to Pond 006a, within ditches D8 and D64, are nearly full of sediment.*

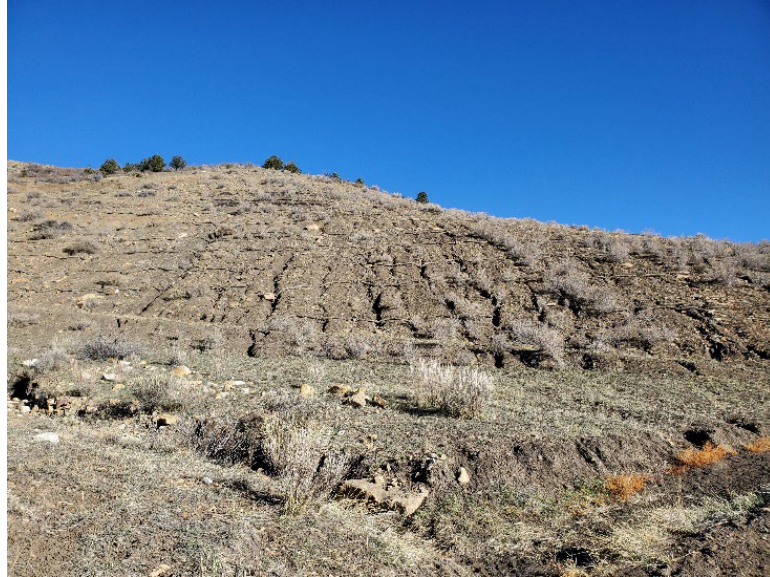
- The reclaimed land above Pond 006a, reported to have been seeded in 2007, is still eroded (see left-side picture in Photo 8). **See maintenance item #4 on Page 2 of this report for how this shall be addressed by the Operator.**

Photo 8: Erosion on the reclaimed area above and west of Pond 006a.

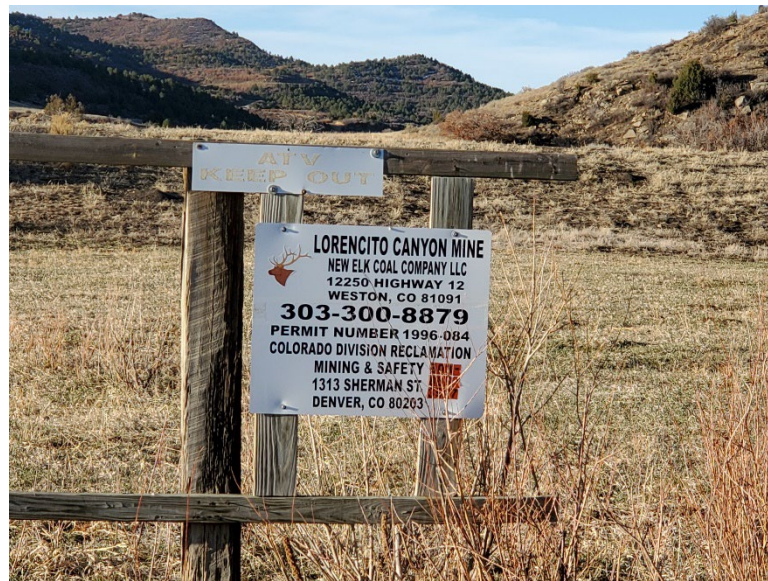
- Mine signs were posted at road entrances (Photo 8) and at the entrance to the permit boundary in compliance with Rule 4.02.

Photo 9: Mine sign.
