MINERALS PROGRAM INSPECTION REPORT
PHONE: (303) 866-3567

MINE NAME: Wattenberg Lakes	MINE/PROSPECTING ID#: M-2004-051	MINERAL: Aggregate	COUNTY: Weld
INSPECTION TYPE: Preoperation Inspection	WEATHER: Clear	INSP. DATE: April 3, 2024	INSP. TIME: 10:00
OPERATOR: Holcim - WCR, Inc.	OPERATOR REPRESENTATIVE: Wyatt Webster	TYPE OF OPERATION: 112c - Construction Regular Operation	
REASON FOR INSPECTION: Preoperation Inspection	BOND CALCULATION TYPE:	BOND AMOUNT: \$520,000.00	
DATE OF COMPLAINT: NA	POST INSP. CONTACTS: None	JOINT INSP. AGENCY: None	
INSPECTOR(S): Brock Bowles	INSPECTOR'S SIGNATURE:

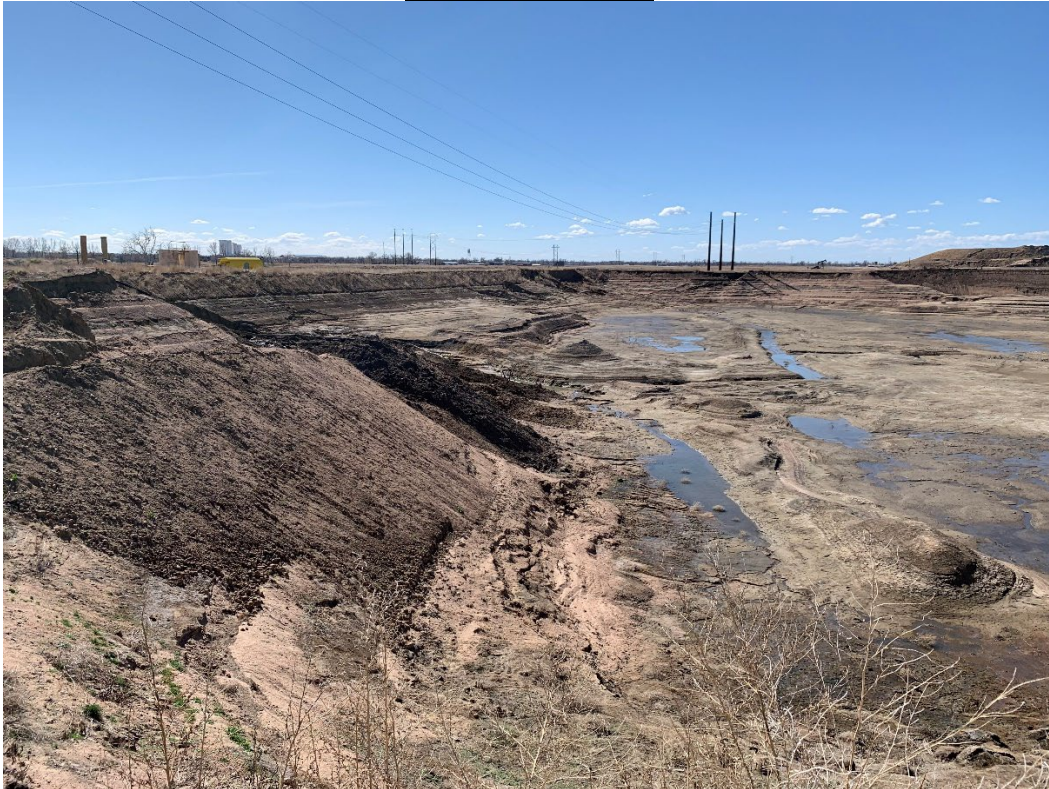
The Struck Pit (pond 1) was being dewater in preparation for mining and backfilling the side slopes (photo 1). The water was being pumped to the adjacent Ski Pond. The pond will be expanded further to the west as part of AM1.

The south and east banks of the Struck Pond will be back filled to meet the 3h:1v design requirement outlined

in AM1 (see photo 1).

Photo 1 – East side of Struck Pond, facing south. This is the lowest point in the pond where de-watering is taking place.

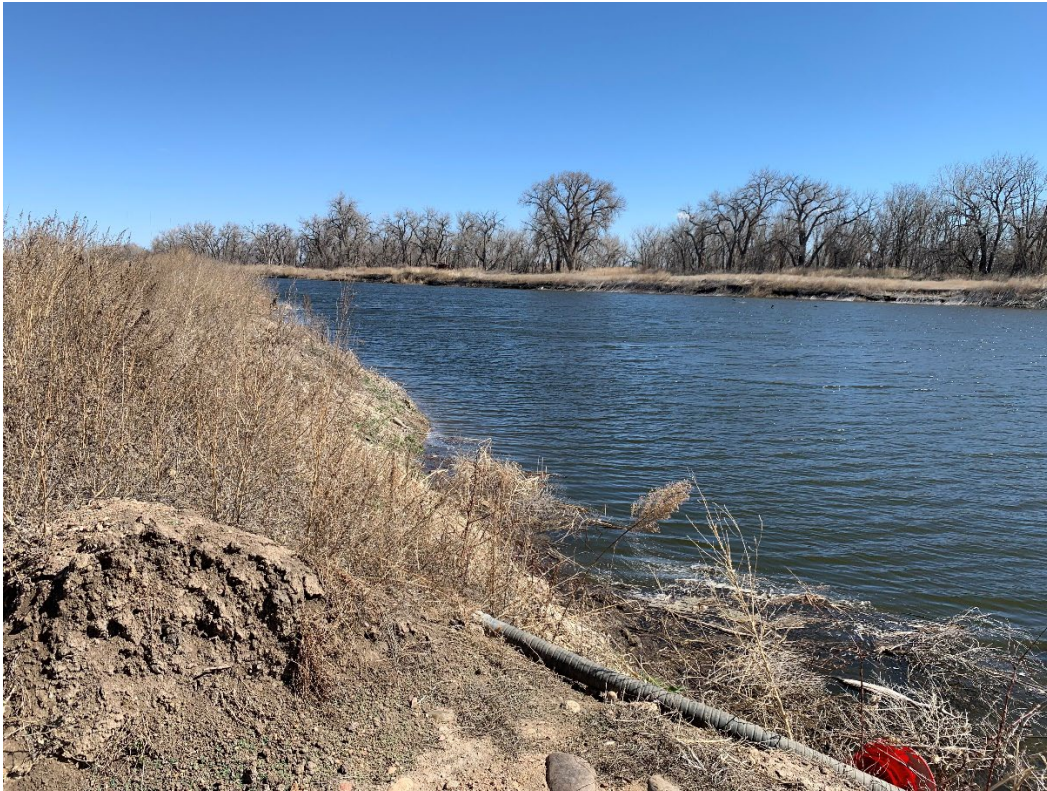
The triangle shaped pond in the southeast corner of the permit area is an unlined pond that currently contains water (photo 2). The evaporation is accounted for in the SWSP but there isn't a permanent augmentation plan in place for the pond. The pond is scheduled to be backfilled as part of the AM1 plan.

Photo 2 – Triangle pond in southeast section of the permit, photo facing northeast.

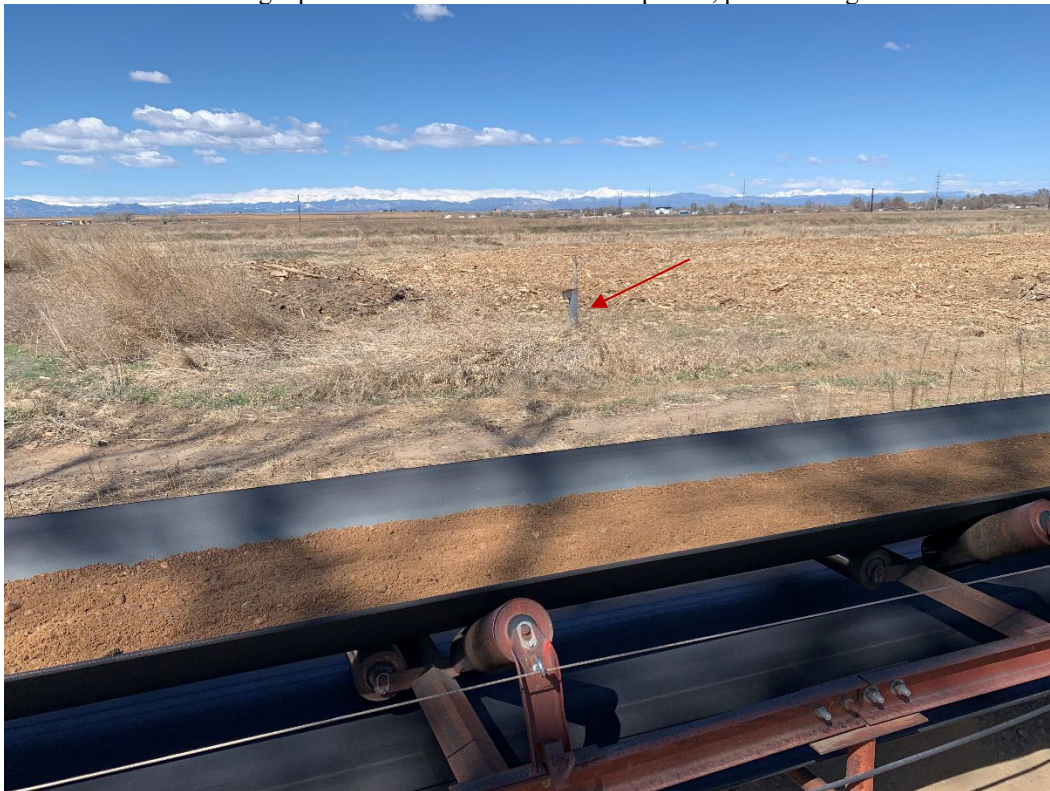
Monitoring Well MW-4 was damaged during some recent work on the site (photo 3). According to Mr. Webster, it was damaged to the extent that he can no longer take readings. MW-4 is located on the east side of clay lined Pond 3. Mr. Webster will submit a TR requesting that DRMS review if MW4 can be abandoned or if the well needs to be re-drilled.

Photo 3 – Groundwater well MW4 on the east side of Pond 3

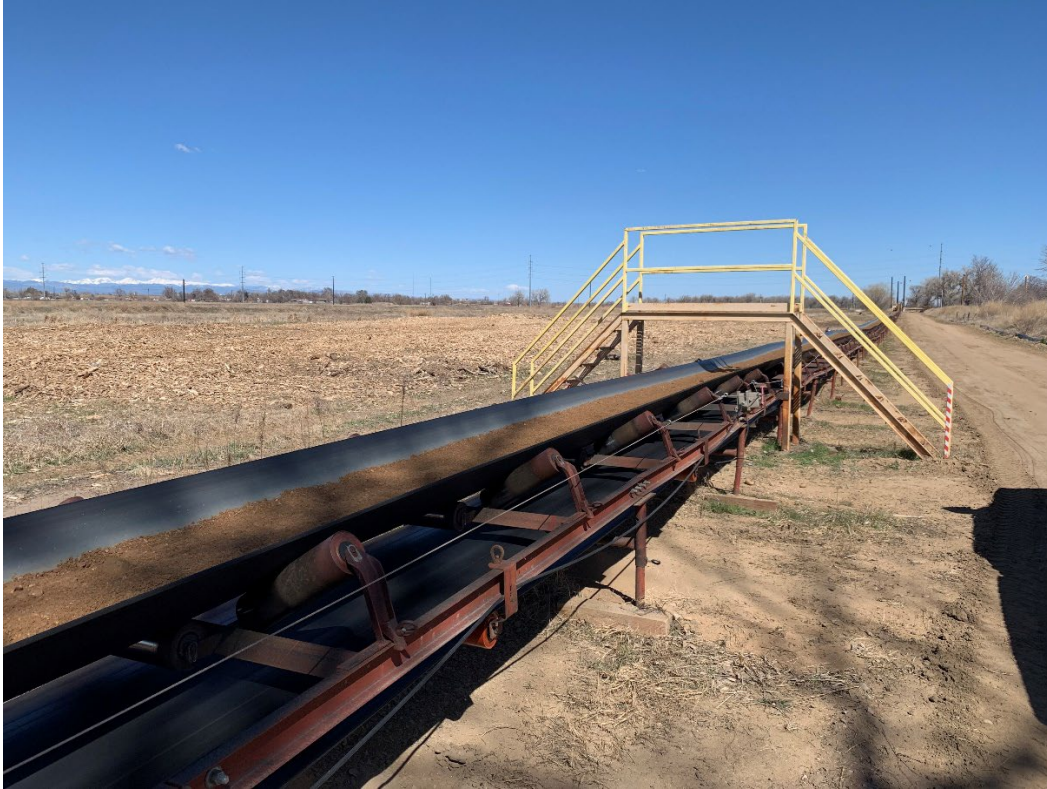
Pond 3 is the northern most pond. It is lined but has not been certified by DWR according to the 2023 SWSP. The pond did not contain water. A spillway is proposed on the east side of the pond to prevent damage to the pond during high flood events (photo 4). This design is in coordination with the City of Westminster and the location is shown on Map F-1.

Photo 4 – Area of proposed spillway, facing north. Pond 3 is to the left and the S. Platte River is behind the berm on right.

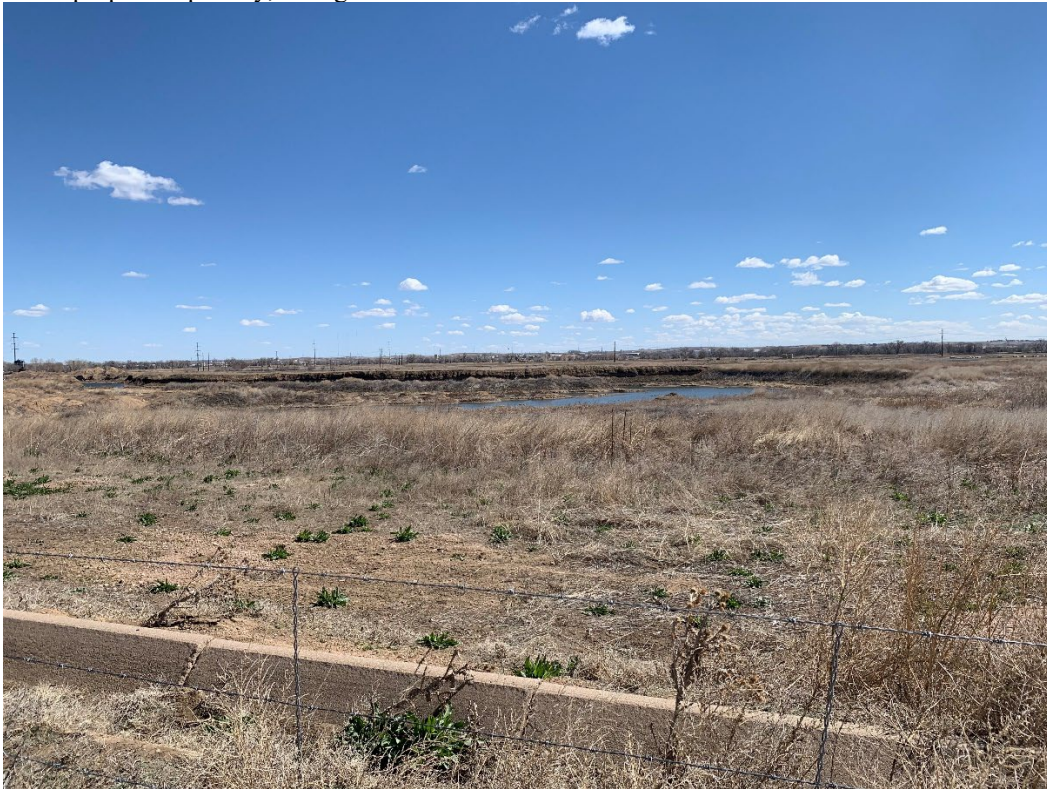
A wetland saltgrass meadow is proposed in the northwest corner of the permit area, south of the oil well pad. The area is currently lower than the water table and will be backfilled to 8-10 above the groundwater (photo 5).

Photo 5 – Proposed saltgrass meadow area that will be backfilled.
