**MINERALS PROGRAM INSPECTION REPORT**  
**PHONE: (303) 866-3567**

| <b>MINE NAME:</b><br>Pikeview Quarry | <b>MINE/PROSPECTING ID#:</b><br>M-1977-211 | <b>MINERAL:</b><br>Limestone (general),<br>granite gneiss and do | <b>COUNTY:</b><br>El Paso |
| <b>INSPECTION TYPE:</b><br>Monitoring | <b>WEATHER:</b> Clear | <b>INSP. DATE:</b><br>April 3, 2024 | <b>INSP. TIME:</b><br>10:00 |

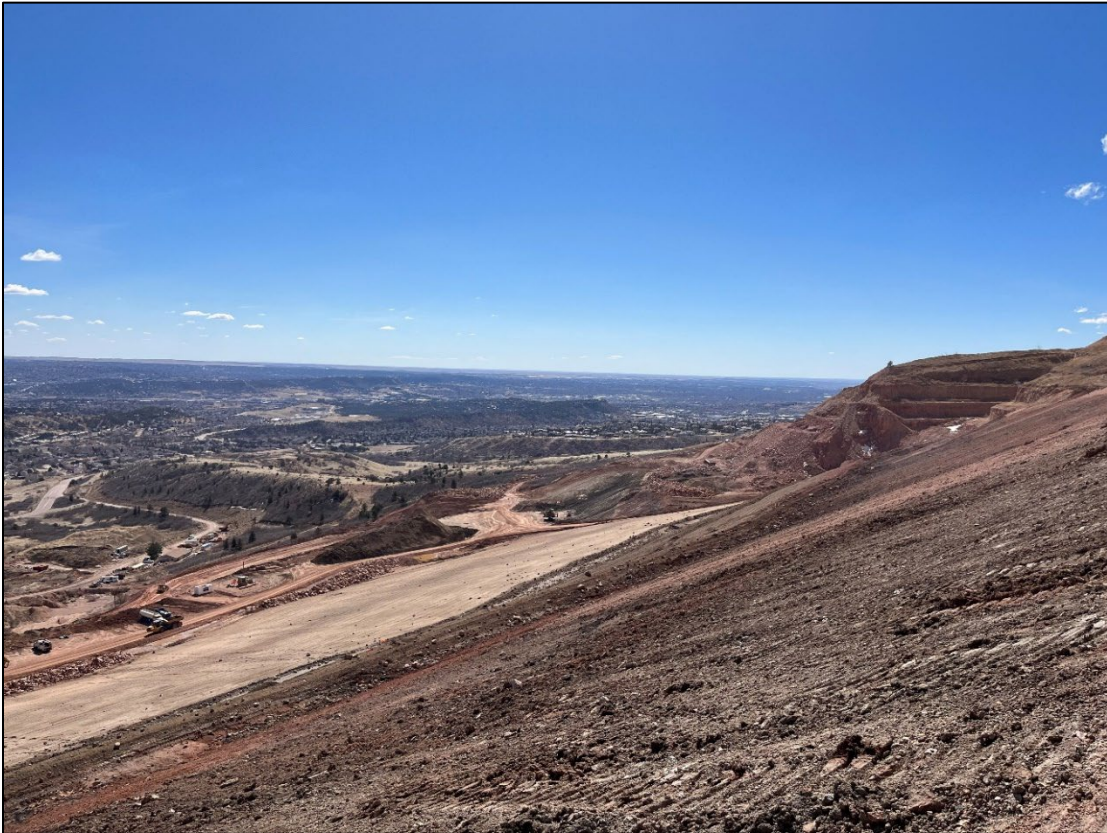
**Photo 1: View SE of the lower and south borrow areas, taken from level 4.**

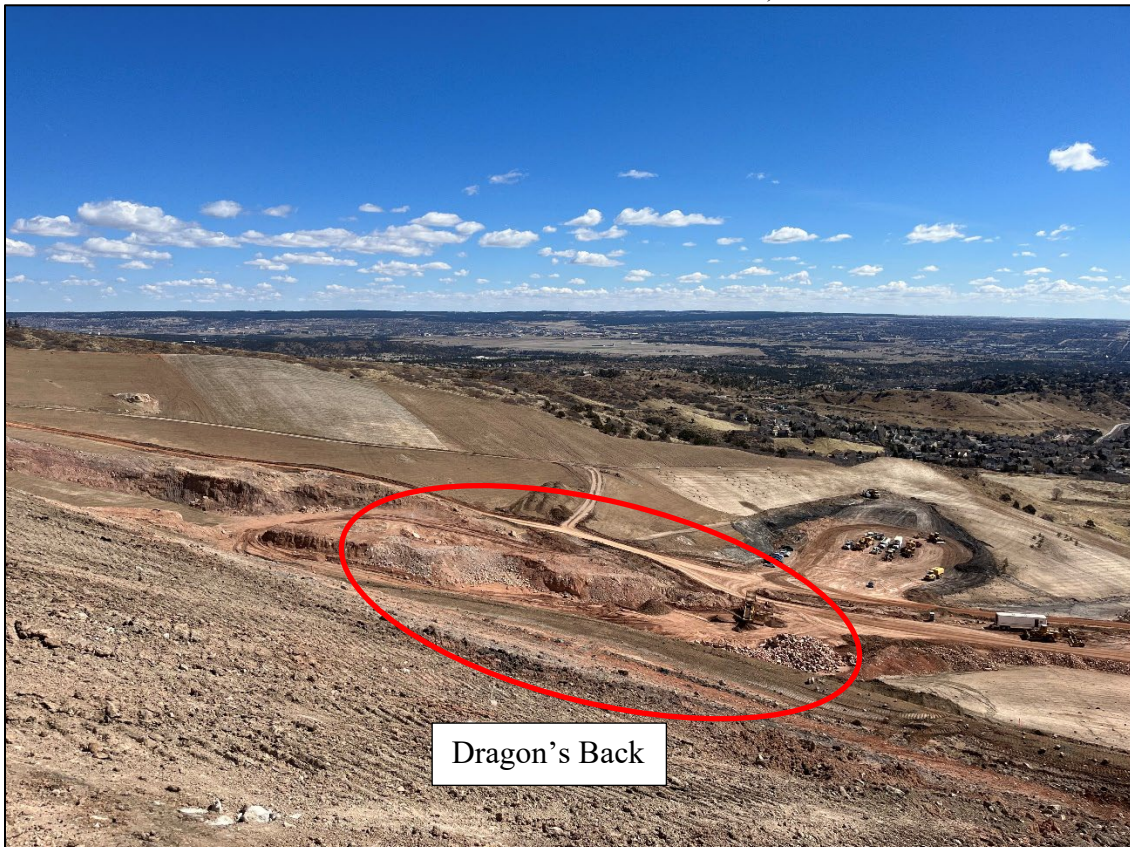
**Backfilling and Grading:** Mr. Schnabel indicated that material was being taken from all borrow areas at the site; lower, shop and south (Photos 2 and 4). As little material as possible is being taken from the shop area to provide better topography in this area post mine and to avoid less quality material. Material from the various borrow areas is placed in an alternating pattern and mixed before grading. This ensures that compaction is optimal on benches. Subgrade contouring is complete on the lower bench and middle benches and growth media has been placed. All placed backfill continues to be tested for compaction in accordance with the approved specifications.

**Photo 2: View NE of the shop area, dragon's back, and north vegetated area.**

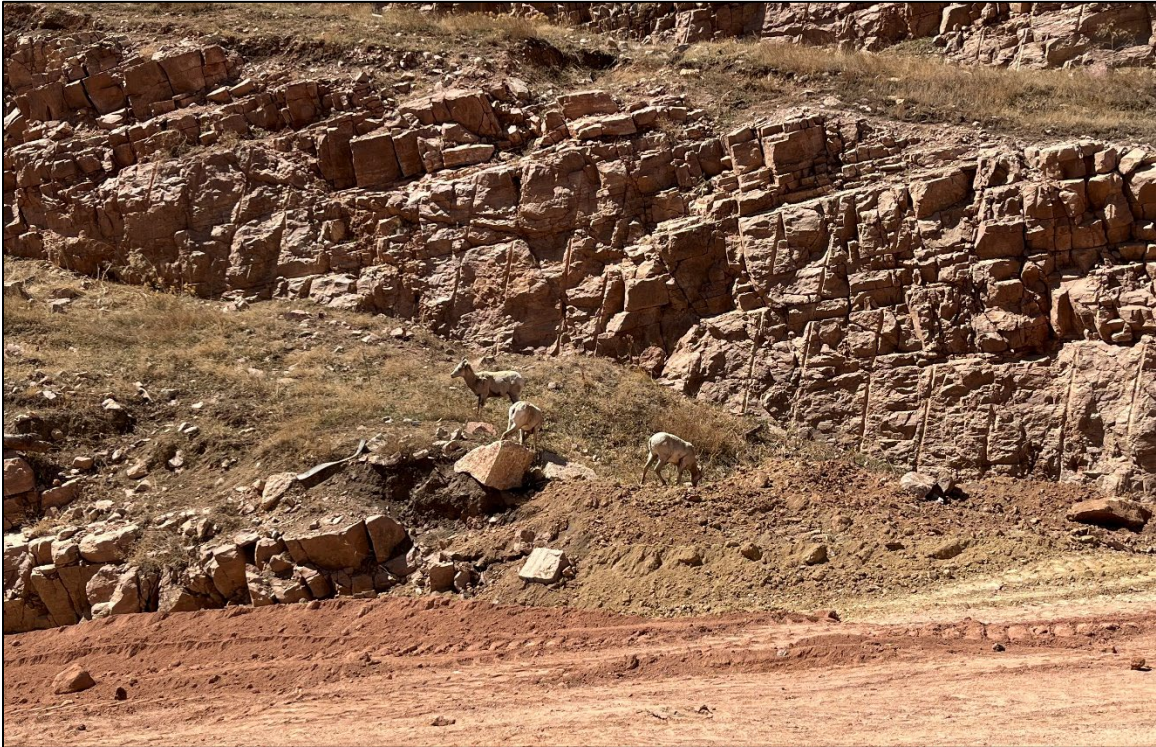
**Fish and Wildlife:** No negative impact on wildlife was observed. Three young Bighorn sheep were noted to be grazing in the upper levels of the buttress (Photo 3).

**Photo 3: Three young Bighorn Sheep were noted to be grazing near the upper buttress benches.**

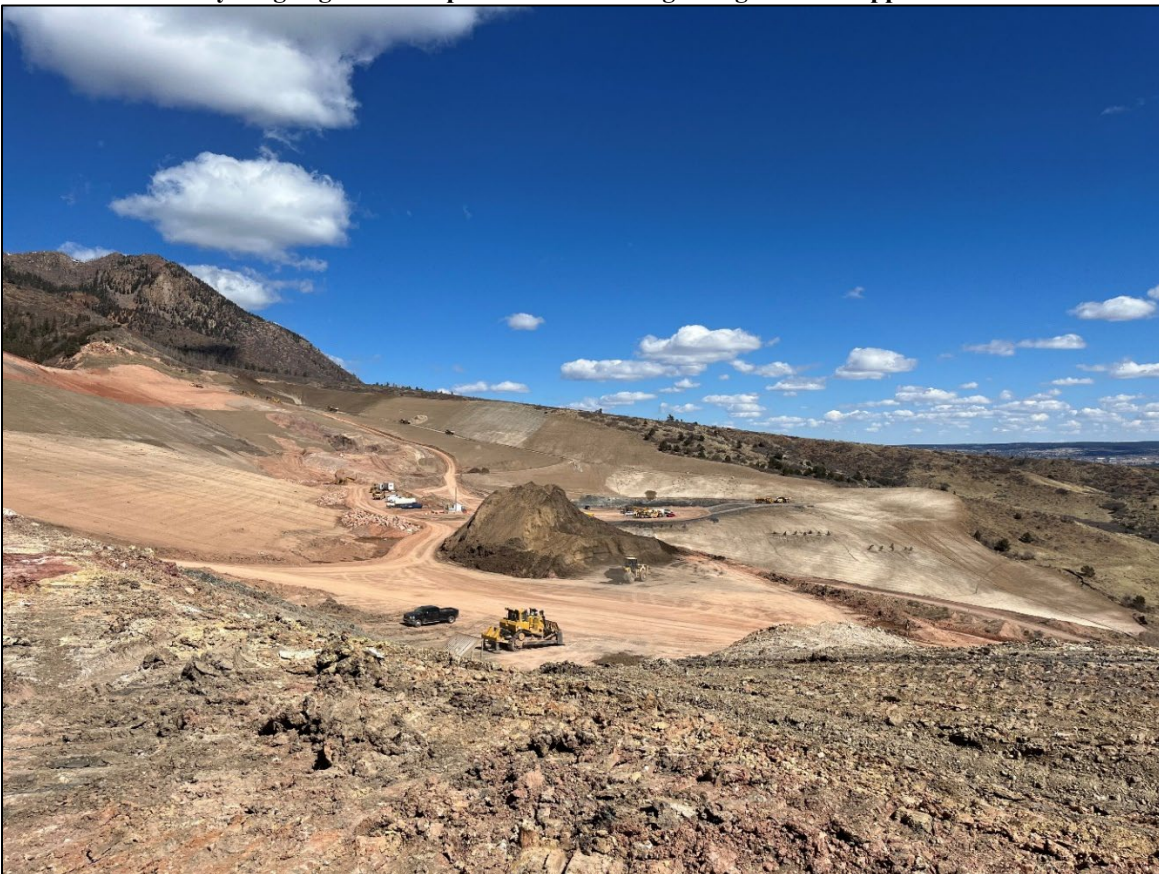
**Photo 4: View north from the south borrow area, a topsoil pile is located in the foreground. The revegetated northern slope is visible in the foreground.**

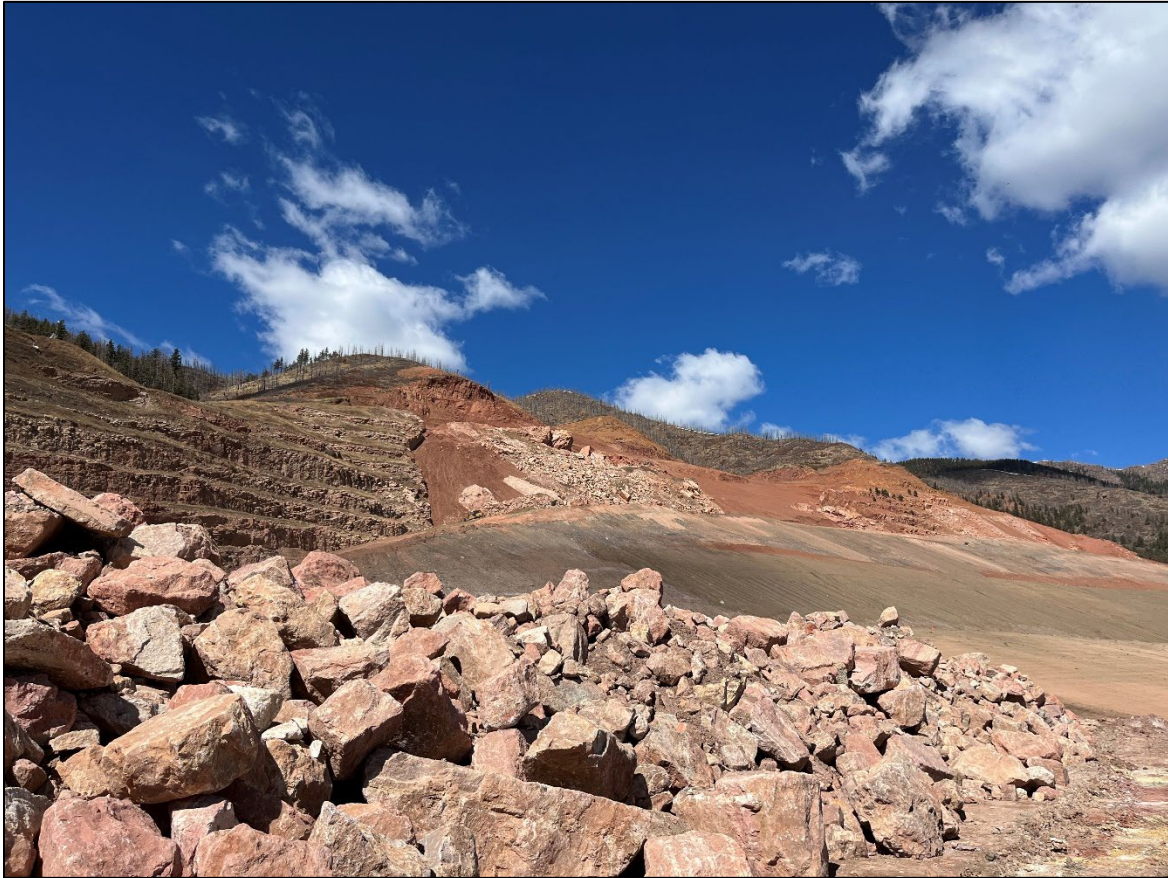
**Roads:** The uppermost road located just below the South Peak continues to deteriorate. Access is still fully blocked with safety berms (Photo 5). The South Peak area is planned to be blasted at the start of April and continue until the start of May. Traffic remains in a one-way pattern, with equipment maintaining two lengths behind all other vehicles. One way traffic will be maintained at the site for as long as possible but will eventually need to revert to a two-way pattern once topsoiling and revegetation efforts fully commence.

**Explosives:** The highwall on the "South Peak" area (Photo 5) has been approved to be blasted to achieve a

stable final slope. Drilling was complete at the time of inspection and blasts were scheduled to begin April 4<sup>th</sup> and continue until May.

As discussed in previous inspection reports, the current design of the North Ditch above level 4 will need to be amended to work around older 'Kiewit cliff' feature (Photo 5) and the 'big rock' feature, to direct water from the maintain seep towards the site's main drainage, and to work around the exposed large bedrock feature (named the "Dragon's Back") below level 4 (Photo 2). As of the date of this inspection, the Division has not yet received this revision request. A majority of the riprap used to construct these channels is already on site. Any remaining volume needed will be created through removal of portions of the 'Dragon's back' feature.

**Photo 5: View west of the South Peak area, 'Big Rock' outcrop (south), and Kiewit Cliffs (north) feature.**
