Division of Reclamation,
Mining and Safety

MINERALS PROGRAM INSPECTION REPORT

MINE NAME: Native/Pierre Mine	MINE/PROSPECTING ID#: M-1977-321	MINERAL: Clay (general)	COUNTY: Pueblo
INSPECTION TYPE: Monitoring	WEATHER: Cloudy	INSP. DATE: March 13, 2024	INSP. TIME: 12:00
OPERATOR: Summit Brick & Tile Co.	OPERATOR REPRESENTATIVE: Julie Welte	TYPE OF OPERATION: 112c - Construction Regular Operation

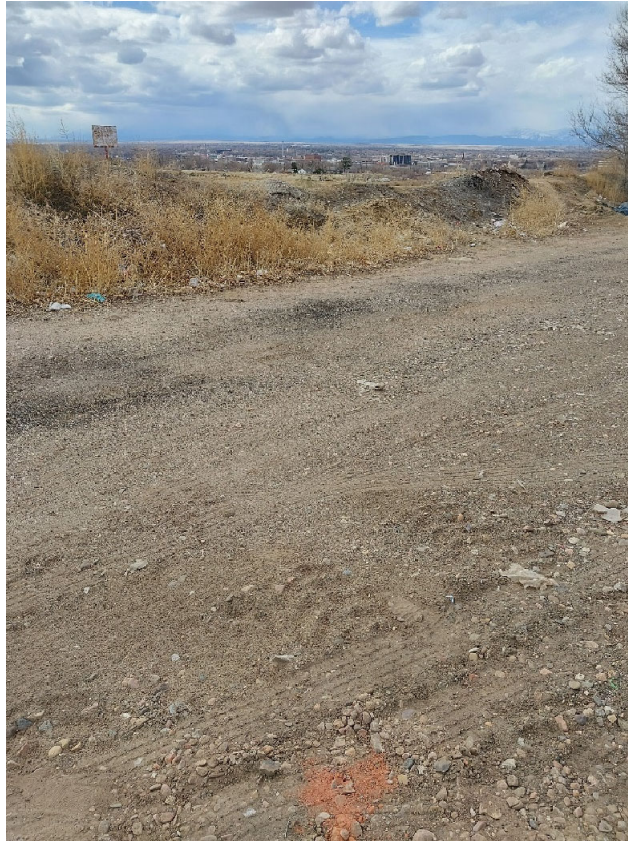
Photo #9: Permit boundary marker G, see map below. Operator does not maintain a post, rather an orange mark on the ground. The permit boundary is right next to an alley entrance and frequently.

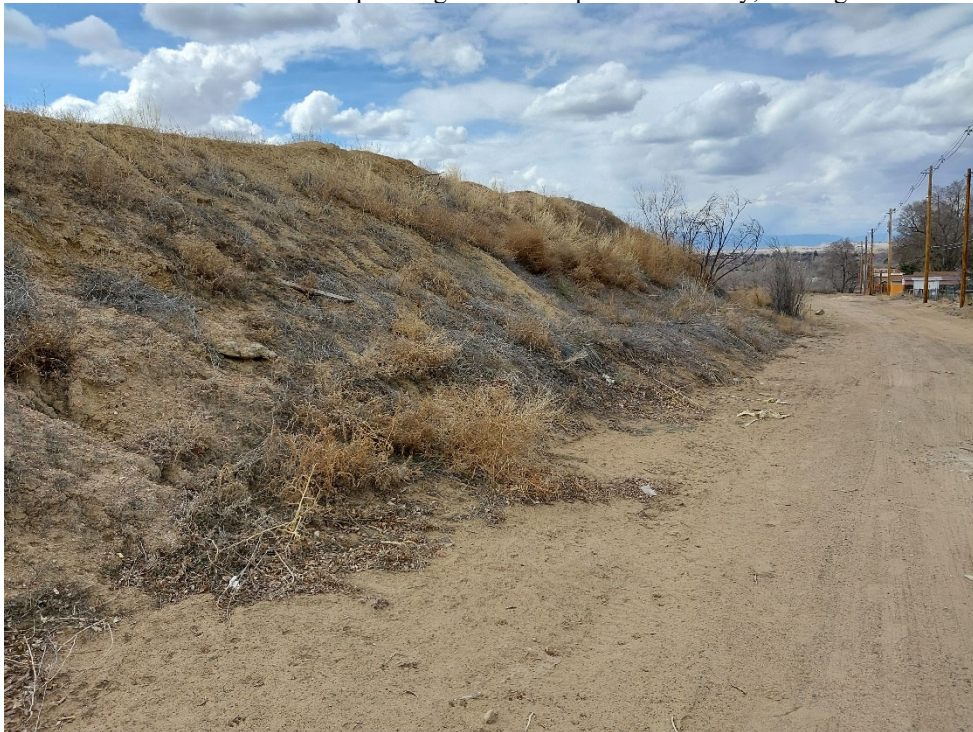
Photo #18: North side of berm along the north side of the permit boundary, looking west. Slope is at angle of repose but is well vegetated and appears to be stable.

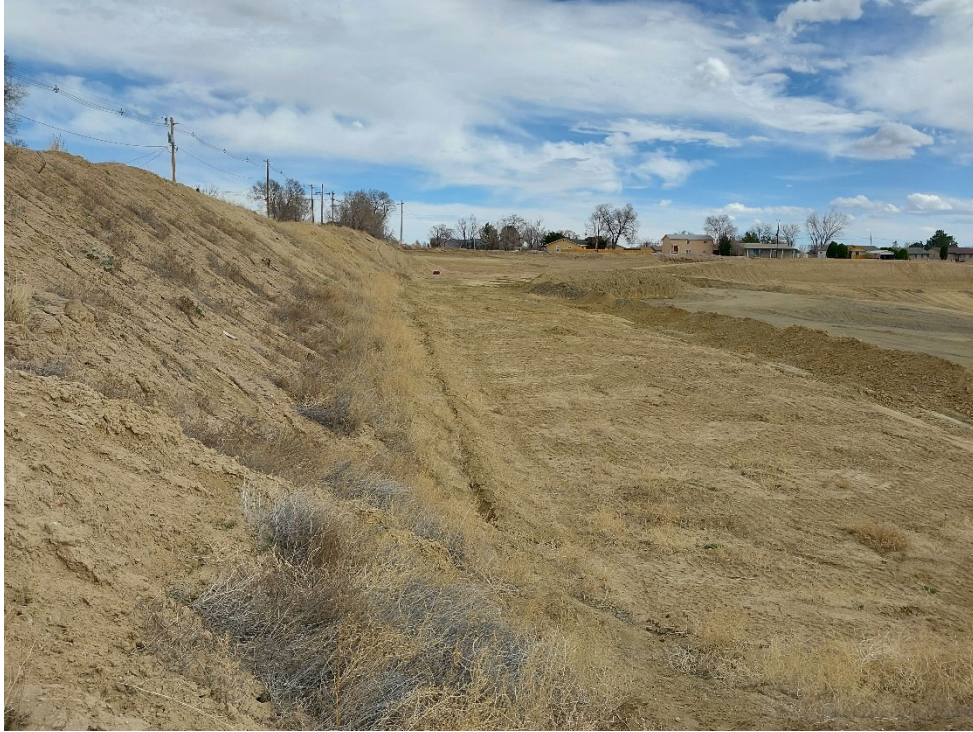
Photo #19: South side of berm along the north side of permit boundary and affected area, looking east. Slope is at an angle of repose but appears to be stable.

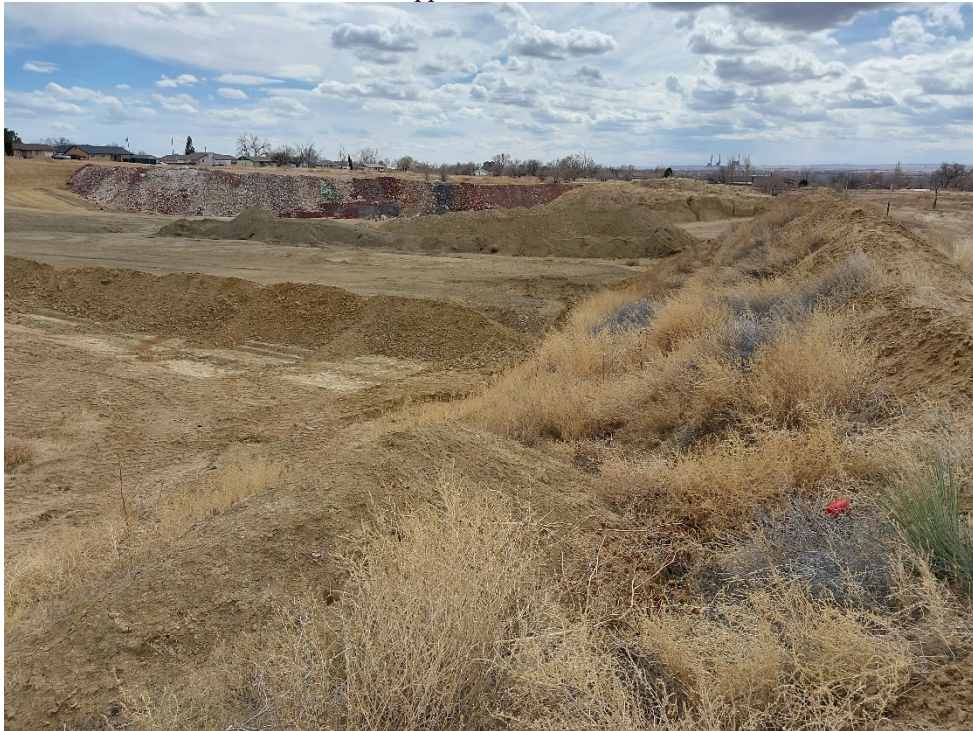
Photo #20: The right side of the photo shows the north-south berm around the affected area, looking south. Slopes are at angle of repose but appear to be stable. The discarded brick stockpile, topsoil stockpile, and product stockpile can be seen in the background in the center and left of the photo.

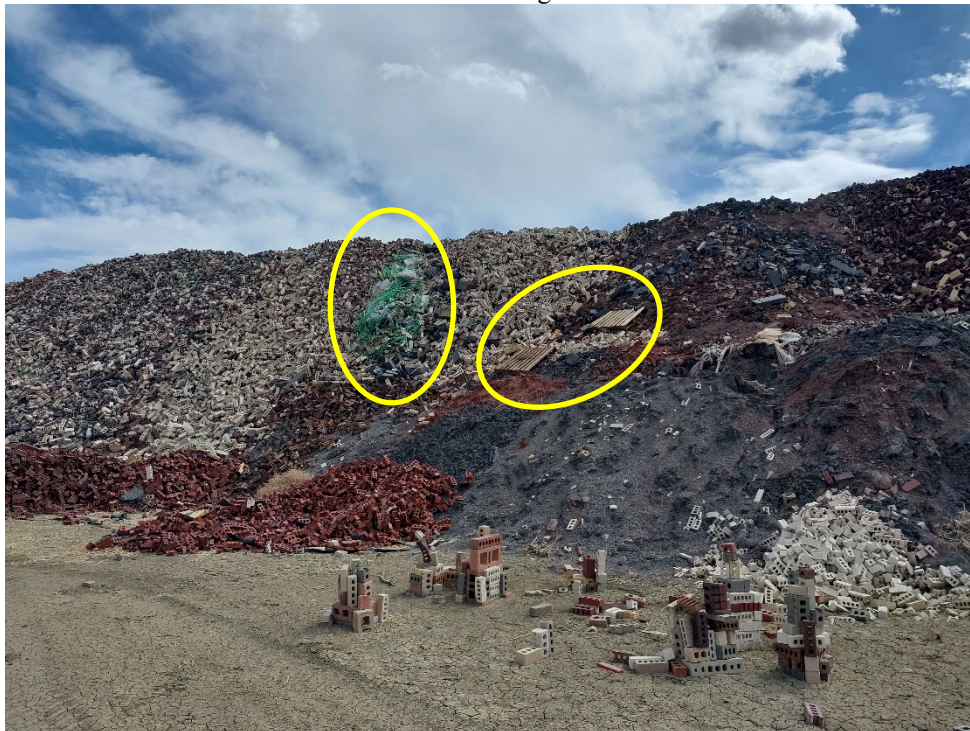
PROBLEM: Trees, wooden pallets, plastic wrap, and plastic banding were mixed in with the approved discarded brick backfilling material. These items are not inert materials per Rule 1.1(22) and the incorporation of them with backfill material does not comply with Rule 3.1.5(9).

Discarded bricks are stockpiled on the south side of the affected area, south of the pit. According to the file review, the discarded bricks will be used for back fill. The slope of the stockpile is at an angle of repose but appears to be stable. From the top of the stockpile of discarded bricks, along the southeast permit boundary line, plastic and pieces of wooden pallets were seen mixed in with material. It appeared that as the discarded bricks are brought over from the brick plant, they are packaged on a pallet and secured with plastic binding. These pallets were then dumped onto the pile as is. From the floor of the pit, more plastic and pallets were observed, see the photos below. On the far east side of the discarded stockpile, it appeared that a tree had been buried by the material.

Plastic and wood are not inert materials as defined by Rule 1.1(22) and should not be present within the

backfilling material in accordance with Rule 3.1.5(9). Julie stated that Summit Brick and Tile Co. performs cleanup operations at the site at least once a month. She called the plant manager while we were on site and let him know that the material needs to be cleaned up and, in the future, only the bricks should be discarded. The operator was instructed to provide photos of the discarded brick stockpile after the plastic and wood has been removed and provide them to the Division as proof of abatement.

Photo #24: Plastic banding and wooden pallets seen in the discarded brick stockpile to be used for backfilling material. Operator needs to remove these items as they are not inert and cannot be used as backfilling material.

CORRECTIVE ACTIONS: The operator shall remove these mediums from the discarded brick backfilling material and provide photos that the material has been removed.

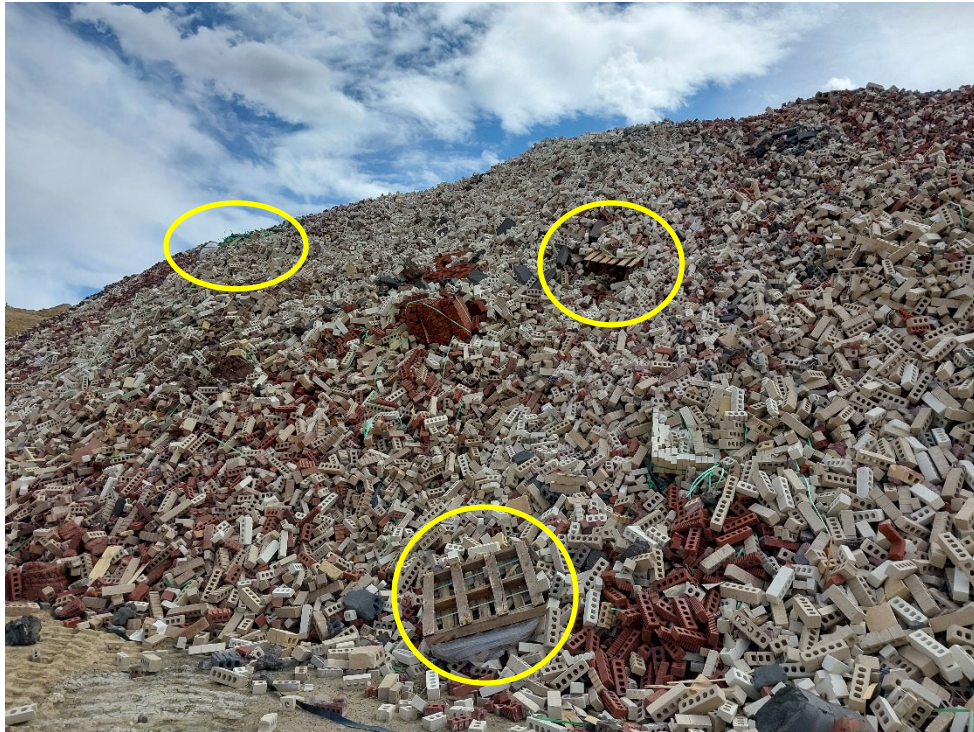
Photo #25: Plastic banding and wooden pallets in the discarded brick stockpile to be used as backfilling material. Operator needs to remove these items as they are not inert and cannot be used as backfilling material.

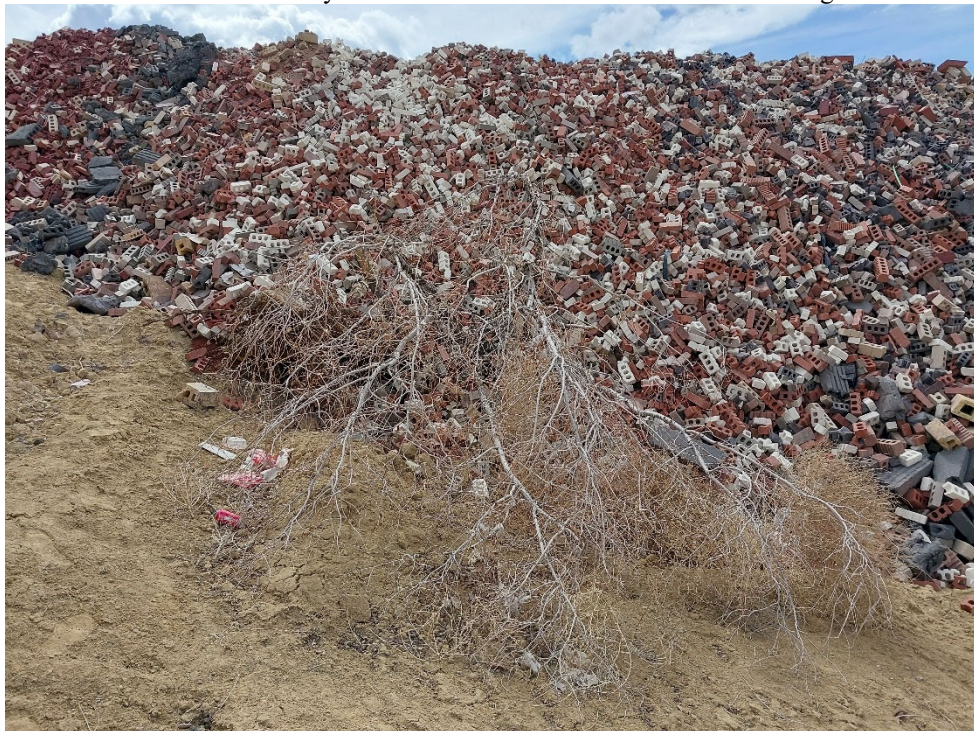
Photo #26: Tree that has been buried by discarded brick dumping. Operator needs to remove item it is are not inert and cannot be used as backfilling material.

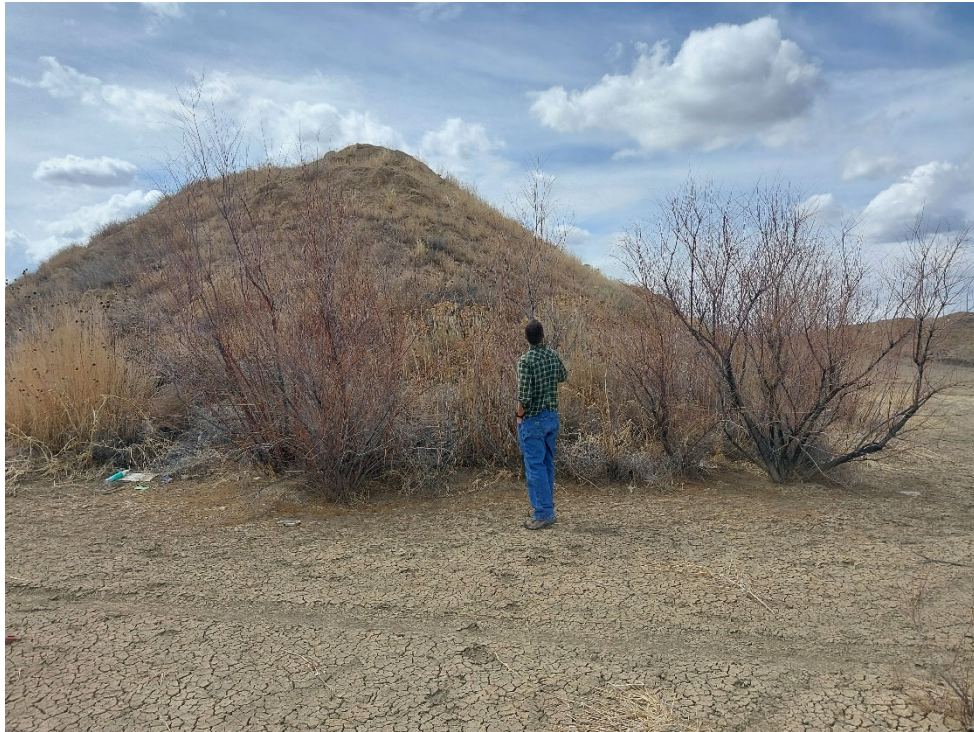
PROBLEM: Tamarisk (salt cedar) trees are present within or have volunteered into the permit area and are becoming established. This is a problem for failure to employ weed control methods for a state listed noxious weed species within the permitted area, and to reduce the spread of weeds to nearby areas as required by Section 3.1.10 (6) of the rule.

Tamarisk, a list B noxious weed, was observed on the pit floor. One stand was observed at the east side of the topsoil stockpile and another stand at the foot of the discarded brick stockpile on the west side of the affected

Photo #27: Tamarisk viewed on the east side of the topsoil stockpile, looking west, Jared Ebert is standing next to the plant and is six feet tall. Operator needs to remove the list B noxious weed.

CORRECTIVE ACTIONS: The operator shall implement the existing weed control plan in accordance with Section 3.1.10 (6) of the Rule and provide photographs of the removal of the tamarisk to the Division.

Julie was informed of the problem and instructed to have the tamarisk removed and to provide photos to the Division as proof of abatement.

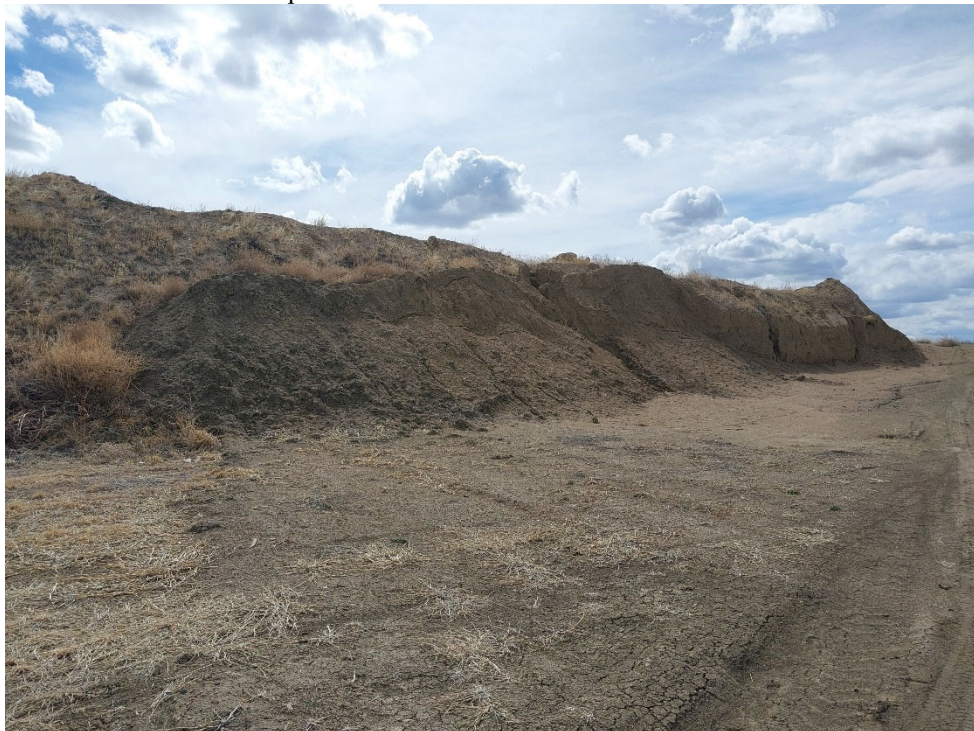
PROBLEM: The topsoil stockpiles do not have stable slopes and therefore susceptible to erosion Rule 3.1.9(1).

The topsoil stockpile is located between the two pit access roads and is in accordance with the annual map submitted on March 7, 2023. Much of the topsoil stockpile had slopes of about 3:1. There was one section where the slope was at an angle of repose. The slope stability on the north side showed instability and incision.

Photo #28: North side of topsoil stockpile, looking west southwest. This slope is at an angle of repose, is not vegetated, and is not stable. There are incisions in the material that can be viewed. Operator needs to repair this slope and restabilize the topsoil stockpile.

CORRECTIVE ACTIONS: The operator shall stabilize the slopes of the topsoil stockpile and provide the Divisions with photos of the repaired slopes.

Julie was informed of the problem and instructed to stabilize the topsoil stockpile and provide photos to the Division as proof of abatement.
