Inspection Report, Hayden Gulch Loadout, C-1992-081

PERMIT INFORMATION

Permit Number: C-1992-081 Mine Name: Hayden Gulch Loadout Operator: Hayden Gulch Terminal, LLC Operator Address: Ms Miranda Kawcak 29515 Routt County Road 27 Oak Creek, CO 80467	County: Routt Operation Type: Loadout Permit Status: Active Ownership: Private
Operator Representative Present:	
Operator Representative Signature: (Field Issuance Only)

Inspection Start Date: April 10, 2024 Inspection Start Time: 07:45 Inspection End Date: April 10, 2024 Inspection End Time: 08:30		Inspection Type: Coal Partial Inspection Inspection Reason: Normal I&E Program Weather: Clear	
Joint Inspection Agency: None		Joint Inspection Contacts:	
Post Inspection Agency: None		Post Inspection Contacts:	
Inspector(s): Hunter Ridley	Inspector's Signature: <i>Hunter Ridley</i>		Signature Date: April 12, 2024

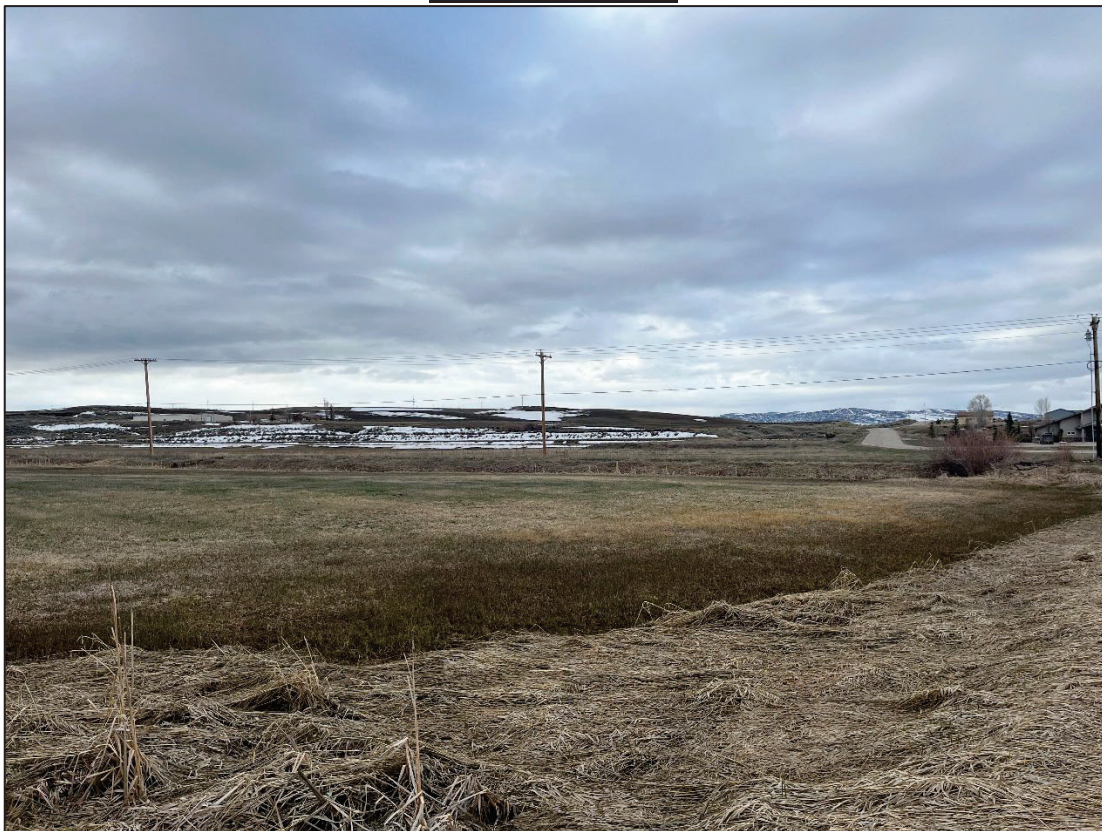
Areas not Phase III bond released include the fields directly north and south of Hwy 40, to be reclaimed to agricultural use as hay fields. This area includes 6.8 acres of which 2.3 are disturbed (Photo 1).

The remaining permit area near Hwy 40 was well vegetated and stable (Photo 1). This area of disturbance will be fully incorporated into adjacent hay fields at the conclusion of the 10-year liability period. Topsoil piles along the recently released TAHR looked well vegetated, stable, and free of erosional features.

Photo 1: View east of the unreleased agricultural fields, taken from Hawthorne St

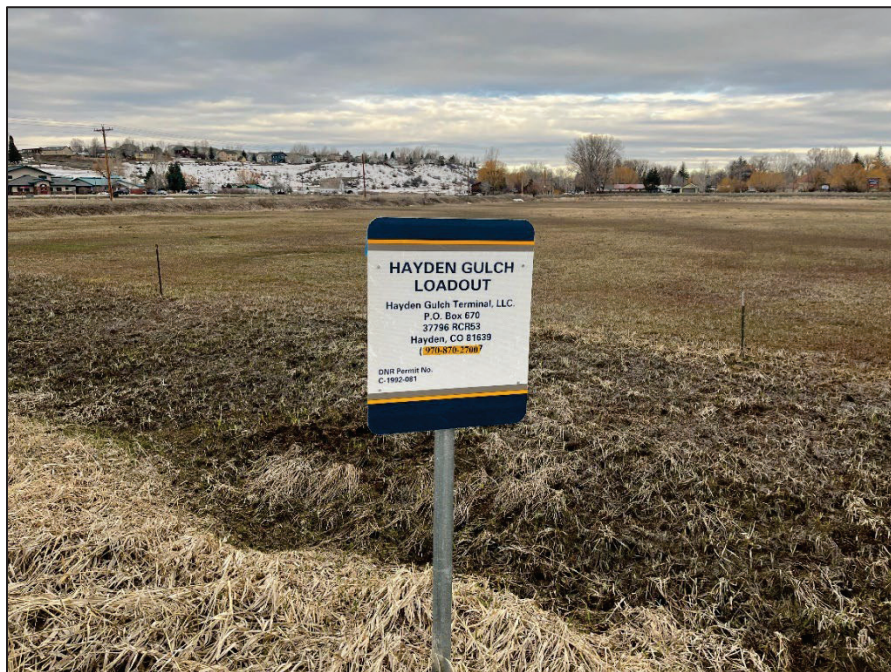
Mine identification signs were observed adjacent to the unreleased agricultural section north and south of Hwy 40 (Photo 2) and at the western end of the TAHR (Photo 3). All required information was present on the signage.

Photo 2: Mine identification sign at the intersection of Hwy 40 and Hawthorne St.

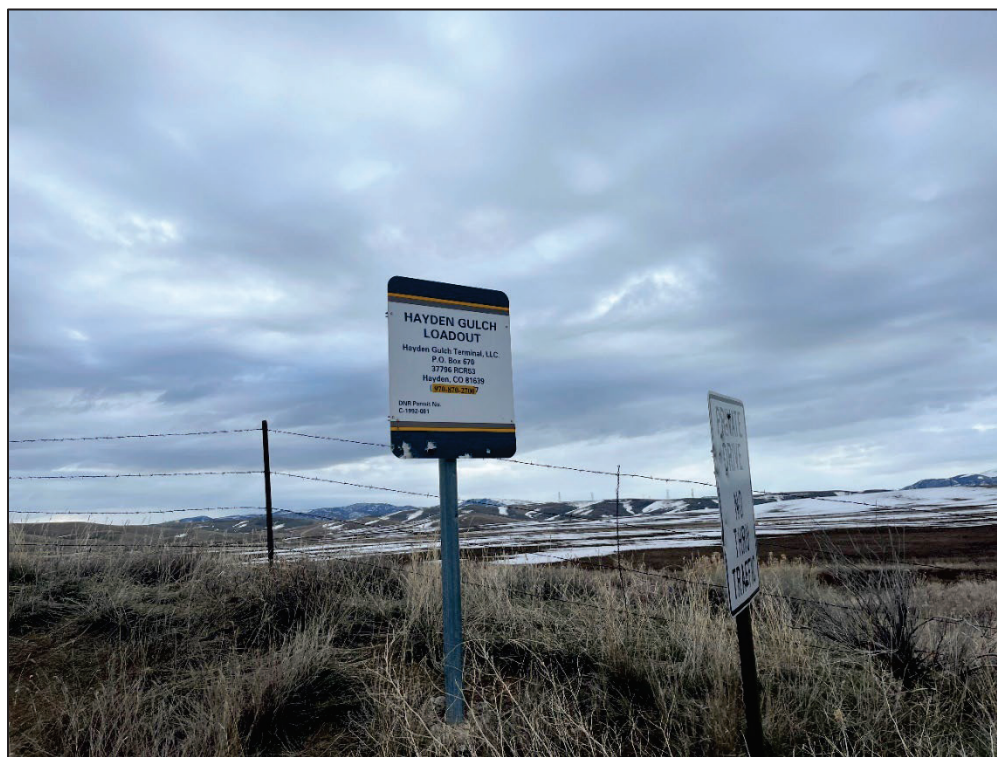
Photo 3: Mine identification sign at the western end of the TAHR.

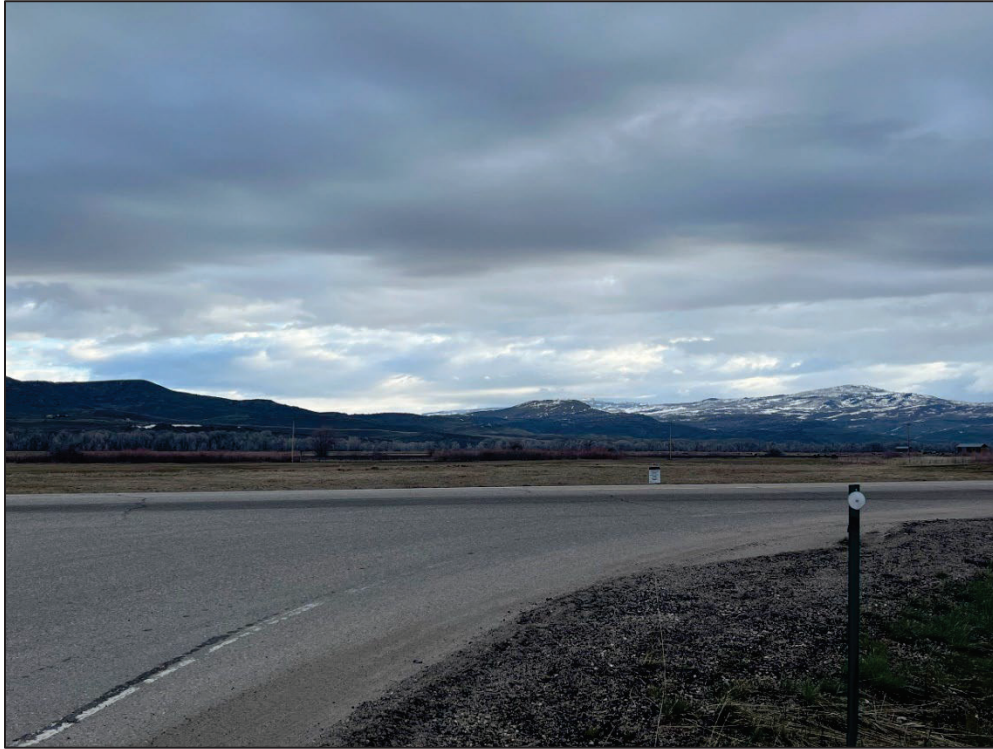
Maintenance of the recently released Tie Across Haul Road (TAHR) is the responsibility of the City of Hayden. The TAHR was dry and easily navigable (Photo 4). No erosion features of concern were noted.

Photo 4: View south of the turn off from CR 37 to the TAHR.

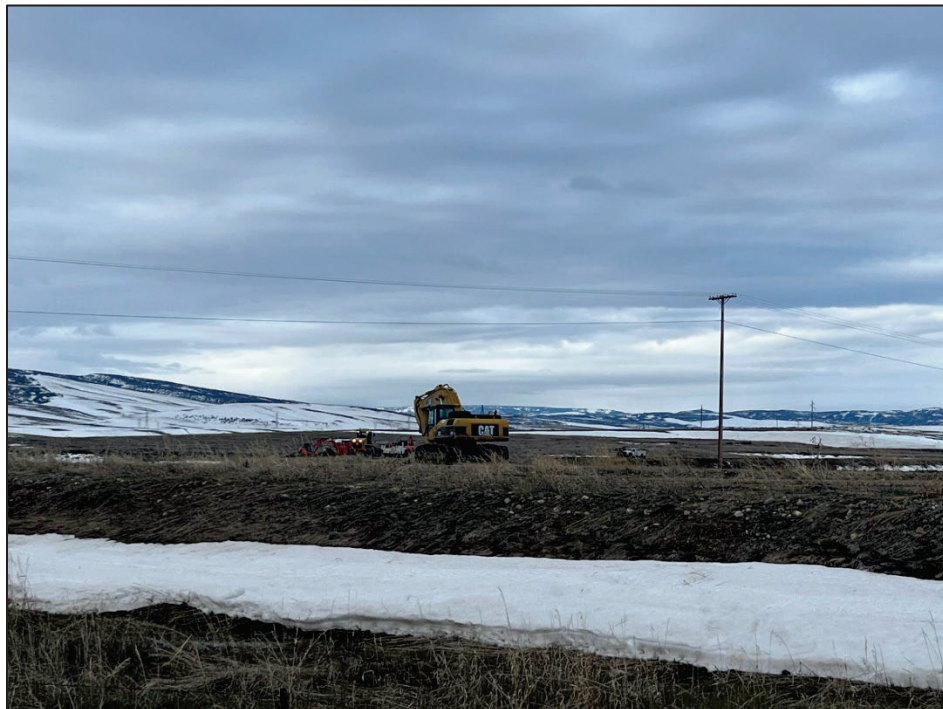
Truck Loop Pond 001 was functioning properly. Rail Loop Pond 002 was inaccessible due to the culvert construction happening along the Sage Creek Trail. Construction on the culverts within the previously released Tracks to Trails area has recommenced (Photo 5). City of Hayden equipment was noted to be working in this area at the time of inspection. This area was turned over to the City of Hayden for recreational use with the approval of SL-2 in 2022. Culverts in southern Tracks to Trails rail loop area which were not being replaced were flowing and free of blockages (Photo 6).

Photo 5: Excavators and dozers had resumed work to replace culverts in the Tracks to Trails area.

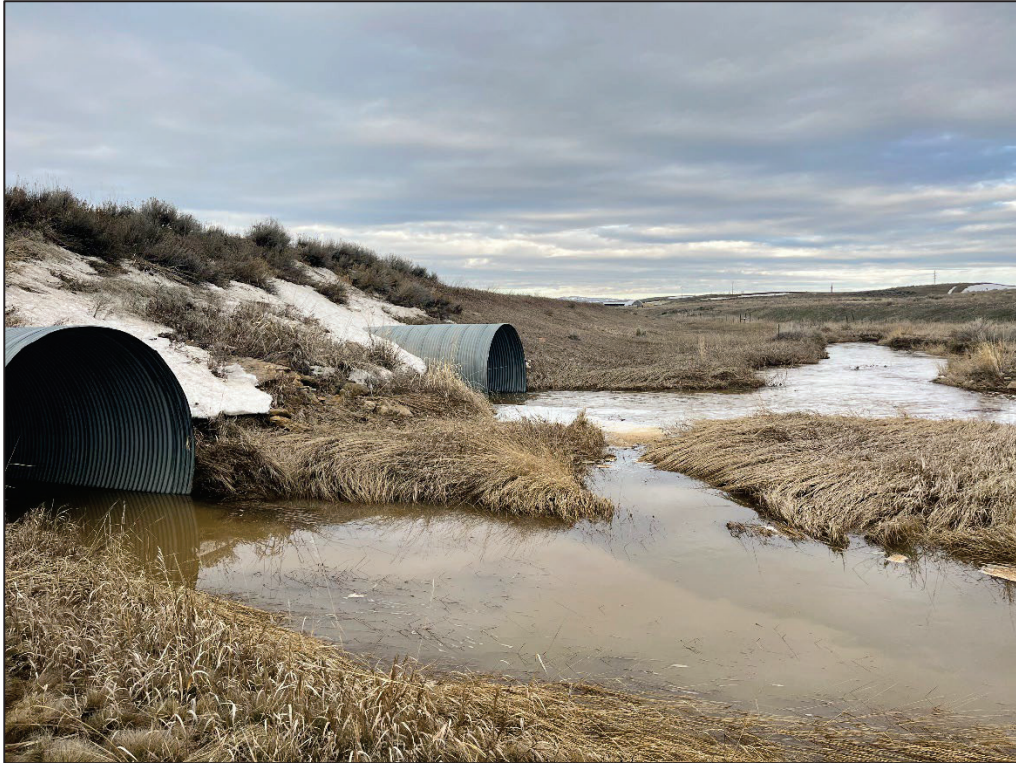
Photo 6: Culverts in the Tracks to Trails area along the TAHR were flowing properly.
