Bowie 1 inspection report

Permit Number: C-1981-038 Mine Name: Bowie No. 1 Mine Operator: Bowie Resources, LLC Operator Address: Mr. Basil R Bear P.O. Box 1488 Paonia, CO 81428	County: Delta Operation Type: Underground Permit Status: Active Ownership: Private
	Operator Representative Present: None
Operator Representative Signature: (Field Issuance Only)

Inspection Start Date: April 8, 2024 Inspection Start Time: 16:30 Inspection End Date: April 8, 2024 Inspection End Time: 18:00	Inspection Type: Coal Partial Inspection Inspection Reason: Normal I&E Program Weather: Clear
Joint Inspection Agency: None	Joint Inspection Contacts:
Post Inspection Agency: None	Post Inspection Contacts:
Inspector(s): Robert Zuber, P.E.	Inspector's Signature:

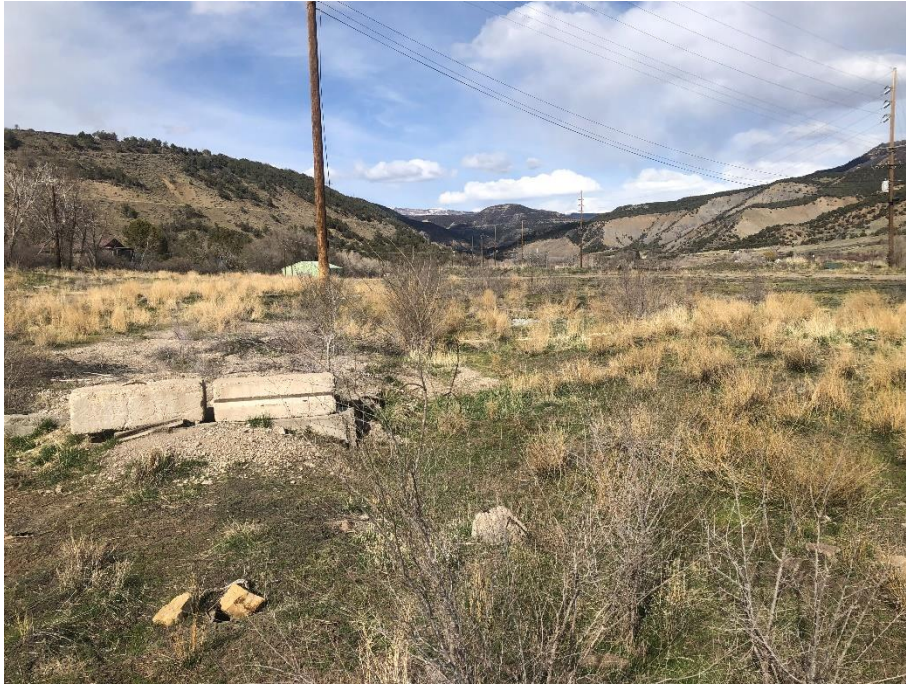
West side of loadout

No erosion was seen at the loadout, including the steep slope between the loadout and the orchard below. The trestle across the river appears stable.

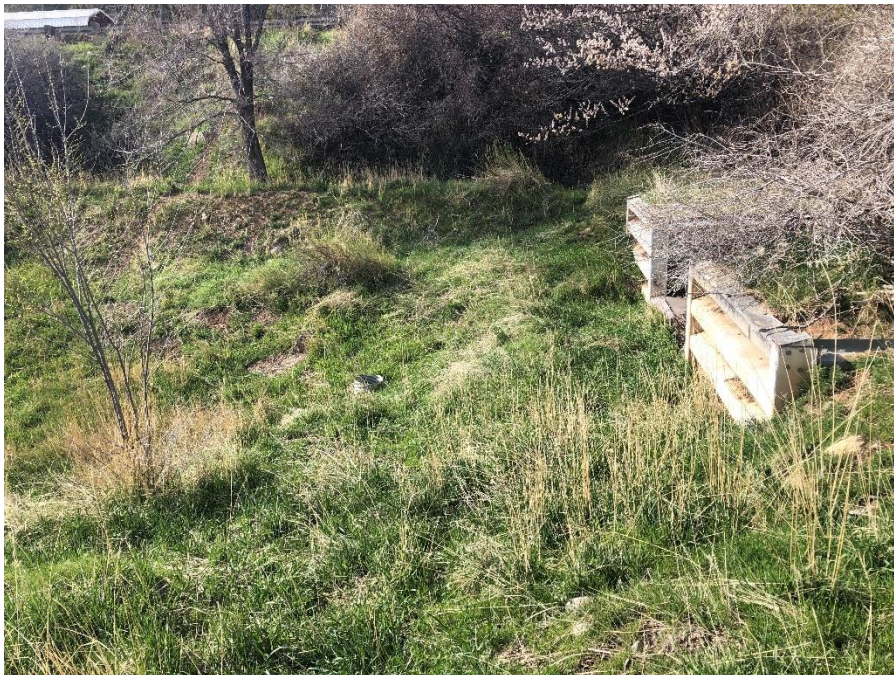
Pond at loadout

The ponds at the loadout and the Coal Storage Area (near Black Bridge Road) were empty of water, and no problems were identified with these ponds.

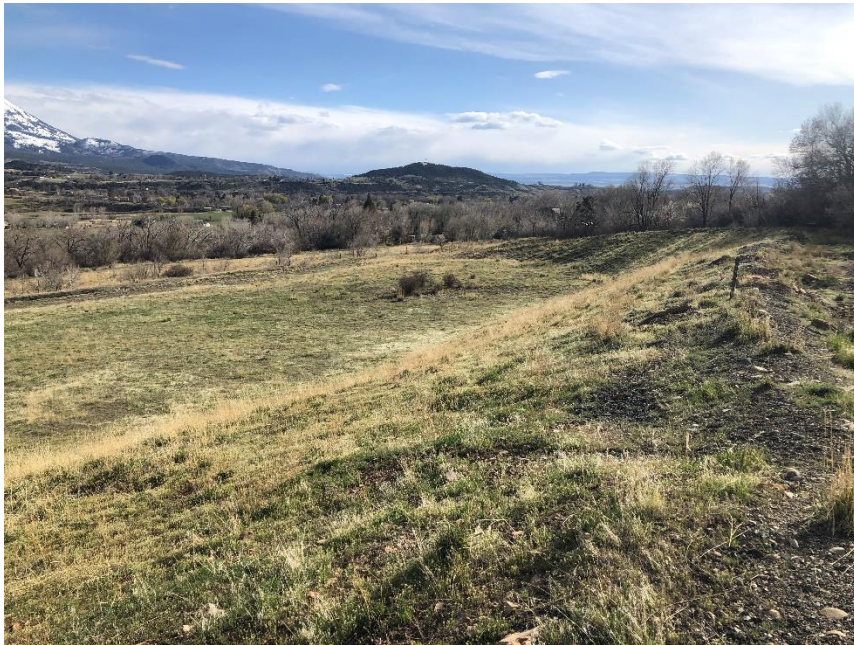
Coal storage by Black Bridge Road, looking west

No erosion or other problems were seen with the Coal Storage Area beside the intersection of Highway 133 and Black Bridge Road.

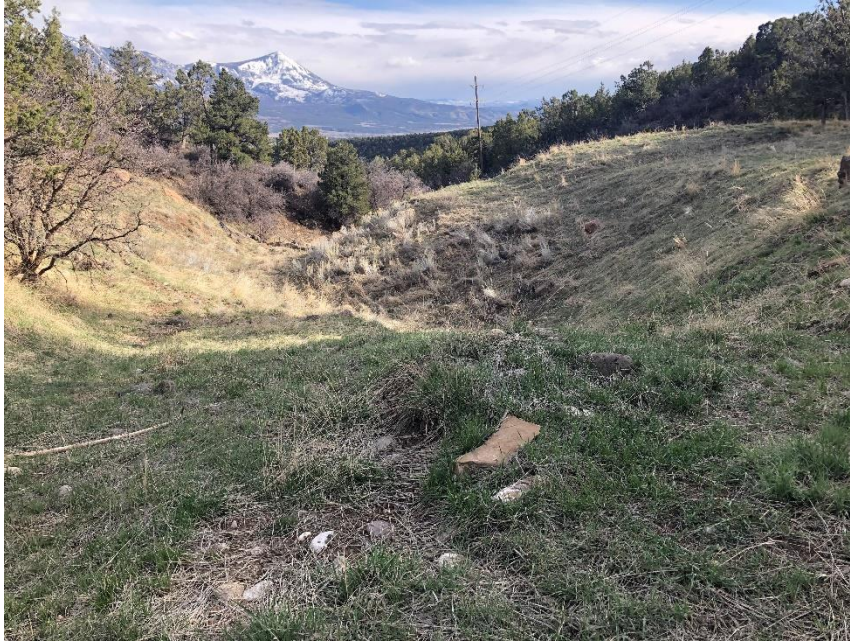
Pond 4, looking down the drainage at reclaimed pond

No erosion was seen at the reclaimed ponds at the East Mine (Ponds 1 – 4). No weeds were seen at these ponds except for small amounts of cheat grass. The vegetation at Ponds 1 and 2 is good, and at Ponds 3 and 4 it is very good.
