Division of Reclamation,
Mining and Safety

Permit Number: C-1981-012 Mine Name: New Elk Mine Operator: New Elk Coal Company, LLC Operator Address: Mr. John Terry 12250 Highway 12 Weston, CO 81091	County: Las Animas Operation Type: Underground Permit Status: Active Ownership: Private
	Operator Representative Present: John Terry
Operator Representative Signature: (Field Issuance Only)

Inspection Start Date: March 26, 2024 Inspection Start Time: 14:31 Inspection End Date: March 28, 2024 Inspection End Time: 12:55	Inspection Type: Coal Complete Inspection Inspection Reason: Surety Related Weather: Clear
Joint Inspection Agency: None	Joint Inspection Contacts:
Post Inspection Agency: None	Post Inspection Contacts:
Inspector(s): Amber M. Gibson	Inspector's Signature:

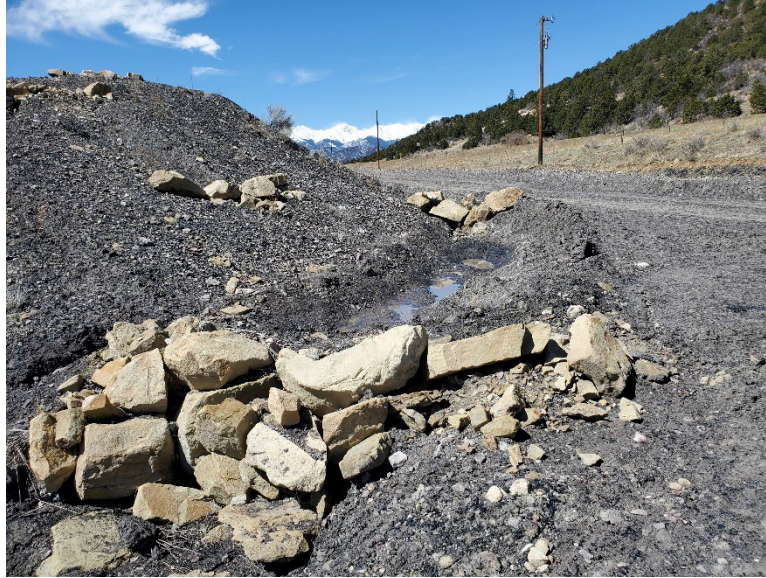
- The sediment basin at the east end of DWDA #2 was dry. The berm around the basin appeared to be stable and has recently been improved. The check dams in the ditches around the DWDA #2 are clear (Photo 1), and ditch D14 leading into the basin is also clear. Culvert C13 was free of obstructions.

Photo 1: Check dams along north-east side of the DWDA #2.

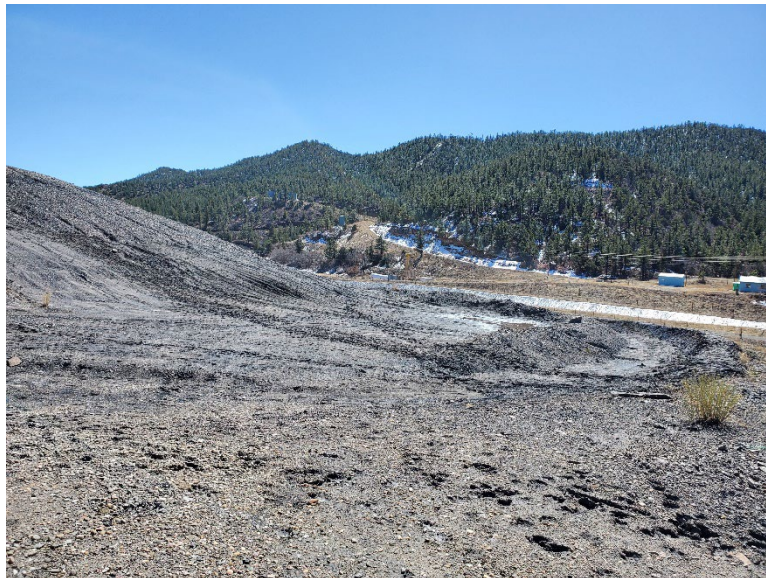
- D3, the ditch around DWDA #1, is clear and free of obstructions.
- Material from pond and ditch cleanings has not been placed in the east side of DWDA #2 since the cessation of pond pumping for the season (Photo 2). The Operator stated that they will begin pumping again soon.

Photo 2: Sediment drying area on the west side of the DWDA #2.

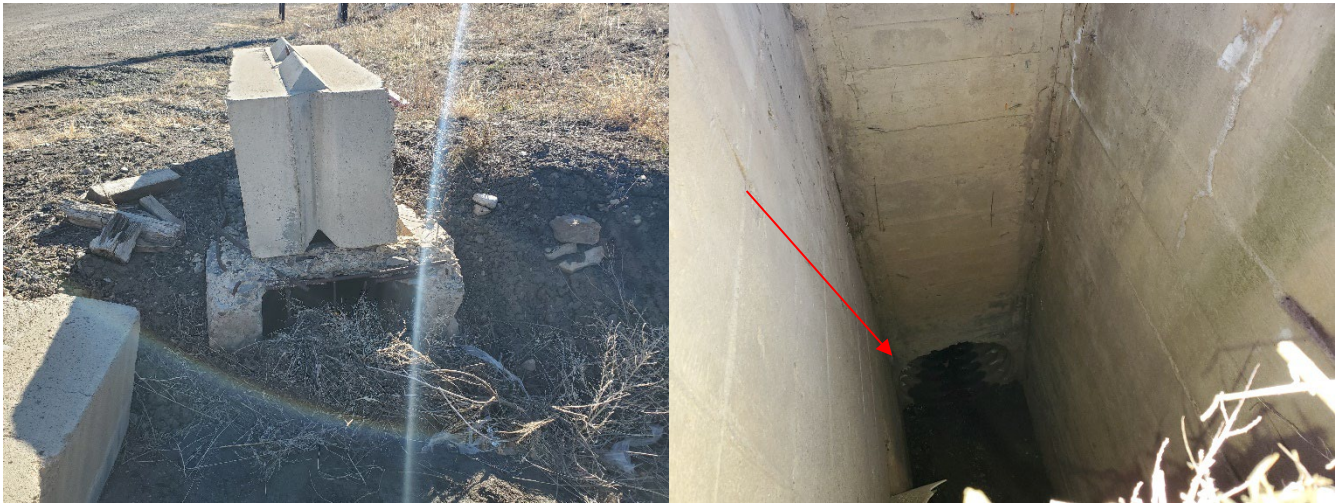
- The measurements for culvert C11 and culvert C90 were missed during the last inspection. The Division collected the following measurements during the March 2024 inspection:
 - C11: C11 was covered by a concrete barrier, and was unreachable (Photo 3). However, the Division and the Operator estimated the metal culvert to have an approximately 24” diameter.

Photo 3: (Left) concrete cover over C11. (Right) Arrow points to C11.

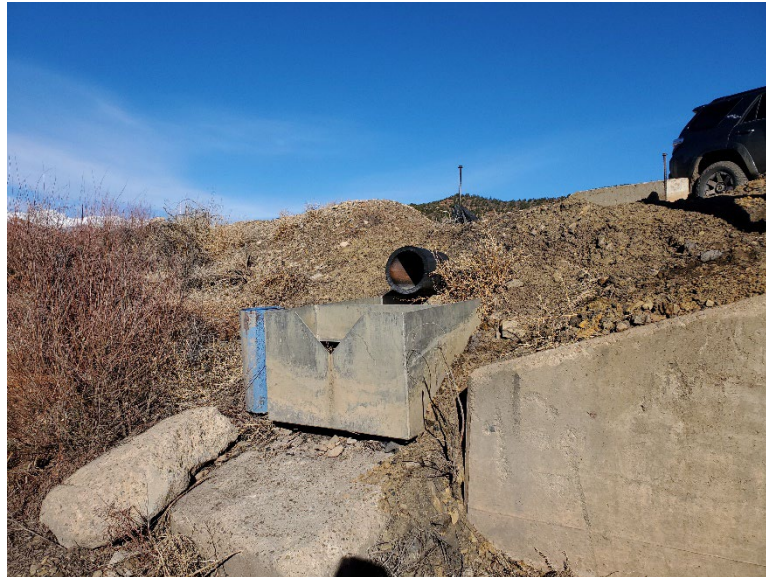
- C90: It was determined during the inspection, that the culvert measured as C86 in the Division’s February 2024 report, was actually C90 (Photo 4). C86 was measured during this inspection as a 60” diameter, concrete culvert (Photo 5).

Photo 4: Culvert C90.

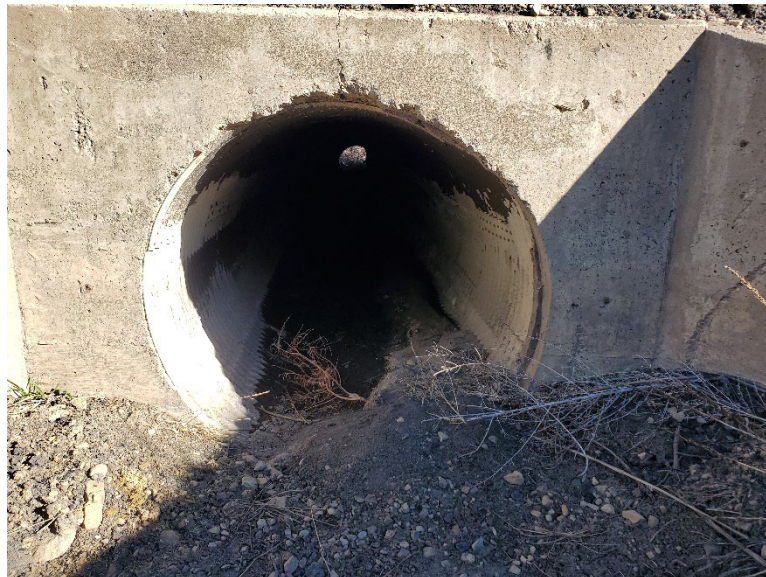
Photo 5: Culvert C86.

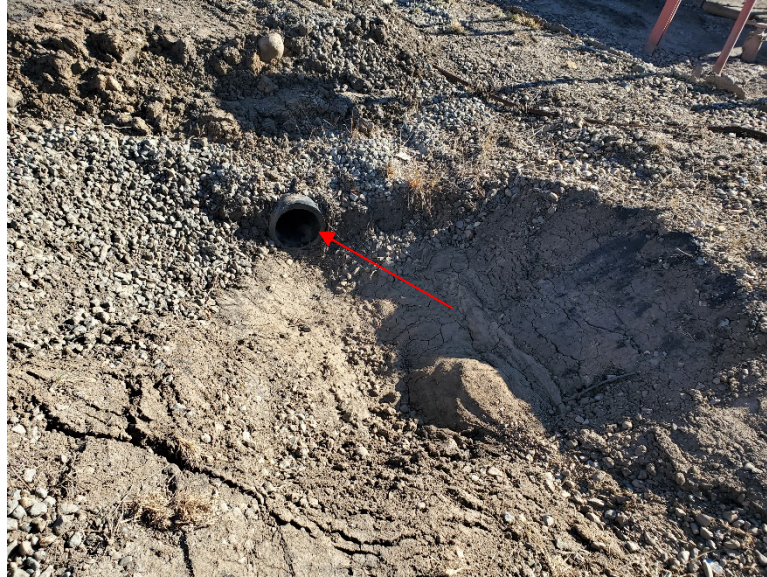
- During the Division's February 2024 inspection, culvert C12 was nearly covered by gravel from the road. Since that inspection, the Operator has cleared the area around C12 of debris (Photo 6).

Photo 6: The arrow points to C12. The area around the culvert has been cleaned.

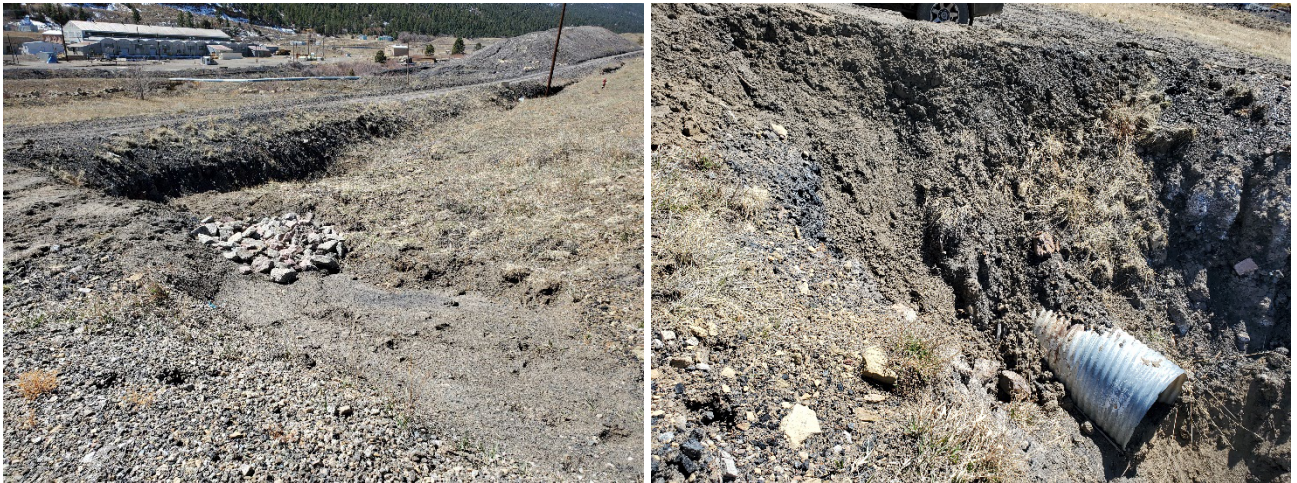
- During the Division's February 2024 inspection, erosion was observed leading down from south of Highway 12, to the north side of Culvert C14. Since the previous inspection, the Operator has repaired the erosion, armored, and stabilized the ground above and around C14 (Photo 7).

Photo 7: (Left) ground above C14. (Right) Bank repaired around C14.

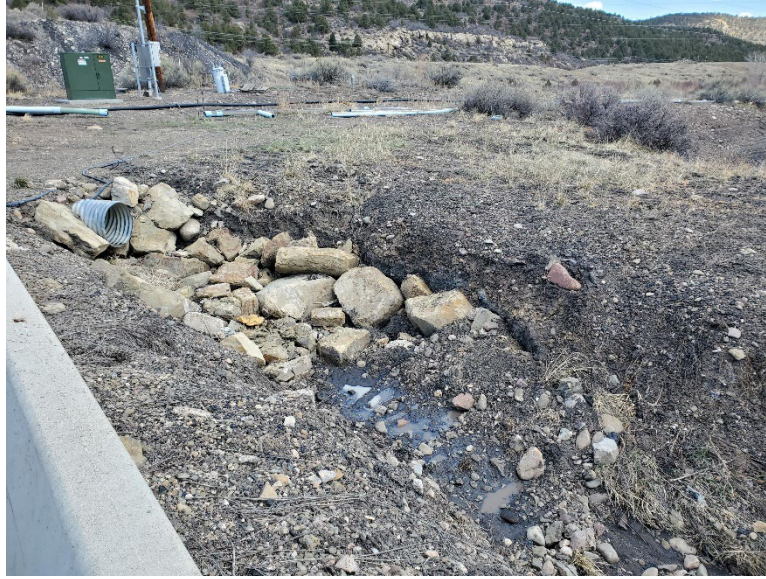
- The S.A.E., located to the south-east of C14, appeared stable, and no signs of erosion were observed.
- Erosion was observed around Culvert C65 during the Division's February 2024 inspection. Since the previous inspection, the Operator has repaired and stabilized the area (Photo 8).

Photo 8: Repaired area around C65 that water had undercut.

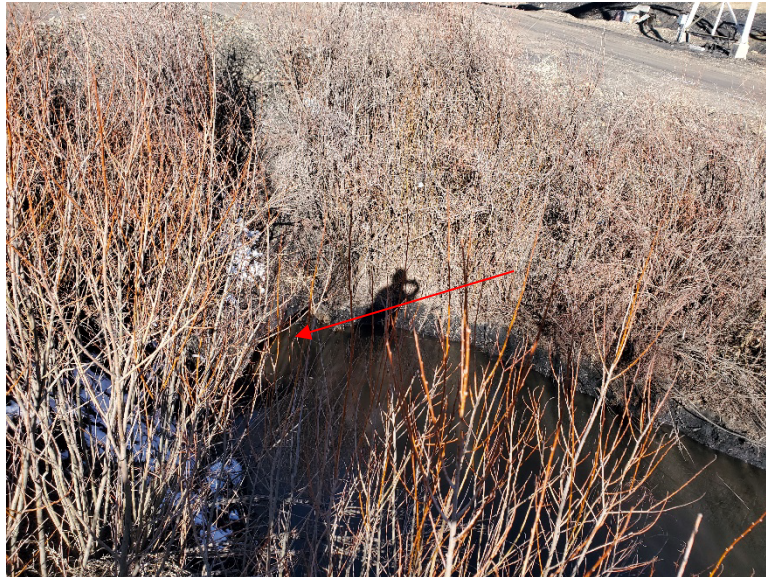
- During the Division's February 2024 inspection, the Operator was instructed to clear the vegetation out in front of culvert C61. During the March 2024 inspection, the Division observed that the area around C61 has been cleared (Photo 9).

Photo 9: The area in front of C61 has been cleared of vegetation.

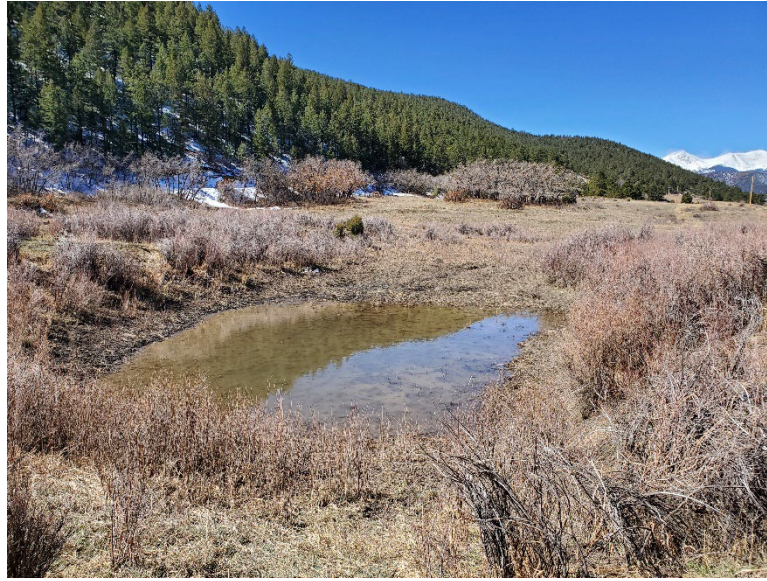
- Erosion was observed on the road area above and to the side of Culvert C16D during the February 2024 inspection. This area had not been addressed by the time of the March inspection. **The Operator shall repair the erosion around C16D and stabilize the road area.**
- Containment area #1 had some water in it (Photo 10). No signs of erosion were observed.

Photo 10: Containment area #1.

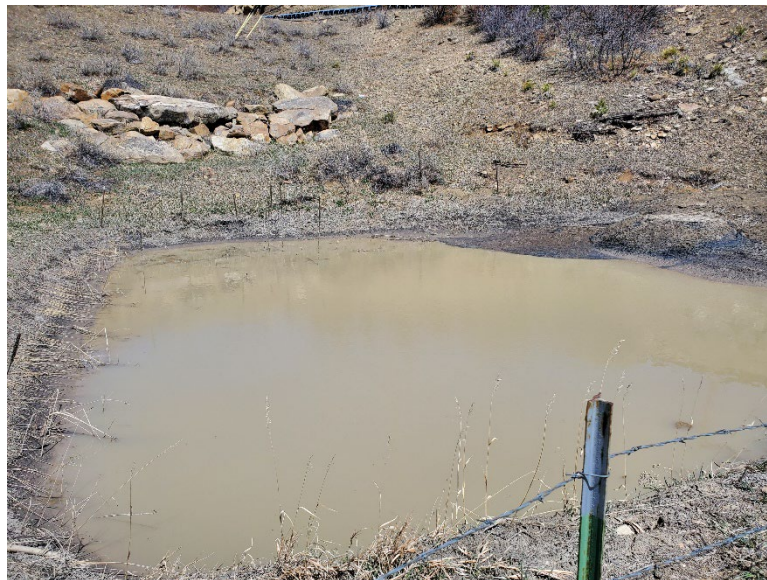
- Containment area #2 was dry. No signs of erosion were observed.
- Containment area #3 was dry. No signs of erosion were observed.
- Containment area #4 was dry. No signs of erosion were observed.
- Containment area #5 contains water and is still below capacity, but needs to be cleaned soon (Photo 11).
The Operator shall clean the sediment from the containment area prior to resuming operations, or if the sediment load increases.

Photo 11: Containment Area #5.

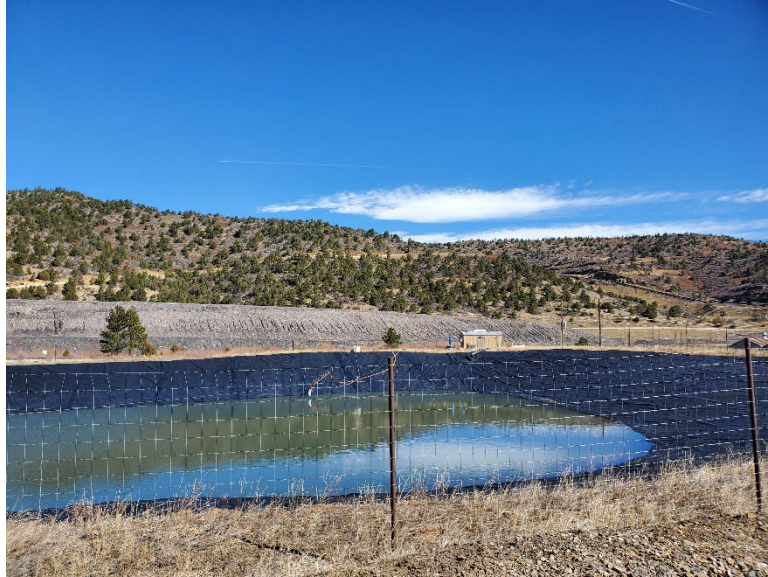
- Stream buffer zones were observed throughout the site.
- Pond 001A contained a small amount of water and was not discharging (Photo 12).

Photo 12: Pond 001A

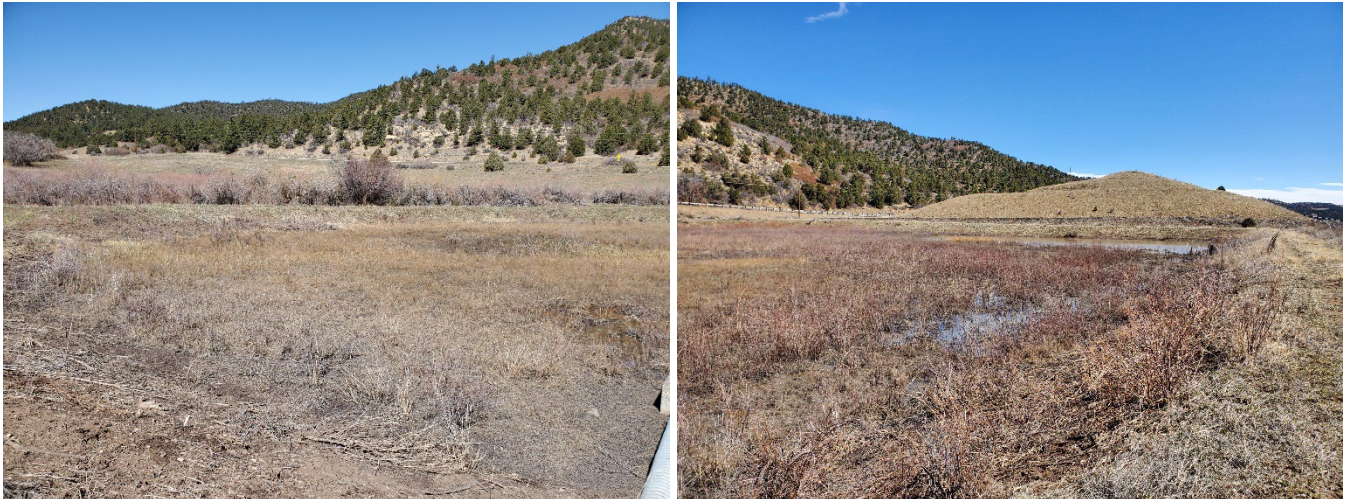
- Pond 004 contained a small amount of water, primarily within its east side (Photo 13). Pond 004 was not discharging. The bank appeared to be stable.

Photo 13: (Left) Dry west side of Pond 004. (Right) Some water within east side of the pond.

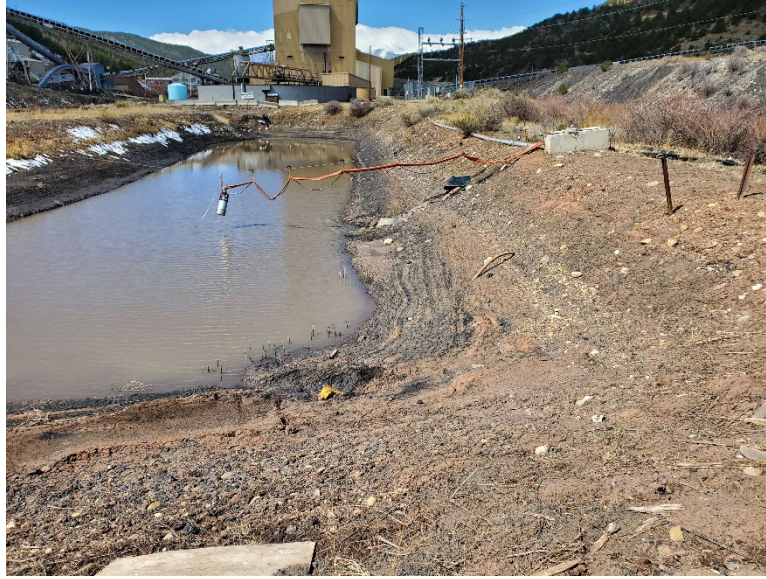
- Pond 006A contained some water. During the last inspection, the Division noted that the north-east corner of the bank had been eroded where water had been pumped into the pond. The Operator has since repaired and stabilized the bank on the east side of Pond 006A (Photo 14).

Photo 14: The north-east bank of Pond 006A, where water had begun to incise the bank, has been repaired.

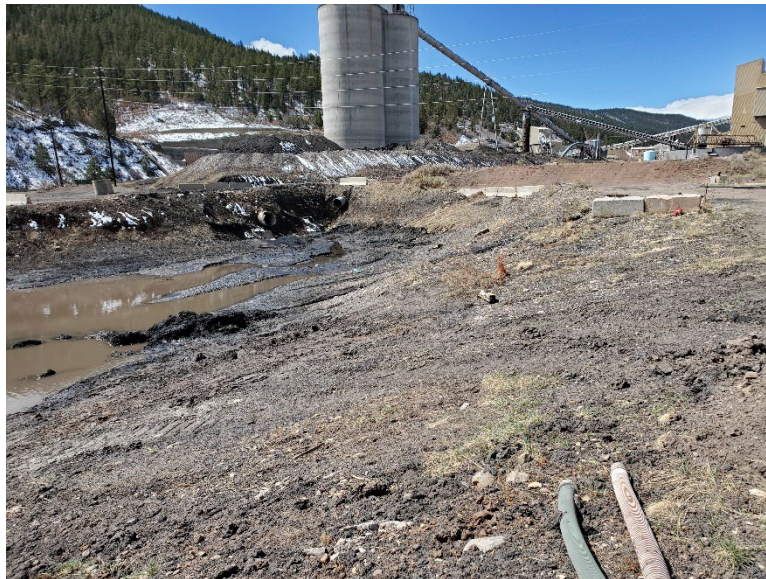
- Pond 007A contained a small amount of water but was not discharging. The emergency spillway was free of obstructions and the embankment appeared to be stable. The Operator stated that they have recently packed down the gopher holes they had observed along the bank. Also, the area along the north-west side of the bank has been repaired since the last inspection (Photo 15).

Photo 15: Northwest bank of Pond 007A has been repaired.

- **The silt fences along the SAE near Pond 007A that were damaged as a result of recent snowfalls, mentioned in the January and February 2024 reports, still need to be repaired.**

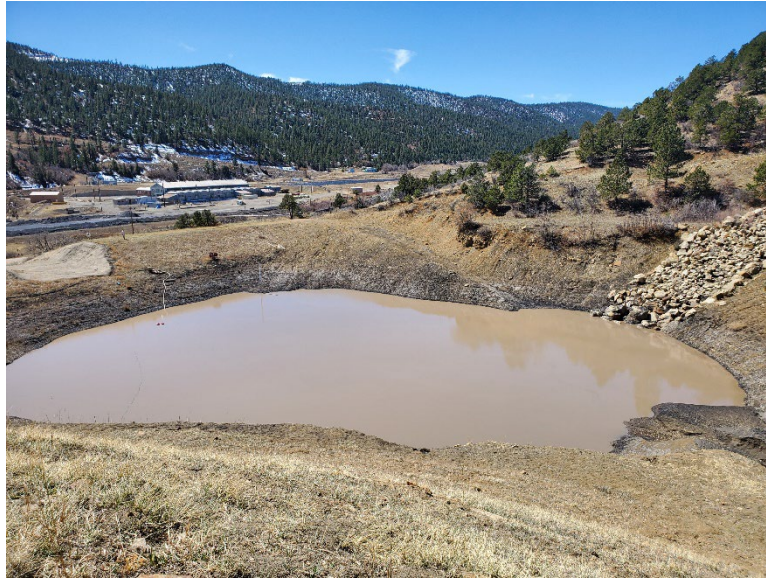
- Pond 08 contained some water, and was well below its capacity (Photo 16). The spillways appeared clear, and the banks were stable. Pond 08 was not discharging.

Photo 16: Pond 08

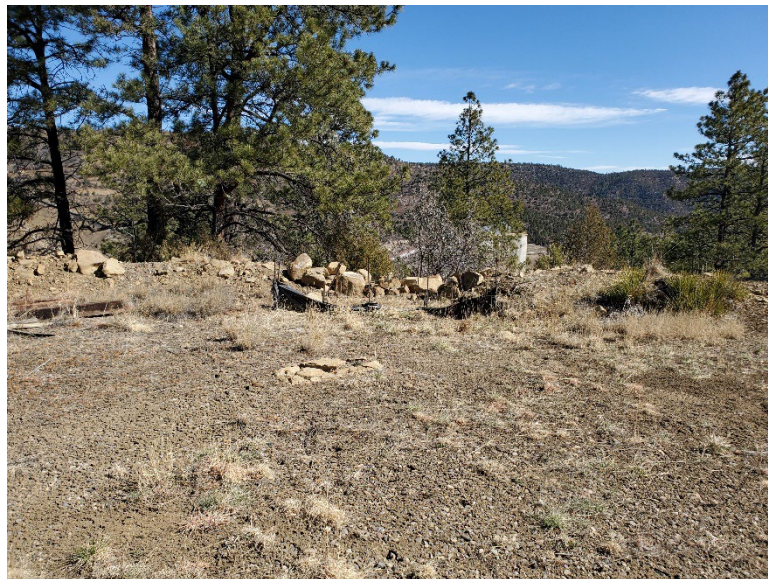
- The S.A.Es along the southern portion of the permit, along Ditch D18, appeared stable. However, **the silt fence on the western border of the S.A.E. on the top of the hill needs to be repaired (Photo 17).**

Photo 17: Silt fence in south portion of permit, east of the large water tanks.

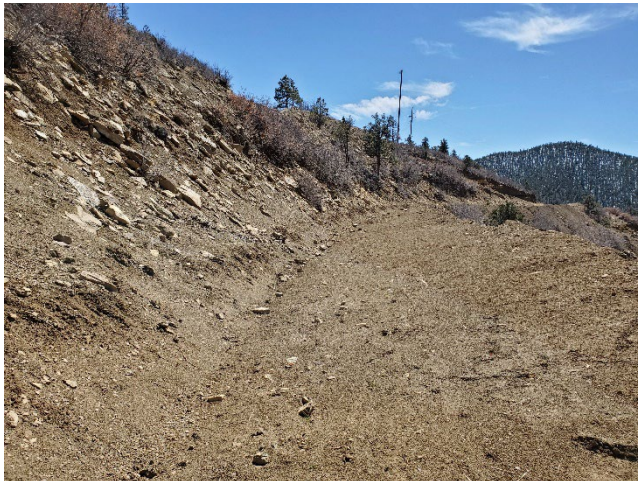
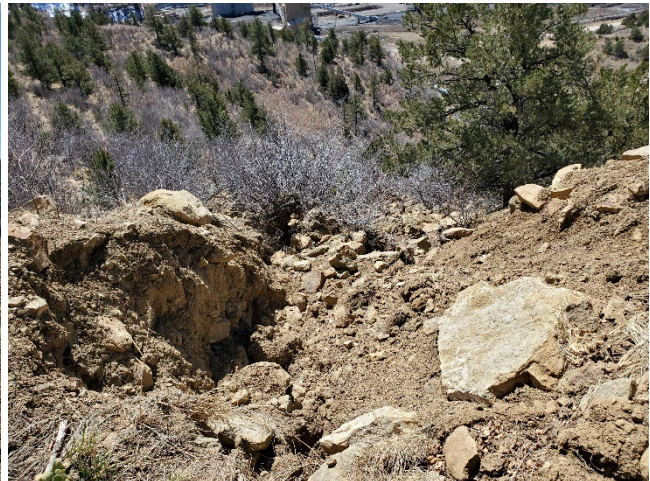
- The Division and the Operator walked a portion of ditch D55 starting at the north-central portion of the RDA to the eastern extent of the ditch. The Division noted in the November 2023 inspection, that there were a few areas up-slope and down-slope of D55 that had exhibited some slumping/sliding that needed to be stabilized and a few areas within D55 where sediment had accumulated in the ditch and needed to be removed. The beginning of a slide was also observed in the north-east corner of the RDA, starting in D55.

- The Operator has since cleared most of the ditch of debris, and has used some of the larger boulders to stabilize the area in the north-east corner (Photo 18). However, the Operator stated that the excavator used clean the ditch was unable to access the western-most areas of D55 (Photo 19). When operations resume, the Operator stated that they should have access to smaller more maneuverable equipment to clear the debris along the western portion of D55. At this time, D55 appears overall to be stable.

Photo 18: (Left) Cleared and stabilized portion of D55. (Right) Stabilized area in north-east corner of RDA, within D55.

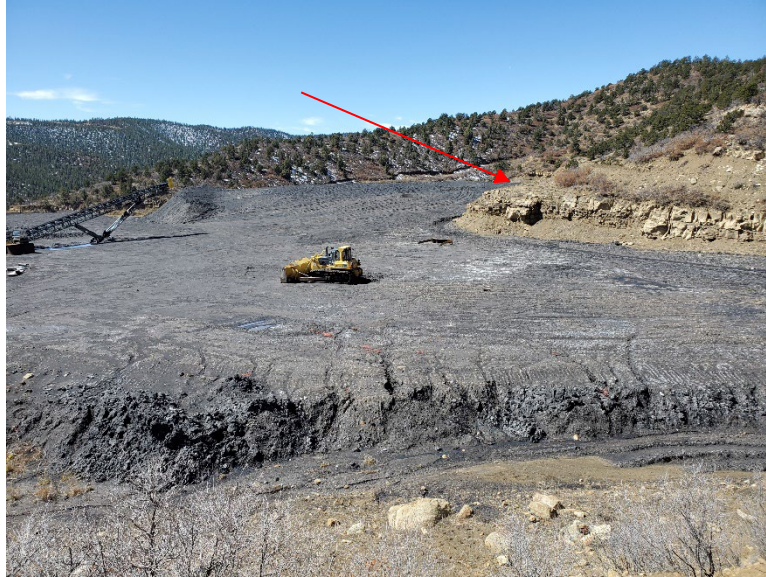
Photo 19: The arrow points to the extent of the ditch that the Operator was able to access with the excavator. The portion of D55 to the west of the arrow has not yet been cleared.

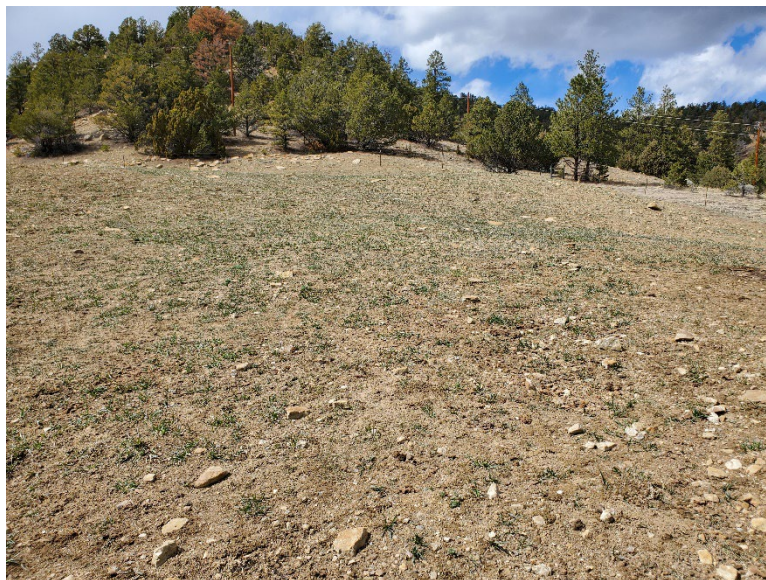
- During the November 2024 inspection, the Division observed that the former Golden Eagle ventilation shaft area had been grazed. The grazing and cattle occupancy at the vent shaft area had significantly impacted the revegetation reclamation efforts within the area. The Operator was advised that they may need to re-vegetate this area prior to consideration of its release. During this March 2024 inspection, it appears that some vegetation has been able to re-establish (Photo 20), but may still need to be re-vegetated prior to consideration of its release.

Photo 20: Former Golden Eagle ventilation shaft area.

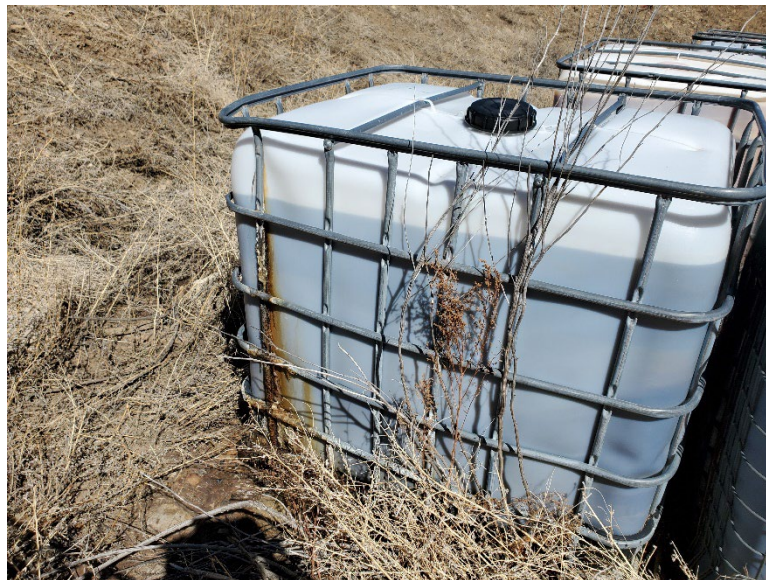
- The old equipment and debris that was located in the yard area around the C&W Train Shop is still being salvaged and the area is being graded.
- The berm separating the yard from the Purgatoire River appears to be stable.
- The Portable Explosives and Chemical Storage area was overall stable. However, the Division observed leaking from one of the tanks (Photo 21). **The Operator stated that they will either repair or replace this tank.**

Photo 21: Leak observed on a mag-fluoride tank.

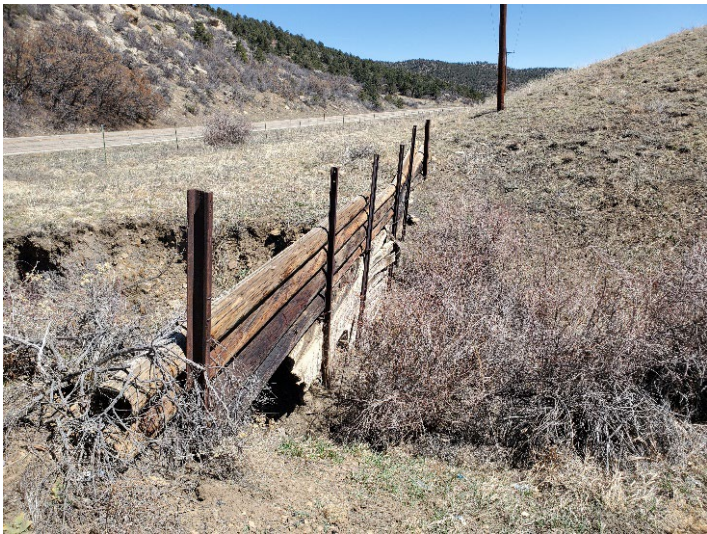
<p>-Wood (telephone poles) horizontal, Metal beams vertical -The Operator was not sure if this belongs to NECC, or if this is owned by another entity -This structure merits further investigation</p>
2	Retaining Wall *Dam

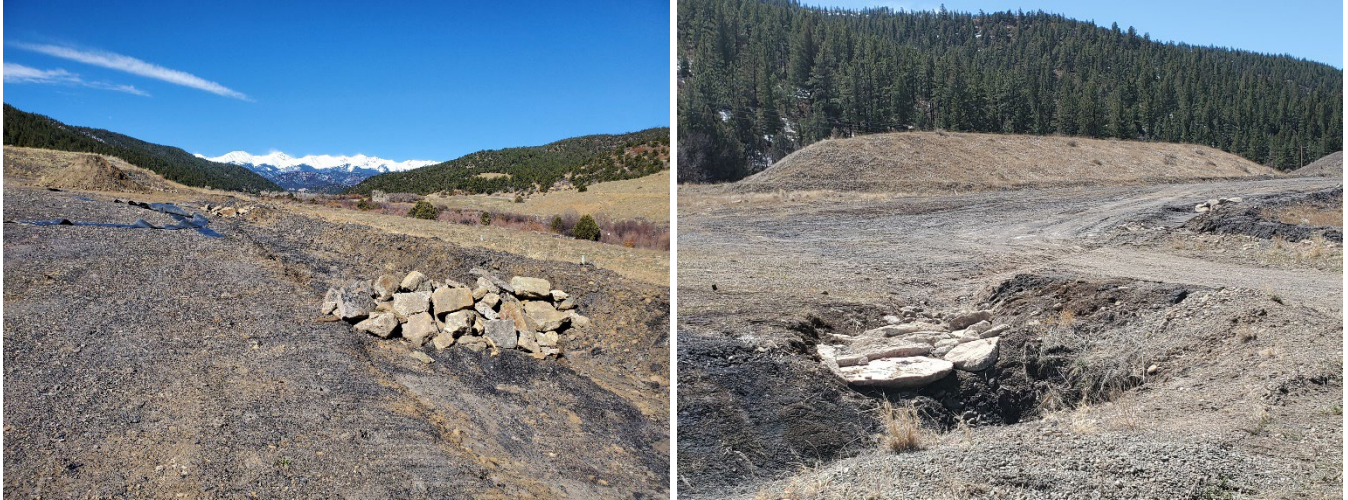
- During the February 2024 inspection, the Division observed erosion gullies leading off to the north and north-west side of the Stockpile Storage Area, located east of the Train Yard. The Operator was instructed to repair and stabilize the erosion gullies, and install any necessary BMPs to stabilize the area. Since the last inspection, the Operator has repaired the erosion on and to the sides of the Stockpile Storage Area, and has installed check dams along the north-east and north-west sides of the road leading into the area (Photo 23).

Photo 23: Check dams along both sides of the Stockpile Storage Area. The erosion has been repaired and the area has been stabilized.

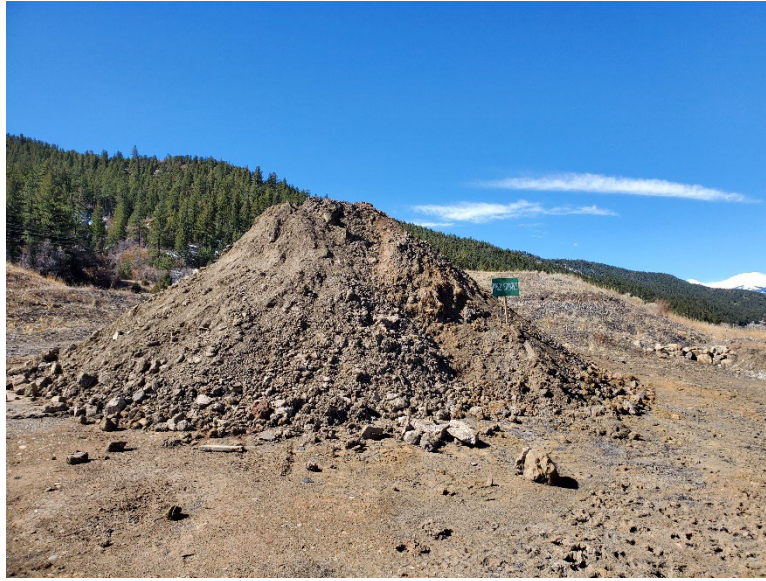
- In the Stockpile Storage Area, a new pile of topsoil was observed during the previous inspection. The Operator stated that the soil was salvaged during the debris clean-up work conducted during the past year in the Train Yard Area and that the pile contains topsoil quality soil. The Division had instructed the Operator to stabilize the pile with a vegetative cover (Rule 4.06.3(2)(a)(i) and identify it with signage (Rule 4.02.7). Since the previous inspection, the Operator has installed a topsoil sign (see Photo 24), and stated that the pile hasn't been vegetated yet because there is still some topsoil to salvage and sift out from the recent grading done at the Train Storage Area.

Photo 24: Newest topsoil stockpile with a topsoil sign.
