Re: GCC Energy, LLC, King II Mine
CDRMS Permit # C-1981-035
Stoner Engineering: Quarterly Inspection: King I Water Quality Improvements Inspection
1st Quarter 2024

Date: April 5, 2024

Re: King Coal I – Quarterly Water Quality Improvements Inspection

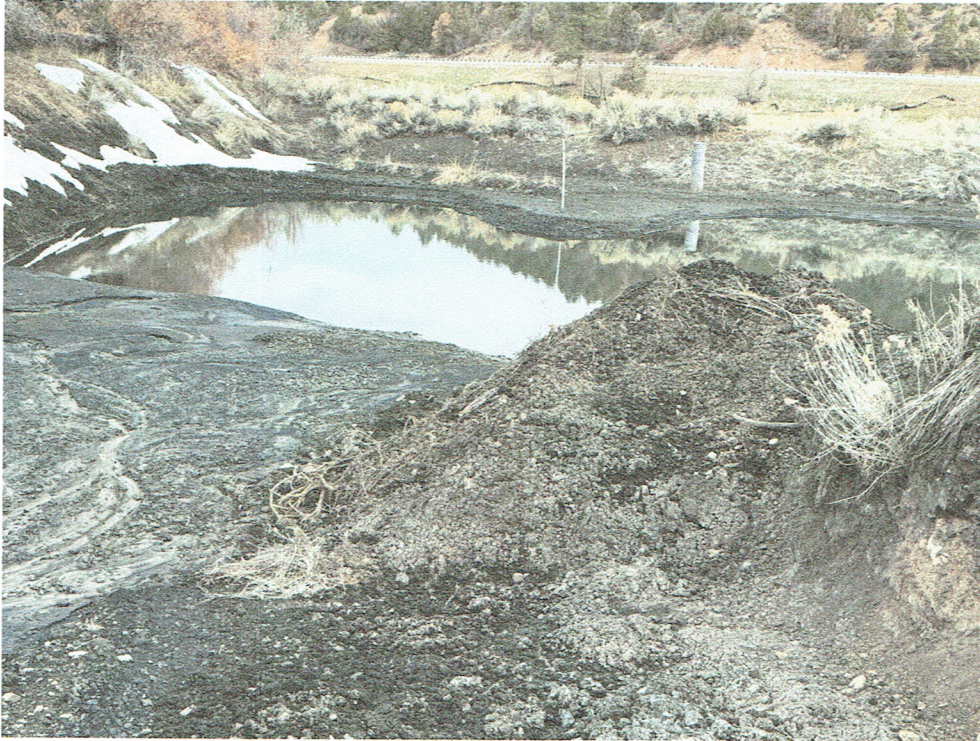
The sedimentation traps at the entrance to the site are generally in good condition. Both ponds held water from recent storm events at the time of the inspection. There was slightly more water in the east pond while the west pond water level appeared to be similar to the previous inspections. The excess waste material within the West pond appears to be at the same level of completion with the exception of a small pile of material that was pushed into the pond, most likely as a result of site maintenance (see Pic. 1). Sediment removal operations should continue as soon as the site/weather conditions allow. While the excess material should be removed as soon as possible to ensure adequate pond capacity for runoff/storm events, the ponds overall capacity appears adequate.

Pic. 1 – West pond, excess waste material from site maintenance.

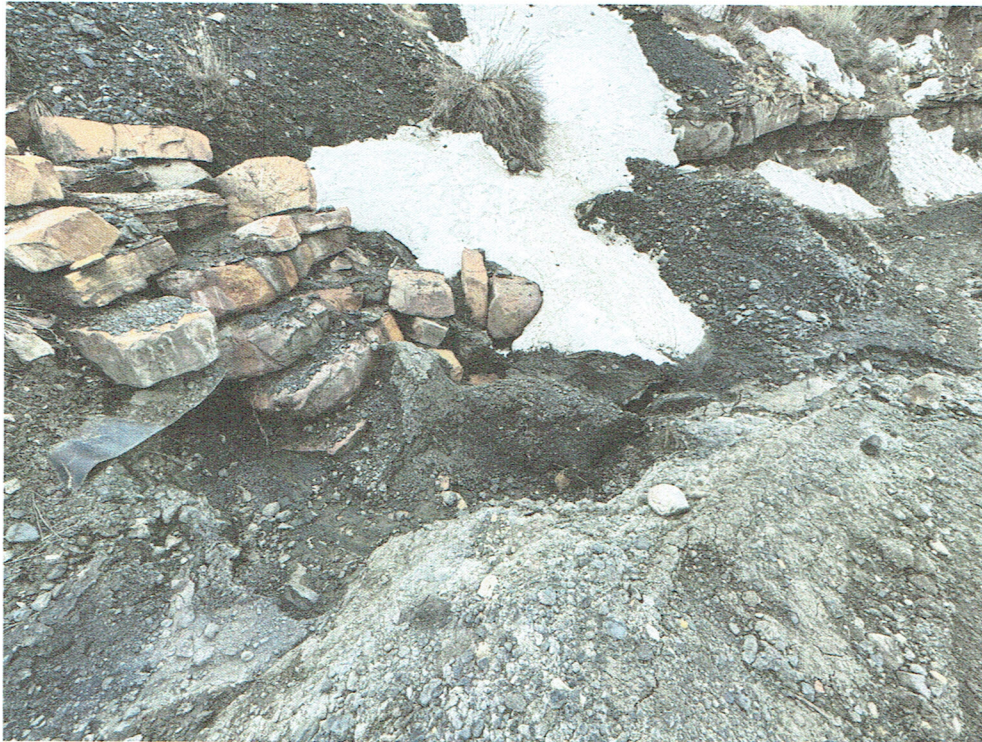
While the existing ditches and culverts appear to be generally in good condition, the culvert under the haul road (Reach 10) is in need of cleaning (see Pic. 2). There was also some visible erosion in the channel of the upper section of Reach 10 at the top of the waste embankment pile (see Pic. 3). The upper level channel section should be extended and improved to prevent runoff from running along the side of the channel.

Pic. 2 – Reach 10 Culvert under haul road.

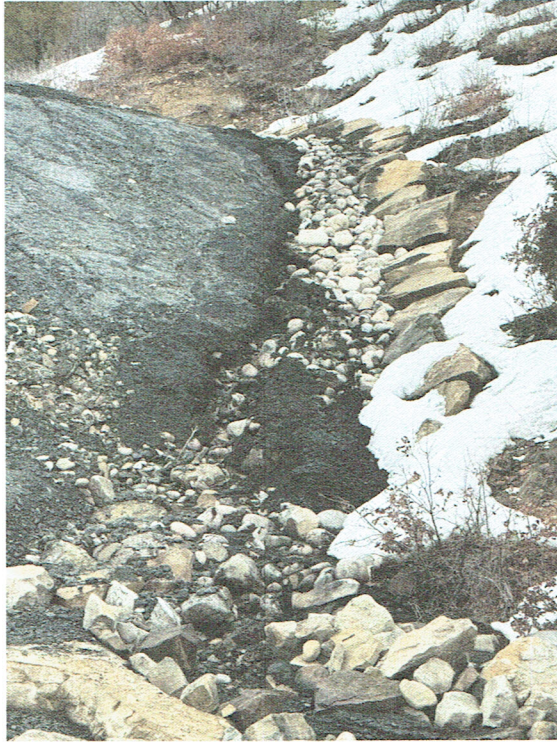
Pic. 3 – Erosion channel, upper section or Reach 10.

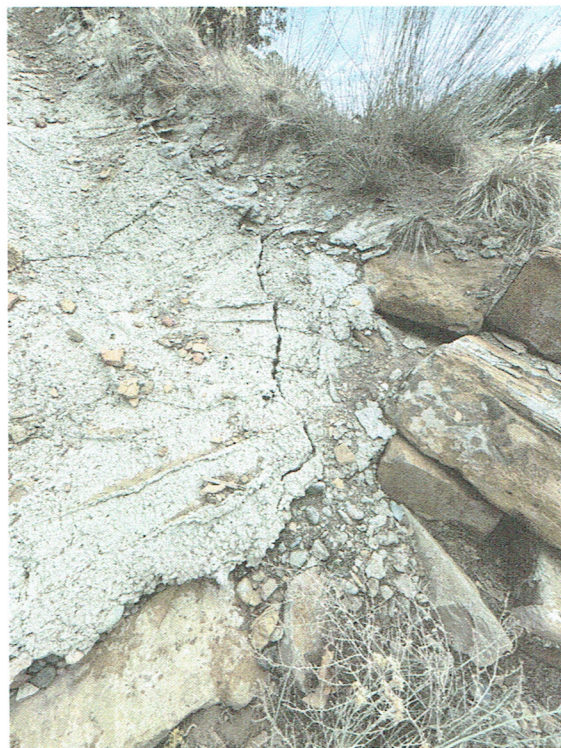
There was some cracking present on the armored channel section of the upper section of the east clear water ditch (Reach 1). The cracks are minimal at this time and appear to be related to shrinkage and possibly some settlement of the underlying berming (see Pic. 4). The cracks are located along the right side at the base of the armored section and should be monitored for progression.

Pic. 4 –Lower armored section of the North clear water ditch.
