Re: GCC Energy, LLC, King II Mine
CDRMS Permit # C-1981-035
Stoner Engineering: Quarterly Inspection: King II Water Quality
Improvements Inspection 1st Quarter 2024

Date: April 5, 2024

Re: King Coal II - Quarterly Water Quality Improvements Inspection

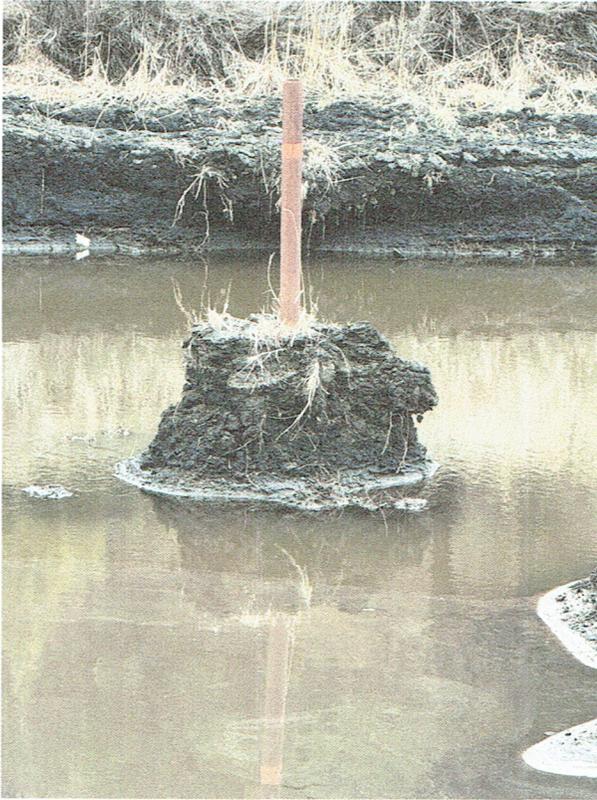
The water quality pond held water at the time of the inspection though the elevation at the bottom of the pond could not be determined due to water within the pond (see Pic. 1). The removal operations appear to be at a similar stage of completion noted during the previous inspection. Removal of sediment from the pond is on hold due to current water levels. Excess sediment should be removed from the detention pond as soon as site/weather conditions allow. Water continues to be diverted to the south side of the pond via ditch in an attempt to help dry out the upper section of the pond. The south side of the pond has been isolated via a cut in the existing sediment level to allow for drying of the sediment (see Pic. 2).

Pic. 1 – Water level of detention pond.

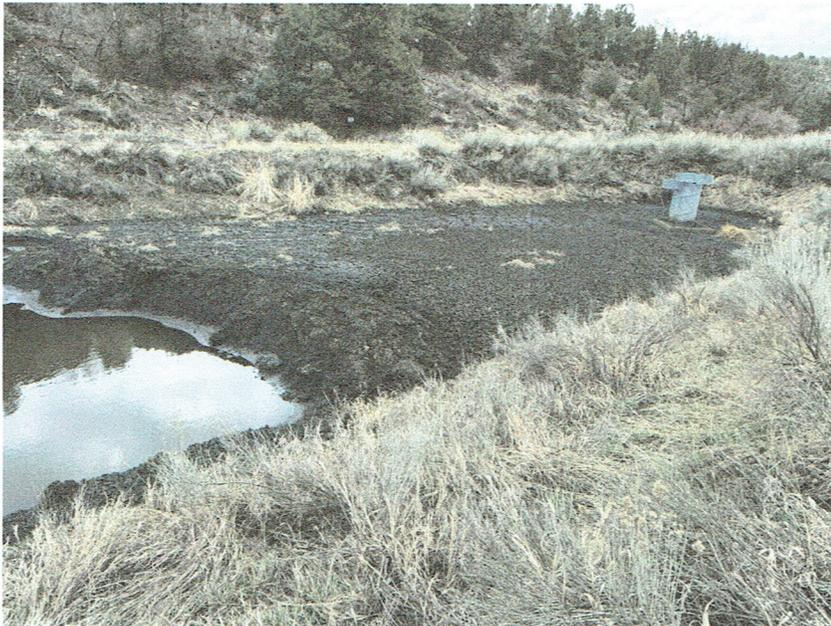
Pic. 2 – Sediment removal upstream of outlet structure allowing drying of sediment at pond outlet.

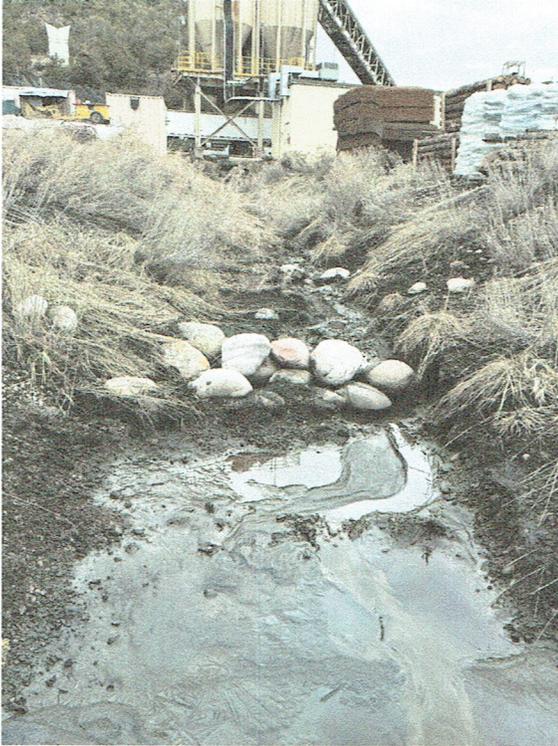
The erosion control structures for the treated water ditch located south of the scale house is also in good condition (see Pic. 3). All ditches should be inspected and repaired as necessary, especially after storm events.

Pic. 3 Erosion control measures south of the scale house.

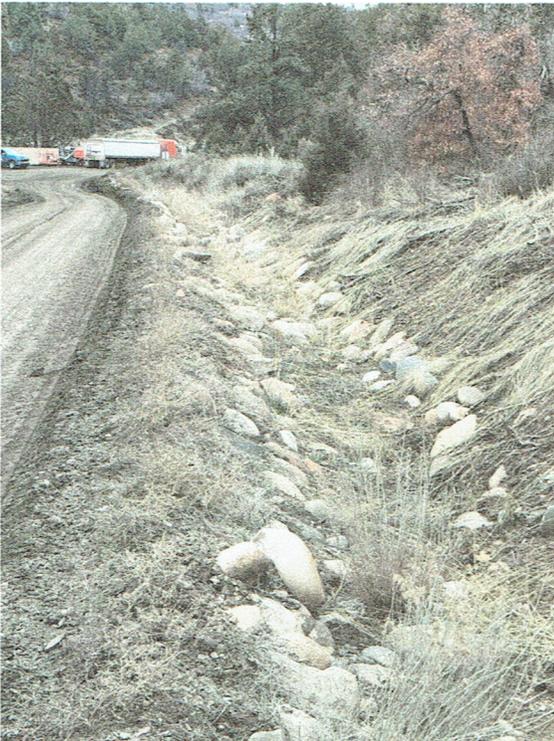
The culvert pipes and ditches on the site were in generally good condition overall (see Pic. 4). The culvert pipes and ditches should be monitored after storm events and cleaned out in the event that sedimentation occurs or debris buildup at the culvert inlets or outlets is observed.

Pic. 4 –West clear water ditch.
