Re: GCC Energy, LLC, King II Mine
CDRMS Permit # C-1981-035
Stoner Engineering: Quarterly Inspection: Refuse Pile 1st Quarter 2024

Re: King Coal I – Quarterly Waste Pile/Embankment Inspection

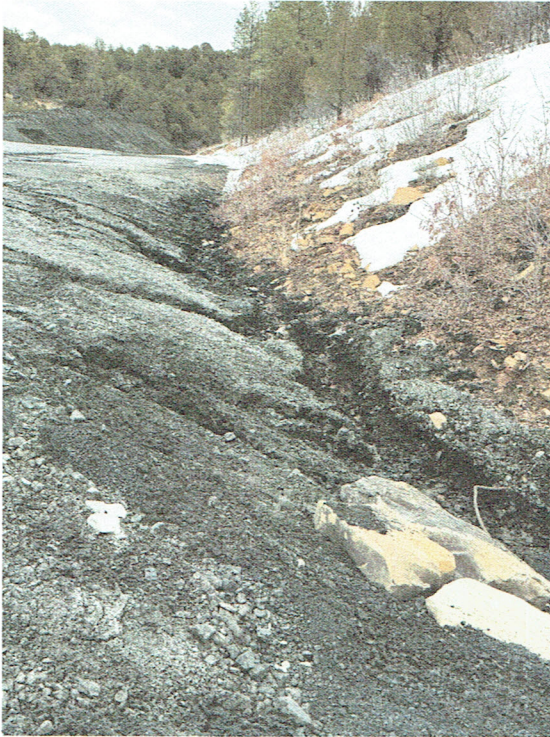
The south treated water ditch (Reach 10) experienced some limited erosion along the upper section. The channel section needs to be extended up the existing slope and the channel section improved to minimize the potential for erosion (see Pic. 1). The north clear water ditch (Reach 1) was found to be in generally good condition. There was some minor cracking at the base of the armored section of the channel that should be monitored to ensure that it does not continue to progress (see Pic. 2). The Reach 10 culvert under the haul road at the base of the main waste pile needs to be cleaned out.

Pic. 1 –Upper section Reach 10, channel improvements needed.

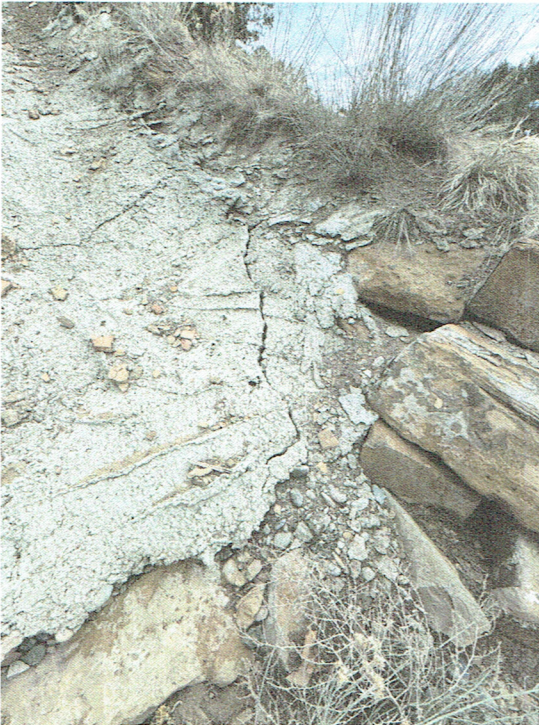
Pic. 2 – Minor cracking, lower armored section of Reach 1.

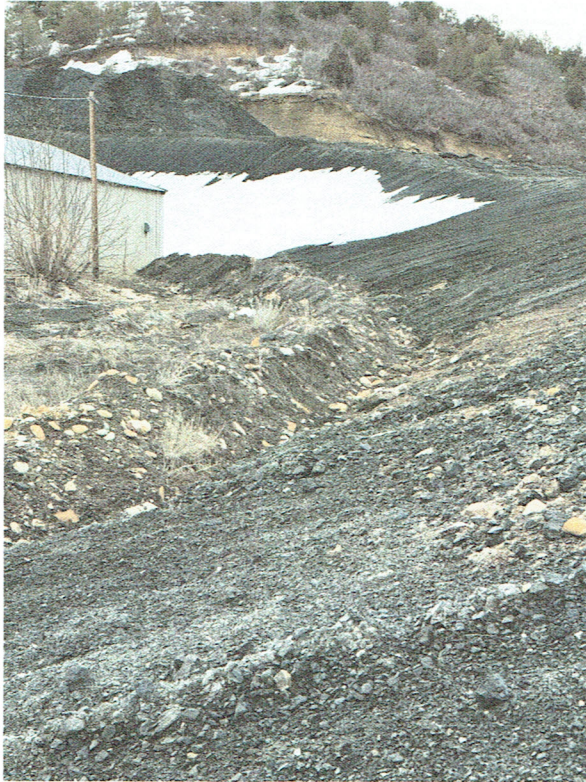
The face of the upper and lower waste embankments appeared to be in good condition (see Pic. 3 & 4). There were no signs of instability or sloughing observed on either waste embankment pile at the time of the inspection.

Pic. 3 – Face of lower waste embankment pile.

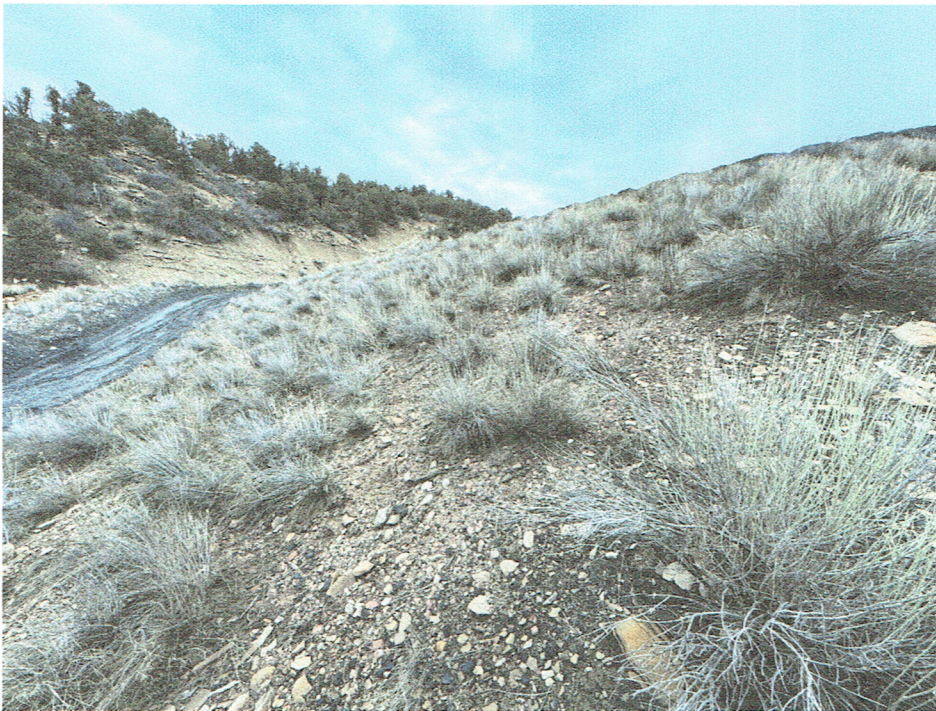
Pic. 4 – Face of the main embankment waste pile.
