April 8, 2024  
Project#01349-0001

Subject: Summary of Instrumentation Monitoring  
1<sup>st</sup> Quarter 2024  
Bowie Coal Waste Disposal Area No. 2  
Paonia, Colorado

**SUBJECT: Summary Report, 1<sup>st</sup> Quarter 2024, Inclinator and Active Vibrating Wire Piezometer Data January – March 2024, Bowie Mine #2 Coal Waste Disposal Area (CWDA) #2**

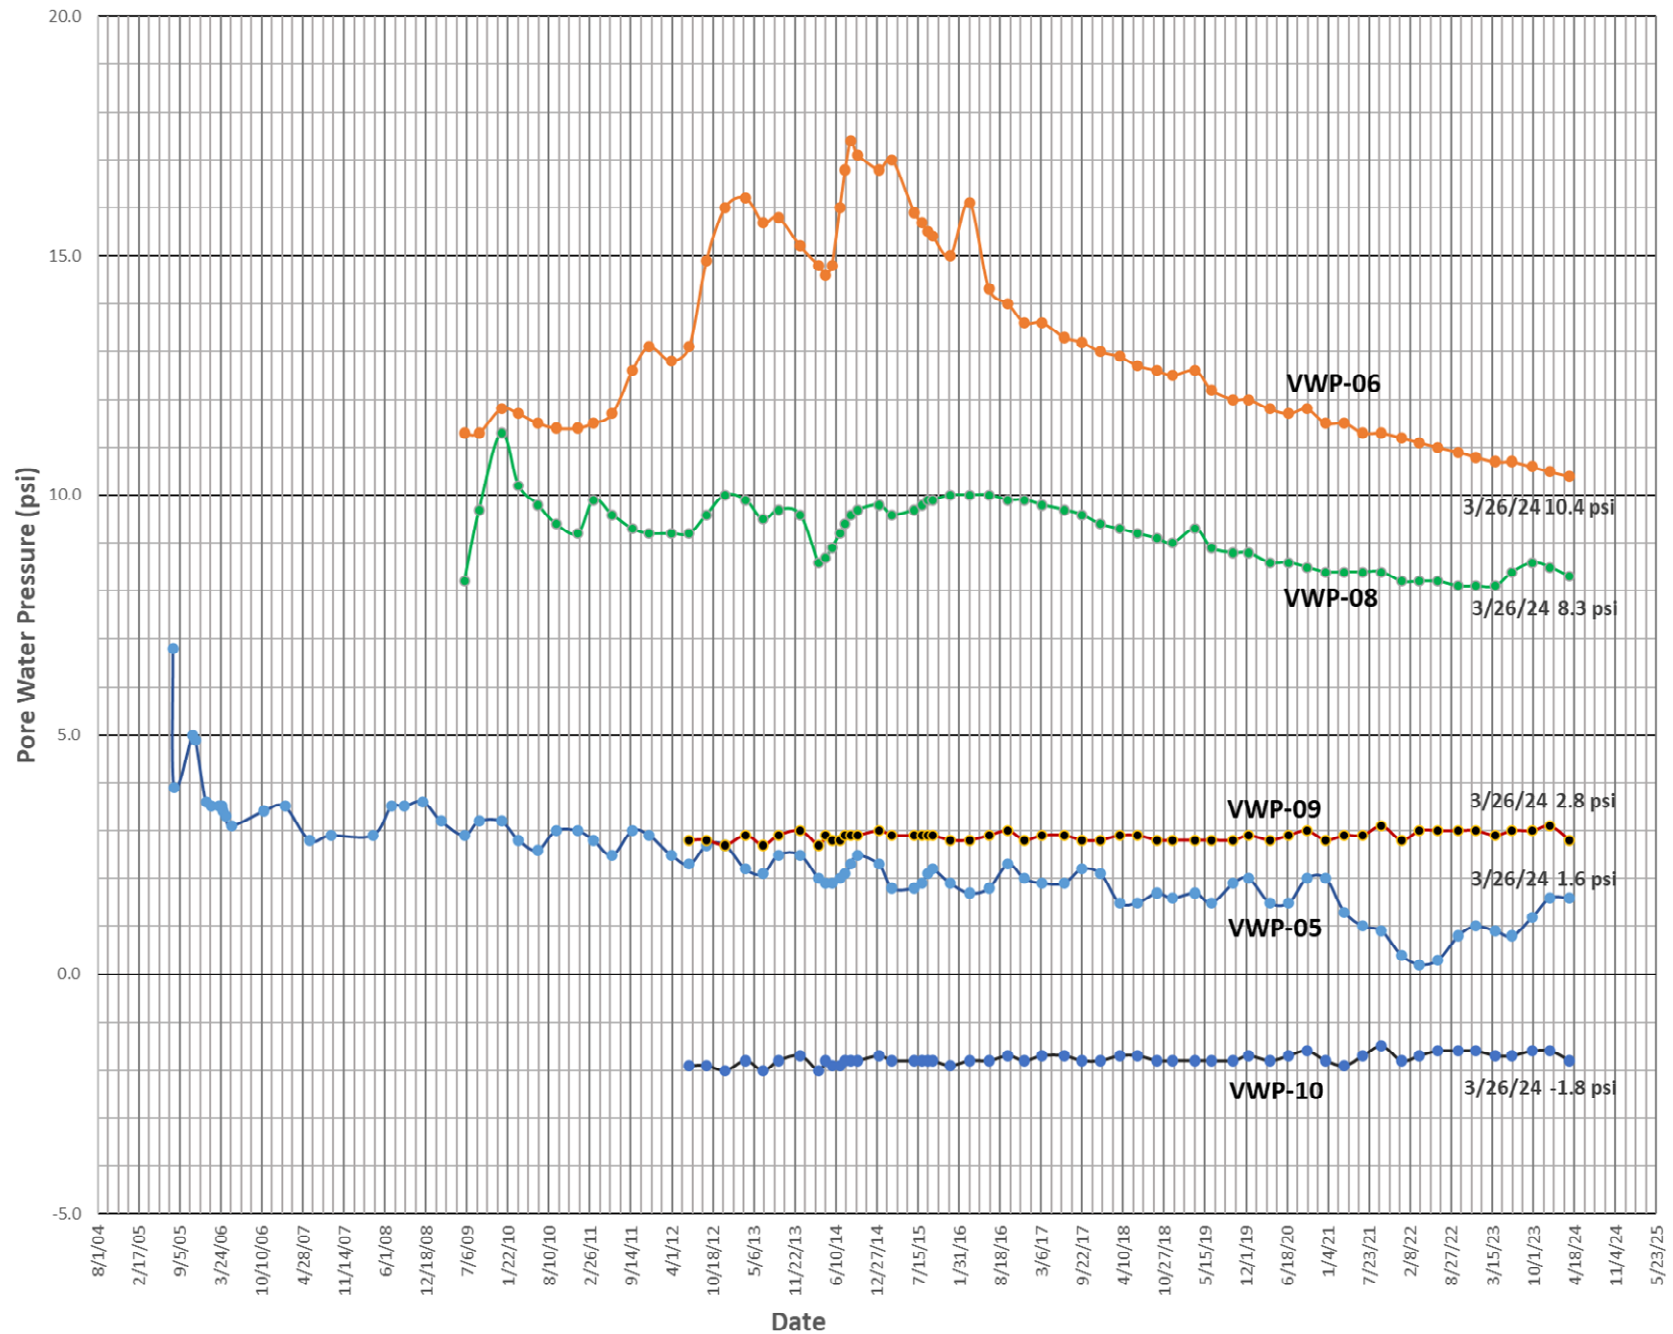
**Figure 2 - Bowie Mine #2 - CWDA #2**  
**Active Vibrating Wire Piezometer Data**

As seen on Table 1 and Figure 2, the VWP readings and trends are consistent with recent and historic readings. When compared to a year ago (Q1 2023), pore pressure readings in all the VWP's changed by small amounts (-0.3 to 0.7 psi). When compared with last quarter (Q4 2023), pore pressures also changed by relatively small amounts (0 to -0.3 psi) for all five VWP's. Although four of the five VWP's remain steady or have general declining trends in pore pressure over the life of the VWP's, one of the piezometers (VWP-05) has exhibited pronounced seasonal cyclical behavior for its lifespan, except from mid-2021 to mid-2022 where there was a steady decline in pore pressures. This piezometer generally (but not always) shows low pore pressures for Q1 and Q2 and higher pressures for Q3 and Q4, with a net loss of 5.2 psi over the lifetime of that VWP. The other four VWP's have experienced net changes of 0 to -0.9 psi since installation, meaning current readings are very similar to initial readings. For VWP-09 and VWP-10, pressures have been consistent throughout the lifetime of the piezometers; however, for VWP-06 and VWP-08, they experienced wild fluctuations in pore water pressure in the first half of their lifetimes but have settled to pressures similar to the installation pressures in the past several years.

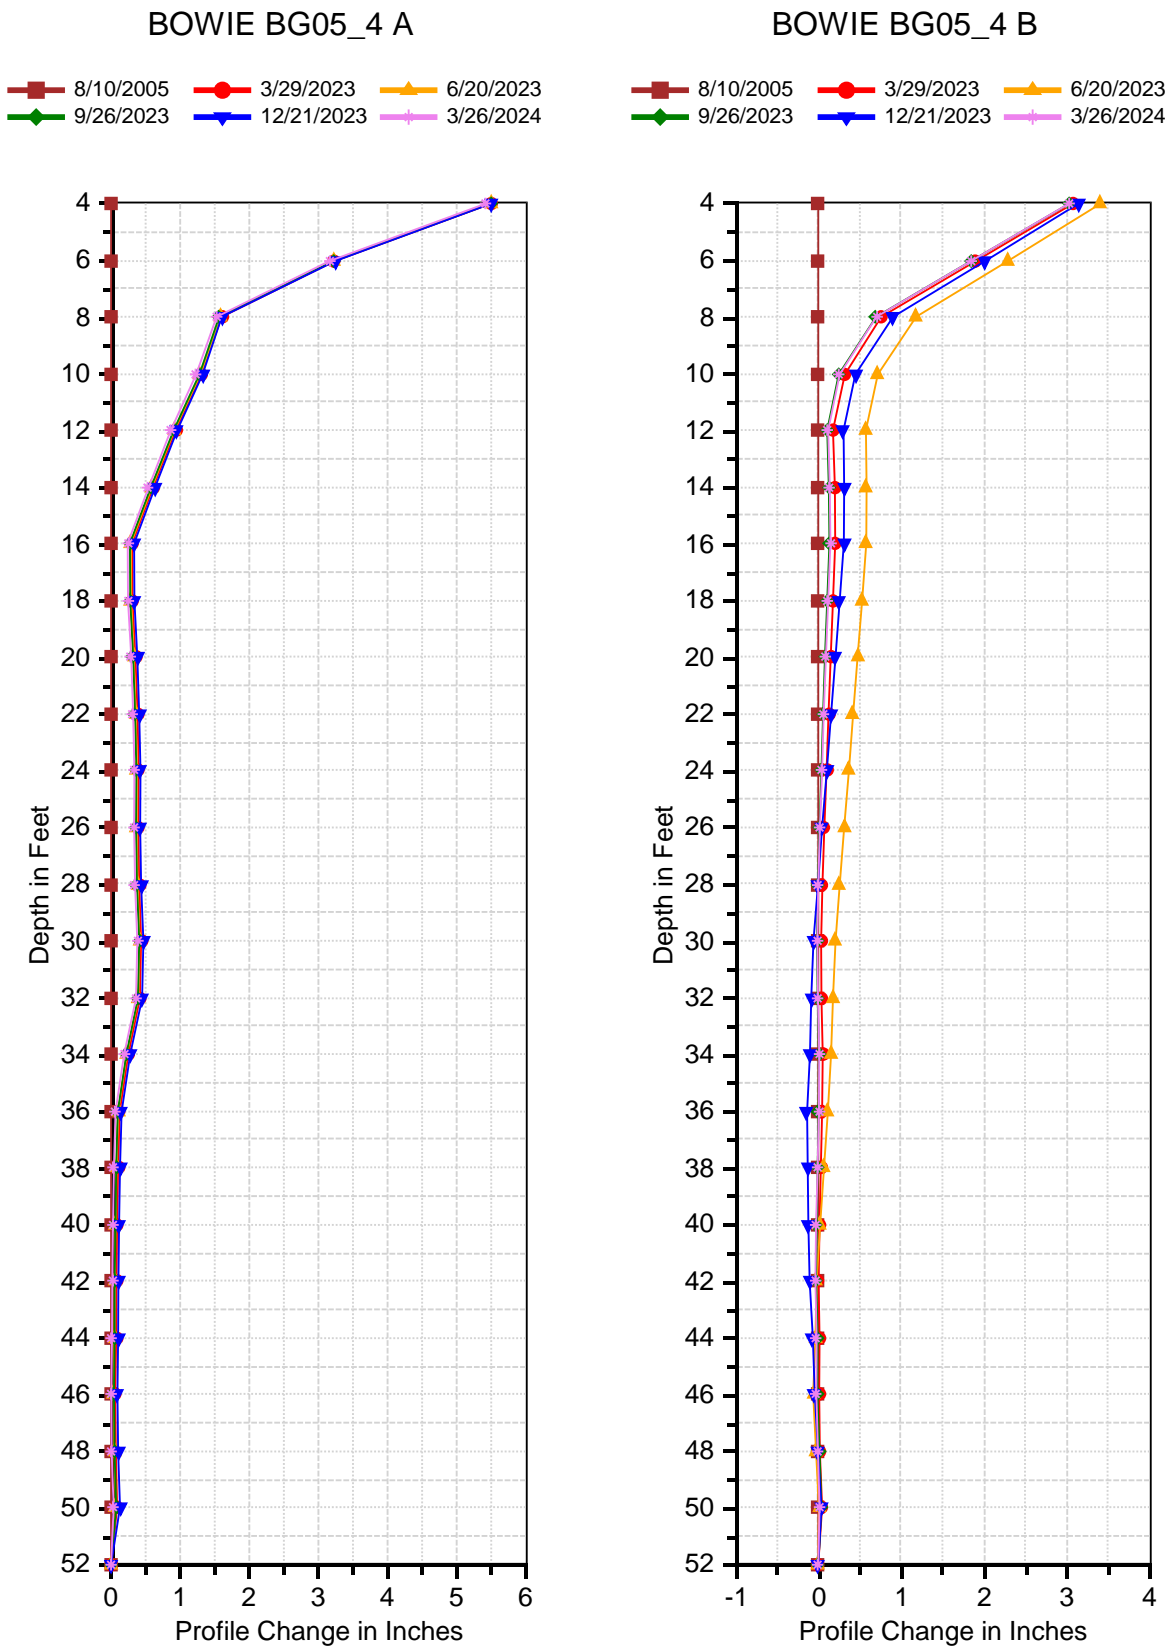
Figure 3 - Inclinator Displacement Curves

As described in previous reports, historic displacements indicated on the plots for the approximate upper 14-16 feet of the inclinometers since installation in 2005 are due to placement of cover soil on the face of the waste pile during revegetation/regrading operations in late 2006 and early 2007. This man-caused displacement is documented in a report by Buckhorn Geotech dated December 22, 2008, to Bowie Resources called *Revised Stability Evaluations for Coal Mine Waste Disposal Area No. 2, Bowie No. 2 Mine*.

Based on the current inclinometer readings, BG05\_7 shows near perfect alignment (essentially identical readings for 19 years) with the initial reading in 2005 for the downslope direction (Axis A). Inclinometers BG05\_4 and BG05\_5, however, show a bulge of less than 1/2-inch in the inclinometer pipes (below the surface regrading). Based on our records, this bulge developed slowly from 2005 to 2010, but no movement has been recorded since then. This suggests there had been some gob pile settlement early in the lifetime of the inclinometers, but no recent or additional movement has occurred. Some "noise" which is understood to be relatively common in orthogonal direction (Axis B) readings, was observed over the past few years for all three inclinometers. This can be due to various mechanical or installation causes that are unrelated to slope movement. For example, grout voids, poor grout coverage, or soil settlement around the instrument can all contribute to vibrations and pipe movement that impacts inclinometer
