## Bowie #2 inspection report

**PERMIT INFORMATION**

<b>Permit Number:</b> C-1996-083 <b>Mine Name:</b> Bowie No. 2 Mine <b>Operator:</b> Bowie Resources, LLC <b>Operator Address:</b> Mr. Basil Bear P.O. Box 1488 Paonia, CO 81428	<b>County:</b> Delta <b>Operation Type:</b> Underground <b>Permit Status:</b> Active <b>Ownership:</b> Private
	<b>Operator Representative Present:</b>  Basil Bear in office
<b>Operator Representative Signature: (Field Issuance Only)</b>

<b>Inspection Start Date:</b> April 9, 2024 <b>Inspection Start Time:</b> 11:45 <b>Inspection End Date:</b> April 9, 2024 <b>Inspection End Time:</b> 14:40		<b>Inspection Type:</b> Coal Partial Inspection <b>Inspection Reason:</b> Normal I&E Program <b>Weather:</b> Clear	
<b>Joint Inspection Agency:</b>  None		<b>Joint Inspection Contacts:</b>  	
<b>Post Inspection Agency:</b>  None		<b>Post Inspection Contacts:</b>  	
<b>Inspector(s):</b>  Robert Zuber, P.E.	<b>Inspector's Signature:</b>

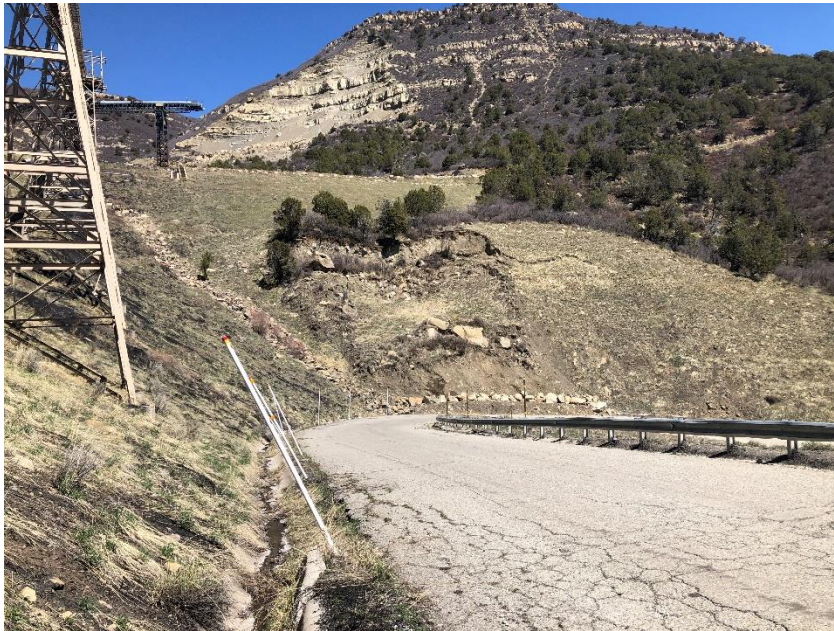
The road to the portals was in adequate condition. The slopes adjacent to this road are generally stable, except for the slide at Curve 10 (see Slides and Other Damage section).

The slide above Curve Number 10 appears to have moved more in recent months. This is an ongoing project for BRL.

**Slide at Curve 10**

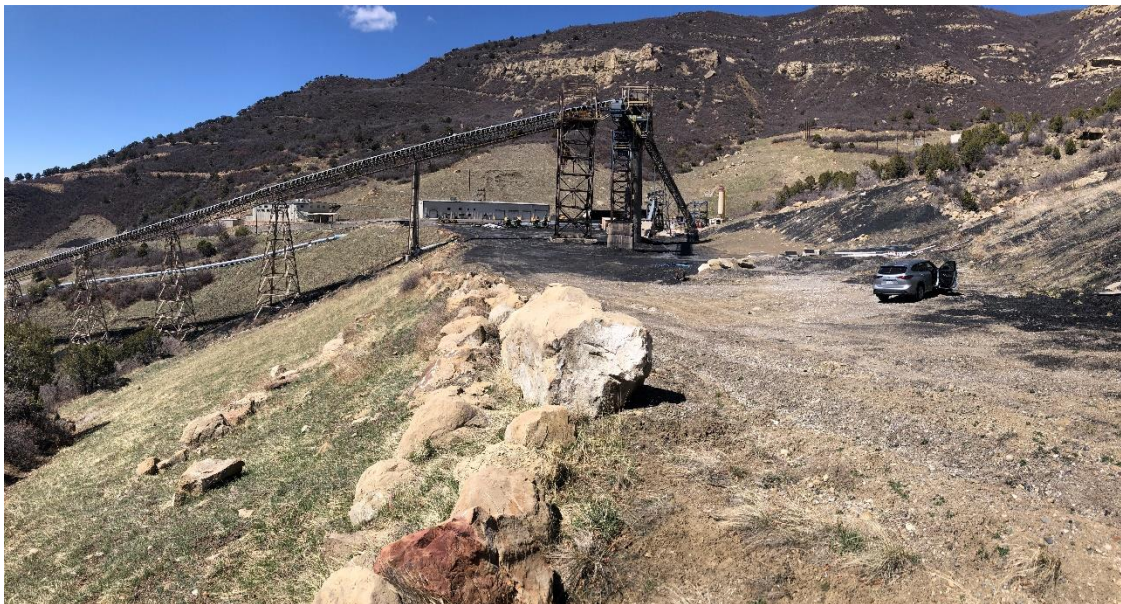
**D Portal Bench, looking west**

Several structures were inspected on the D Portal Bench. Heights of structures were measured with a laser instrument and horizontal dimensions were measured by counting paces. These measurements are estimates. The following list generally moves from east to west.

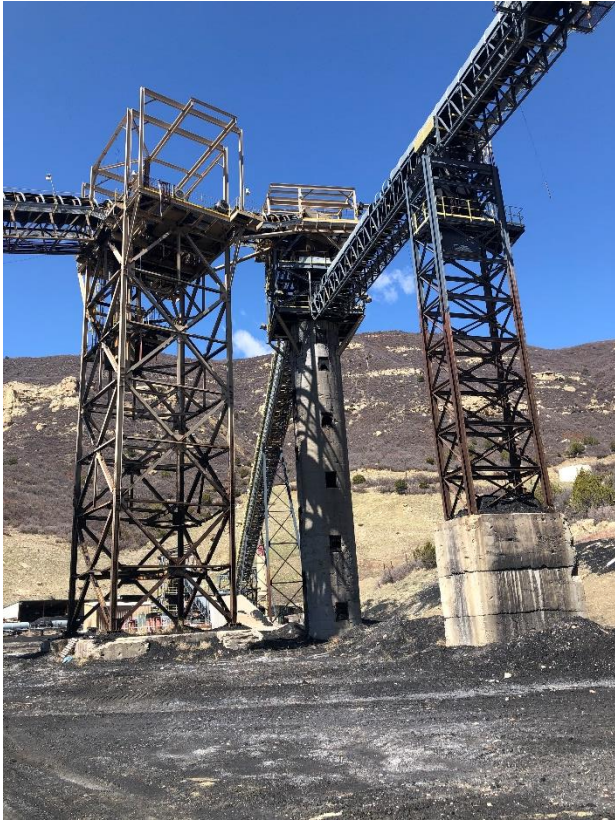
- Stacking Tube – The height of the tube itself is 82 feet. With the superstructure on top of it, the structure height is 120 feet. The diameter of the tube is 10 feet.

**D Portal Bench – stacking tube and conveyor supports**

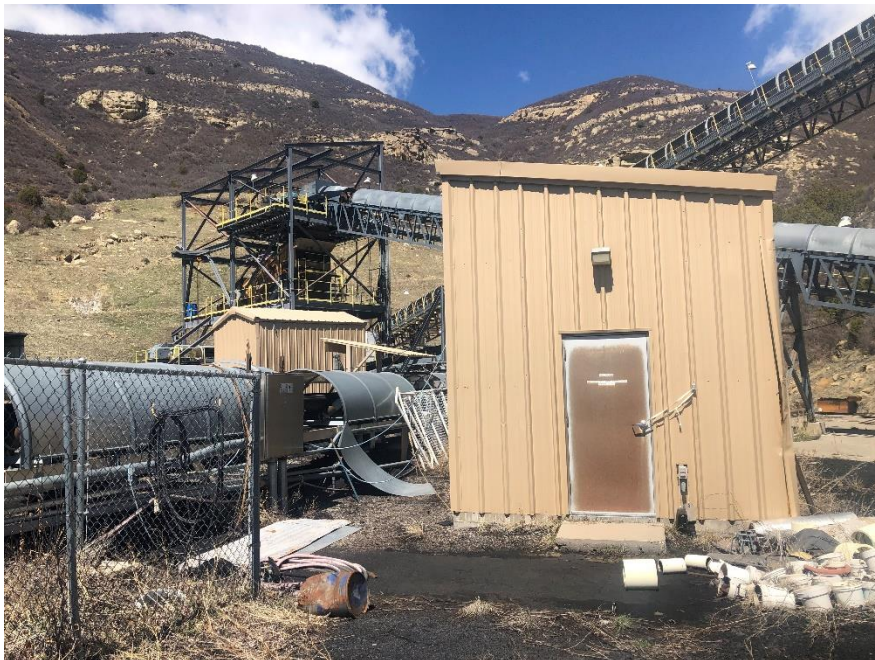
- Two small structures (brown metal) near the top of the downhill conveyor –
  - The southeast building is 13 feet high, and horizontal dimensions are 10 feet by 17 feet.

- The northwest building is 13 feet high, and horizontal dimensions are 8 feet by 12 feet.
- Screen and Crusher Structure - 45 feet high, and horizontal dimensions are 20 feet by 38 feet.

**D Portal Bench – small metal structures near top of transfer (downhill) conveyor**

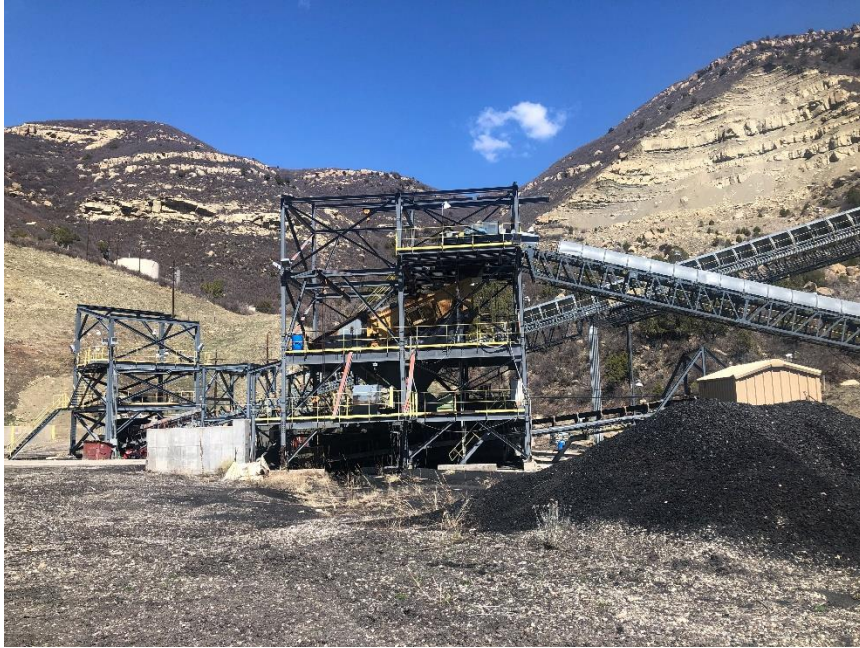
**D Portal Bench - screen and crusher structure**

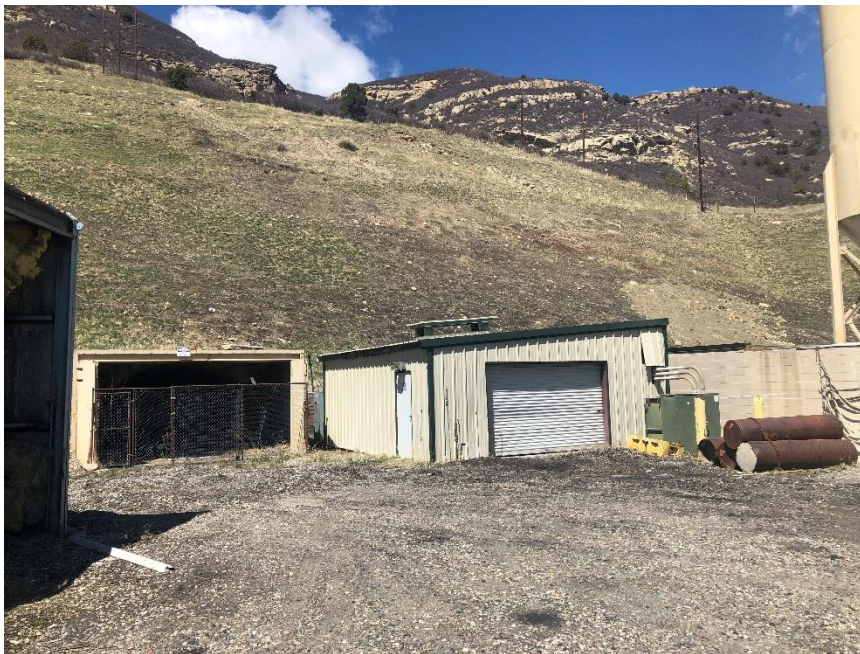
- Mine Vent Fan – Part has been removed. Portion left is 11 feet high, and horizontal dimensions are 20 feet by 20 feet.
- Rock Dust Storage Bin
  - The height of the bin is 52 feet, and the diameter is 8 feet.

**D Portal Bench – mine vent area**

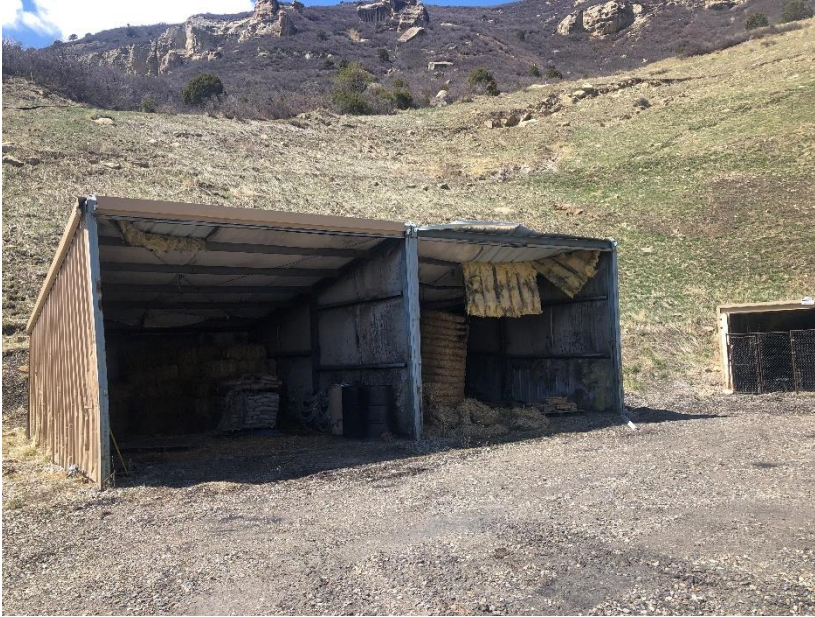
- The height of the block structure below the bin is 8 feet, and the horizontal dimensions 12 feet by 35 feet.
- Covered storage by fuel station - 10 feet high, and horizontal dimensions are 20 feet by 24 feet.

**D Portal Bench - covered storage by fuel station**

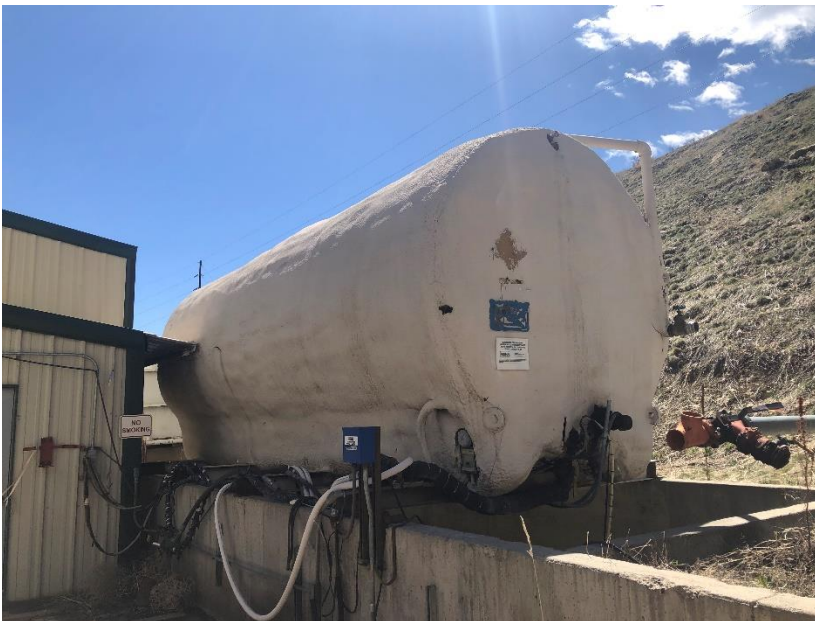
Six tanks are located at the D Portal Bench. A large one is behind the building, and five of them are in the building. Dimensions were not measured.

**D Portal Bench – large tank**

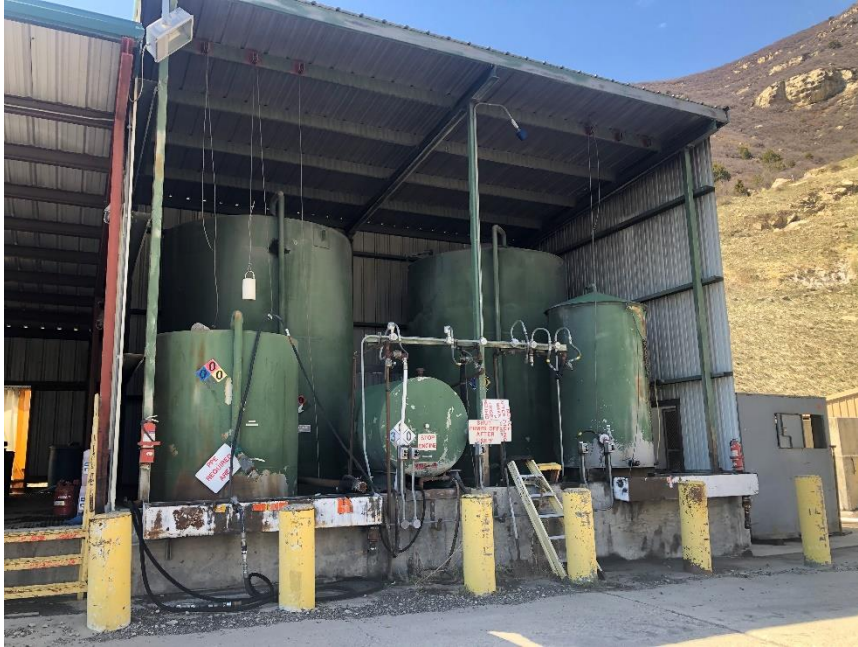
**D Portal Bench – covered tanks**

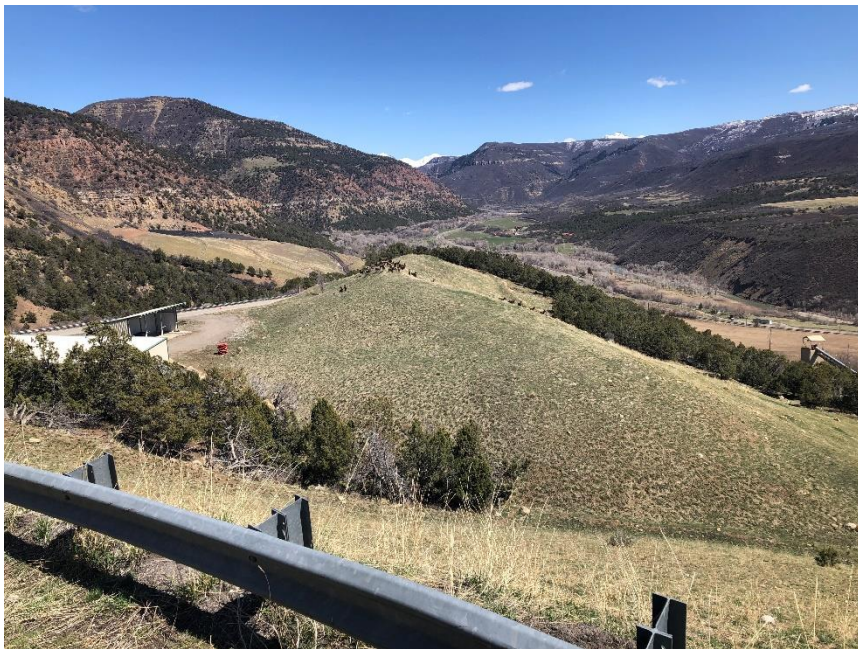
Many elk were seen on Topsoil Stockpile A.

No erosion or other problems were seen with topsoil stockpiles or coverfill piles.

**D Portal Bench – elk on Topsoil Stockpile A**
