**MINERALS PROGRAM INSPECTION REPORT**  
**PHONE: (303) 866-3567**

<b>MINE NAME:</b> NCCI Pit #1	<b>MINE/PROSPECTING ID#:</b> M-2001-107	<b>MINERAL:</b> Sand and gravel	<b>COUNTY:</b> Weld
<b>INSPECTION TYPE:</b> Surety-Related Inspection	<b>WEATHER:</b> Clear	<b>INSP. DATE:</b> April 3, 2024	<b>INSP. TIME:</b> 10:00
<b>OPERATOR:</b> Northern Colorado Constructors, Inc. Aggreg	<b>OPERATOR REPRESENTATIVE:</b> Chris Zadel	<b>TYPE OF OPERATION:</b> 112c - Construction Regular Operation	
<b>REASON FOR INSPECTION:</b> Surety Related	<b>BOND CALCULATION TYPE:</b> None	<b>BOND AMOUNT:</b> \$486,745.00	
<b>DATE OF COMPLAINT:</b> NA	<b>POST INSP. CONTACTS:</b> None	<b>JOINT INSP. AGENCY:</b> None	
<b>INSPECTOR(S):</b> Brock Bowles	<b>INSPECTOR'S SIGNATURE:</b>

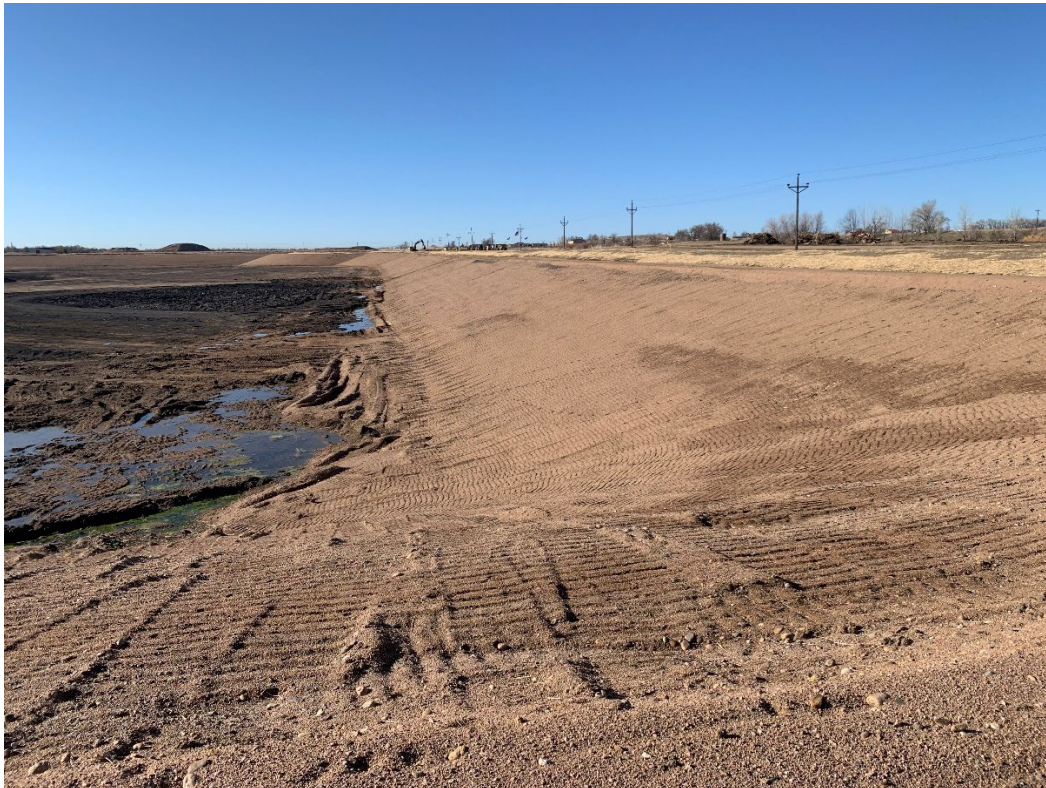
The NCCI Pit reservoir was built with a compacted clay liner (photos 1 & 2). The clay liner was leak tested by DWR between August and November 2023. The liner was approved on November 30, 2023. The storage cell contained a small amount of water. The source of the water was from precipitation that was received within the last 72 hours.

Photo 1 – Reservoir western slope facing south.

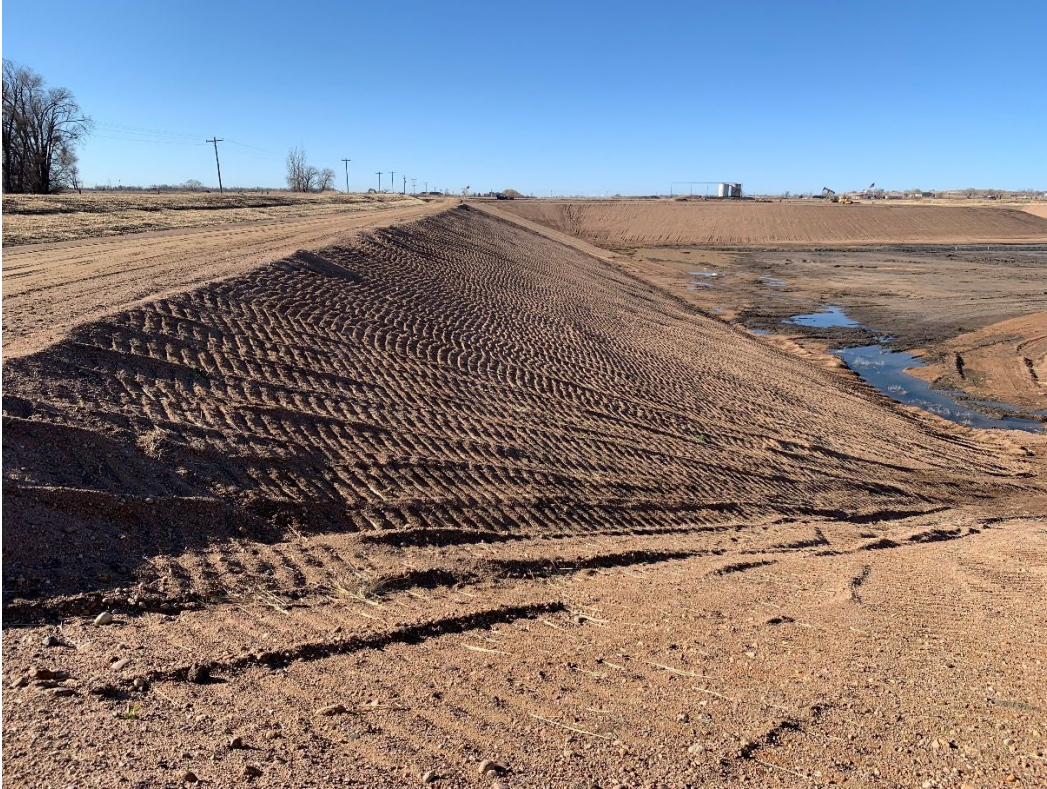
Photo 2 – Northeast corner of reservoir facing south toward oil well peninsula.

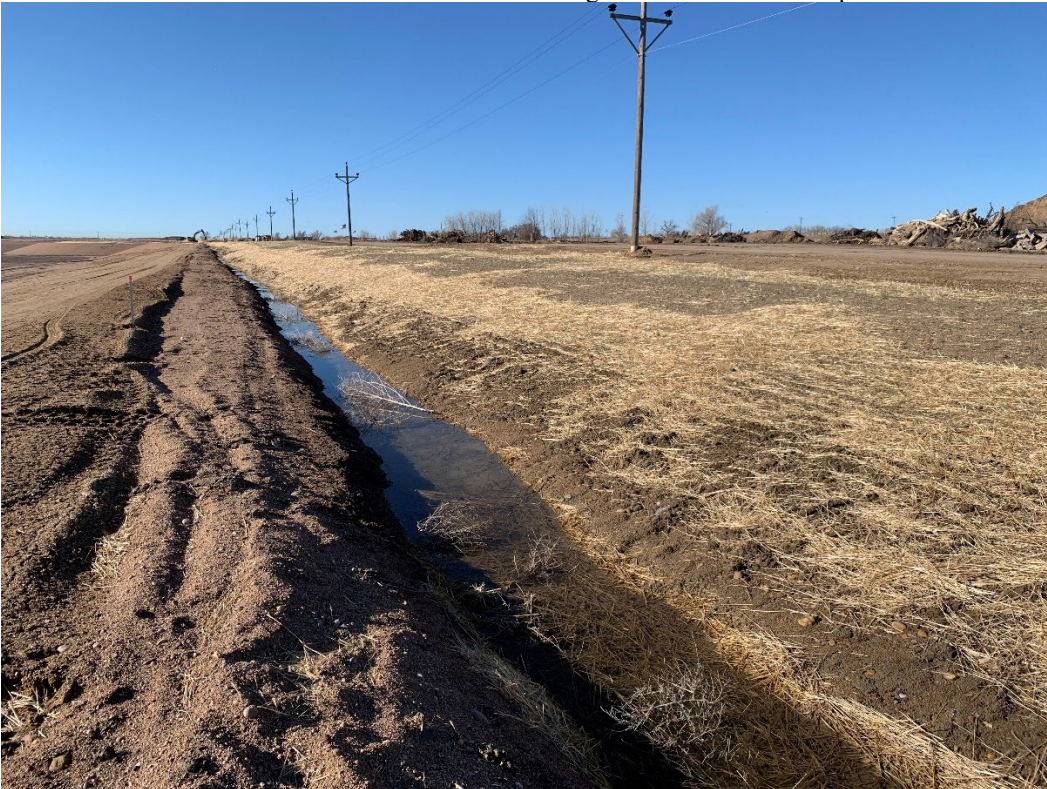
A stormwater diversion ditch was in place on the northeast, north and west sides of the reservoir (photo 3). The ditch directs all stormwater around the reservoir to the northwest corner where it is released into a return ditch back to the South Platte River.

Photo 3 – Western side stormwater diversion ditch, water flows toward picture.

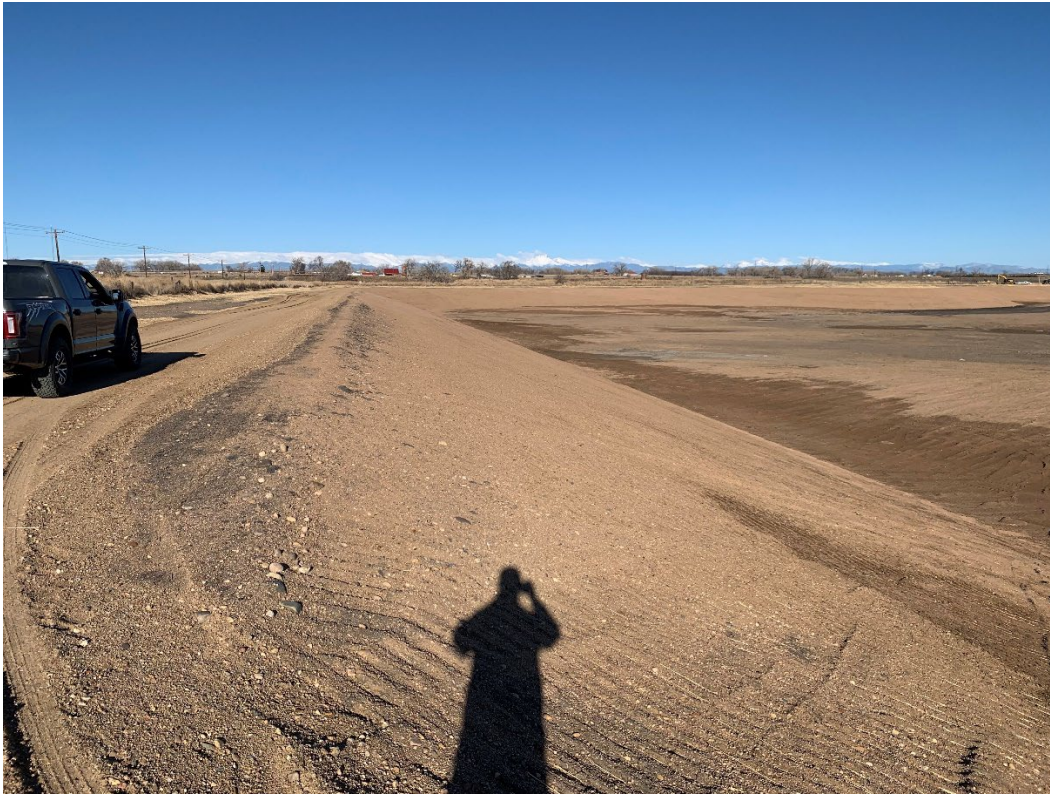
The land the reservoir is on is owned by the City of Thornton. The reservoir has an area of about 80 acres and is 34 feet deep according to the construction drawings approved by the City of Thornton. The side slopes on all sides are graded to 3h:1v and are covered in gravel (photo 4). No topsoil was applied to the side slopes.

Photo 4 – South slope facing west.

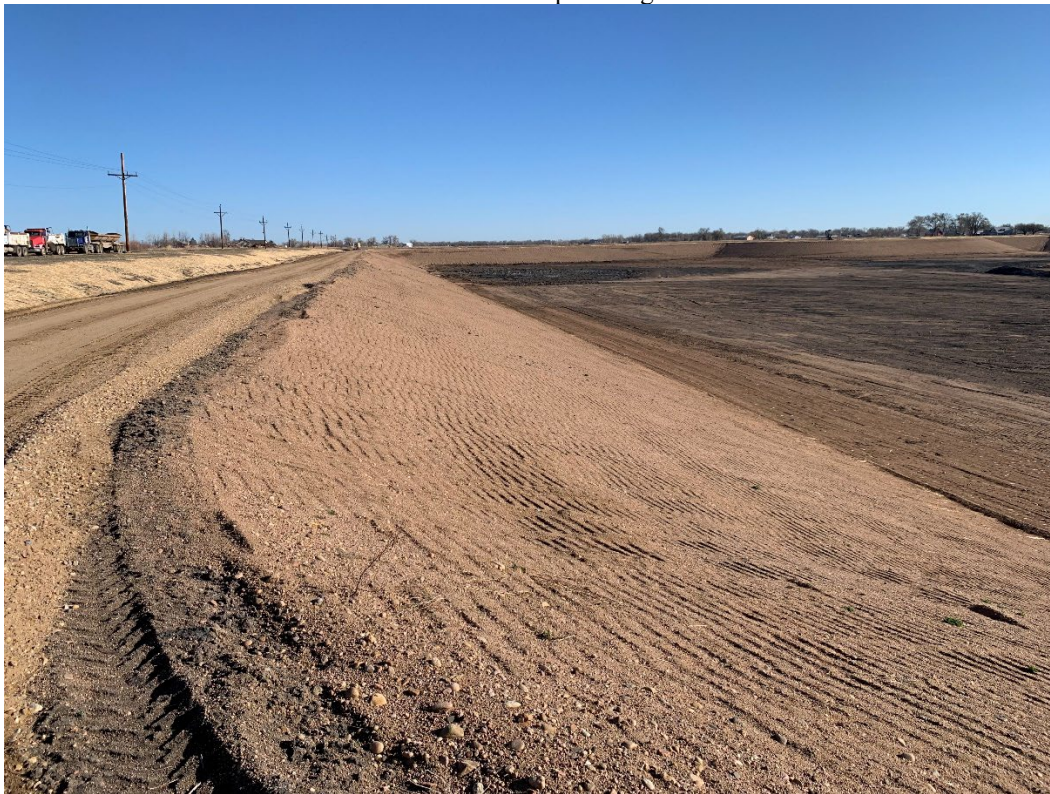
A gravel access road was installed around the perimeter of the reservoir (photo 5). The road is approximately 20 feet wide and slopes away from the reservoir towards the stormwater diversion ditch. This design is consistent with the construction plans.

Photo 5 – Gravel access road (left) around perimeter of reservoir.
