Inspection Report, Foidel Creek Mine, C-1982-056

PERMIT INFORMATION

Permit Number: C-1982-056 Mine Name: Foidel Creek Mine Operator: Twentymile Coal, LLC Operator Address: Ms Miranda Kawcak 29515 Routt County Road No. 27 Oak Creek, CO 80467	County: Routt Operation Type: Underground Permit Status: Active Ownership: Private
	Operator Representative Present: Miranda Kawcak
Operator Representative Signature: (Field Issuance Only)

This was a partial inspection of the Foidel Creek Mine; DRMS Permit No. C-1982-056, operated by Twentymile Coal, LLC. (TC). The inspection was conducted by Hunter Ridley with the Colorado Division of Reclamation, Mining, and Safety (Division). Miranda Kawcak of TC was present at the mine office and Kevin Copeland and Mike Howard of TC accompanied the inspection. **Please address the Bold items below.**

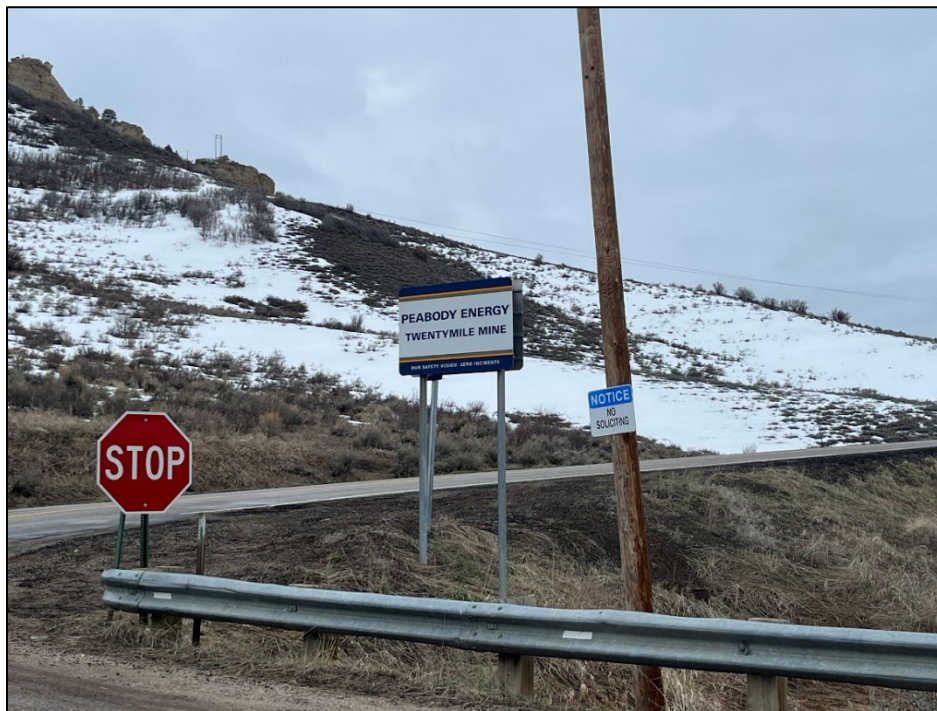
Mine identification markers were observed throughout the site (Photo 3). All information for compliance was present on mine signs. Signs were also noted along CR27 where the mine's permit boundary crosses the public road.

Photo 3: Mine sign at the site entrance off CR 37.

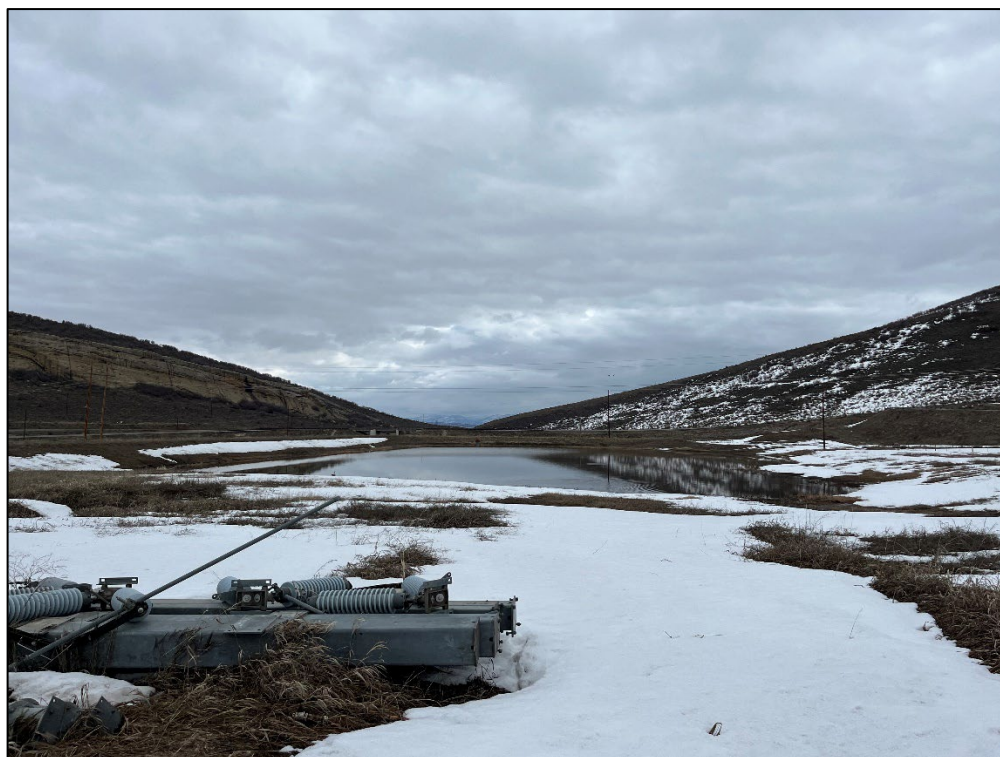
Ponds were checked for discharge and culverts were inspected for function where conditions allowed. No culverts appeared to be fully blocked, but TC should continue to clean out culverts when vegetation and sediment hinders function. Notable observations include the discharge from ponds which are usually dry, i.e. Ponds G (Photo 4) and C (Photos 2 and 12). The recent melt of heavy snow at the site prompted these discharge events. Pond F was also discharging (Photo 5).

Photo 4: View north of Pond G, discharging at the time of inspection.

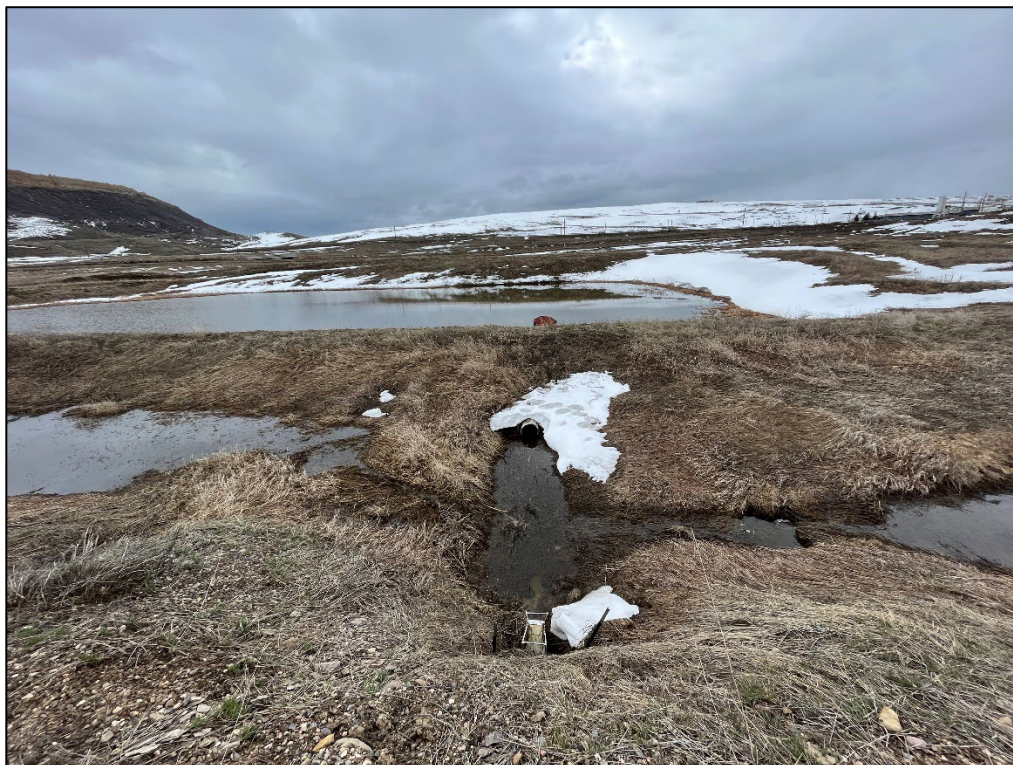
Photo 5: View east of Pond F, discharging at the time of inspection.

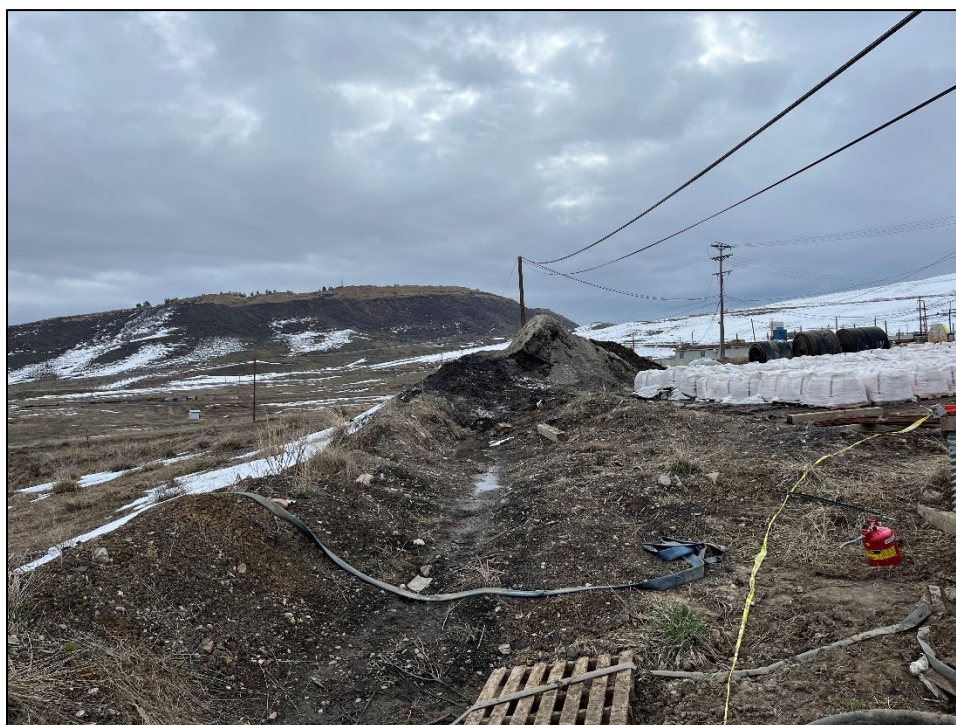
Support facilities such as the PM Bay, warehouse, belt storage area, and surplus storage area were inspected. A ditch behind the warehouse, just east of the weld shop, was found to be blocked by a large pile of ice, snow, and debris left over from winter plowing (Photo 6). Foidel Creek is located directly north of this ditch, and any water flowing out of or around this ditch could potentially be contributing

sediment or pollutants to the creek. This pile of ice and debris will need to be removed to maintain full function of the ditch. **This has been added as a maintenance item. Please ensure this task is completed by the next month's inspection.**

Photo 6: Remnants of snow, ice, and debris have been pushed into the ditch located behind the warehouse, removal of this blockage has been added as a maintenance item.

- Remove the large pile of ice, snow, and debris from the ditch locate behind the warehouse by next month's inspection.
- Ensure BMPs near the Stoker Coal Loadout area are consistently maintained and replaced as needed throughout the spring season.
- Remove excess sediment from ponds around the main facilities area as soon as weather allows.
- Protect topsoil piles throughout the site during maintenance and snow plowing activities in the winter months

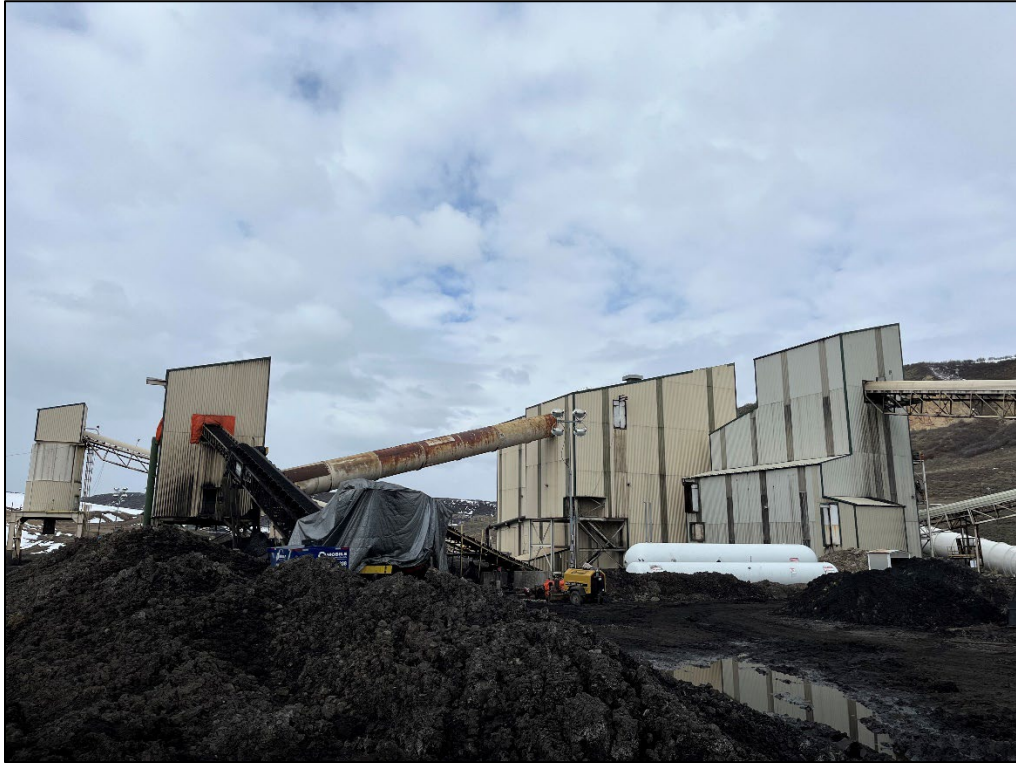
Several months ago, the Division was informed that a large, old conveyor tube located on the eastern side of the wash plant facility had been damaged. However, a temporary replacement conveyor has been put in place at the facility while a new conveyor tube is being fabricated (Photo 7). Coal continues to be processed. The Operator stated that a fully replaced conveyor would likely not be on site until fall of 2024.

The refuse pile was active at the time of inspection. Since the installation of a temporary conveyor system at the wash plant (Photo 7), haul trucks have been able to recommence hauling, piling, reworking, and compacting of refuse material. Lifts three and four of the pile are currently under construction (Photo 8) with plans to topsoil and see at least one bench this year. No standing water was present on top of the refuse pile. Compaction reports for the refuse pile, also called subsidence reports, are conducted quarterly, and received annually on 3/1 of each year.

Photo 7: A temporary conveyor has been added to the wash plant facility.

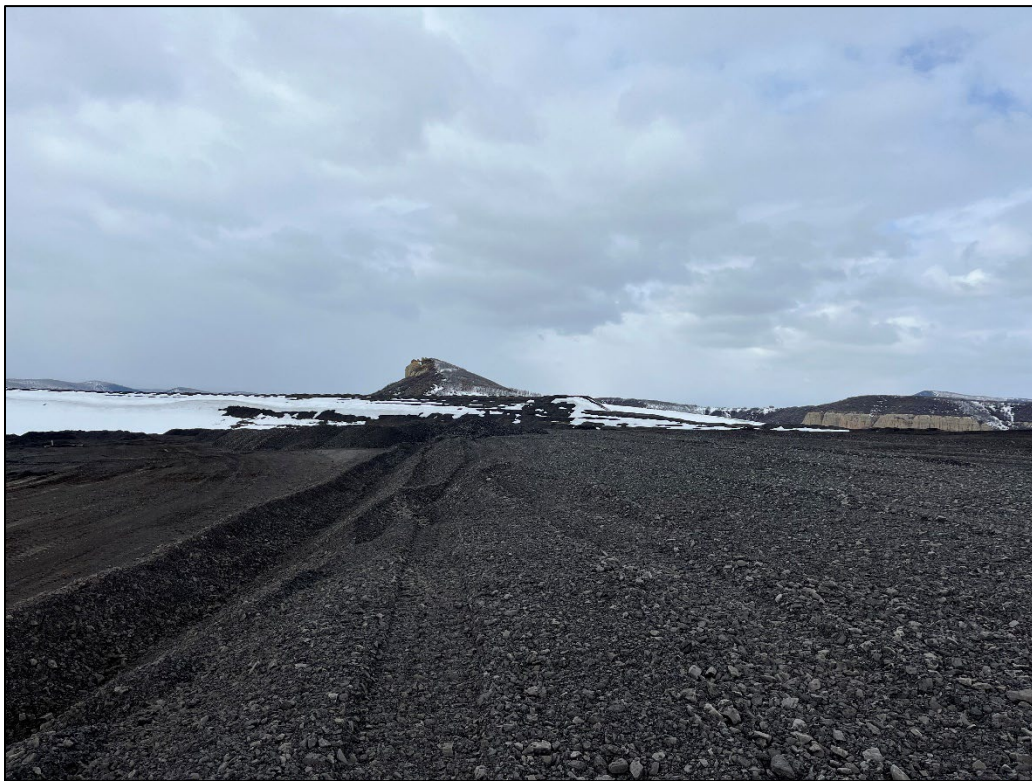
Photo 8: View atop the coal refuse pile.

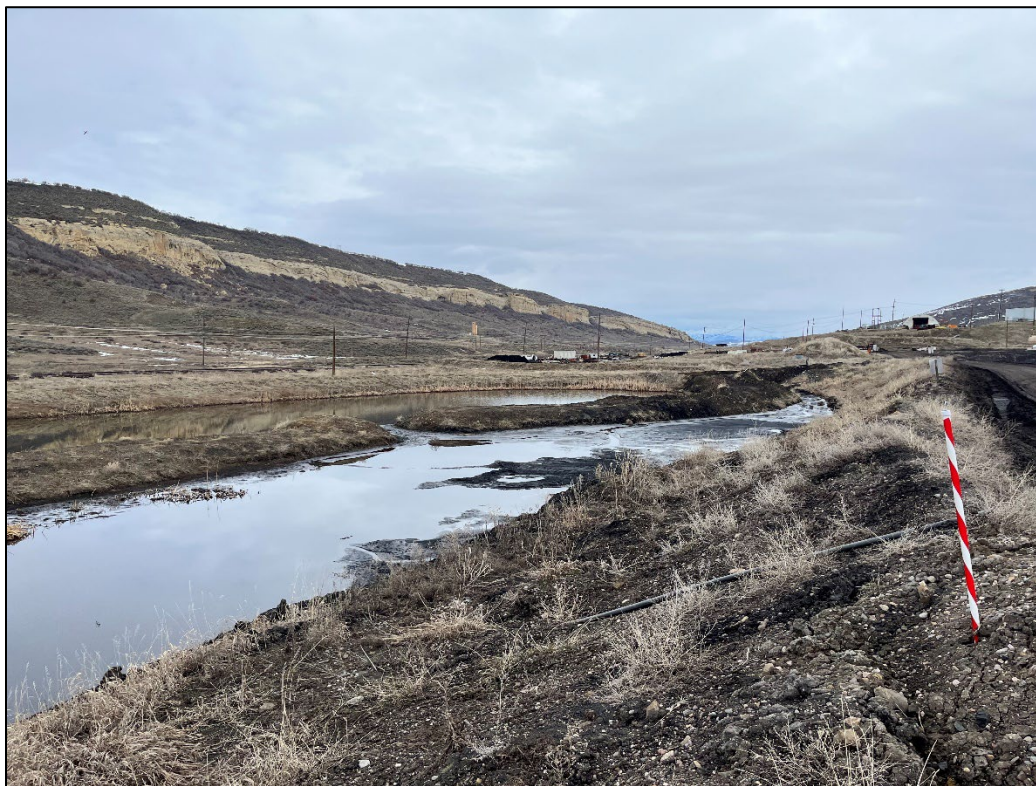
Most ponds around the main facilities area were noted to be in need of sediment cleanout, especially Ponds E (Photo 9) and B (Photo 13). A french drain was recently in need of repair in the BOB (Belt out back) coal storage area. Excess water in this area caused an increase in sediment flow at this end of the main facilities, which contributed to the need for clean out at the ponds. This cleanout effort should be conducted as soon as weather allows and has been added as a maintenance item. No erosional or structural issues were noted at any of the ponds.

Photo 9: View north of Pond B, in need of clean out.

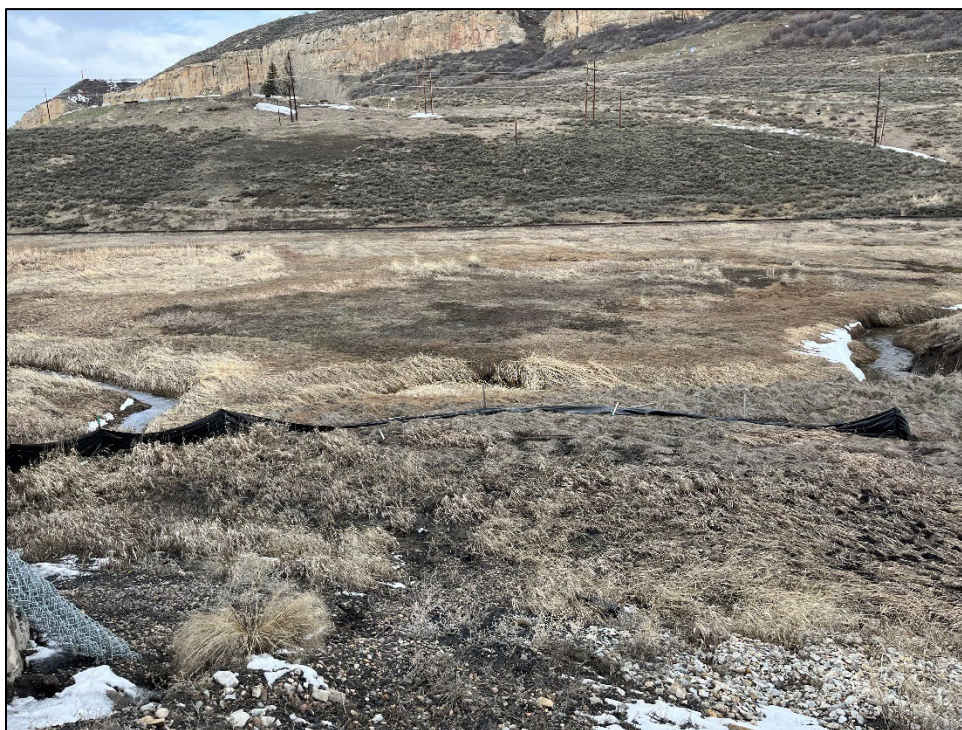
The stoker coal loadout building is routinely inspected to ensure that BMPs are in place and to ensure that the recent sealing of the wash building continues to keep water from draining down the northwestern hillside. Since an SAE (small area exemption) has been granted for this area, it is imperative that proper BMPs are in place to prevent sediment from reaching nearby Foidel Creek, especially as the spring season creates rapid and heavy runoff conditions at the site. As of the date of this inspection, the silt fences on either side of the loadout building were not properly in place (Photo 10). Additionally, hay bales placed behind the building to act as BMPs are nearly at capacity for sediment retention and are therefore in need of replacement (Photo 11). While these BMPs were originally required to deal with excess sediment traveling from the hillside due to a leak at the stoker building, runoff from heavy snowmelt has also caused small rills in the hillside and thus requires BMPs to be consistently in place to protect Foidel Creek. **The upkeep of BMPs in this area continue to be a maintenance item, however the Division will have to pursue more formal corrective actions if proper conditions in this area are not consistently maintained.**

Photo 10: View west towards Foidel Creek taken from behind the stoker loadout building, silt fence is in need of repair.

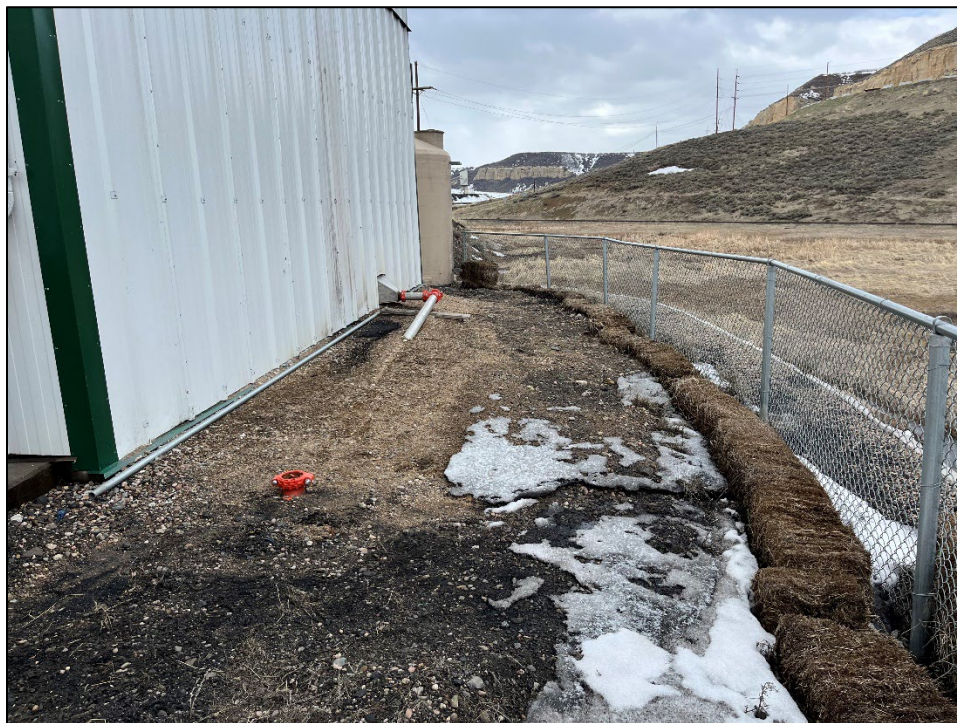
Photo 11: Hay bales behind the loadout building need to be replaced.

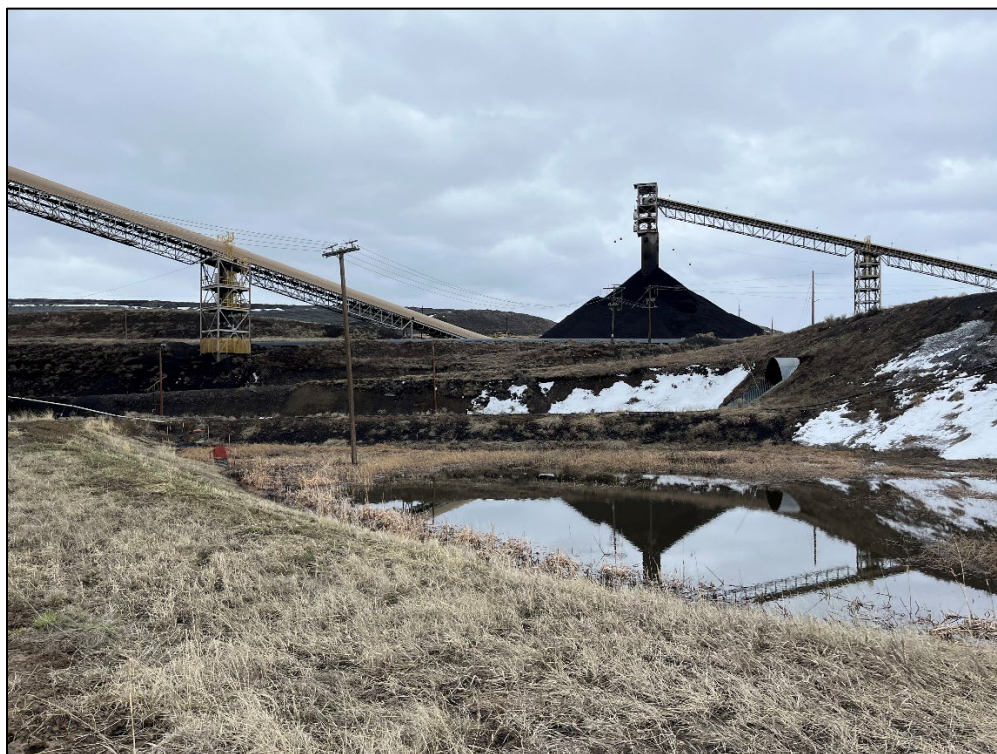
Photo 12: View east of Pond C, discharging at the time of inspection.

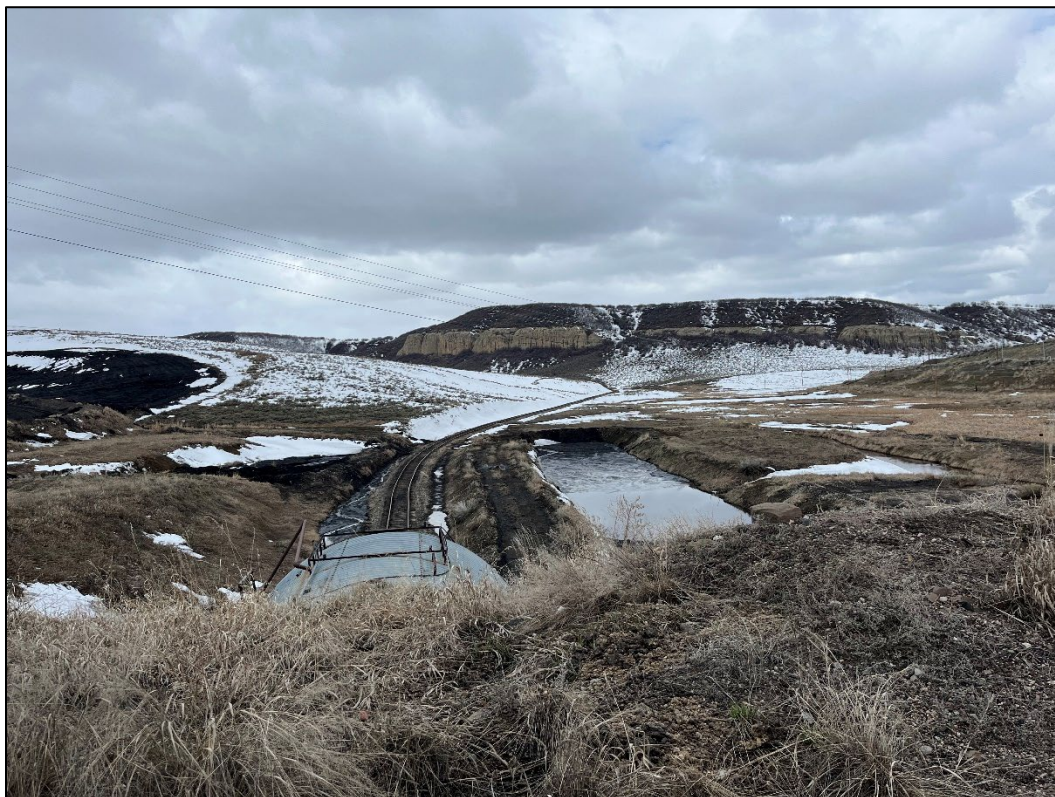
Photo 13: View south of Ponds B, in need of cleanout.

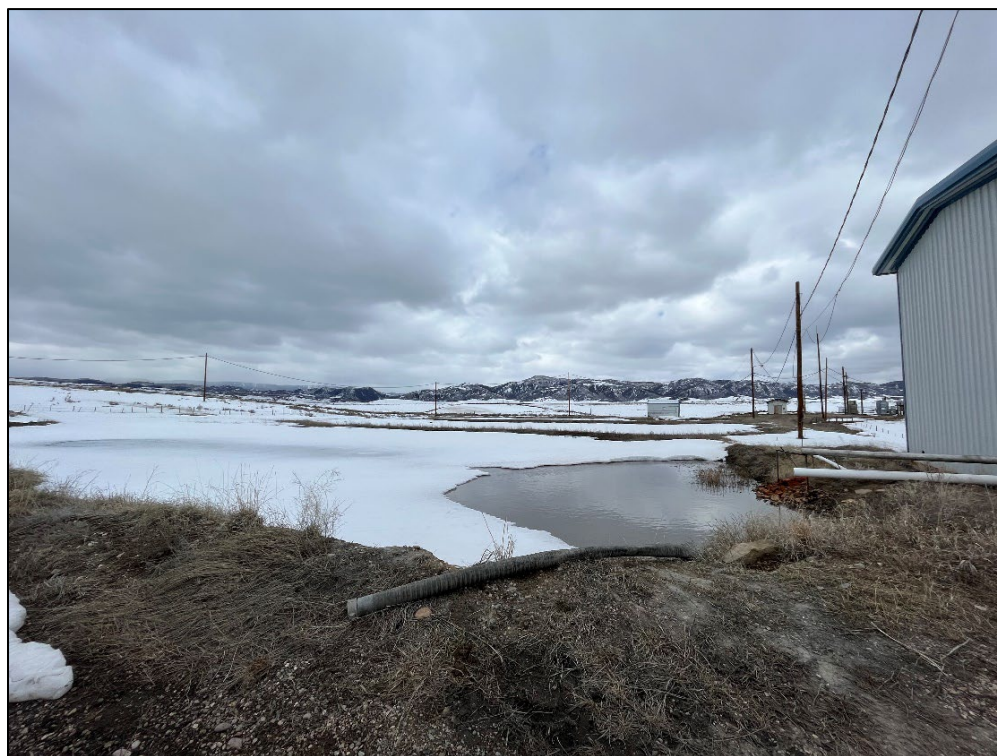
The Tipple Area and Fish Creek borehole is generally unused. The 9 East Exhaust Blower Pad and reclaimed 18 Right boreholes were unable to be inspected in this area due to snow and mud on access roads. The Fish Creek ponds are functioning properly (Photo 14).

Photo 14: View west of the Fish Creek Tipple Ponds.
