# PITCH RECLAMATION PROJECT COLORADO MINED LAND RECLAMATION BOARD 2023 ANNUAL RECLAMATION REPORT

**RECLAMATION PERMIT NUMBER M-1977-004**

April 2024

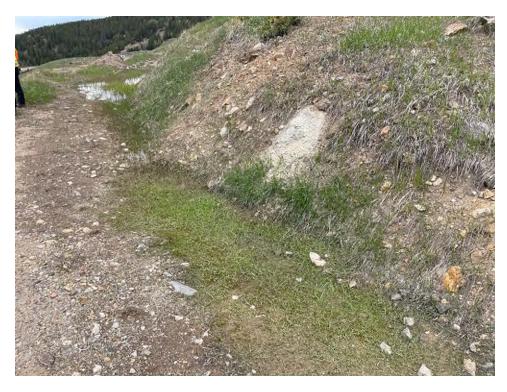
Photograph: 7

**Description: RD-Seep**

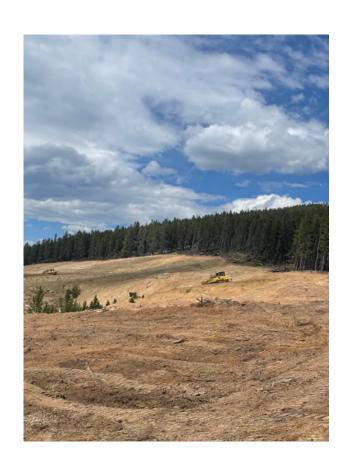
Photograph: 10

**Description: North Pit**

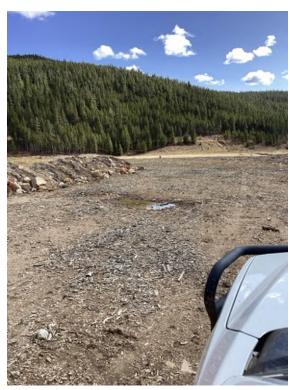
Photograph: 24

Description: Pooling area in Tie Camp

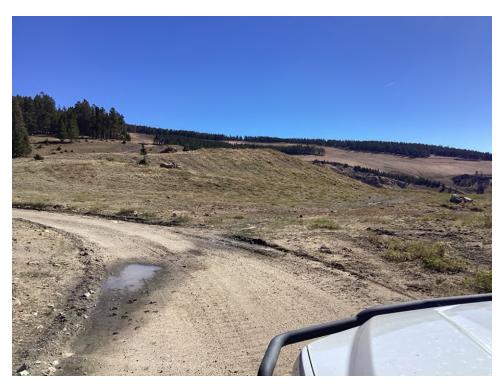
Photograph: 29

Description: Low spot on road and in background at toe of

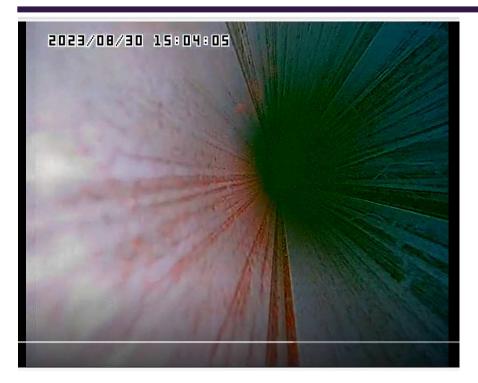
**Image 1:** 198-1 at 20 feet: Example of grooves wore into the inclinometer and material build up in the inclinometer tracks. Image taken abover the water level.

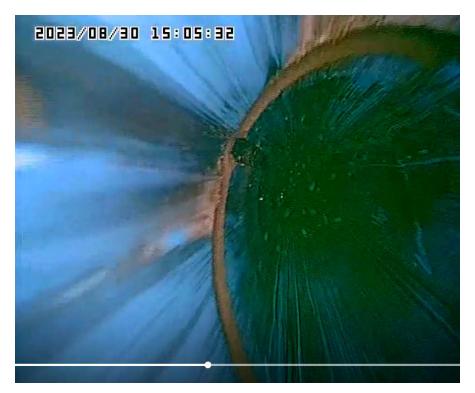
**Image 2:** I98-1 @ 122 feet: Example of separation between inclinometer casing joints observed between 100 feet and the bottom of the inclinometer.

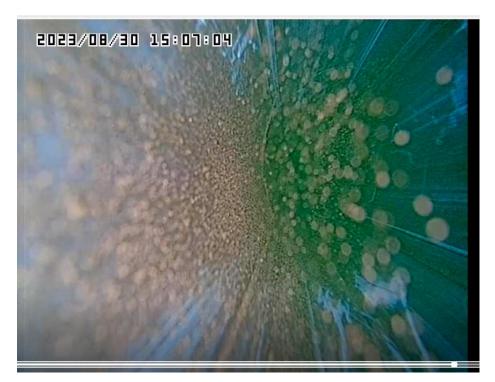
Image 3: 198-1 @ 150 feet: Example of oxidation and silt build up between where with joint separation.

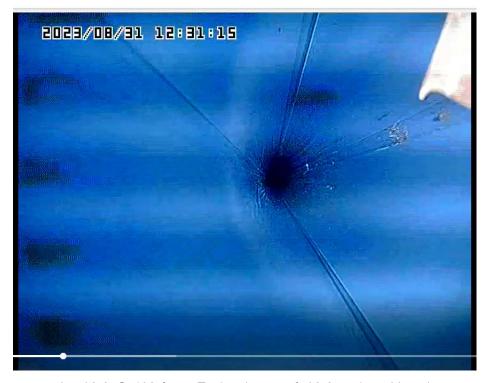
**Image 4:** I98-2 @ 100 feet: Typical image of I98-2 casing. Very little accumulation and mostly clear inclinometer grooves.

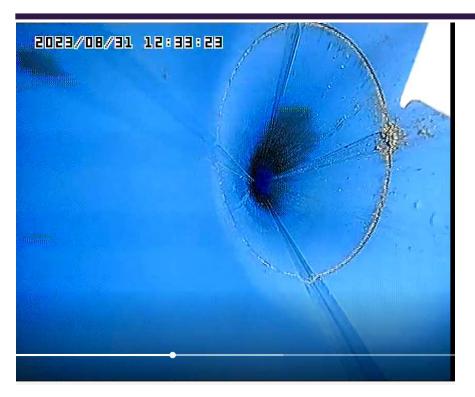
**Image 5:** I98-2 @ 150 feet: Typical image of I98-2 casing joints. Very little separation and mostly clean of oxidation or debris.

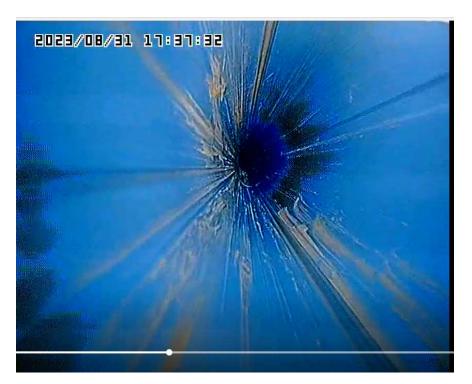
**Image 6:** I98-3 at 20 feet: Image taken from IN-1 survey. Typical image of dirty inclinometer tracks and grooves worn into the casing.

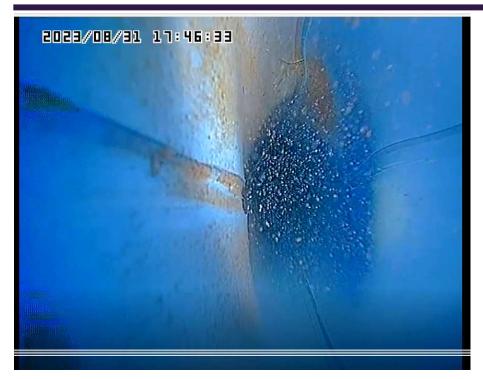
Image 7: 198-3 at 270 feet: Damaged, warped casing.

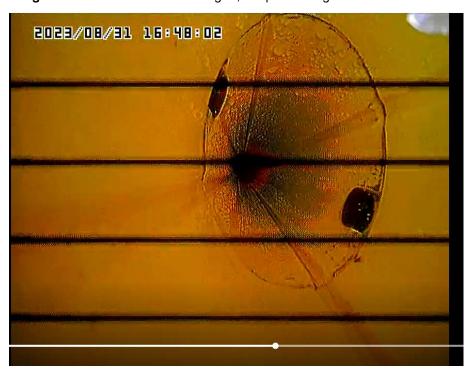
**Image 8**: IN-2 at 32 feet. Typical image of casing joints and grooves observed in IN-1, IN-2, and IN-3. No issues observed in IN-1, IN-2, or IN-3.

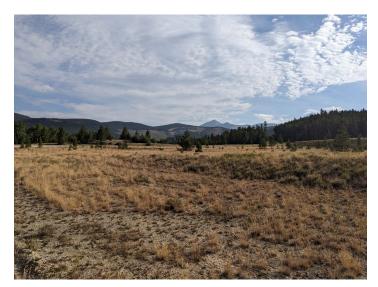
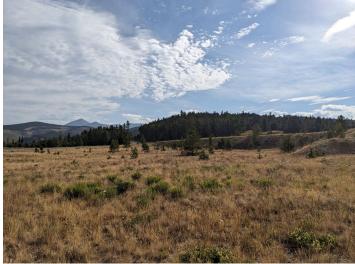
<u>Mill Site</u>: Reclamation of the mill area is complete. The area has been regraded and vegetation is well established. No problems were noted.

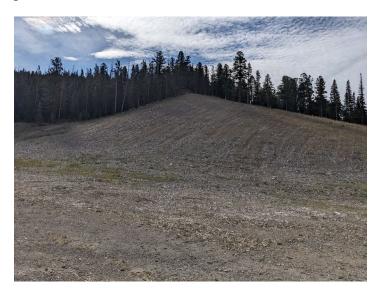
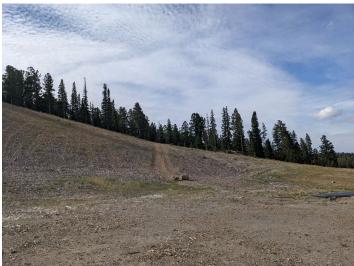
<u>Limestone Quarry</u>: Reclamation grading at the quarry area is complete. The area has been seeded and vegetation is becoming established. The work observed appears to be in accordance with the approved reclamation plan. No problems were noted.

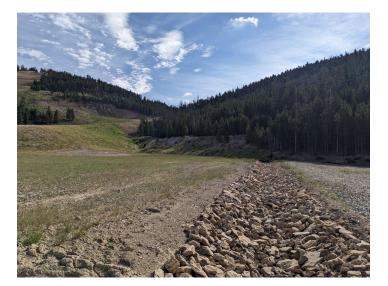
<u>Tie Camp area</u>: The laydown area has been regraded and seeded. Vegetation is becoming established. Drainage structures have been constructed and appear to be functioning as designed. No problems were noted in this area.

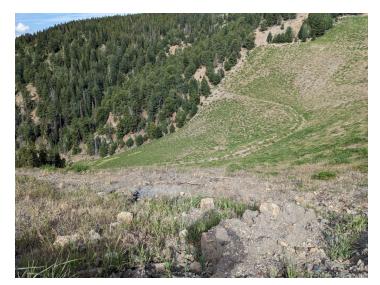
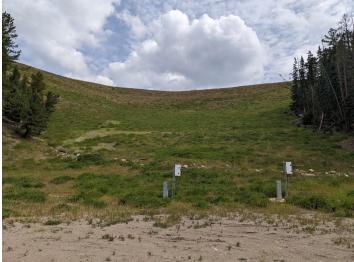
<u>Indian Rock Dump</u>: Slopes appear stable here. Vegetation is well established. No problems were noted.

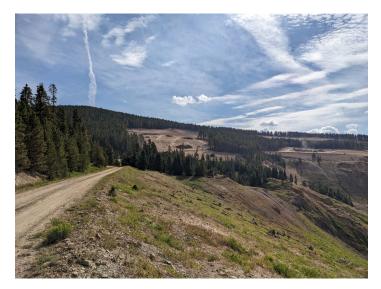
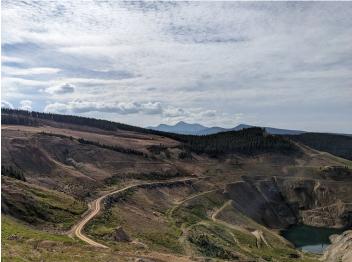
North Pit: The landslide area has been logged and grading is underway. The operator has made significant progress in the area during this operating season. The North Pit diversion ditch was extended behind the Mine Shop and additional drainage channels are being constructed in the landslide area. No problems were noted in this area.

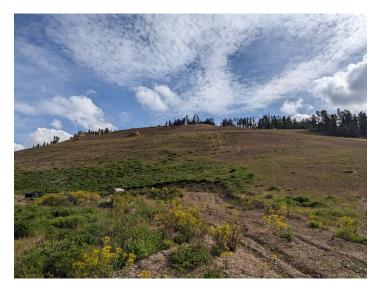
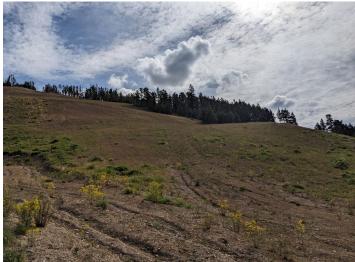
<u>South Pit</u>: Grading and stabilization work took place in the South Pit area in 2020. The slope appears stable and vegetation is becoming well established. No problems were noted in this area.

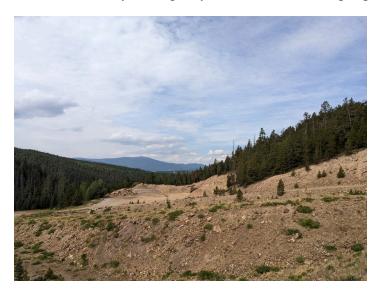
Sandstone Quarry: The quarry is still utilized for rip rap material on site. No problems were noted in this area.

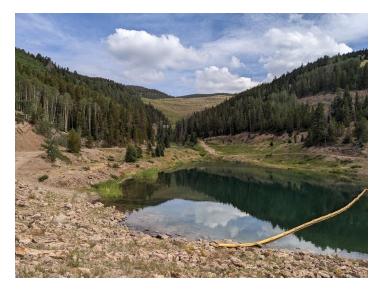
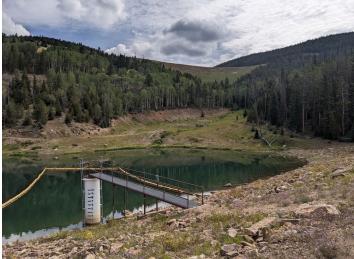
<u>Sediment Pond</u>: The sediment pond is well maintained and appeared to be functioning as designed. No problems were noted.
